**Subject:** FW: H0306-01 Carlingford Landfill  
**Attachments:** tier 2 finalRev A.pdf

**REPORT  
ON THE  
GEOPHYSICAL SURVEY  
AT A  
LANDFILL  
AT  
CARLINGFORD, Co. LOUTH  
FOR  
SITE INVESTIGATIONS LTD.**

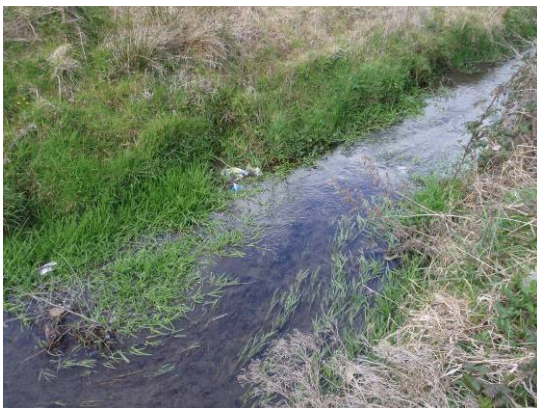
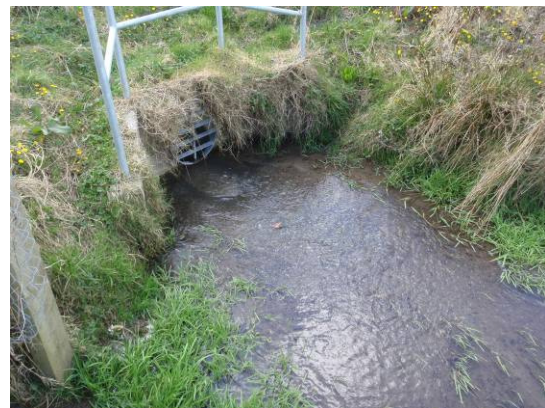
Site Code (Grid Reference)	J 1927 1099
Site Location	Just d/s culvert
Channel Width (m)	6-8
Depth (cm)	5-15
Substrate (in order of dominance)	Mud, Gravel (small amount)
Flow Type	Riffle 10% Glide 90%
Instream Vegetation	<i>Glyceria</i> sp. 20% <i>Rorippa nasturtium-aquaticum</i> agg. <5%
Dominant Bankside Vegetation	Grass, Nettle
Summer Shade of Stream by Bankside Vegetation	<5%
Trout Adult Habitat	None
Trout Nursery Habitat	Poor-None
Trout Spawning Habitat	None

At Site 1 the macroinvertebrate fauna recorded at the site merit a Q-rating of Q3 indicating poor ecological status and moderately polluted conditions.

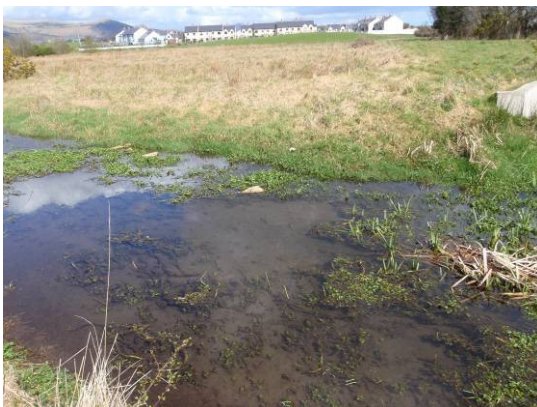
**Site 2**

Site Code (Grid Reference)	J 1924 1116
Site Location	d/s tributary on RHS
Channel Width (m)	c. 8
Depth (cm)	5 - 15
Substrate (in order of dominance)	Mud
Flow Type	Glide 100%
Instream Vegetation	<i>Apium nodiflorum</i> 15% <i>Sparganium erectum</i> <5% <i>Rorippa nasturtium-aquaticum</i> agg. <5%
Dominant Bankside Vegetation	Grass
Summer Shade of Stream by Bankside Vegetation	<5%
Trout Adult Habitat	None
Trout Nursery Habitat	None
Trout Spawning Habitat	None
Lamprey Nursery	Good
Lamprey Spawning	None
