Subject: FW: Historic Landfill at Moate
Attachments: Certification 2018.pdf; Post Remedial Monitoring Programme 2018.pdf; S Moran_2017_IGI register.pdf; Tier 3 Assessment Moate 2018.pdf

Please find the following documentation attached relating to the Certification of Authorisation application for the former Moate Landfill site:

1. Revised Tier 3 Risk Assessment
2. Post remedial Monitoring Programme
3. Credential of the Qualified Person (Sean Moran)
4. Certification.

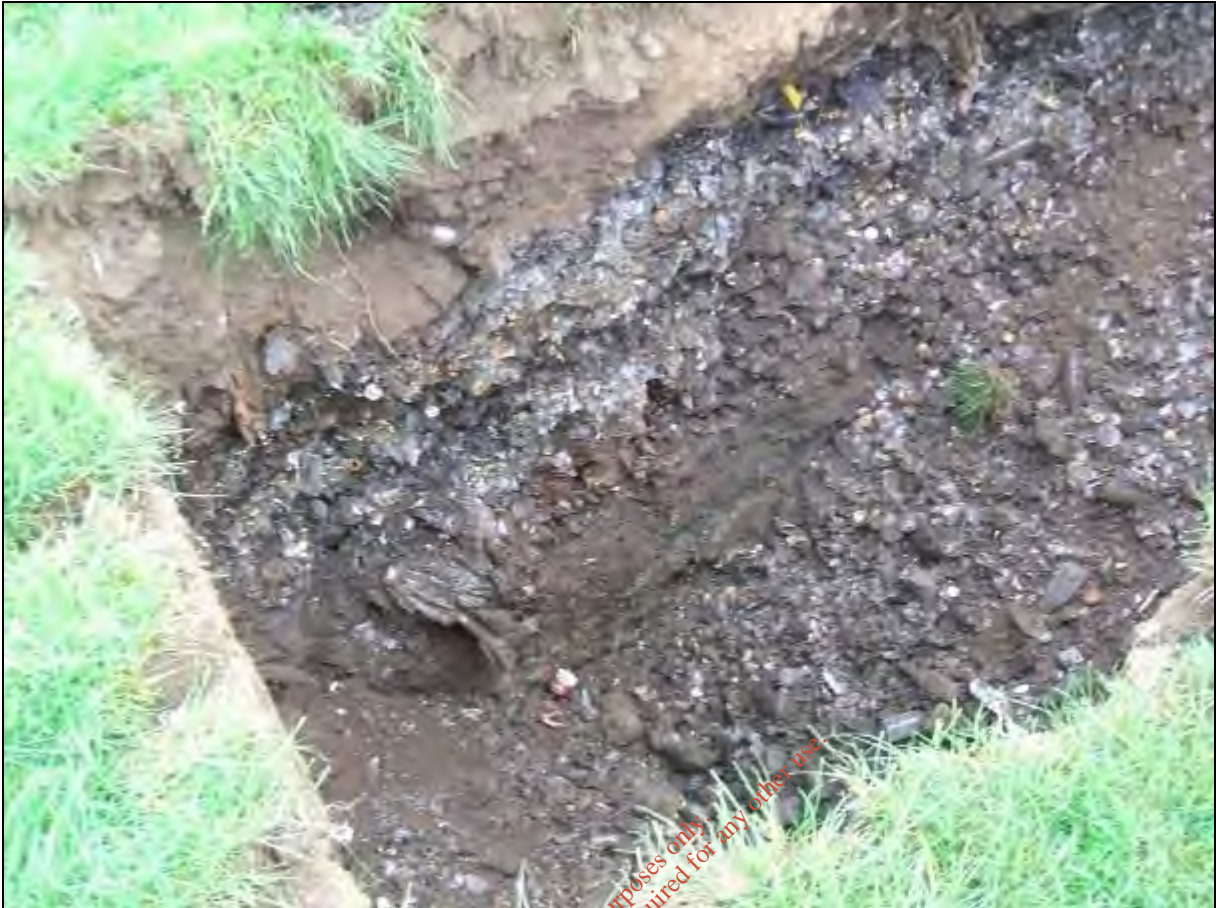
Photograph No 1 Waste material encountered in TP-5

It is assumed that the sandy clay was used as cover material when the site was operational, but no discrete layers were noted. A newspaper dated 1970 was found in TP-4 and food packaging dated 1990 was found in TP-5. There was no evidence of any significant amounts of potentially hazardous waste (e.g. oils, solvents).

The waste encountered comprised plastic bags, glass bottles, concrete blocks, bricks, cardboard, car parts, fragments of steel, newspapers, food packaging all of which were supported by a sandy clay matrix. There was no evidence of food or putrescible waste. The nature of waste observed is typical of household waste that has been buried for more than 15 years and which has undergone considerable biodegradation.

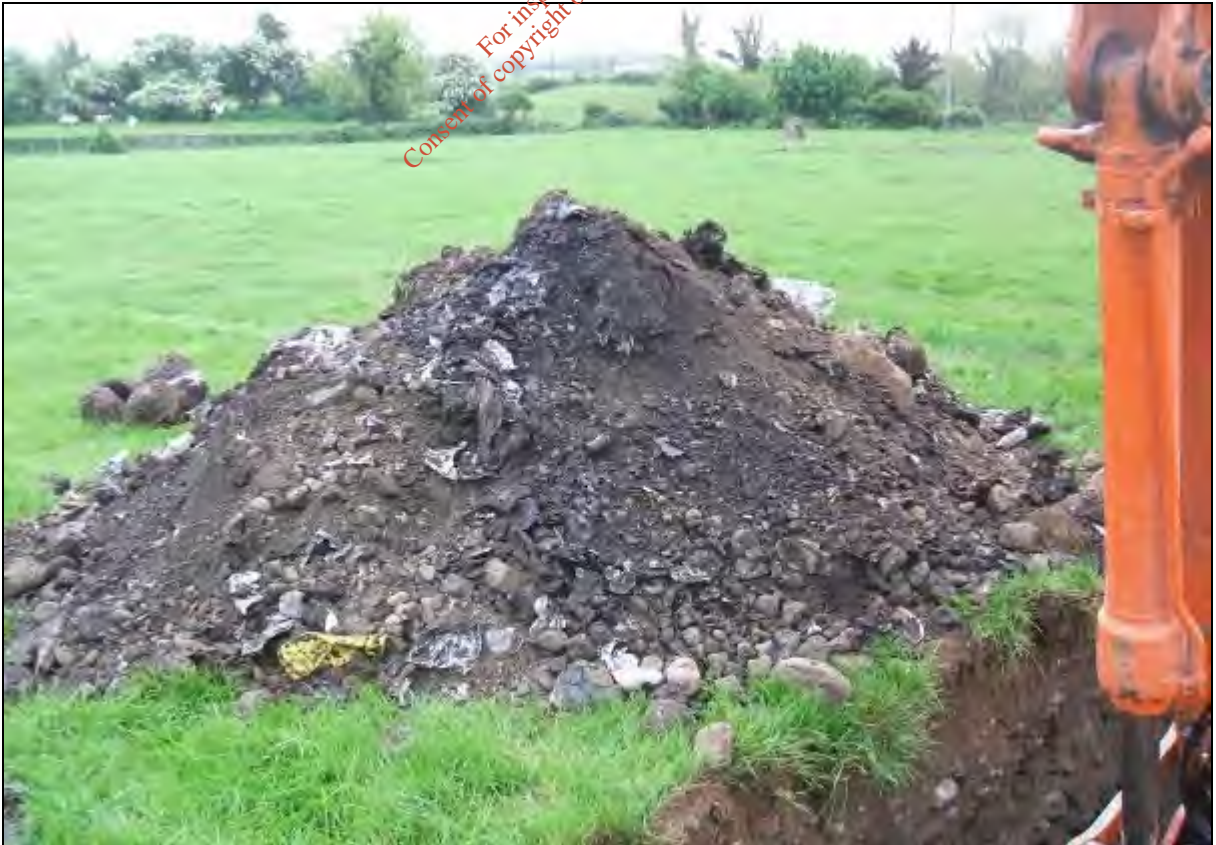
Photograph No 2 Waste material encountered in TP-6

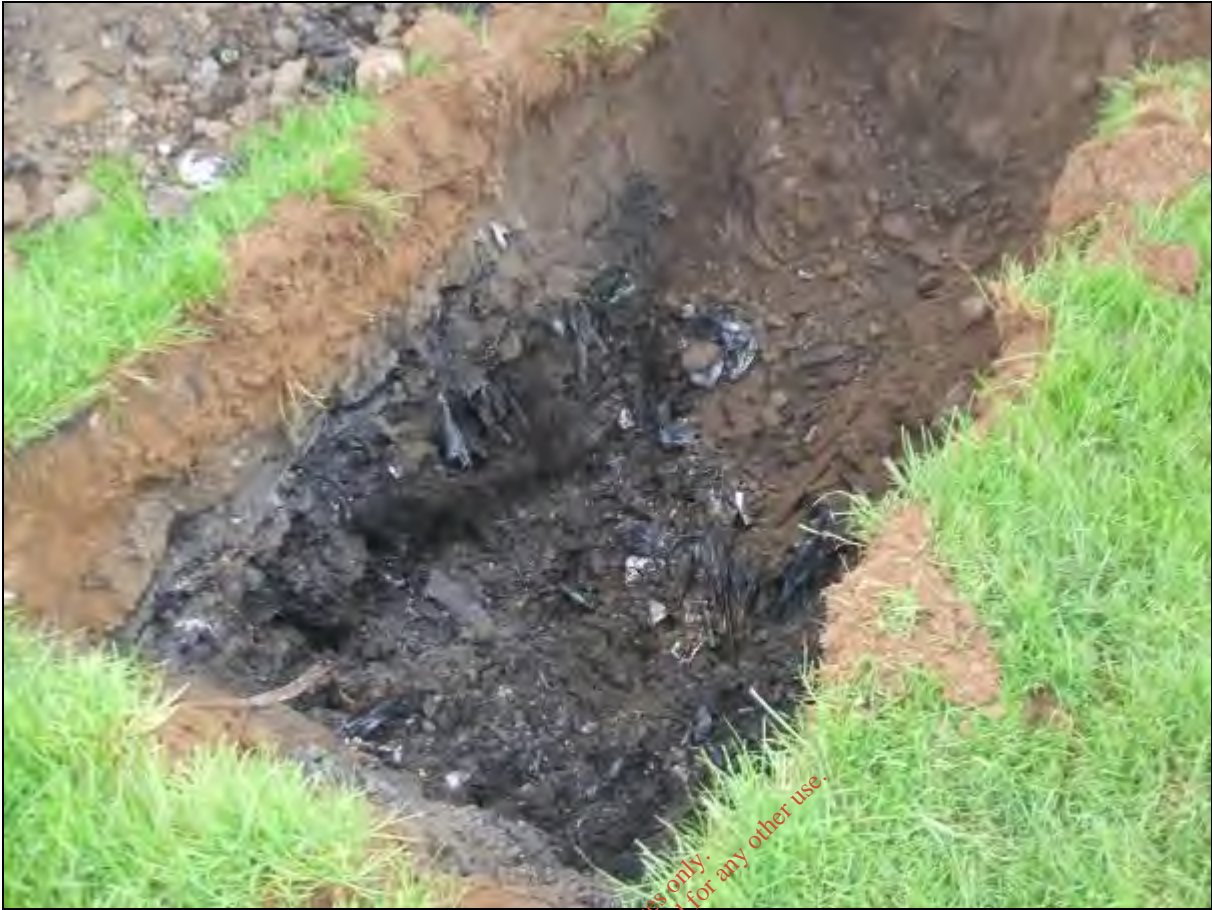
Photograph No.3 Waste material encountered in TP-7

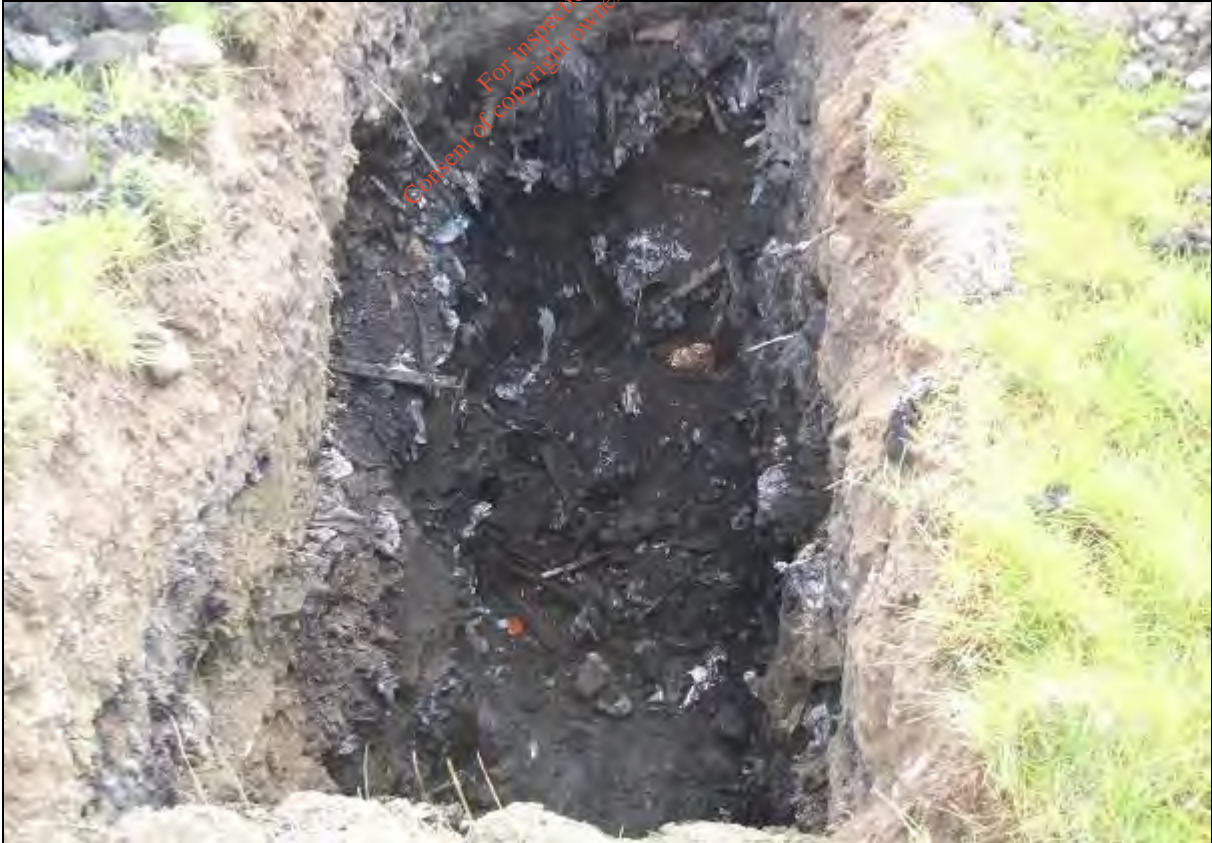
Photograph No.4 Waste material encountered in TP-9

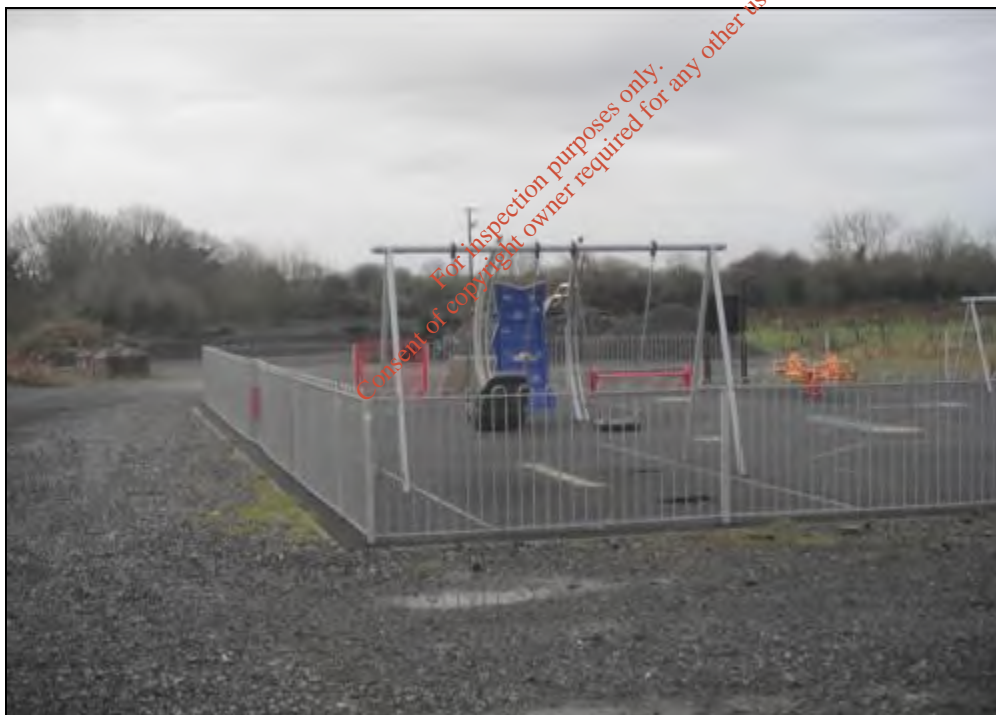
The construction of the playground involved the placement of 600mm of Clause 804 aggregate on a geotextile layer which was then covered with approximately 324m² of soft asphalt. The hard core extends beyond the asphalted area. The playground is surrounded by a 1.2m high railing. (Photograph No 5). Drainage from the play area is directed to the stream along the southern boundary. .

Photograph No 5 Looking South: Playground in eastern part of the site

It is recommended that no buildings or enclosed spaces be either constructed, or provided at the playground or civic amenity area.

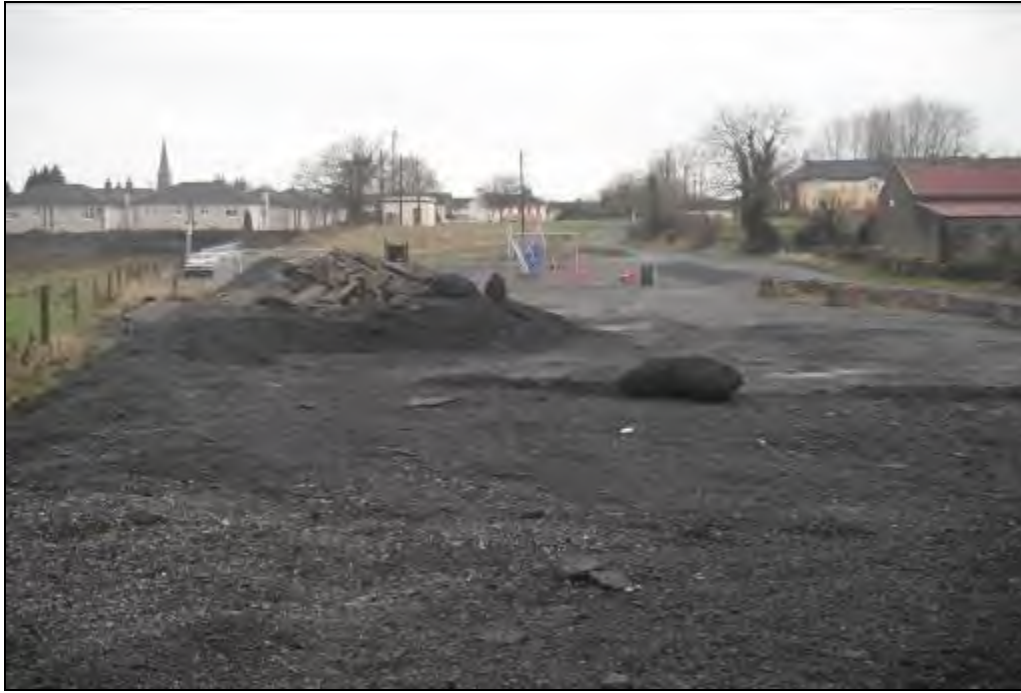
The area to the south of the playground is used to temporarily store road planings (Photograph No 6).

Photograph No 6 Looking North Road Planings

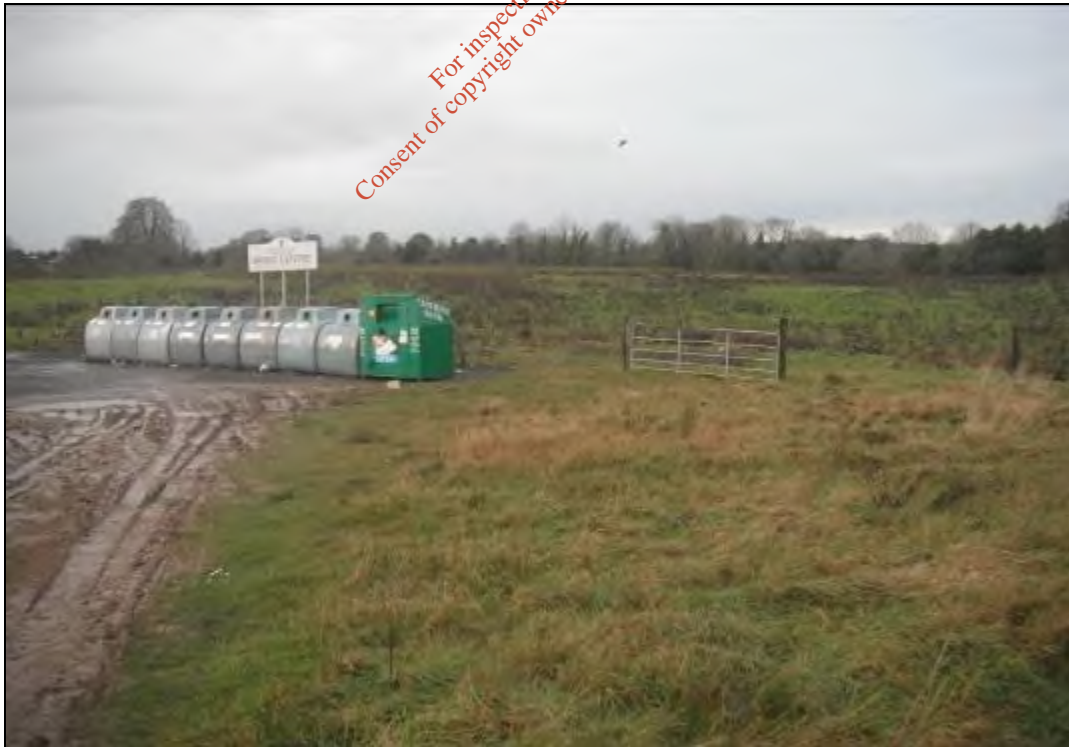
The civic amenity bring centre is to the north of the playground and contains bottle, aluminium cans and clothes banks (Photograph No 7). The proposed location of the Moate Football Club Dressing Rooms is immediately to the south west of the bring centre, with the pitch further to the south.

Photograph No 7 Looking South West: Bring Centre & Southern Part of the Site

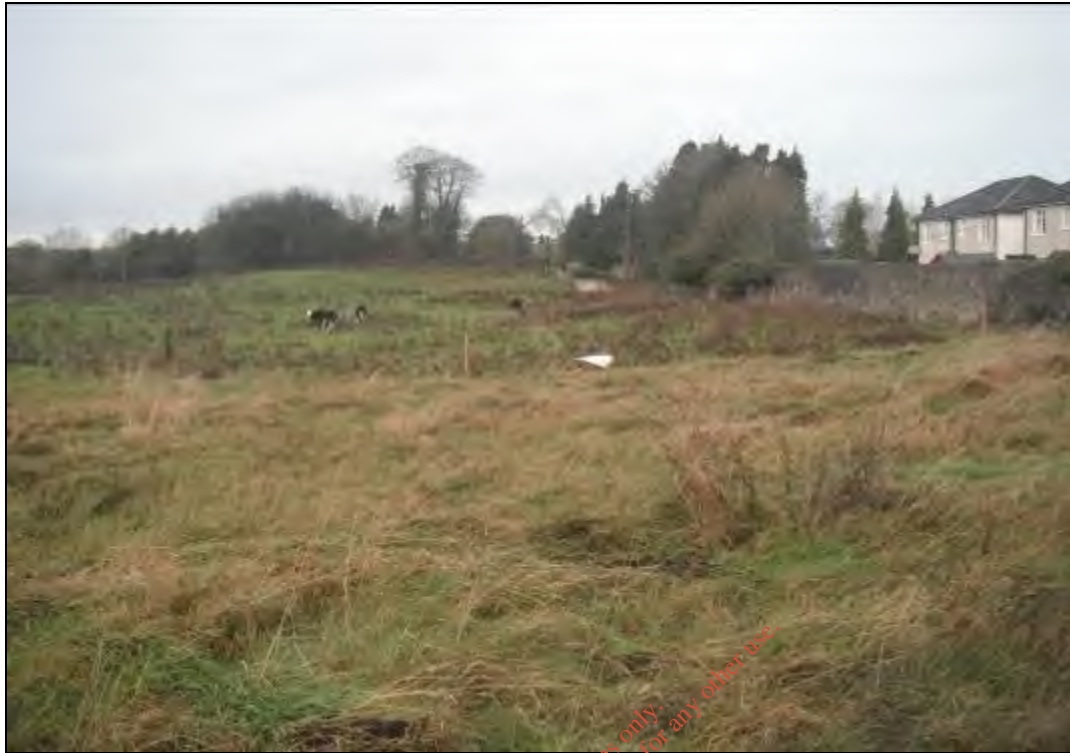
The remainder of the site, is covered in grass and used for animal grazing (Photograph No 8).

Photograph No 8 Livestock in the Northern Unfilled Area.
