INSPECTOR'S REPORT ON AN APPLICATION FOR A CERTIFICATE OF AUTHORISATION FOR A CLOSED LANDFILL

RE: Application by **Kilkenny County Council** for a Certificate of Authorisation for
a closed landfill at **Shermans, County Kilkenny**.

Certificate of Authorisation Register Number **H0233-01**.

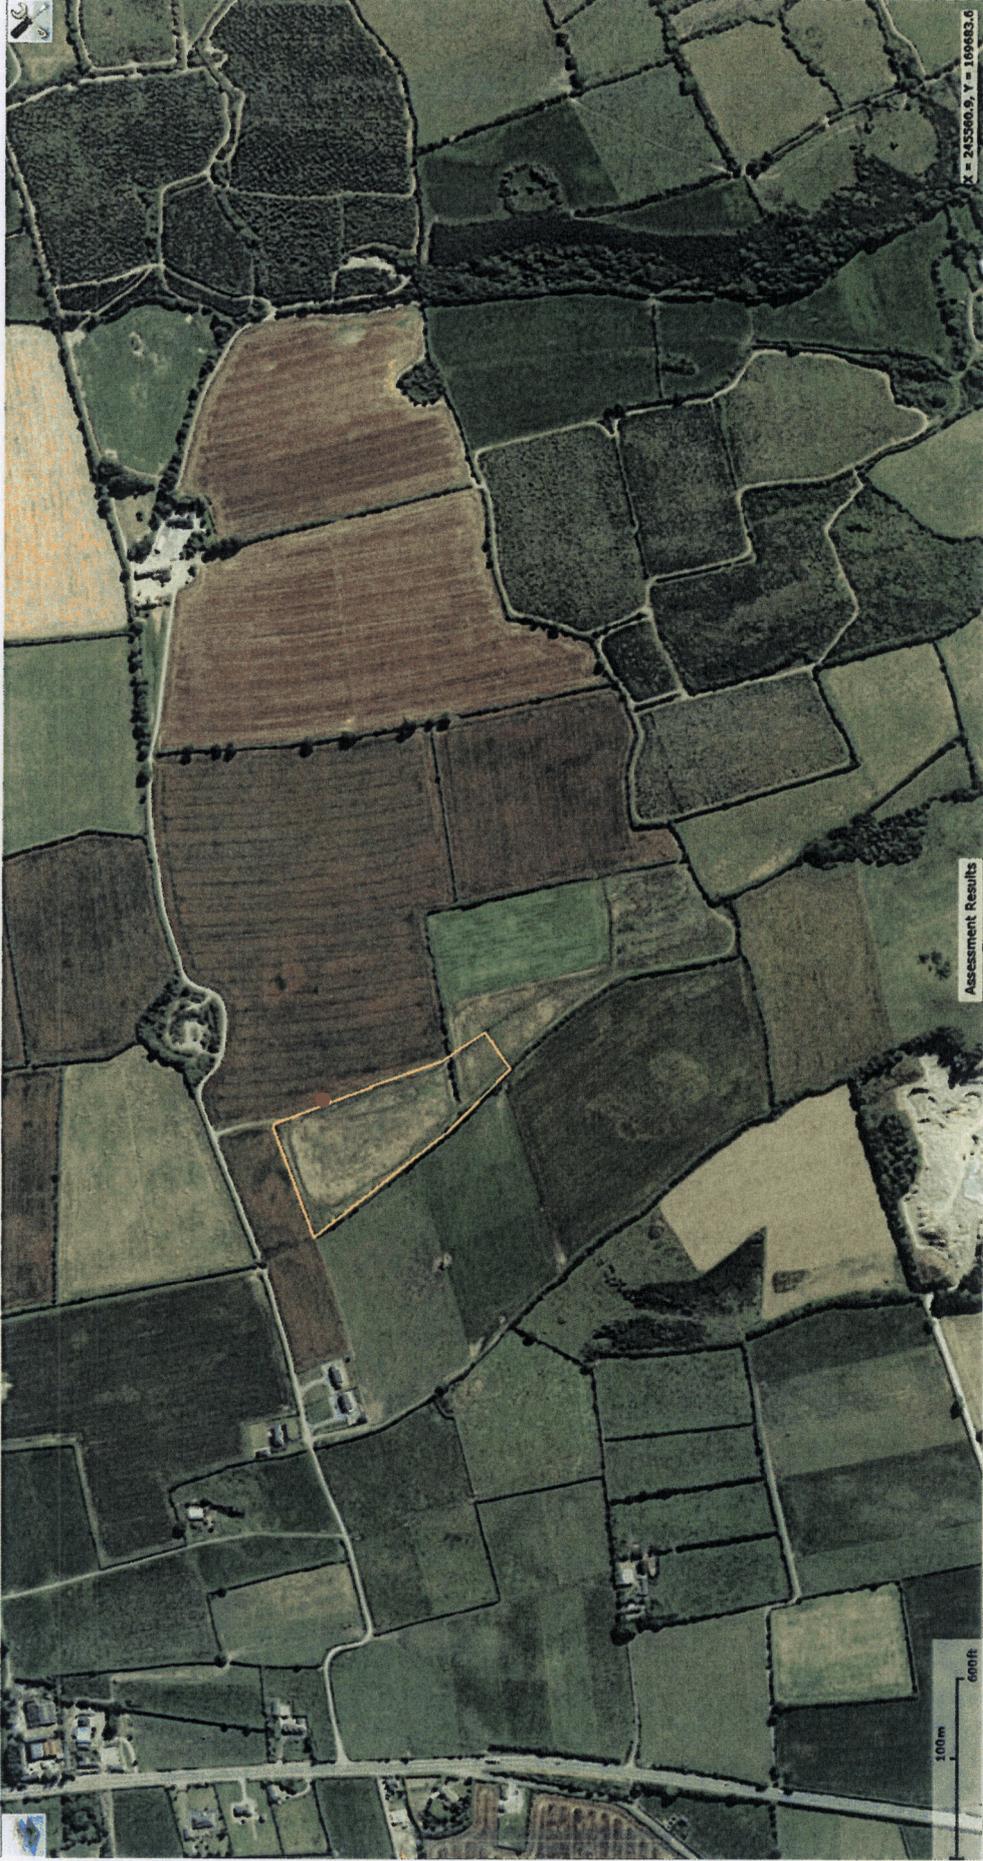
Figure 1 Location of landfill (yellow boundary) as originally delineated in the section 22 register

Location of facility	The Shermans landfill is located 1.5km south-east of Ballyragget in the townland of Donaghmore, about 650m east of the N77 road from Kilkenny to Ballyragget (Figure 1). It is in a former sand and gravel quarry surrounded by agricultural land and access is via a private road that runs along the boundary of the landowner's farmland. For the purposes of the risk assessment, the restoration of the site to agricultural use has been envisaged by the Qualified Person.
Period of landfilling	1987 – 1989
Surrounding area	The landfill site is approximately 50m north of a local private road. There are farm roads running along the northern boundary and most of the eastern site boundary. The surrounding land use is mainly agricultural. The closest residential dwelling is approximately 150m to the west. There is a gravel quarry approximately 300m south of the site (Figure 2).
Area of the closed landfill	1.7 hectares.
