Please find attached revised Tier 3 Risk Assessment for the Closed Landfill at Tipperary Town.

ADDENDUM TO THE TIER 3 ENVIRONMENTAL RISK ASSESSMENT: TIPPERARY TOWN HISTORIC LANDFILL

TIPPERARY COUNCTY COUNCIL

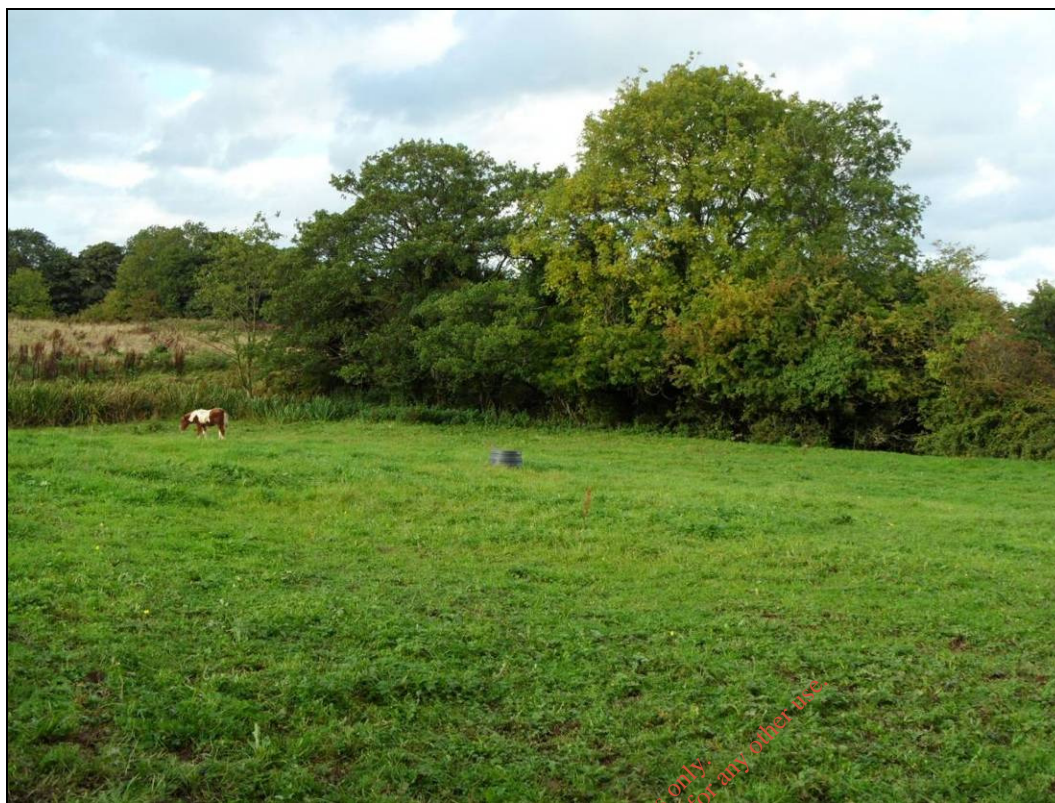
Plate 1 View of the agricultural grassland to the east of the closed landfill. The swamp habitat is visible in the centre left of the image, where it meets the land drain, along the treeline (centre).

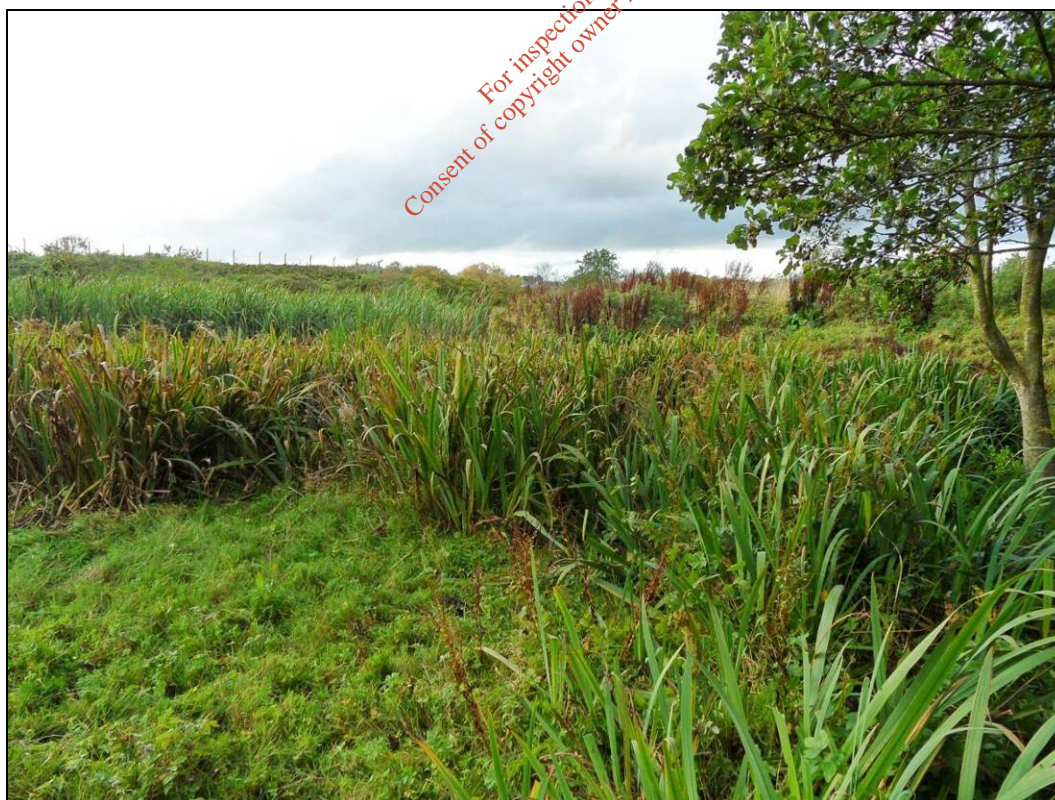
Plate 2 View of the eastern portion of the reed swamp, where it discharges to the land drain. Emergent flora within the swamp and drain were searched for whorl snails.

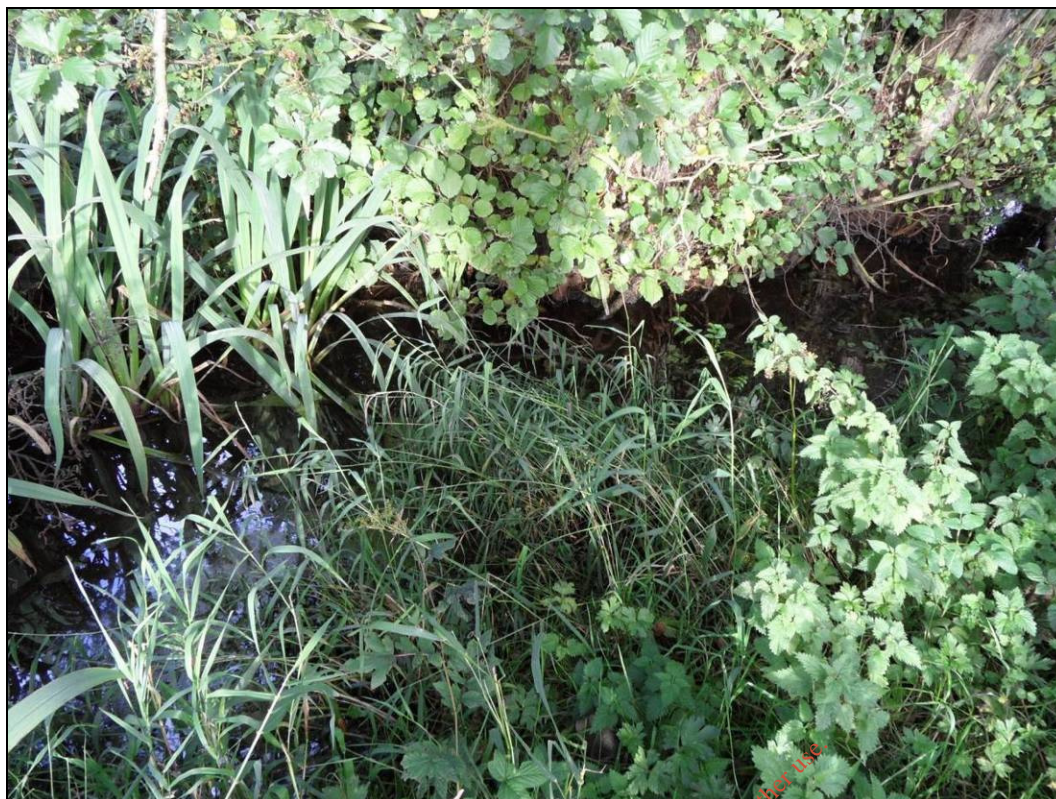
Plate 3 Water levels in the land drain were found to be very low, with no noticable flow.

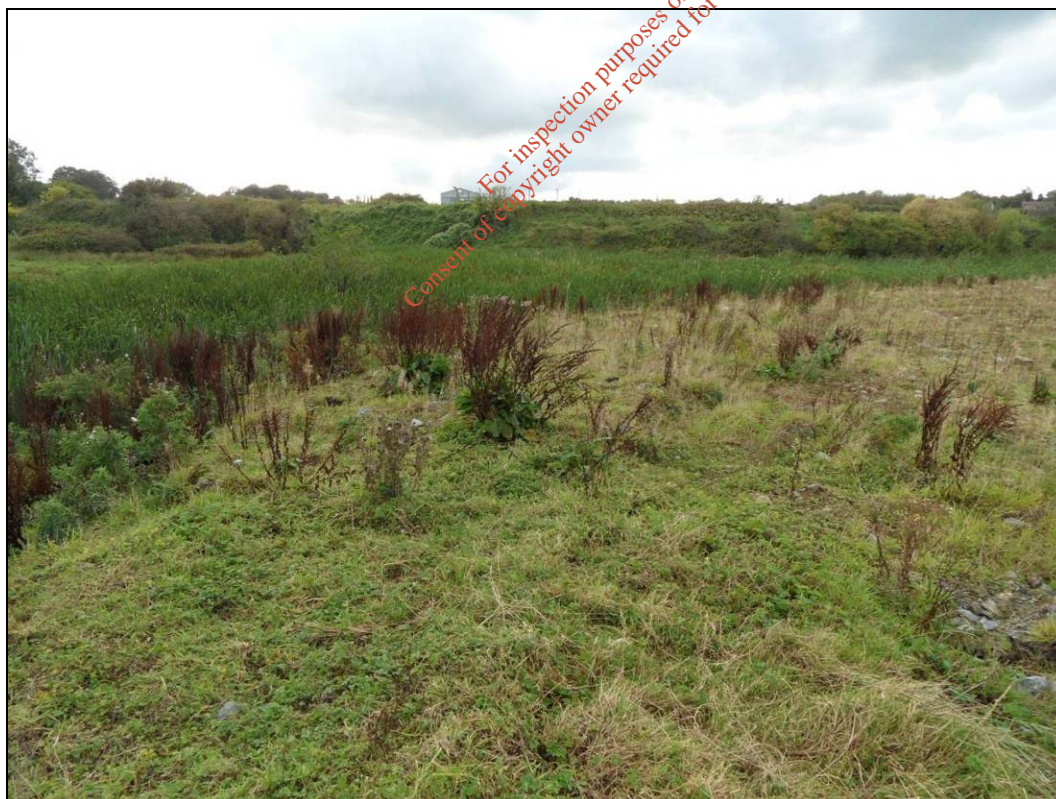
Plate 4 View west from the elevated C&D waste spoil. The swamp habitat is visible in the centre of the image, with the elevated closed landfill in the background.

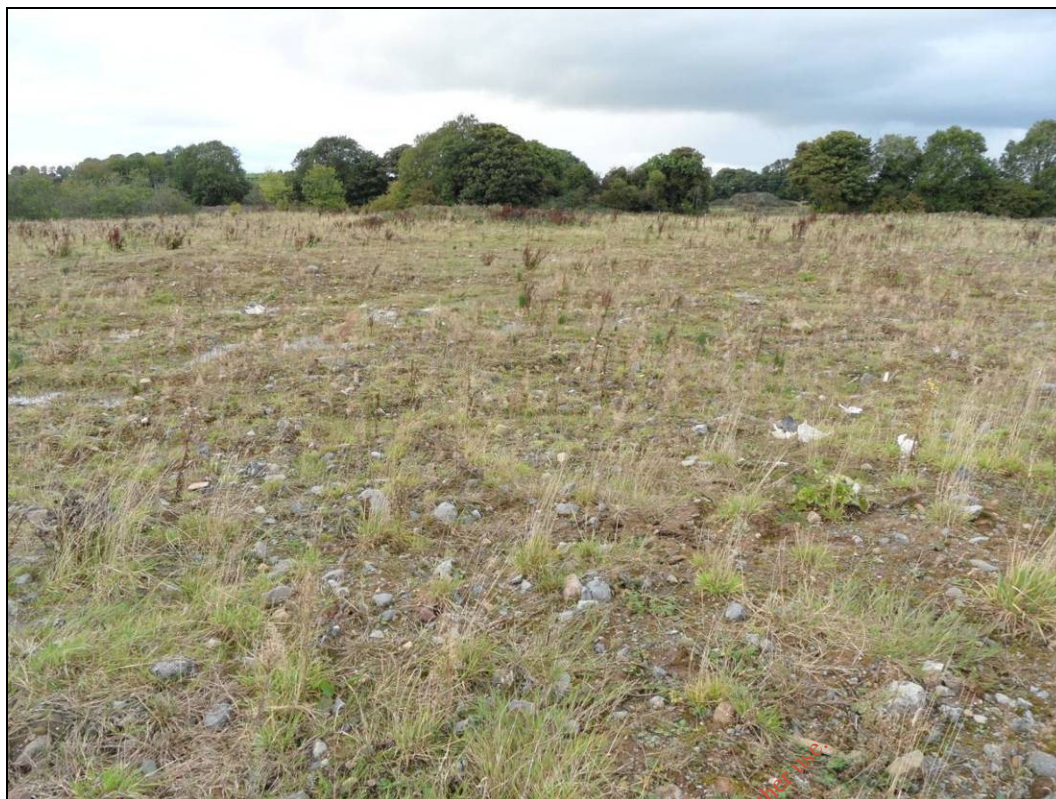
Plate 5 View north across the recolonising bare ground of the C&D waste spoil.

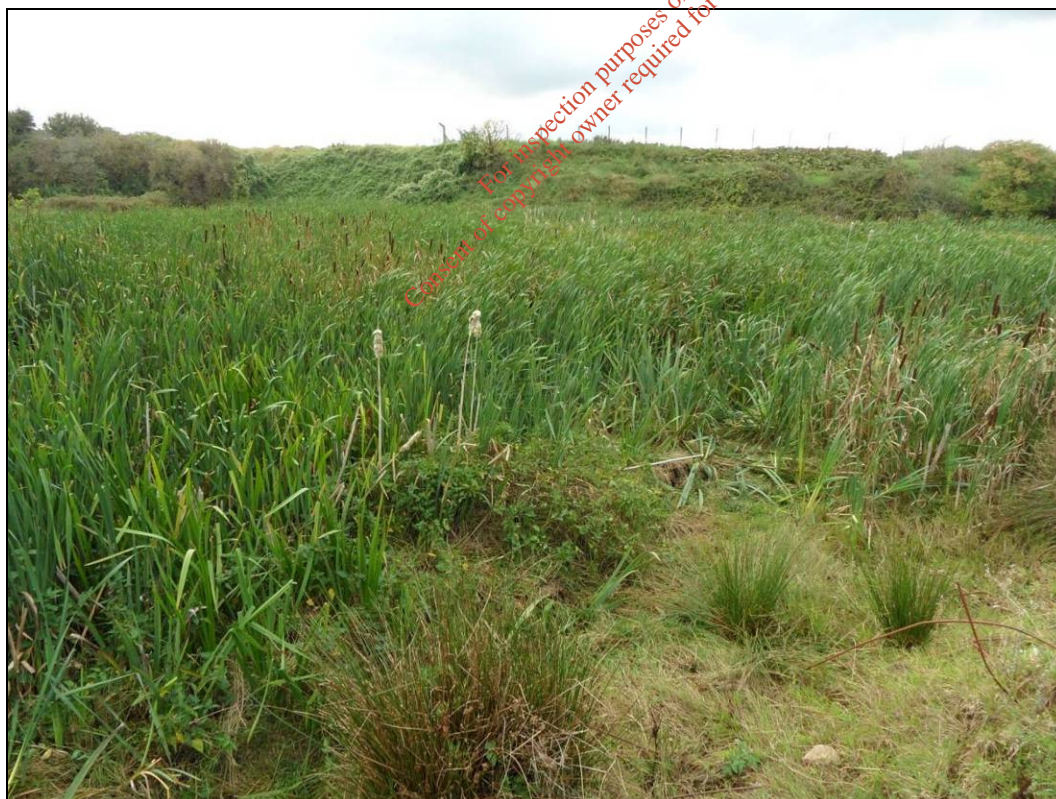
Plate 6 View of the drier margins of the swamp where the C&D spoil has altered the water table.

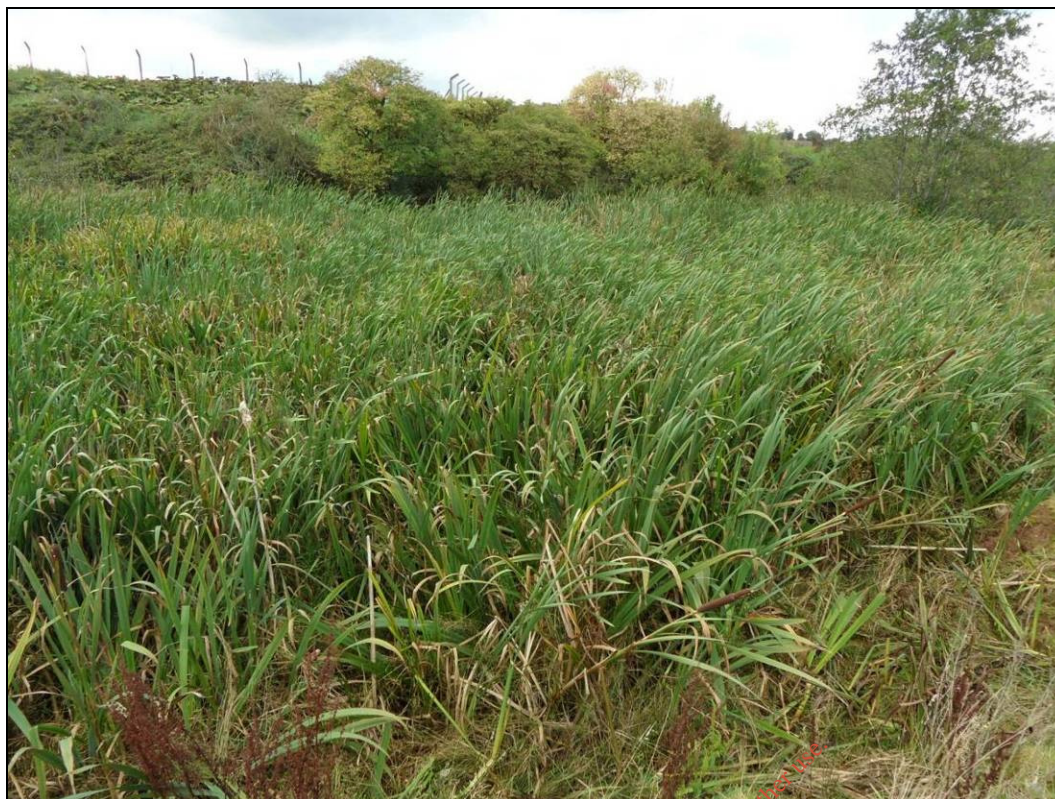
Plate 7 View of the *Typha* dominated swamp directly east of the closed landfill.

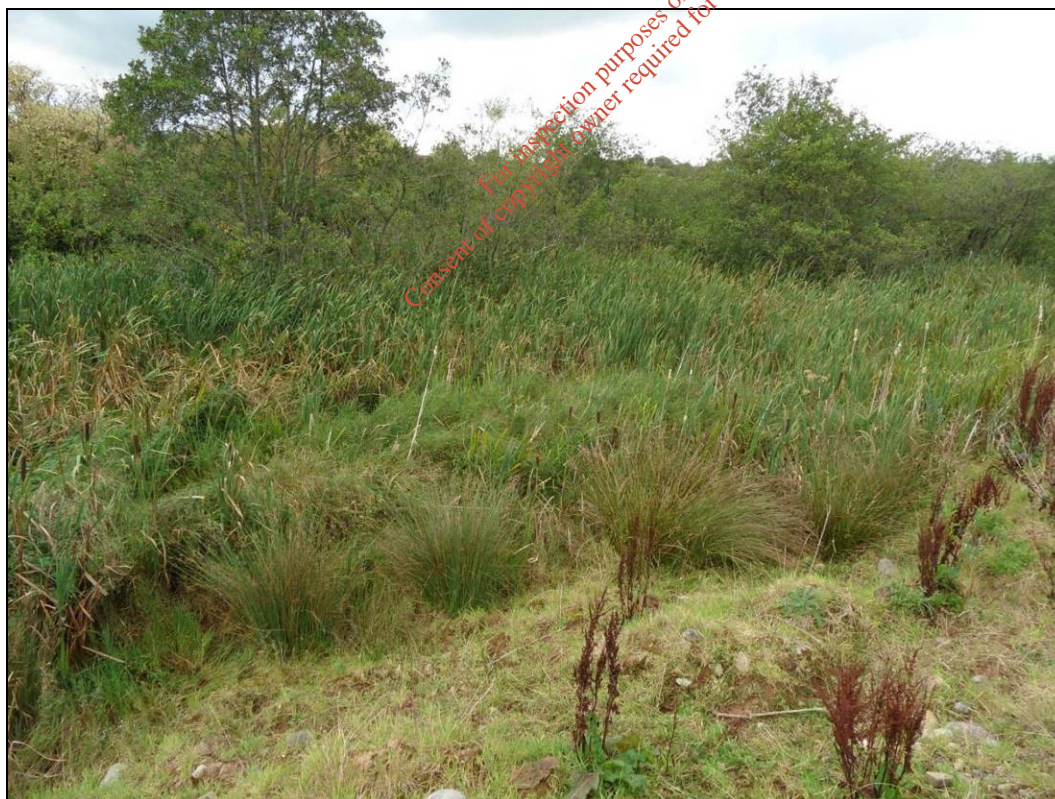
Plate 8 *Typha* dominated swamp with Alder woodland along the northern line of the closed landfill. *Juncus* was common along the interface between the drier C&D spoil and the reed swamp wetland.

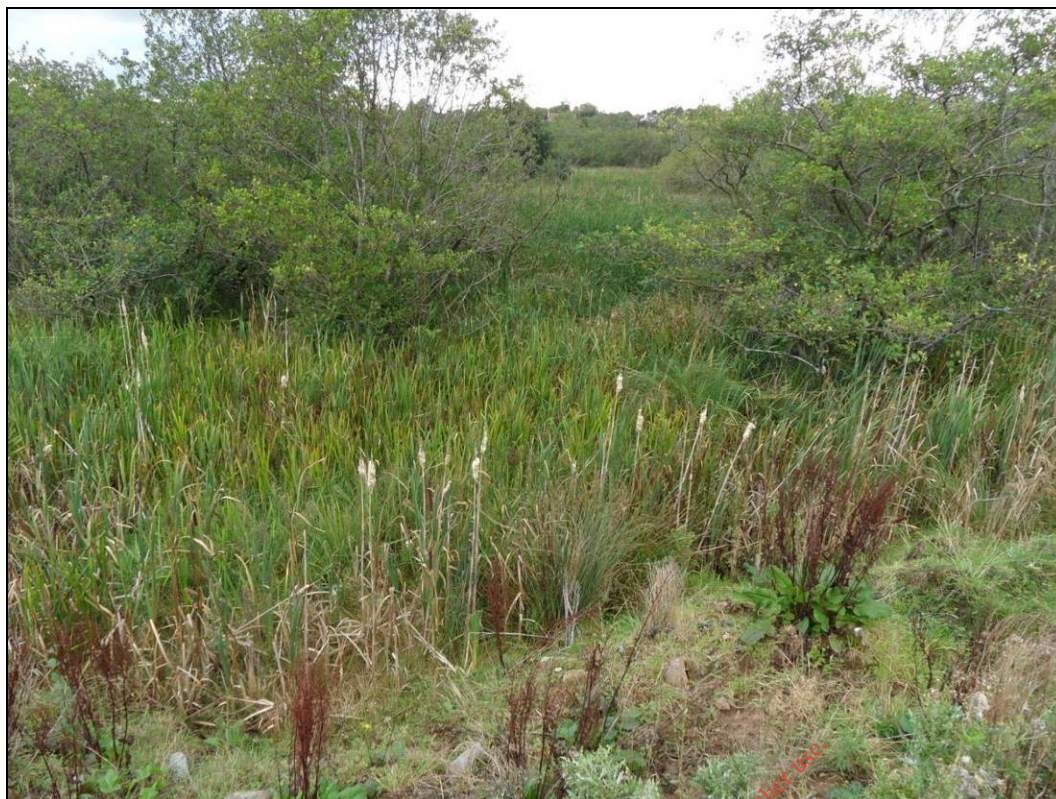
Plate 9 The northern portion of the swamp, view west. Alder and willow wet woodland was recorded from within the permanent wetland habitat.

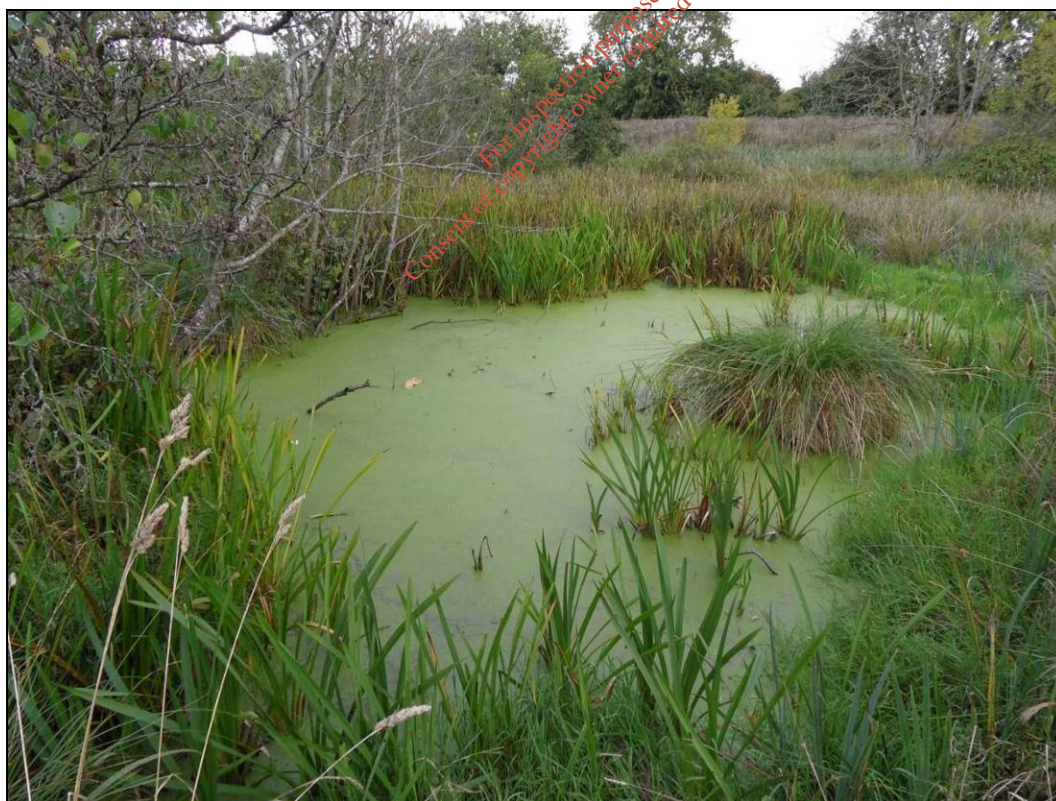
Plate 10 Limited open areas of water were noted. Duckweed was found to be abundant wherever they occurred. Moorhens were recorded from within the swamp.

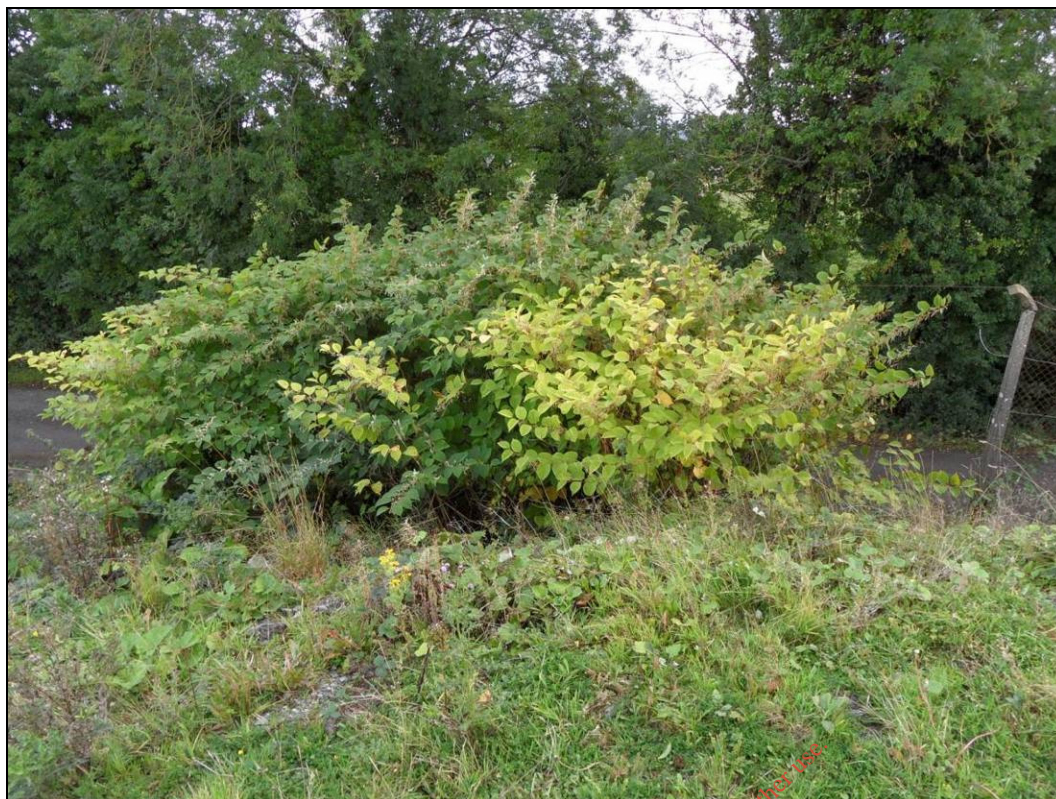
Plate 11 Japanese knotweed was recorded along the road margin at the south eastern corner of the closed landfill site. It is considered that the site presents suitable habitat for the spread of this species, which will continue if unmanaged.

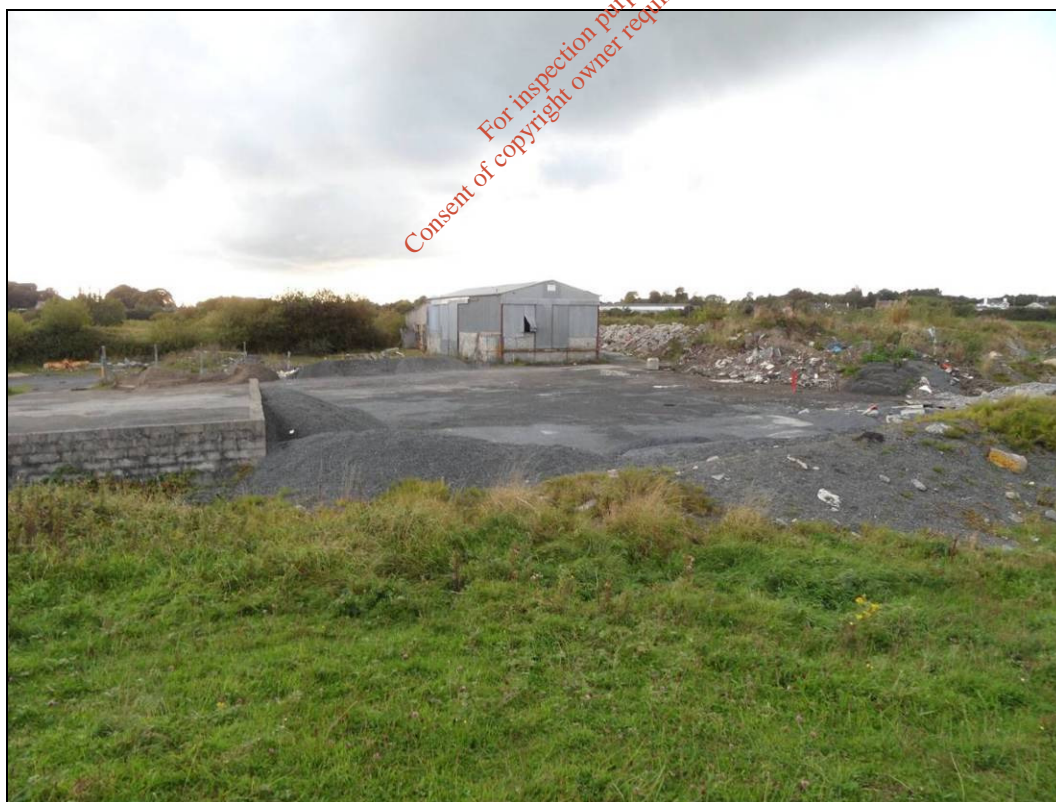
Plate 12 View of the old buildings and material storage on the closed landfill site.

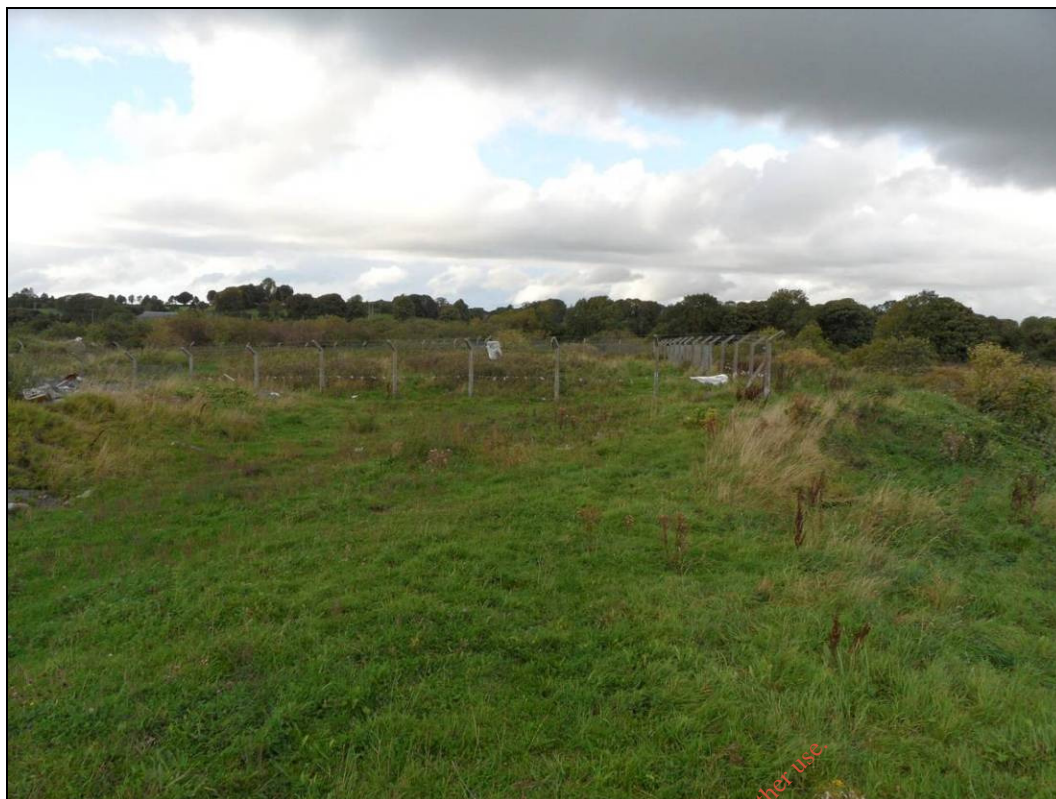
Plate 13 A view north showing the fenced compound on the closed landfill site. The swamp habitat is located to the east (right of the image).

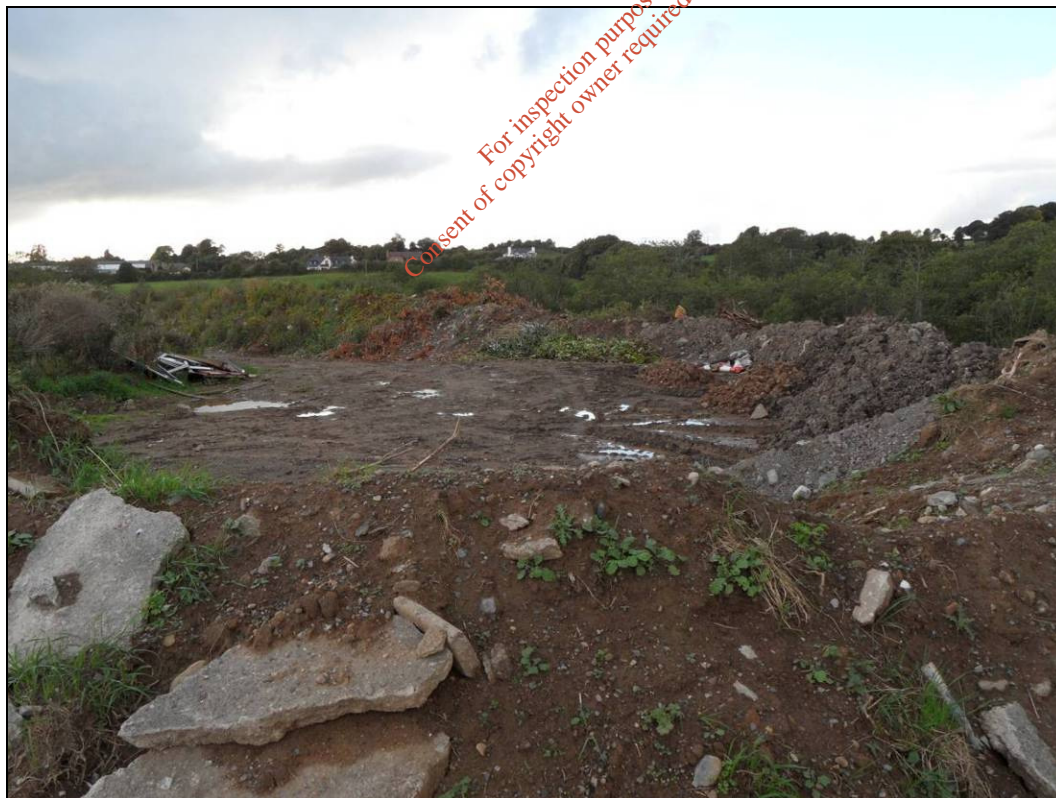
Plate 14 To the north of the fenced compound on the landfill there is an area of freshly dumped topsoil, construction waste and vegetation. This is piled along the embankment at the edge of the swamp habitat.

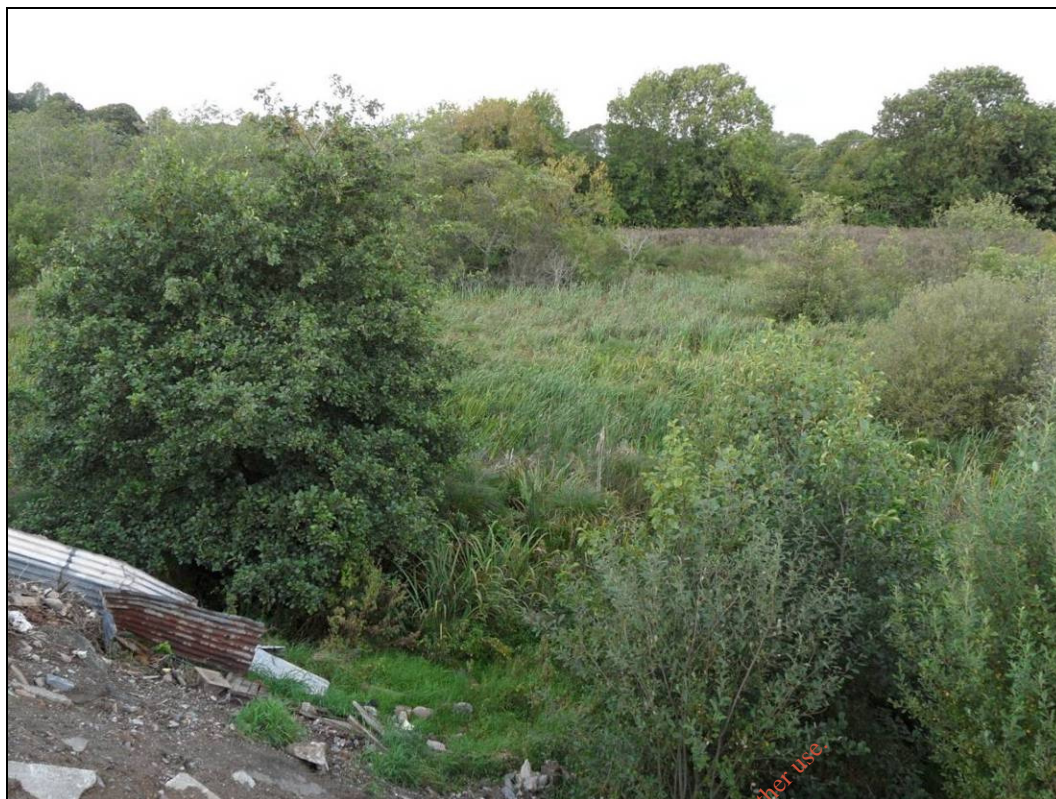
Plate 15 The dumped material was found to be unstable and slipping downslope into the swamp habitat. It is expected that suspended solids and run-off from this waste is washing down into the swamp.

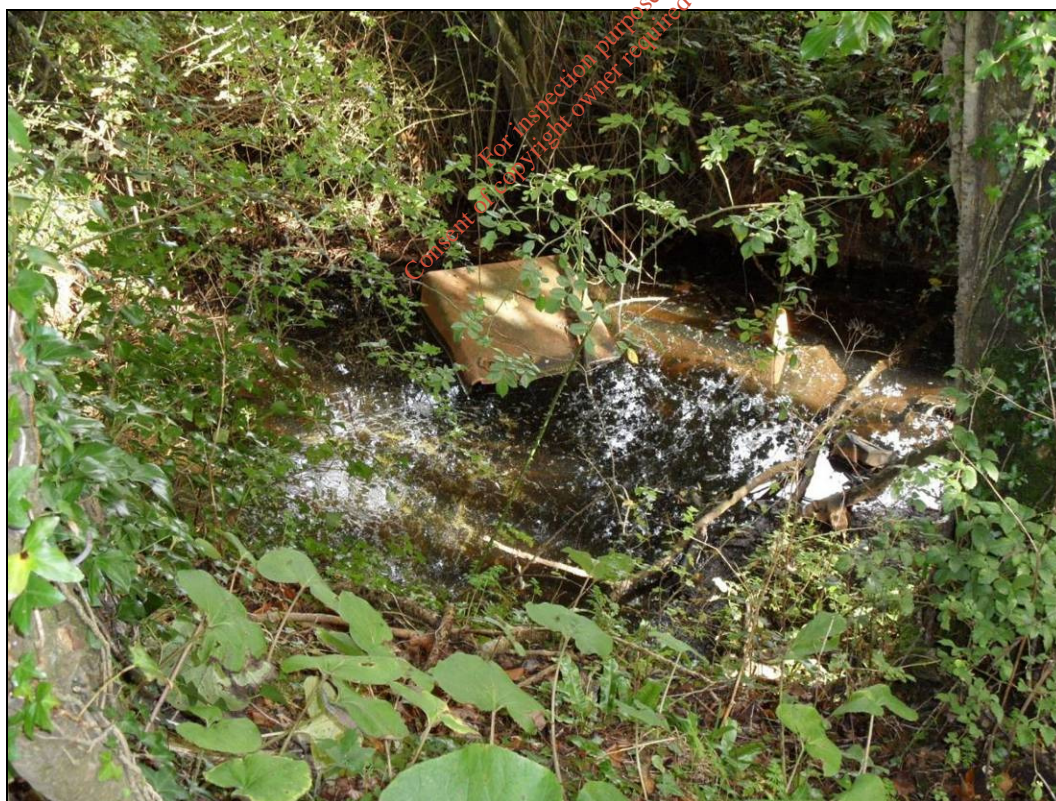
Plate 16 The land drain due south of the landfill was found to be impounded. No flow was recorded from the drain downstream. Pooled water was recorded directly adjacent to the road.

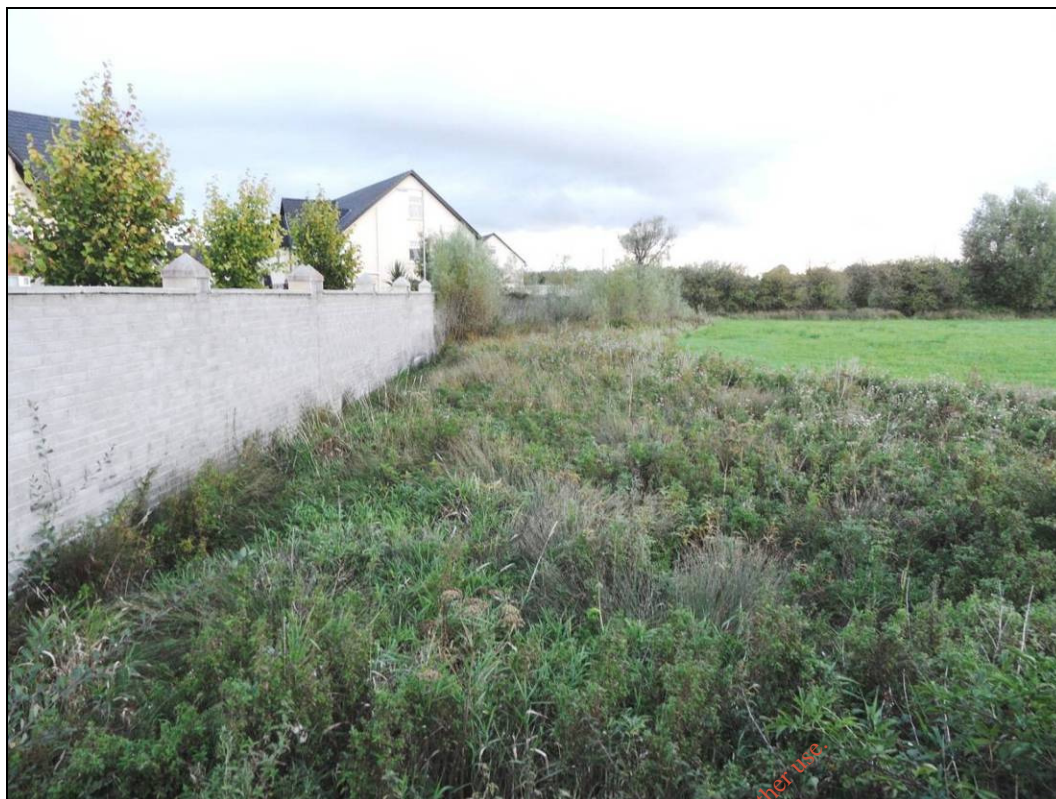
Plate 17 View north from Rosanna Road. No flow was recorded from the land drain due south of the closed landfill, at Rosanna Road. The construction of new residential developments as depicted and across the road to the south are likely to have altered the flow of this drain. The wet grassland / marsh habitat visible in this image is attributed to frequent high water levels within the land drain.
