INSPECTOR'S REPORT ON AN APPLICATION FOR A CERTIFICATE OF AUTHORISATION FOR A CLOSED LANDFILL

TO:	Eimear Cotter, Director, OES
FROM:	Magnus Amajirionwu, Inspector, Environmental Licensing Programme
DATE:	17 October 2018
RE:	Application by Westmeath County Council for a Certificate of Authorisation for a closed landfill at Moate, County Westmeath. Certificate of Authorisation Register Number H0456-01.

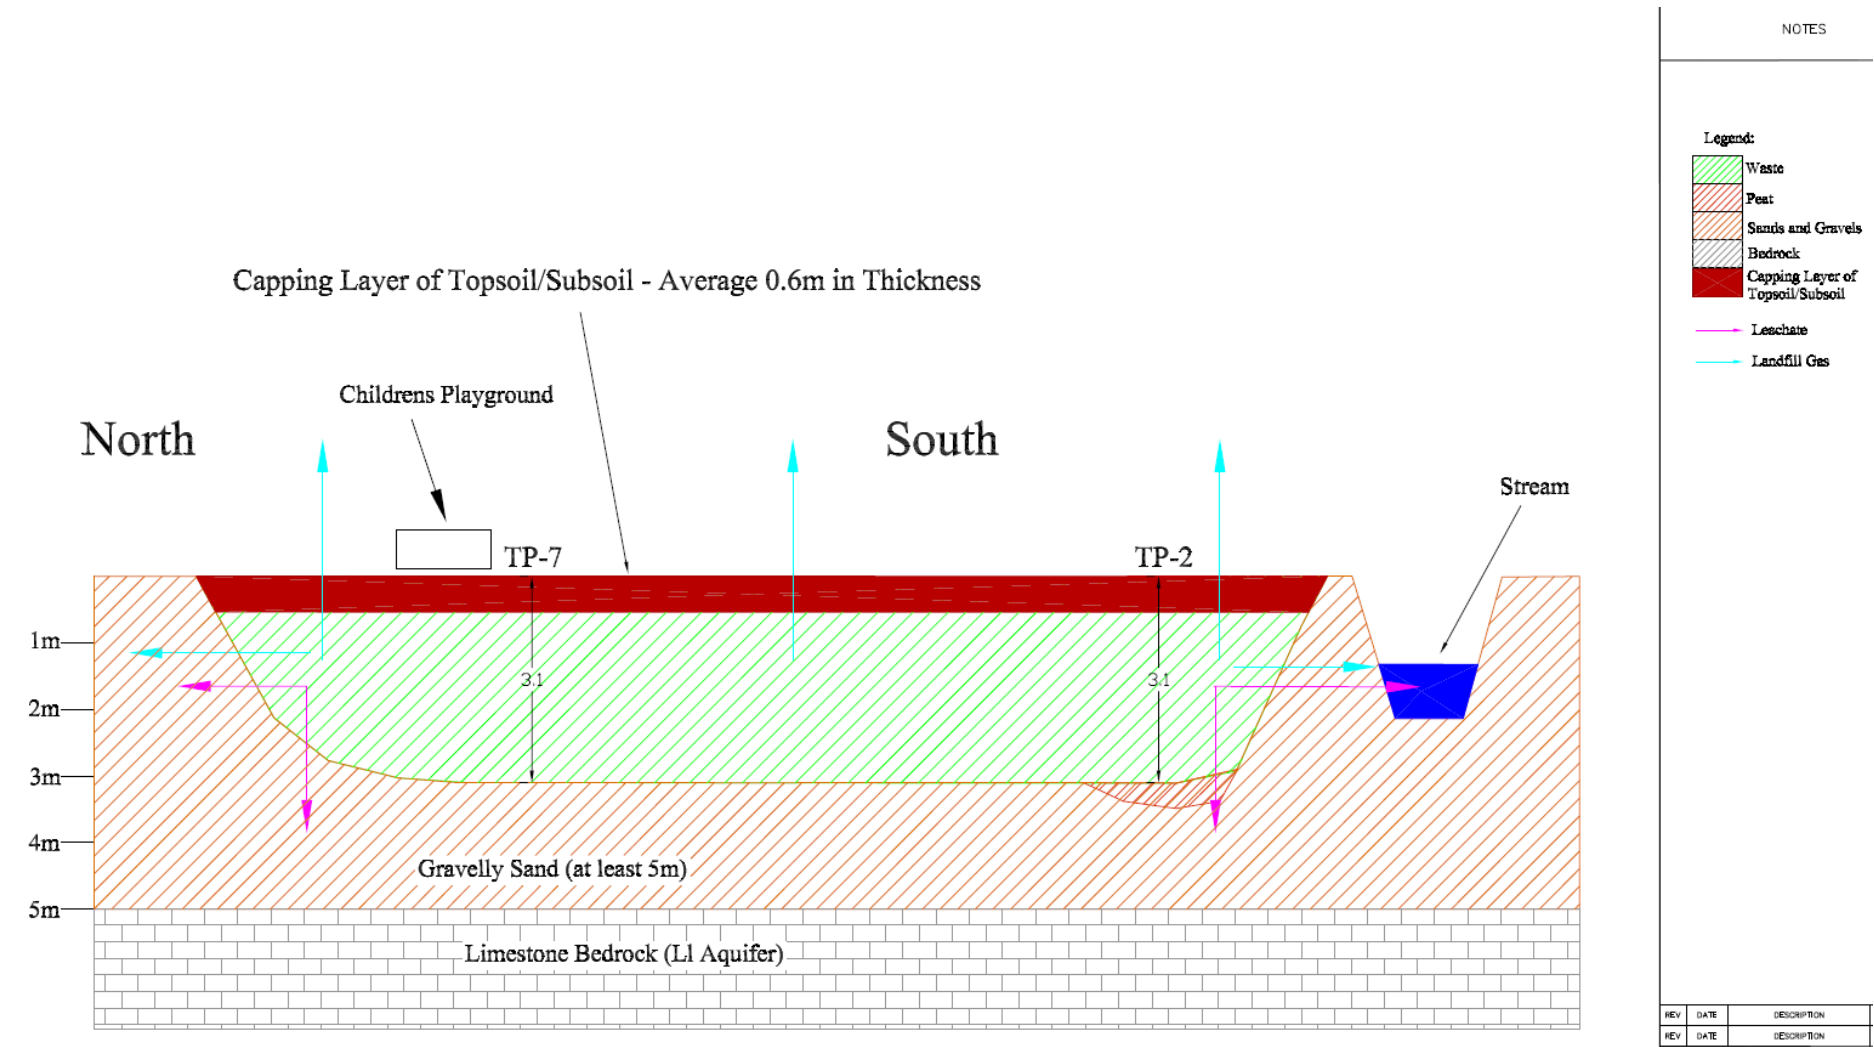
Figure 4 Conceptual site model

Conceptual site model	<p>The conceptual site model developed in 2007 and provided with the original application identified the following pollutant linkages:</p> <ul style="list-style-type: none"> • human health exposure due to landfill gas; • migration of leachate into the surface water body south of the waste body; and • migration of leachate into the underlying aquifer. <p>The conceptual site model is shown in Figure 4. The source, pathways and receptors can be described as follows:</p> <p>Source:</p> <ul style="list-style-type: none"> – Rainfall on the landfill will preferentially percolate through the cap and into the waste. – Leachate is generated in the waste albeit at low strength. – Gas is generated at the landfill. <p>Pathway:</p> <ul style="list-style-type: none"> – Leachate can migrate through the base of the landfill into underlying aquifer beneath. – Seeps of leachate discharge into the surface water body south of the site. – Gas migration can occur through the permeable cap and into bedrock aquifer beneath the waste. – Gas migration beyond the site boundary through field drains. <p>Receptors:</p> <ul style="list-style-type: none"> – Existing houses in close proximity to the site and users of the public amenity and children’s playground on site. – The bedrock aquifer beneath the site.
