Subject: FW: RE: Historic Landfill Cert of Authorisations
Attachments: Summary Report Final.pdf

Tier 2 and 3 Environmental Risk Assessment

Carrigeen Legacy Landfill

Clane,

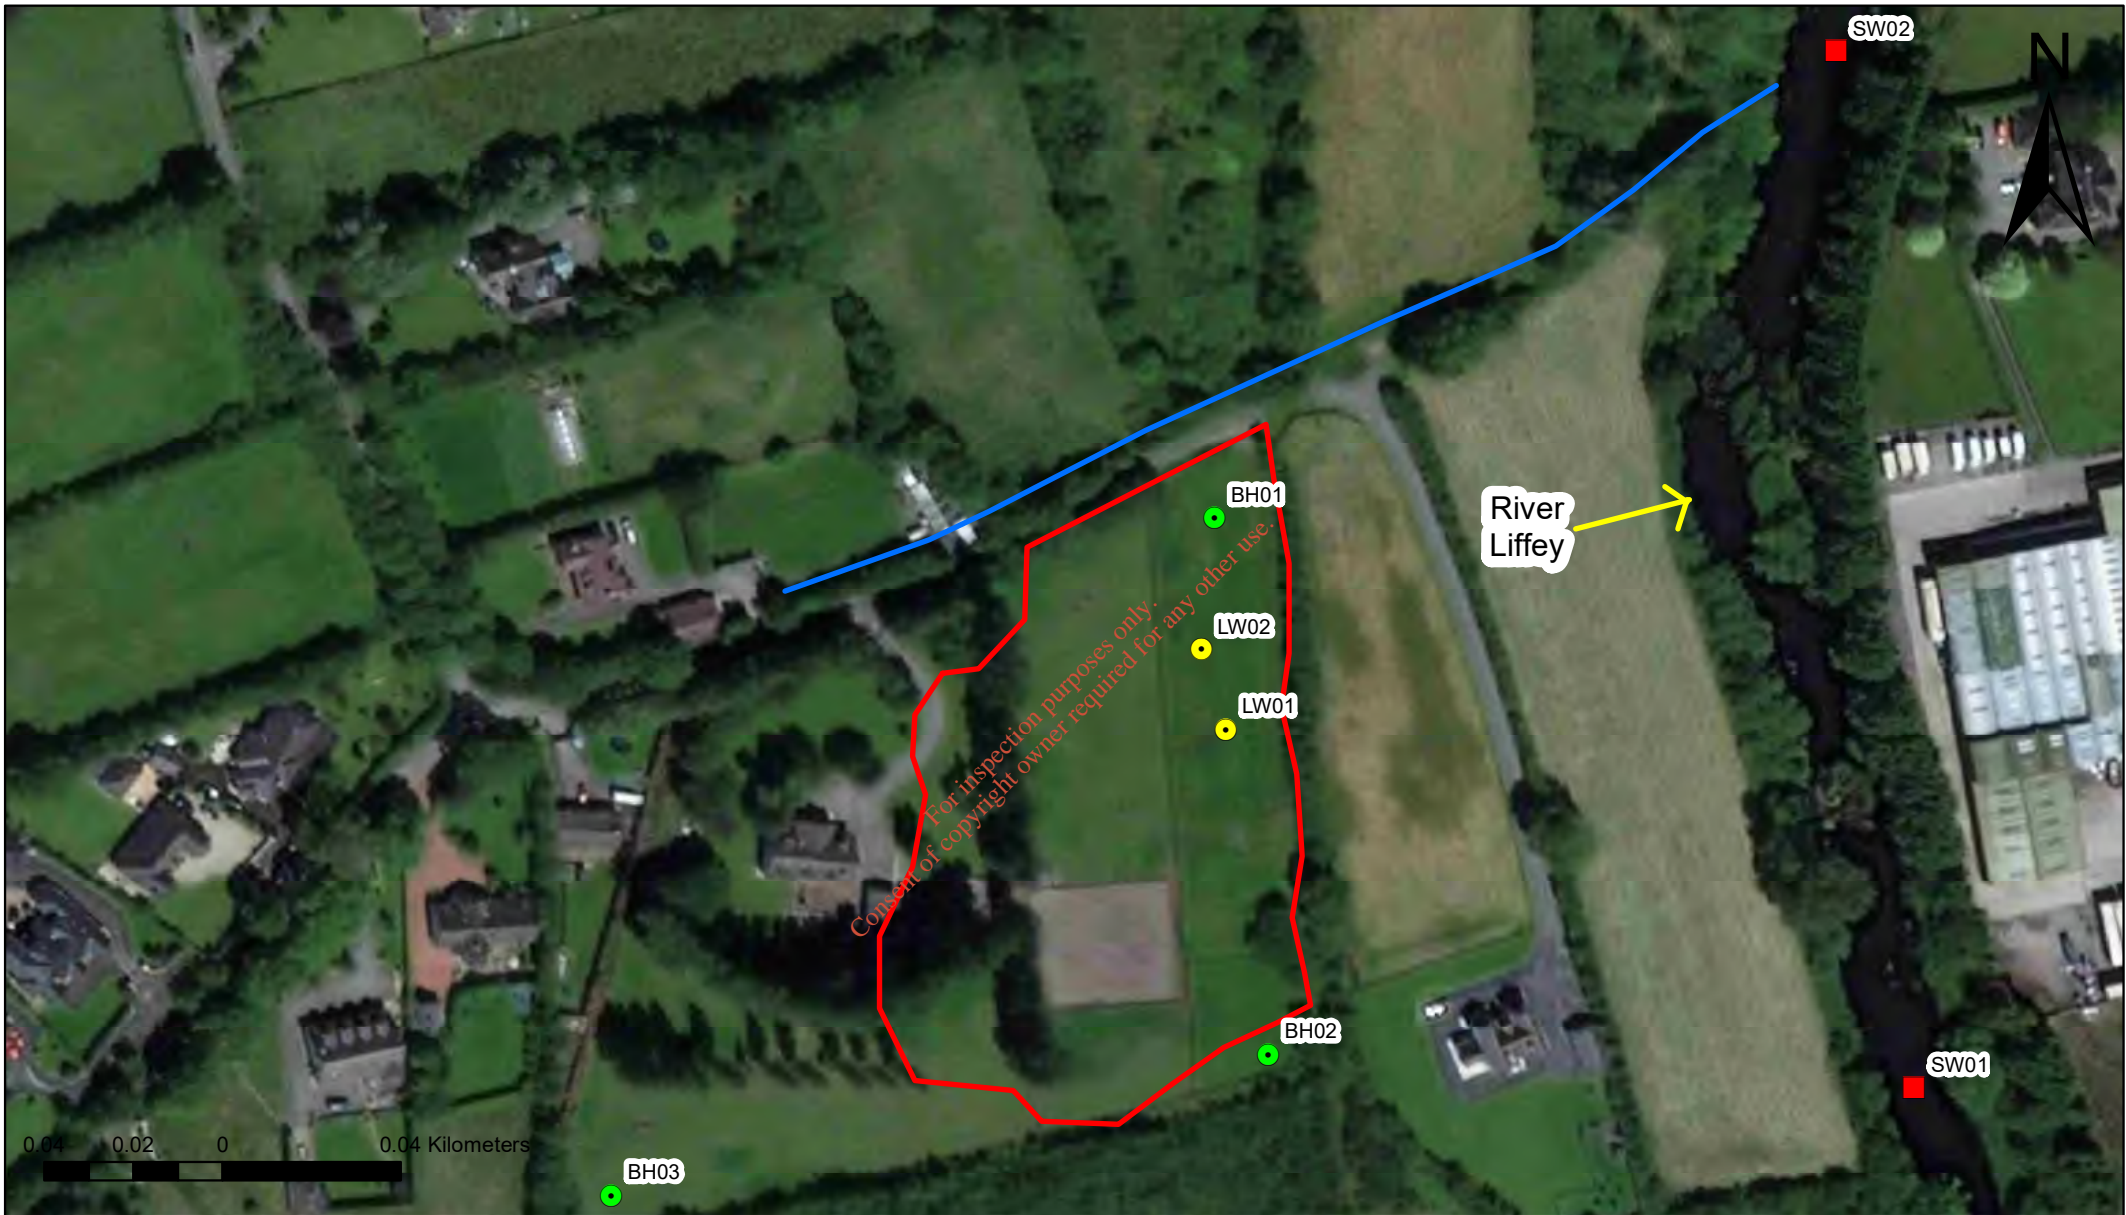
Figure 2.1

<p>O'Callaghan Moran & Associates, Unit 15 Melbourne Business Park, Model Farm Road, Cork. Tel. (021) 4345366 email: info@ocallaghanmoran.com</p>	<p>CLIENT</p> <p>Kildare County Council</p>	<p>Details:</p> <ul style="list-style-type: none"> ■ Surface Water ● Leachate Well ● Borehole — Drain — Site Layout
	<p>TITLE</p> <p>Site Layout</p>

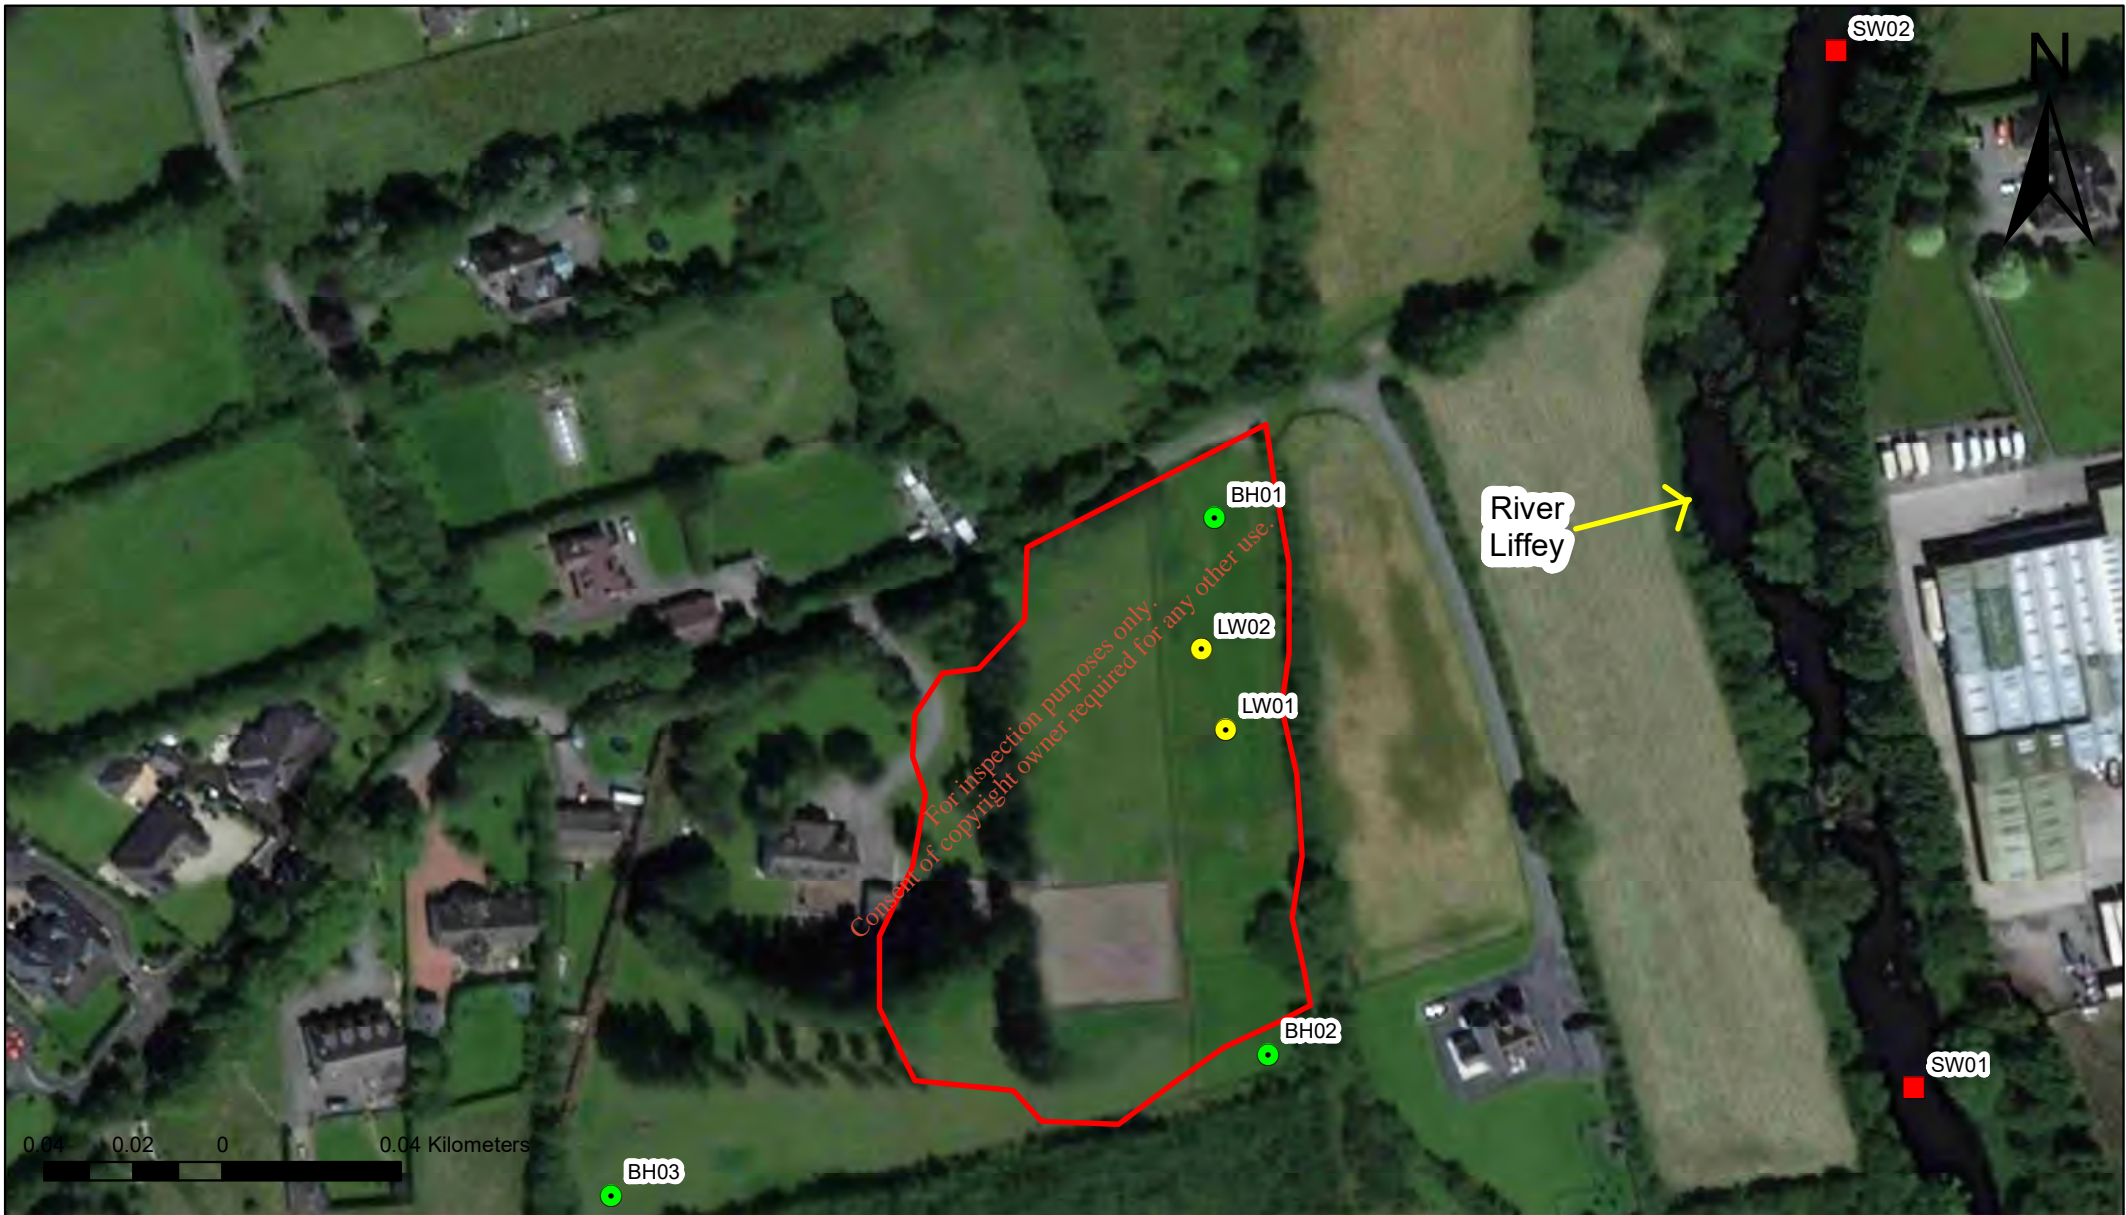
<p>O'Callaghan Moran & Associates, Unit 15 Melbourne Business Park, Model Farm Road, Cork. Tel. (021) 4345366 email: info@ocallaghanmoran.com</p>	<p>CLIENT</p> <p>Kildare County Council</p>	<p>Details:</p> <ul style="list-style-type: none"> ■ Surface Water ● Leachate Well ● Borehole — Site Layout
	<p>TITLE</p> <p>Monitoring Locations</p>

Landfill gas monitoring using a spike probe was carried out in thirty three (33 No) temporary landfill gas monitoring locations using a Dando Terrier Rig to advance the spike probe to a maximum depth of 4.0 mbgl and then pulled out. Monitoring was undertaken using a GA2000 Landfill Gas analyser. Methane (CH₄) was observed to range between 0.0 to 39.2 % (v/v), carbon dioxide between 1.3 and 31.9 % (v/v) and Oxygen between 0.01 to 18.7%. The results are presented on Table 3.4. The monitoring locations are shown on Figure 3.1

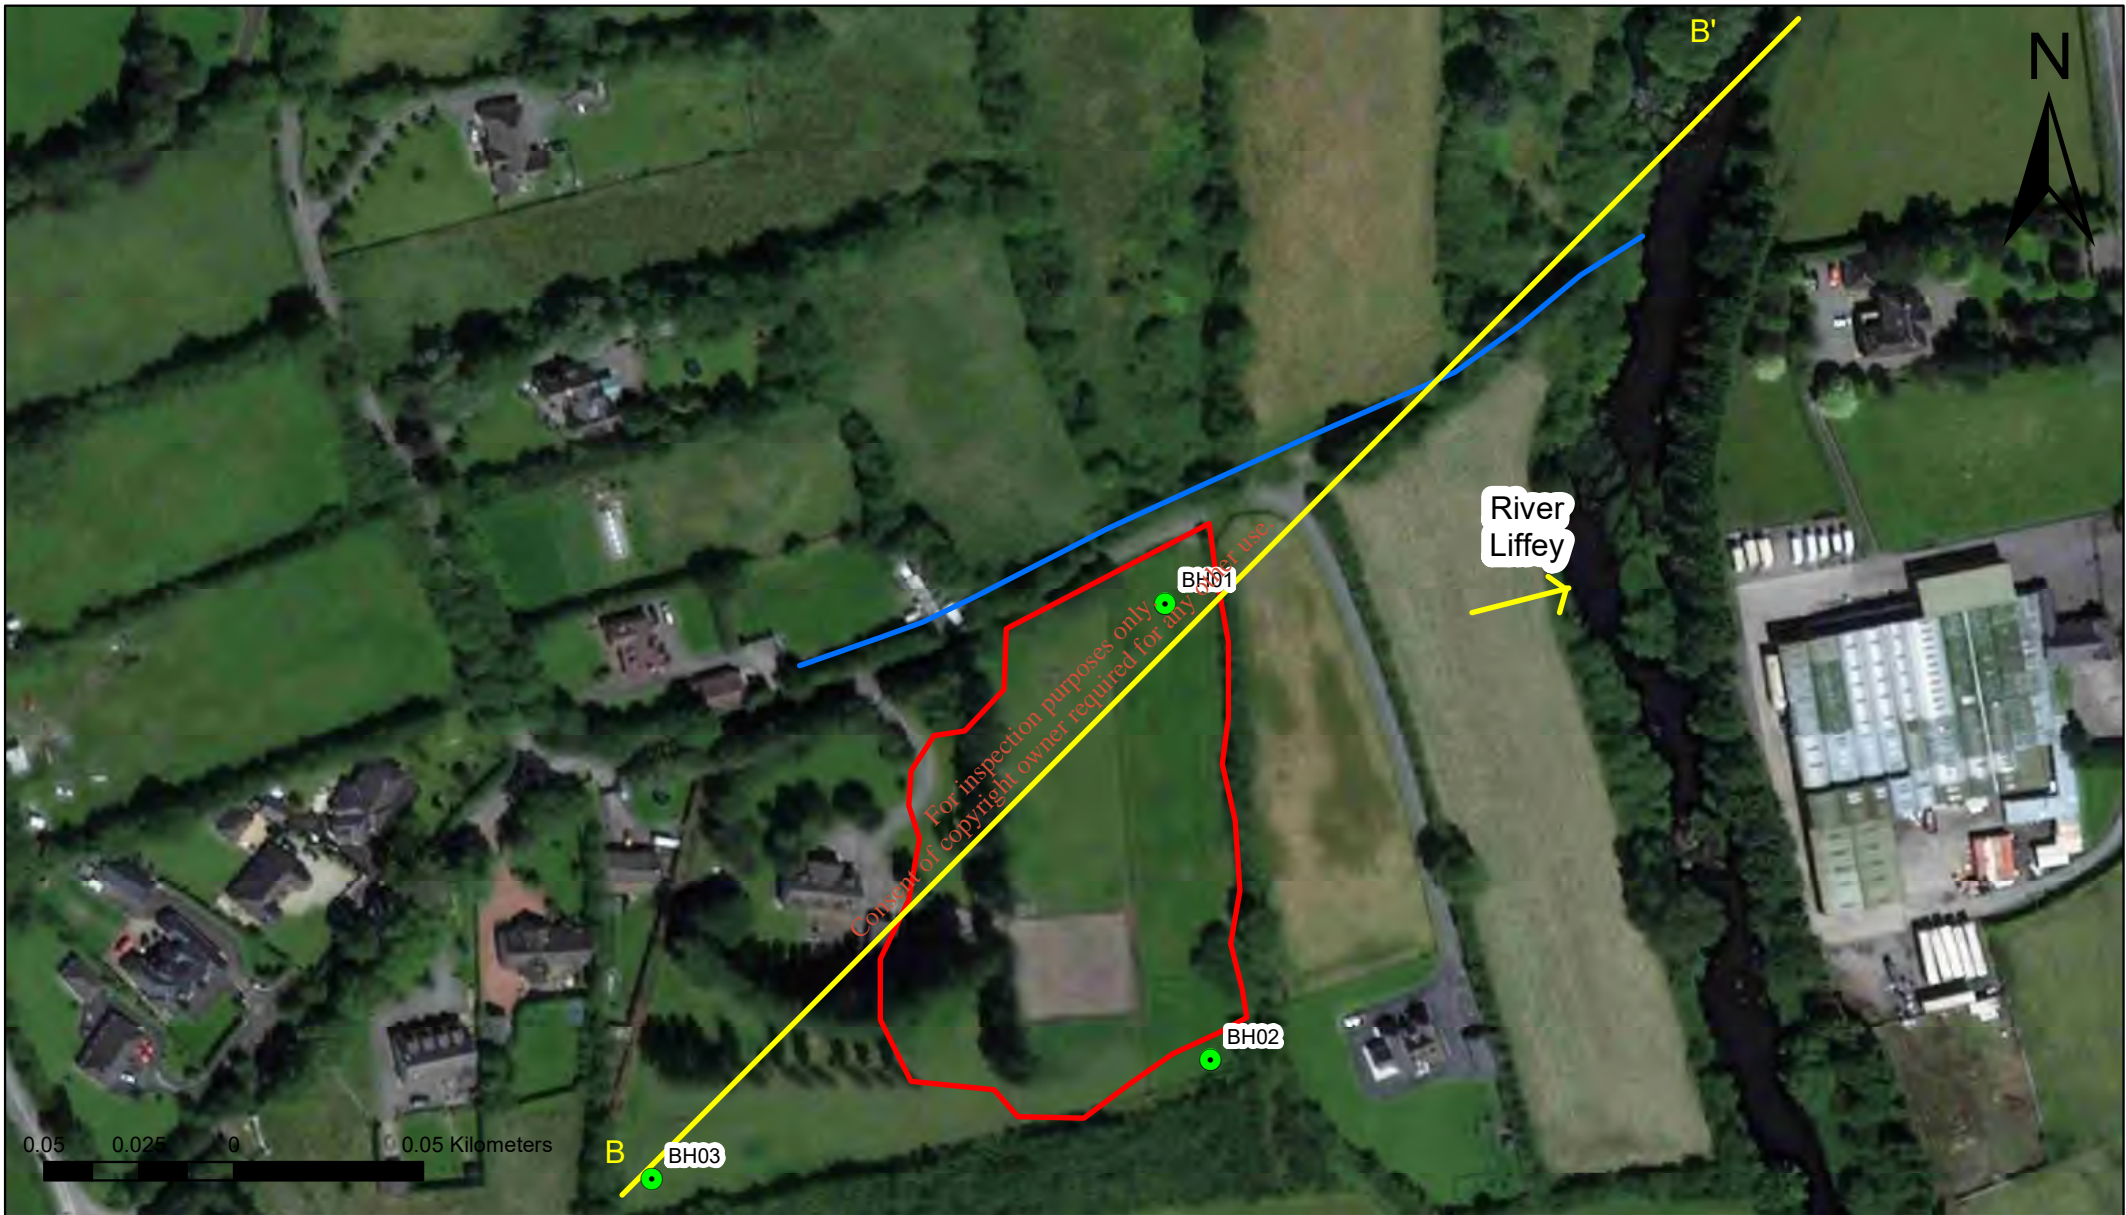
<p>O'Callaghan Moran & Associates, Unit 15 Melbourne Business Park, Model Farm Road, Cork. Tel. (021) 4345366 email: info@ocallaghanmoran.com</p>	<p>CLIENT</p> <p style="text-align: center;">Kildare County Council</p>	<p>Details:</p> <ul style="list-style-type: none"> ● Borehole — Line of Section — Drain — Site Layout
	<p>TITLE</p> <p style="text-align: center;">Line of Section</p>

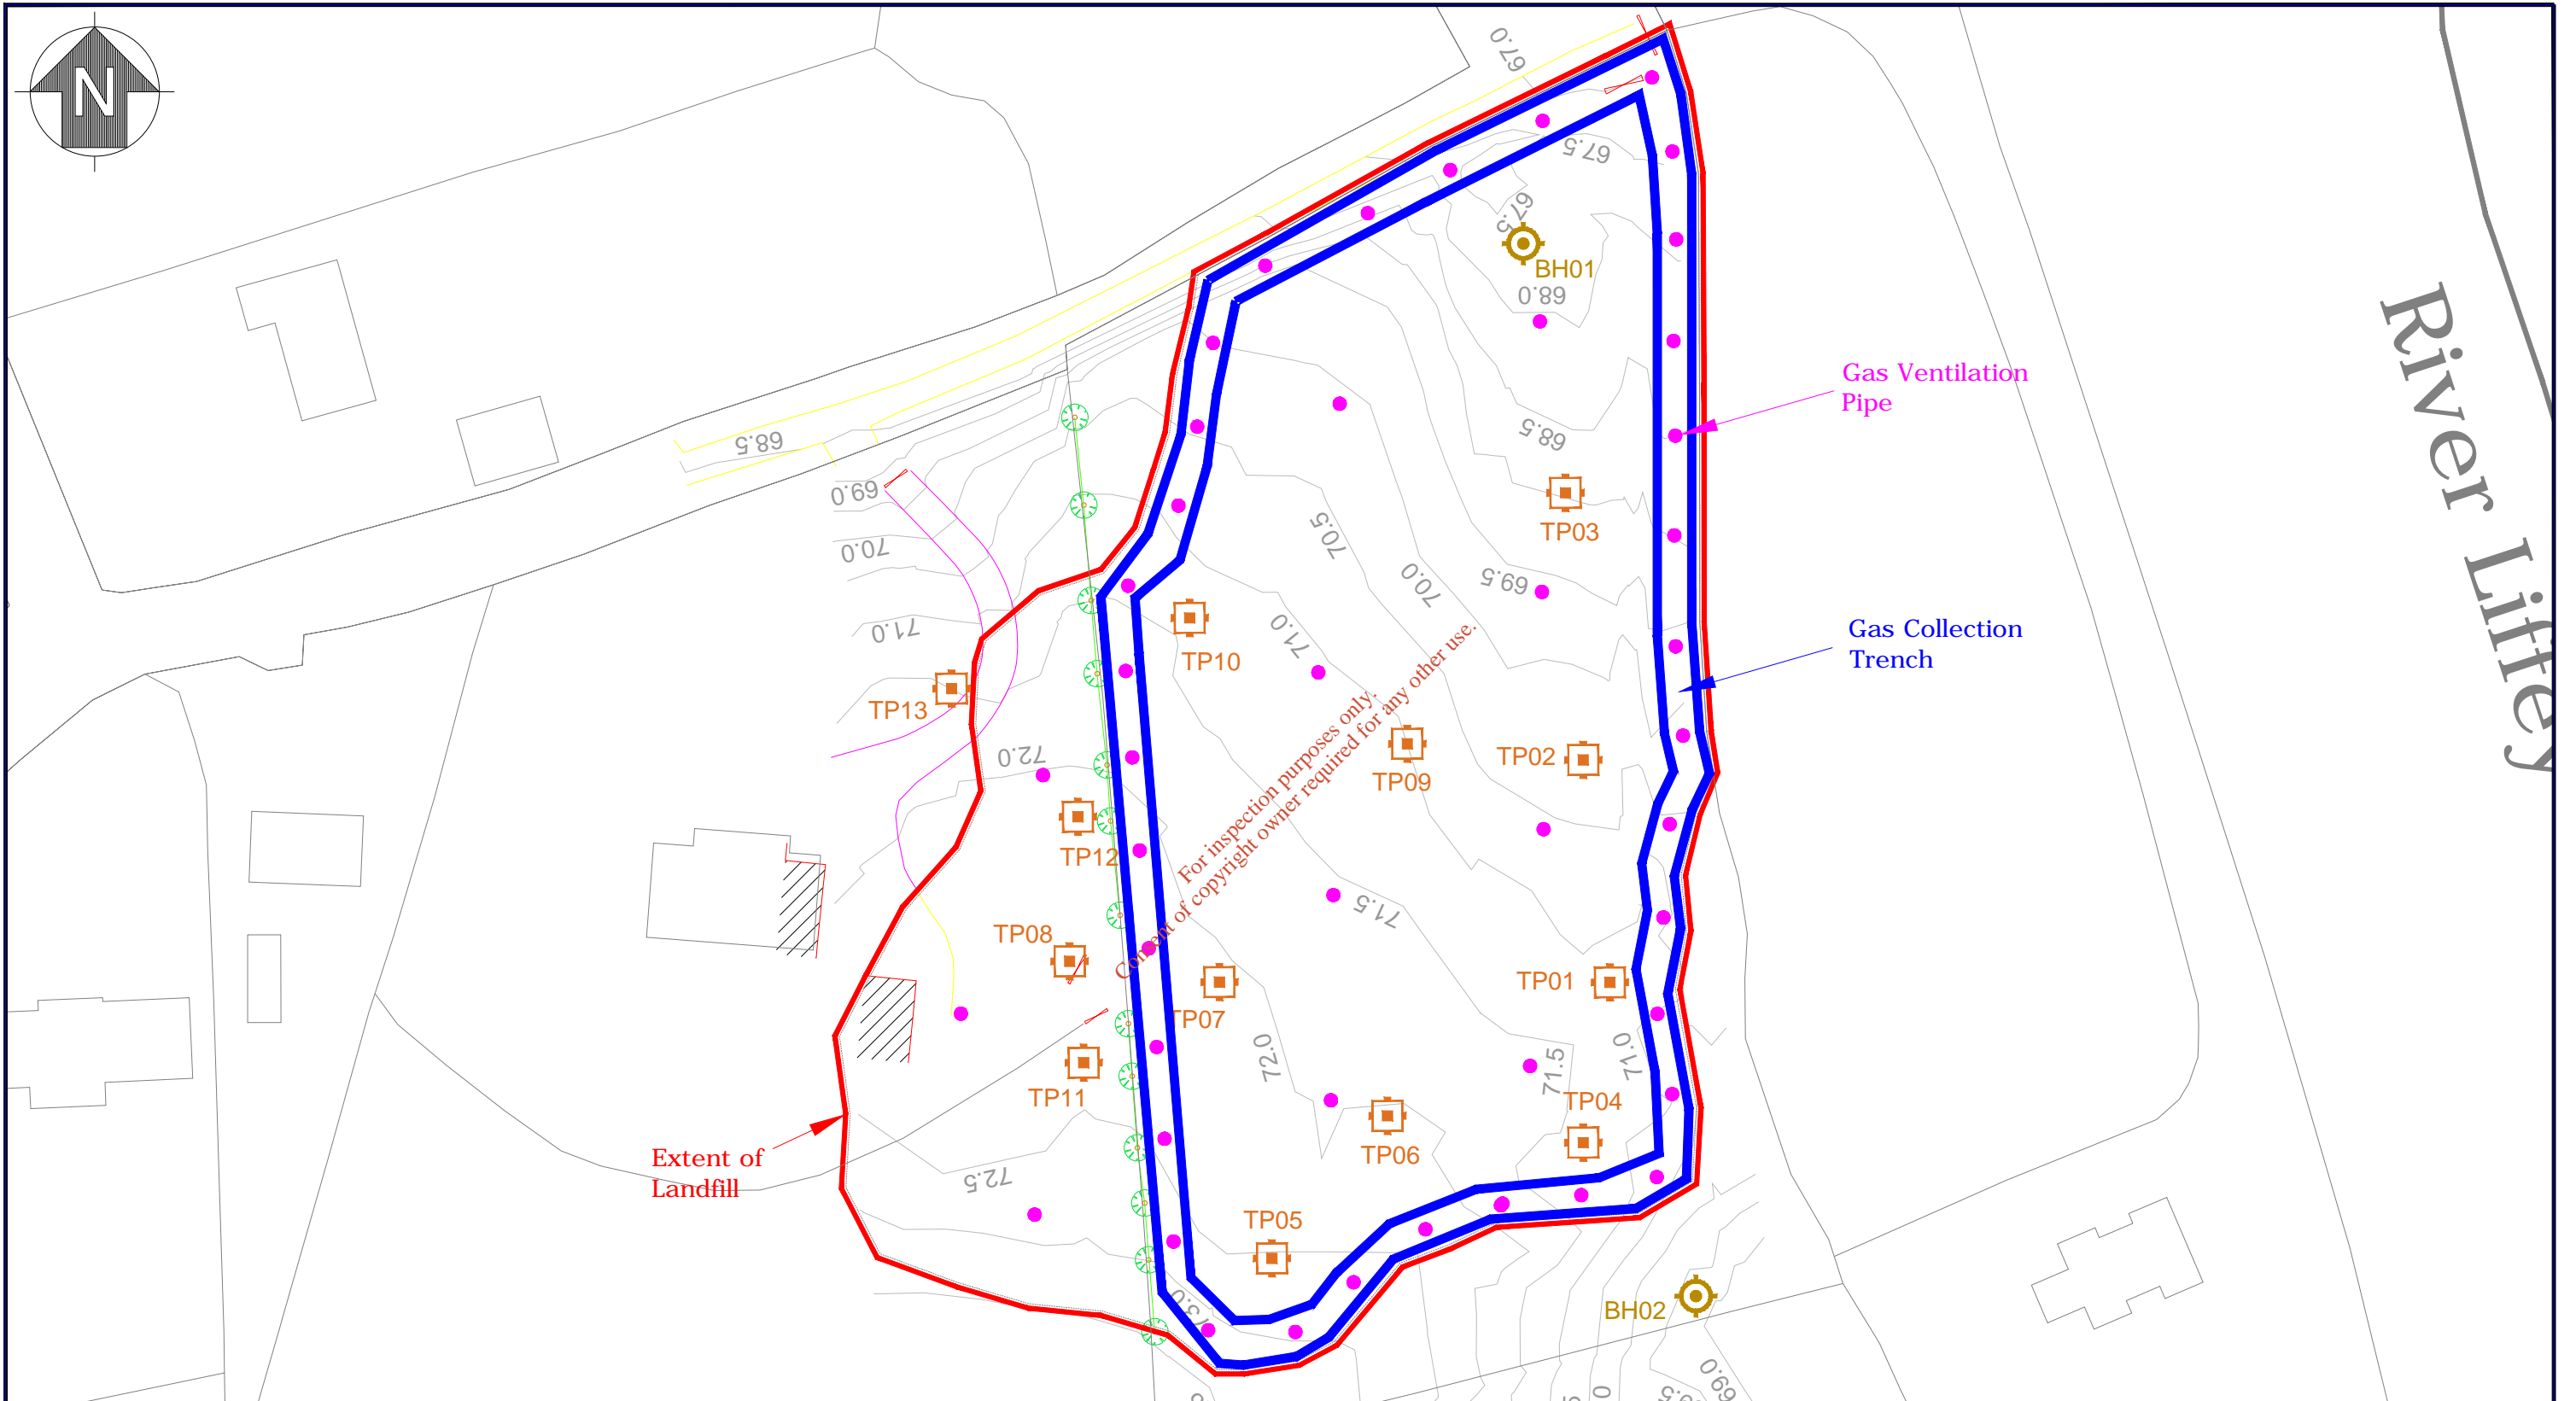
Eight vertical gas ventilation wells will be installed in the cap to reduce the build-up of landfill gas beneath the clay cap. The wells will be of similar construction to the vertical risers in the gas collection trench.
