## **Tier 2 and 3 Environmental Risk Assessment**

### **Carrigeen Legacy Landfill**

**Clane,**

**October 2018**

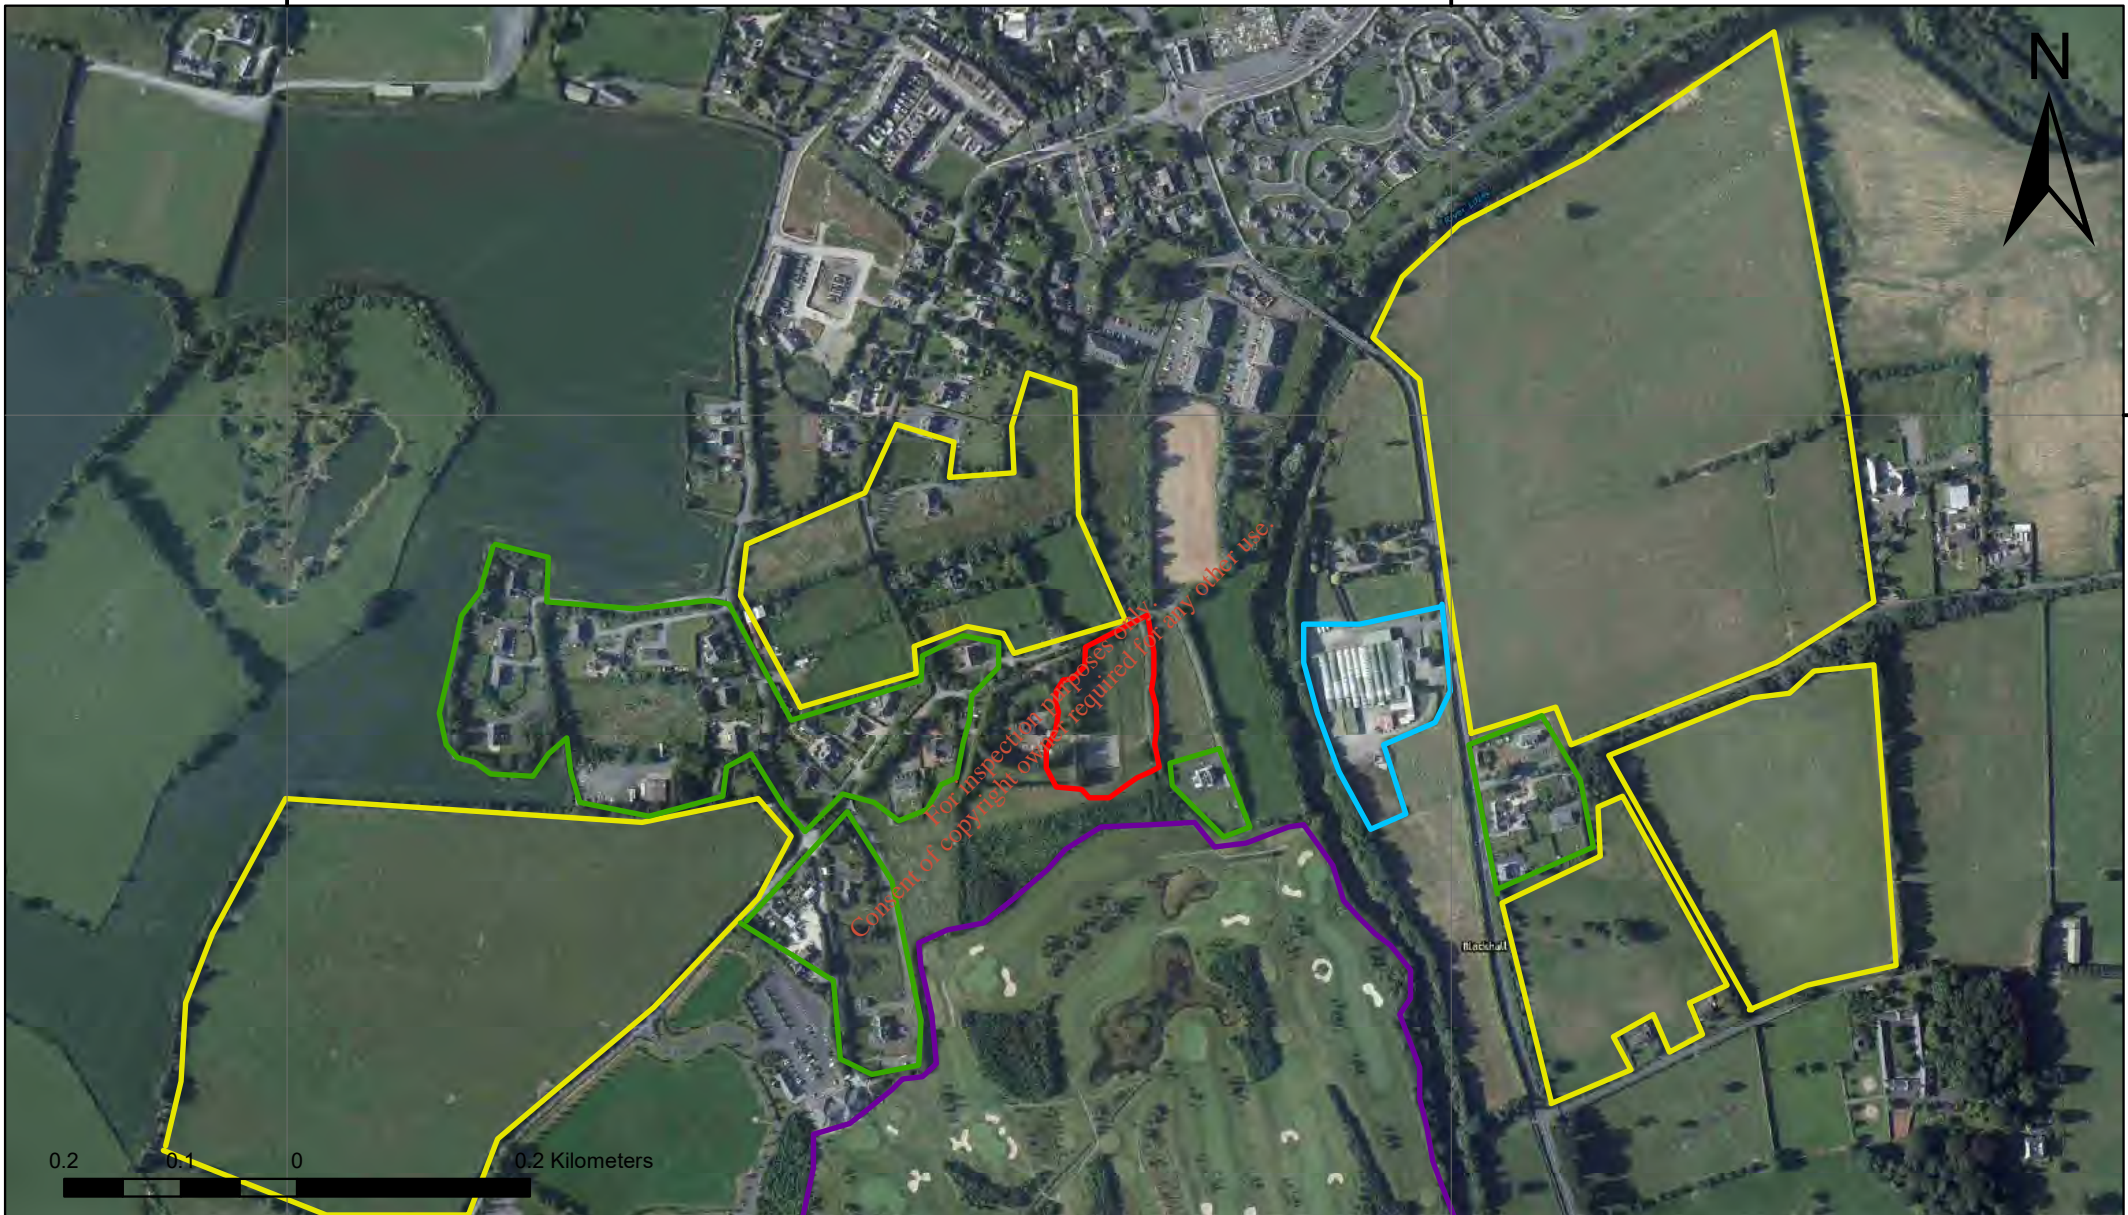
Figure 2.3

The surrounding land use is residential and amenity, with dwellings located on individual sites of. Millicent Golf Course is immediately south of the site (Figure 2.3). The nearest dwelling is within 10m to the west of waste deposition area, with a second house 40m to the south-east. The River Liffey is 85m to the east, where it flows from south to north parallel to the eastern boundary. A tributary of the River Liffey flows from west to east within 10m of the northern north of the landfill and joins the Liffey c 85m to the north-east of the site.
