EU Habitats Directive

Screening Statement

Dunmanway Landfill

Cork County Council

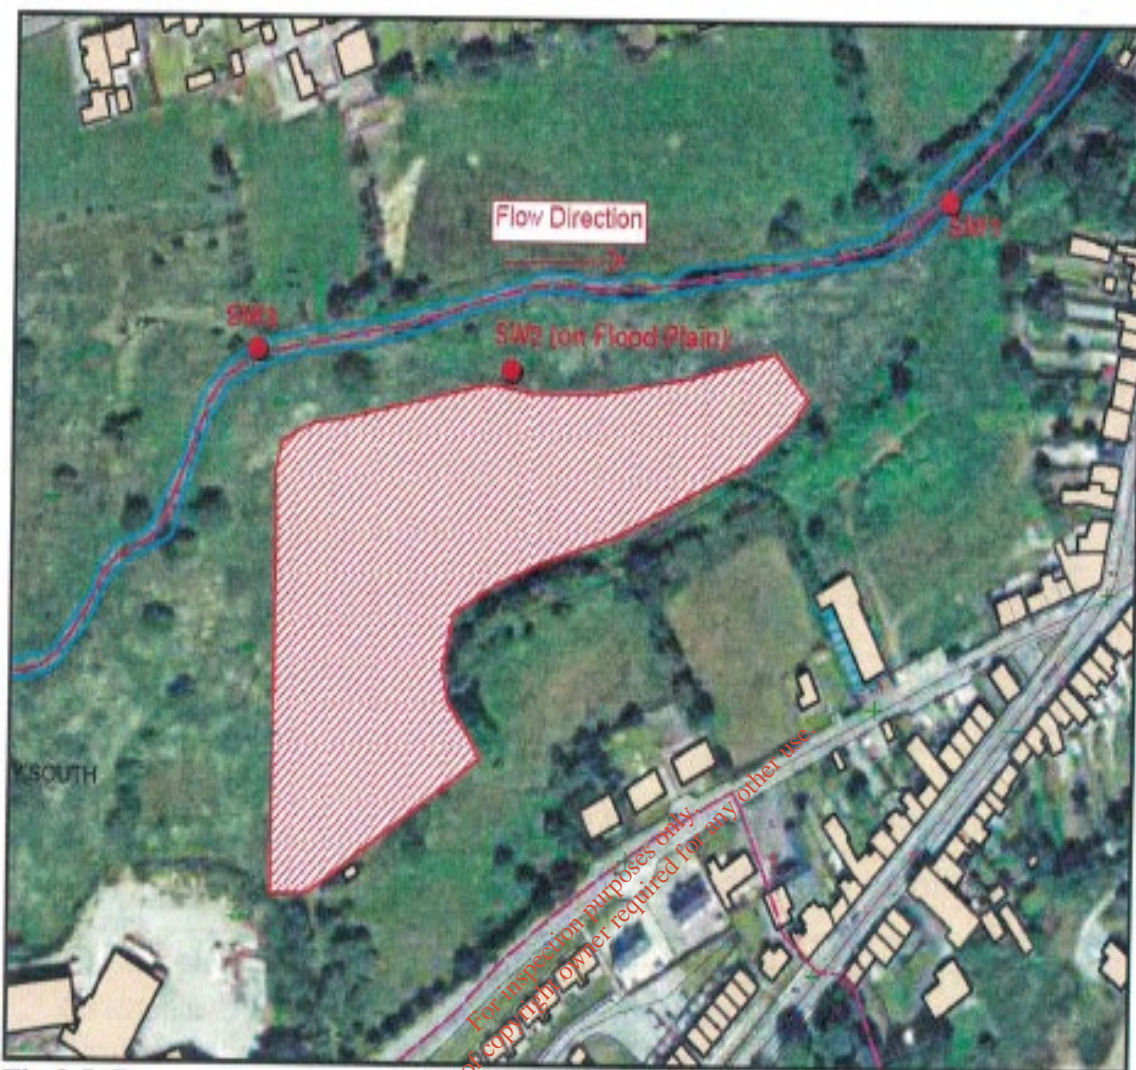
## Appendix 5: Map of Surface Water Sample Points

Source : Image from Tier II Assessment

A comparison of the results between 2008 to 2013 indicate no deterioration in the water quality of the Dirty River. However, results from SW2 in 2013 indicate a low level of contamination from the landfill site and ammonia results from SW2 and SW1, which show significant increases in both sampling years when compared to SW3 also supports the assumption that the landfill is resulting in contamination to the Dirty River.
