## OFFICE OF ENVIRONMENTAL SUSTAINABILITY

### INSPECTOR'S REPORT ON AN APPLICATION FOR A CERTIFICATE OF AUTHORISATION FOR A CLOSED LANDFILL

TO:	Eimear Cotter, Director, Office of Environmental Sustainability
FROM:	Dr Magnus Amajirionwu, Inspector, Environmental Licensing Programme
DATE:	3 December 2018
RE:	Application by <b>Tipperary County Council</b> for a Certificate of Authorisation for a closed landfill at <b>Carrownreddy, Tipperary Town, County Tipperary.</b> Certificate of Authorisation Register Number H0004-01.

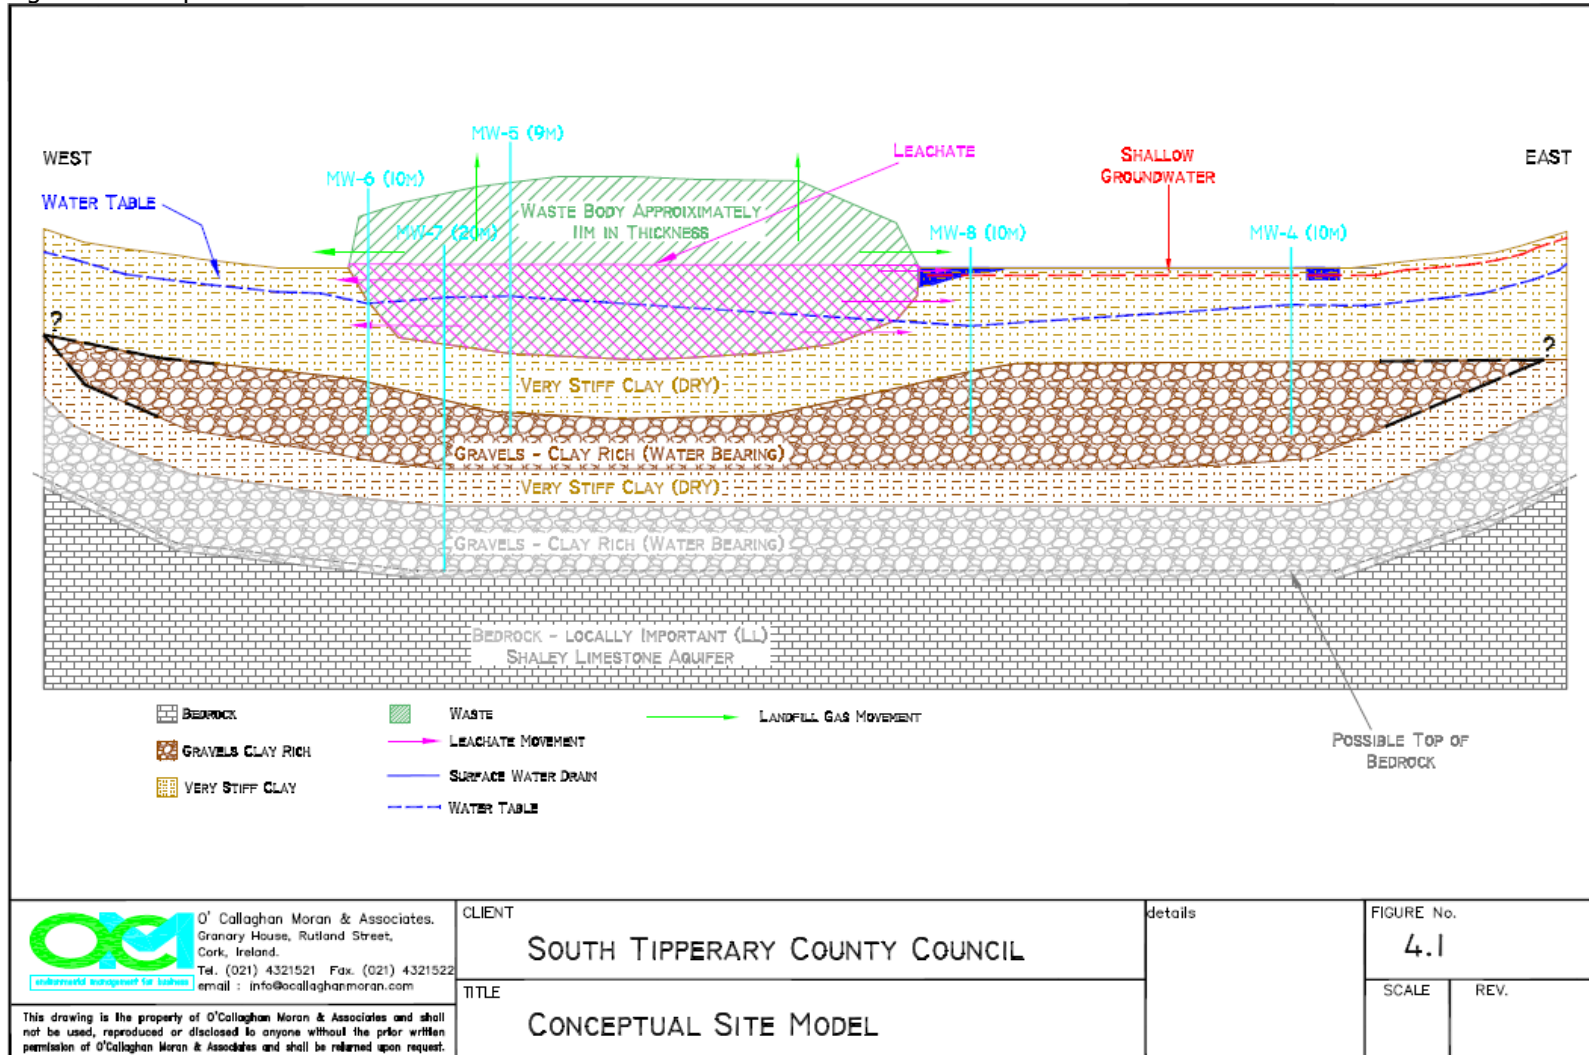
Figure 3 Conceptual site model

<p>Conceptual site model</p>	<p>The conceptual site model developed in 2009 and provided with the original application identified the following pollutant linkages:</p> <ul style="list-style-type: none"> <li>• human health exposure due to on-site and off-site migration of landfill gas;</li> <li>• migration of leachate into the adjoining surface water body (Marsh); and</li> <li>• migration of leachate into the underlying aquifer.</li> </ul> <p>The conceptual site model is shown in Figure 3. The source, pathways and receptors can be described as follows:</p> <p>Source:</p> <ul style="list-style-type: none"> <li>– Rainfall on the landfill will preferentially percolate through the cap and into the waste.</li> <li>– Leachate is generated in the waste albeit at low strength.</li> <li>– Gas is generated at the landfill.</li> </ul> <p>Pathway:</p> <ul style="list-style-type: none"> <li>– Leachate can migrate through the base of the landfill into low permeability clay and gravel, and underlying aquifer beneath.</li> <li>– Leachate discharge into adjoining Marsh (surface water body).</li> <li>– Gas migration can occur through the landfill cap and into silts, clays and fractured bedrock beneath the waste.</li> <li>– Gas migration beyond the site boundary through drains.</li> </ul>

<p>Receptors:</p> <ul style="list-style-type: none"> <li>- Users in close proximity of the site.</li> <li>- Groundwater</li> <li>- Adjoining surface water bodies (Marsh).</li> <li>- Surface water/ protected area</li> </ul>
--	--
