# **Geophysical Report**

AGL15302\_02

**REPORT  
ON THE  
GEOPHYSICAL SURVEY  
AT  
FASSAROE LANDFILL, Co. WICKLOW  
FOR  
RPS.**

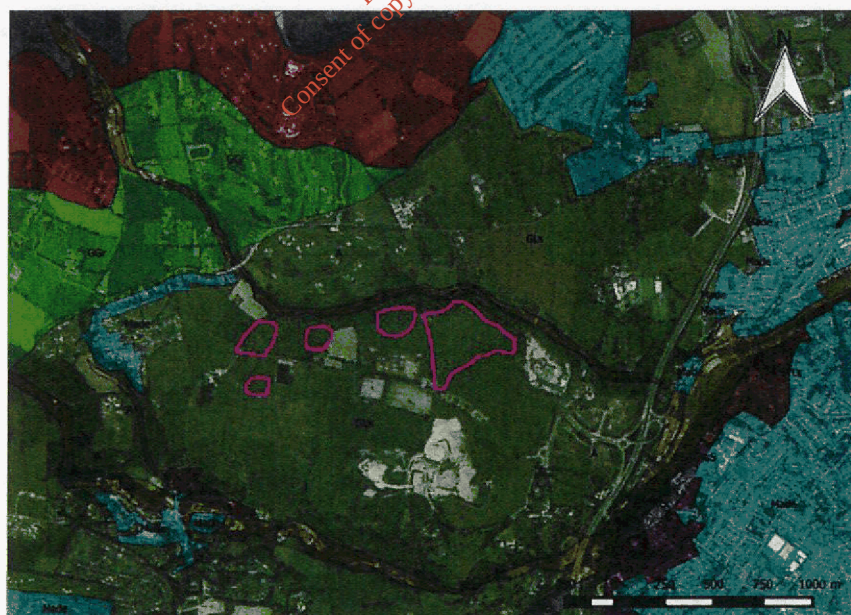
Fig 2.8: The Teagasc soil map with Limestone sands and gravels (GLs) (sites marked in magenta). Alluvium is indicated at the bottom of the valley that bounds the site to the north.

According to the Teagasc Subsoil map the soil across the sites consist of sands and gravels derived from Carboniferous limestone.

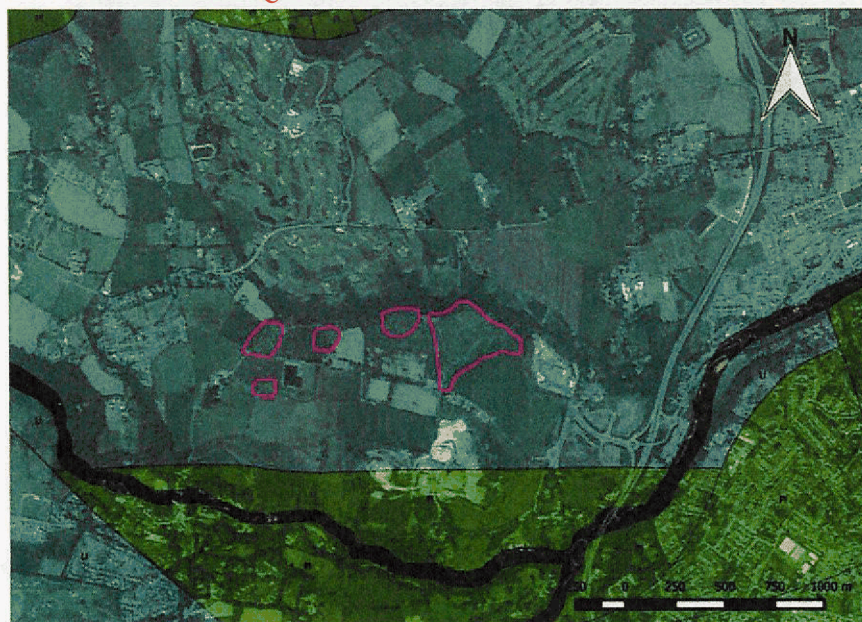
Fig 2.10: The GSI aquifer map indicating Li bedrock aquifer(pale blue) with sites marked in magenta.

The gravels have been categorised as a locally important gravel aquifer while the bedrock is aquifer is classified as locally important (Li) i.e. the bedrock is only productive in localised zones.
