## **APPENDIX C**

# **Geophysical Report**

**REPORT  
ON THE  
GEOPHYSICAL SURVEY  
AT  
FASSAROE LANDFILL, Co. WICKLOW  
FOR  
RPS.**

**31TH MAY 2016**

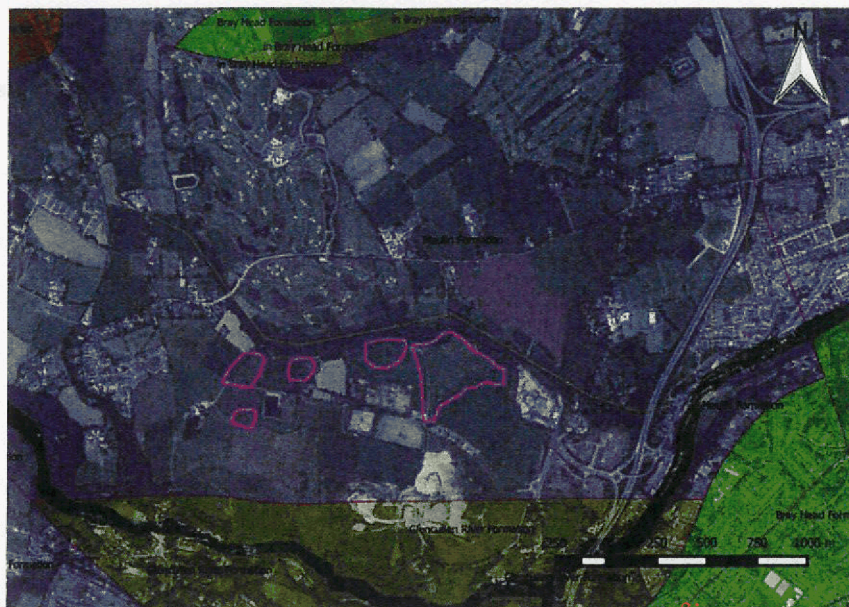
Fig 2.7: The GSI bedrock map (sites marked in magenta, Maulin Formation (purple) and Glencullen River Formation (brown))

The GSI bedrock geology map (Fig. 2.7) shows that all sites are underlain by slate, commonly laminated with pale siltstones with some schists of the Maulin Formation. South of the landfill sites, the bedrock is comprised of tuff & greywacke of the Glencullen River Formation. A fault line between the Glencullen and Maulin Formations is inferred to run south of the site in an east-west direction. Bedrock is buried at depth across the site, overlain by significant thickness of subsoil.

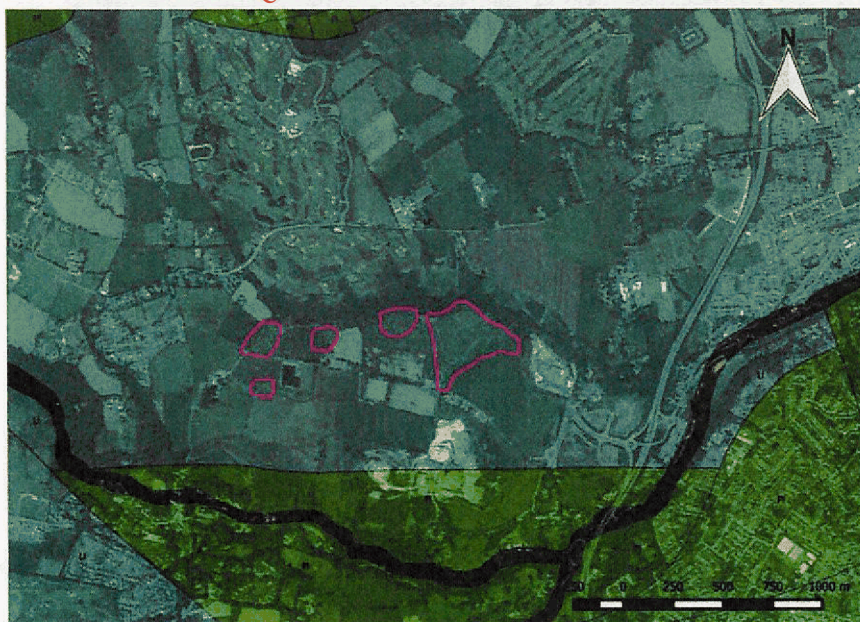
Fig 2.10: The GSI aquifer map indicating Li bedrock aquifer(pale blue) with sites marked in magenta.

The gravels have been categorised as a locally important gravel aquifer while the bedrock is aquifer is classified as locally important (Li) i.e. the bedrock is only productive in localised zones.
