Geophysical Report

AGL15302_02

**REPORT
ON THE
GEOPHYSICAL SURVEY
AT
FASSAROE LANDFILL, Co. WICKLOW
FOR
RPS.**

3TH MAY 2016

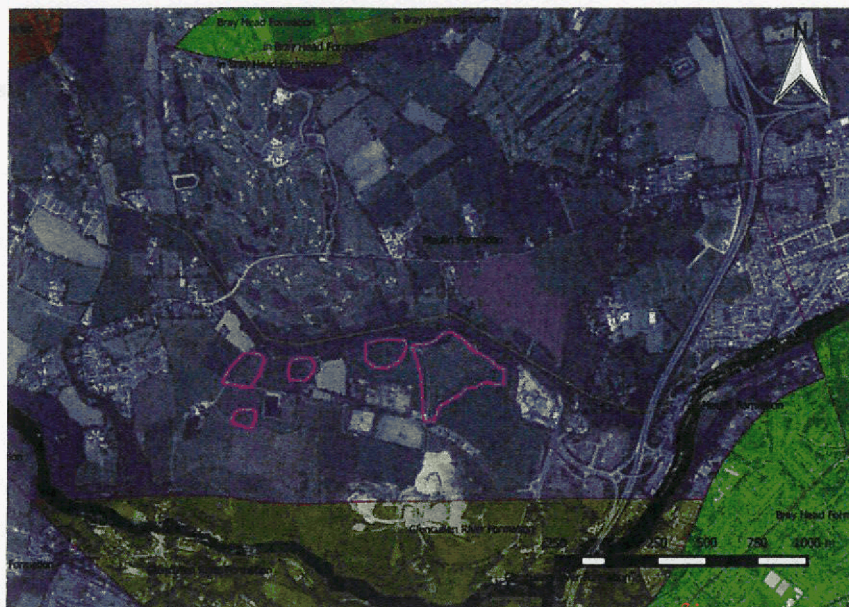
Fig 2.7: The GSI bedrock map (sites marked in magenta, Maulin Formation (purple) and Glencullen River Formation (brown))

The GSI bedrock geology map (Fig. 2.7) shows that all sites are underlain by slate, commonly laminated with pale siltstones with some schists of the Maulin Formation. South of the landfill sites, the bedrock is comprised of tuff & greywacke of the Glencullen River Formation. A fault line between the Glencullen and Maulin Formations is inferred to run south of the site in an east-west direction. Bedrock is buried at depth across the site, overlain by significant thickness of subsoil.

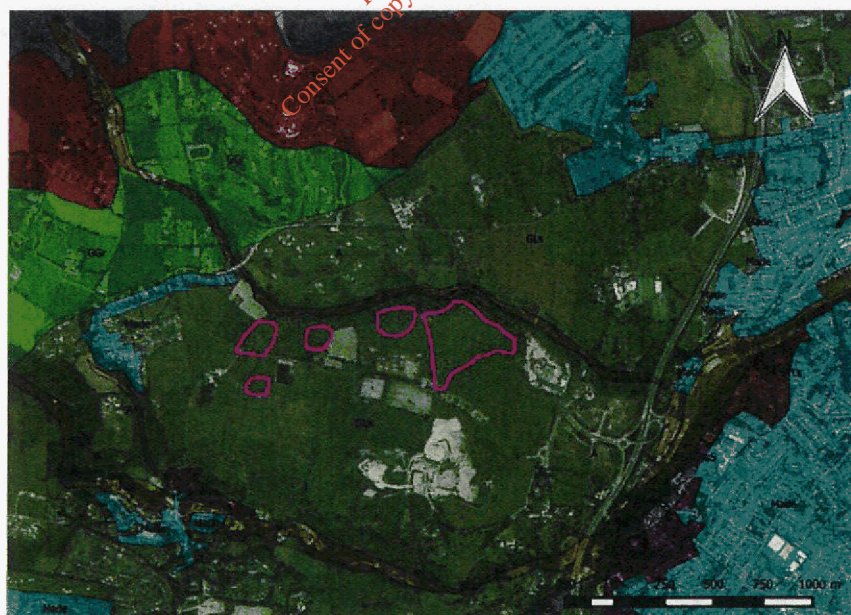
Fig 2.8: The Teagasc soil map with Limestone sands and gravels (GLs) (sites marked in magenta). Alluvium is indicated at the bottom of the valley that bounds the site to the north.

According to the Teagasc Subsoil map the soil across the sites consist of sands and gravels derived from Carboniferous limestone.

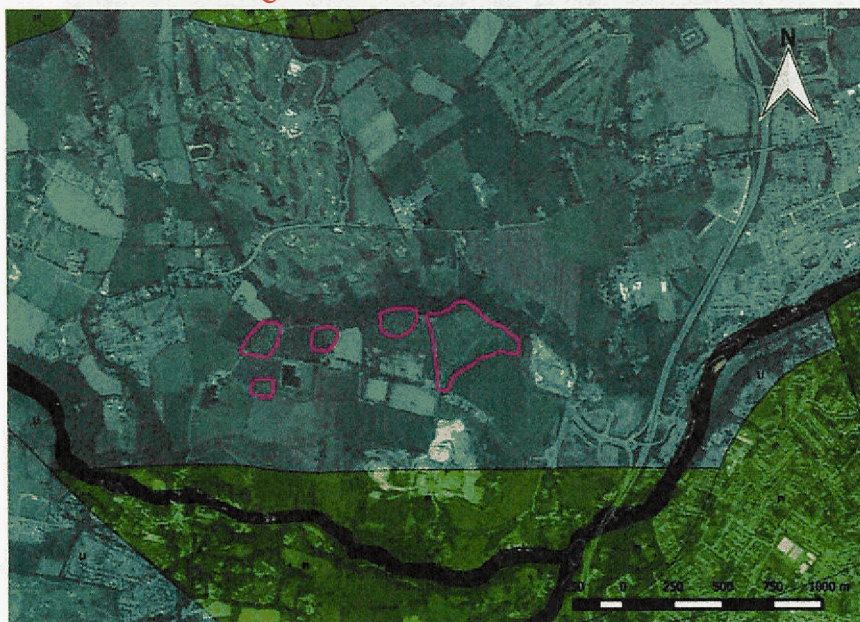
Fig 2.10: The GSI aquifer map indicating Li bedrock aquifer(pale blue) with sites marked in magenta.

The gravels have been categorised as a locally important gravel aquifer while the bedrock is aquifer is classified as locally important (Li) i.e. the bedrock is only productive in localised zones.

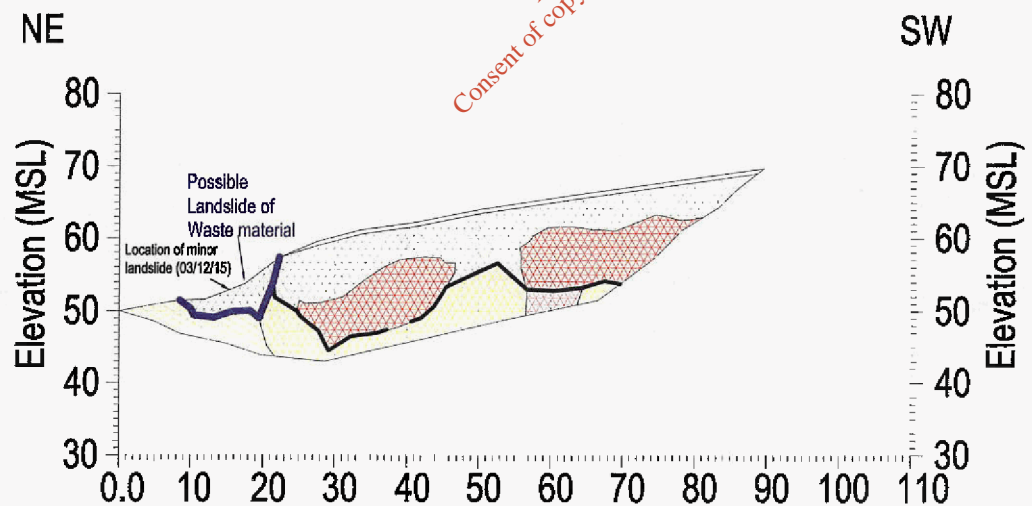
FIGURE 1 : ERT PROFILE - R2

The interpreted lateral extent of the waste material is c. 4.1 Ha and is indicated on Drawing AGL15302_04. Four ERT profiles (R01, R02, R03 & R15) were collected across the site (Drawings AGL15302_08, 09, 10 and 22 respectively). Up to 26m waste has been interpreted based on values contained in Table 2 containing up to 18.5m of waste with high organic and metallic content. The landfill waste appears to extend beyond the site boundary fence towards the lower ground to the north east.

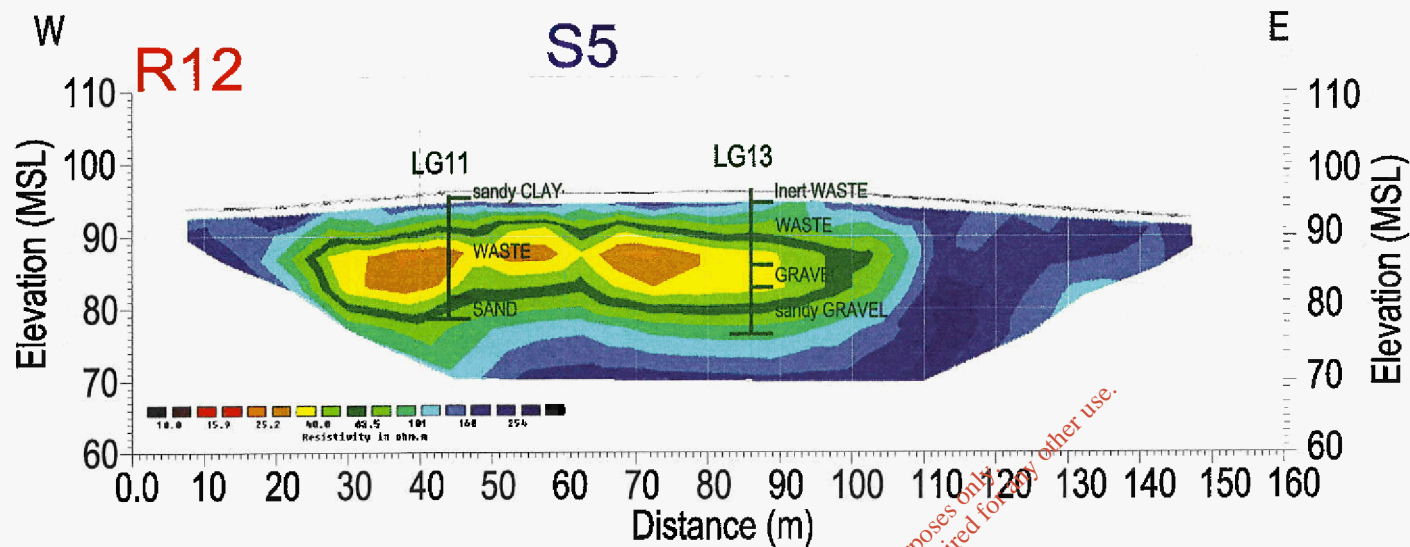
FIGURE 1 : ERT PROFILE - R12

The interpreted lateral extent of the waste material is c. 0.53 Ha and is indicated on Drawing AGL15302_04. Two ERT profiles (R11 and R12) were collected across the site (Drawings AGL15302_18 and 19 respectively). Up to 16m waste has been interpreted based on values contained in Table 2. A maximum thickness of 6m of waste with high organic and metallic content has been observed.
