Fassaroe Historic Landfills

Environmental Risk Assessment

May 2018

| Document No: | MDR1206Rp0007 | | |

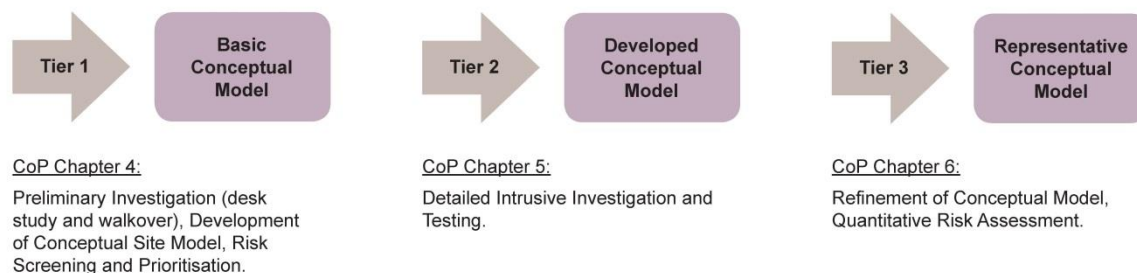
The Code of Practice tiered methodology is as follows:

site investigations and initial screening to indicate the range of high to low risk factors. Areas requiring further investigation are identified, and finally the model is refined. At each stage the information and risks are reviewed and assessed before progressing to the next phase.

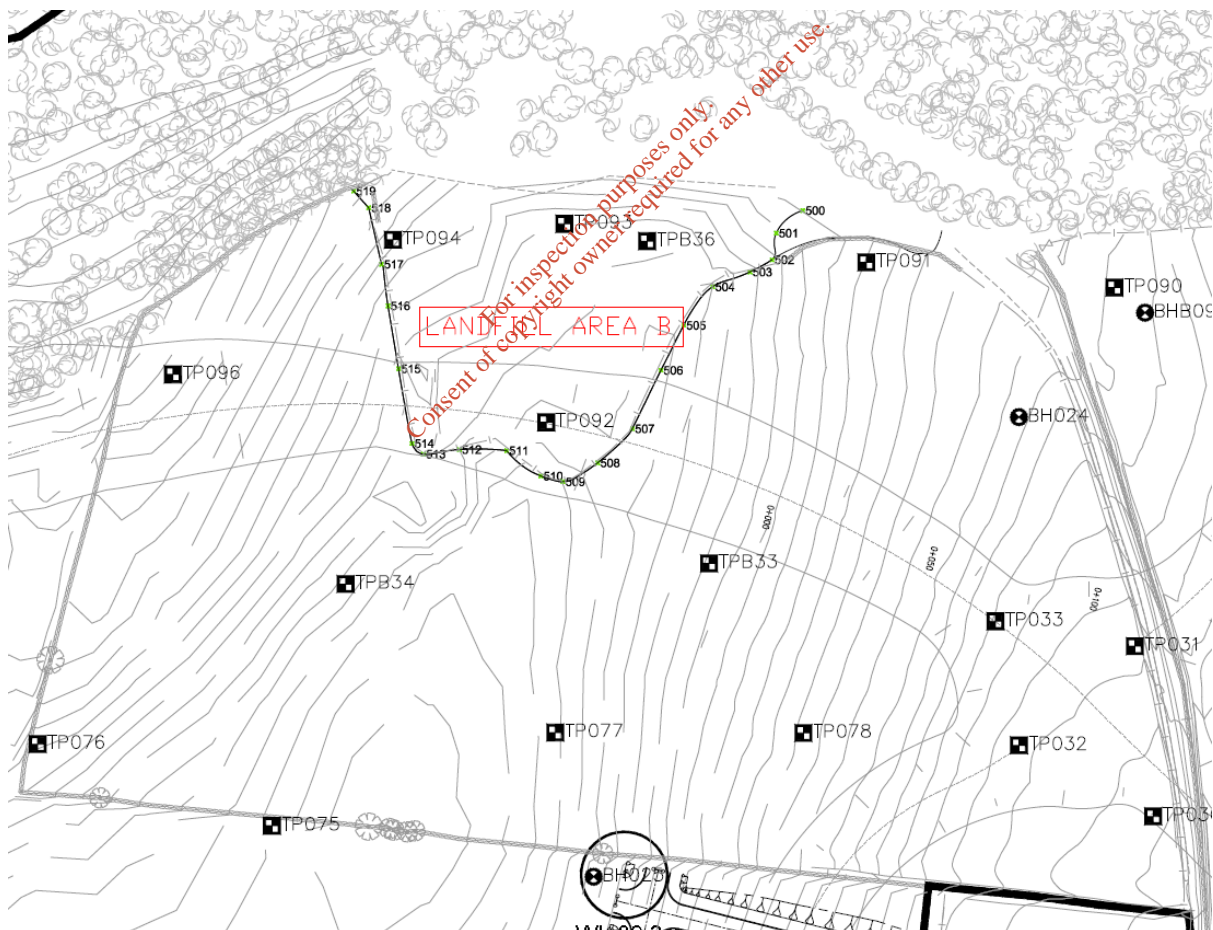
Figure 2 Site 1: Historic SI Locations (Atkins)

Source: Extract from Atkins Drawing 1739GE001 Site Investigation Borehole and Trial Pit Locations. Note Site 1 equates to 'Landfill Area B'

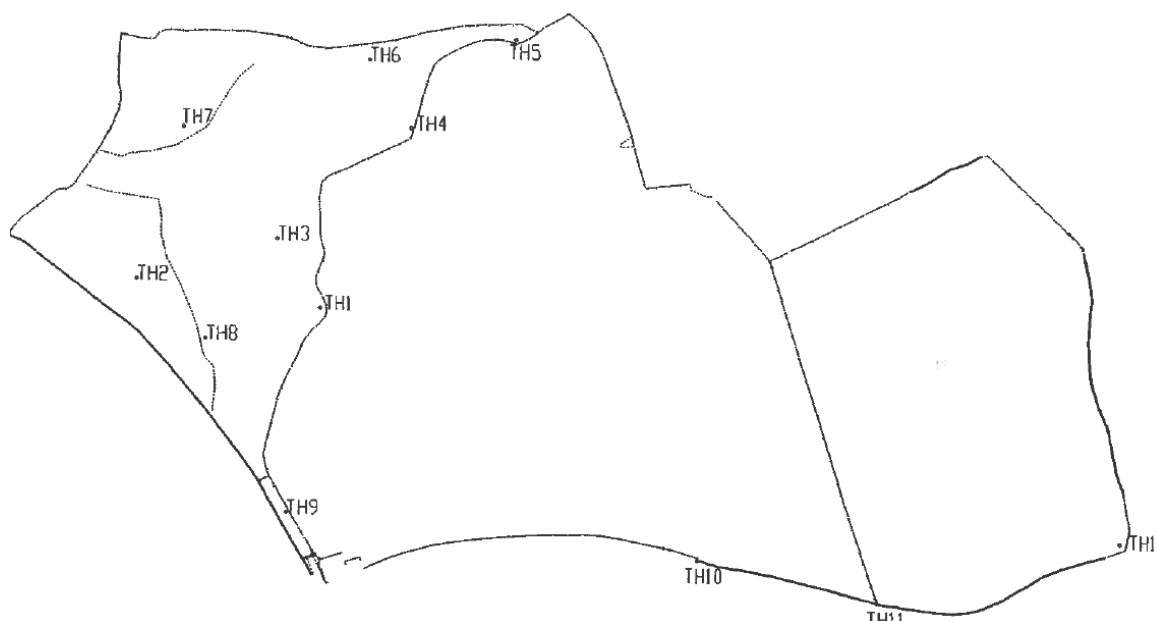
Figure 3 Site 2: Historic SI Locations (Muir Associates, 1998)

Source: Environmental Ground and Geotechnical Site Evaluation Report for Site at Fassaroe, Bray – Muir Associates, January 1998

The report also noted the presence of waste outside the area delineated as landfill which raised some doubt regarding the lateral extent of the waste body.

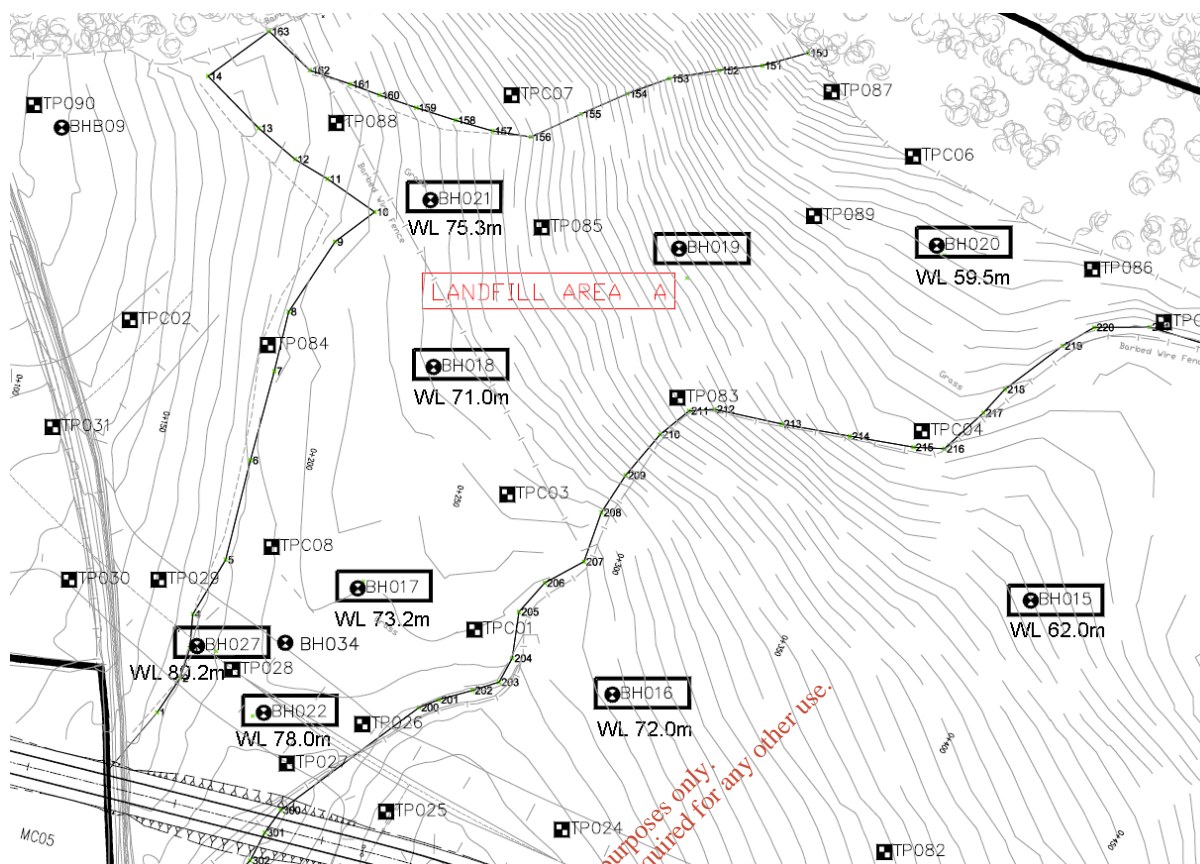
Figure 4 Site 2: Historic SI Locations

Source: Extract from Atkins Drawing 1739GE001 Site Investigation Borehole and Trial Pit Locations.
 Note Landfill Area A equates to Site 2

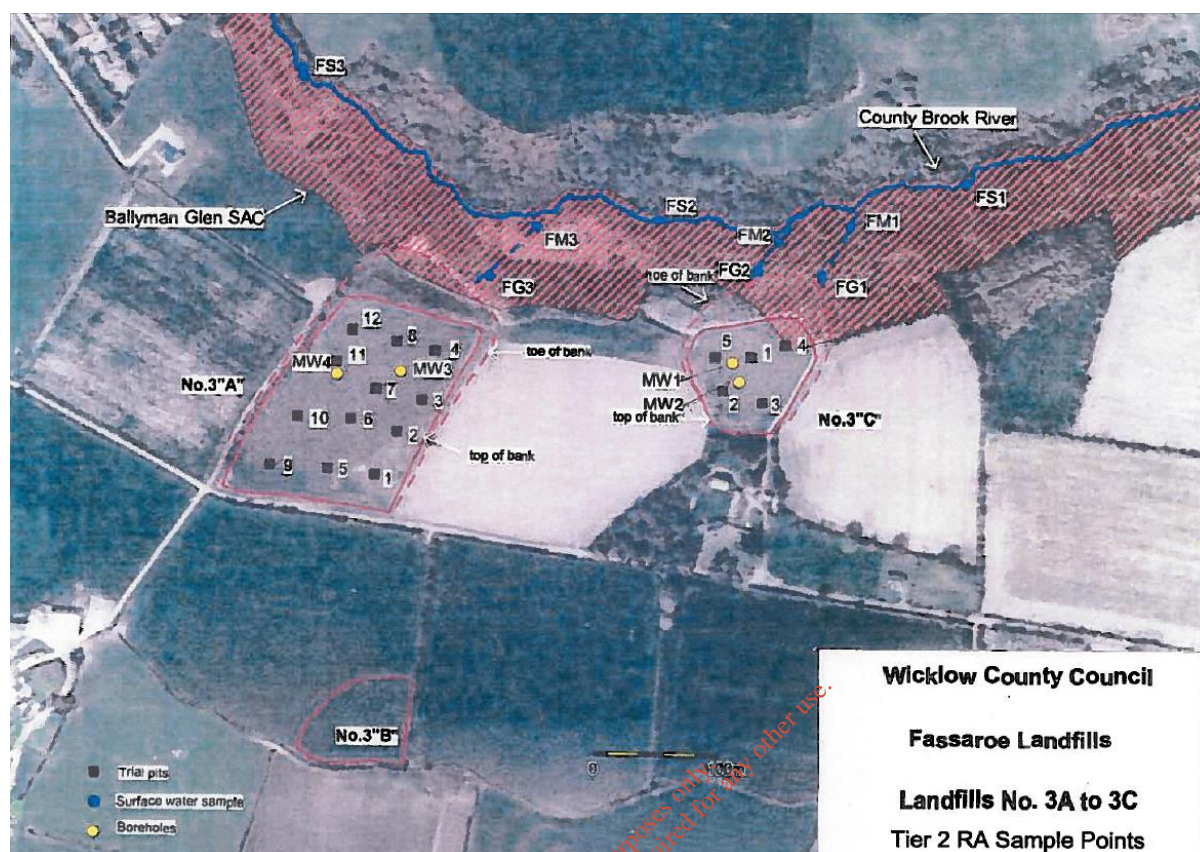
Figure 5 Site 3A & 3C: Historic SI locations

Source: extract from Tier 2-3 Environmental Risk Assessment Landfills No. 3A and 3C - Wicklow County Council, December 2012 (amended April 2013)

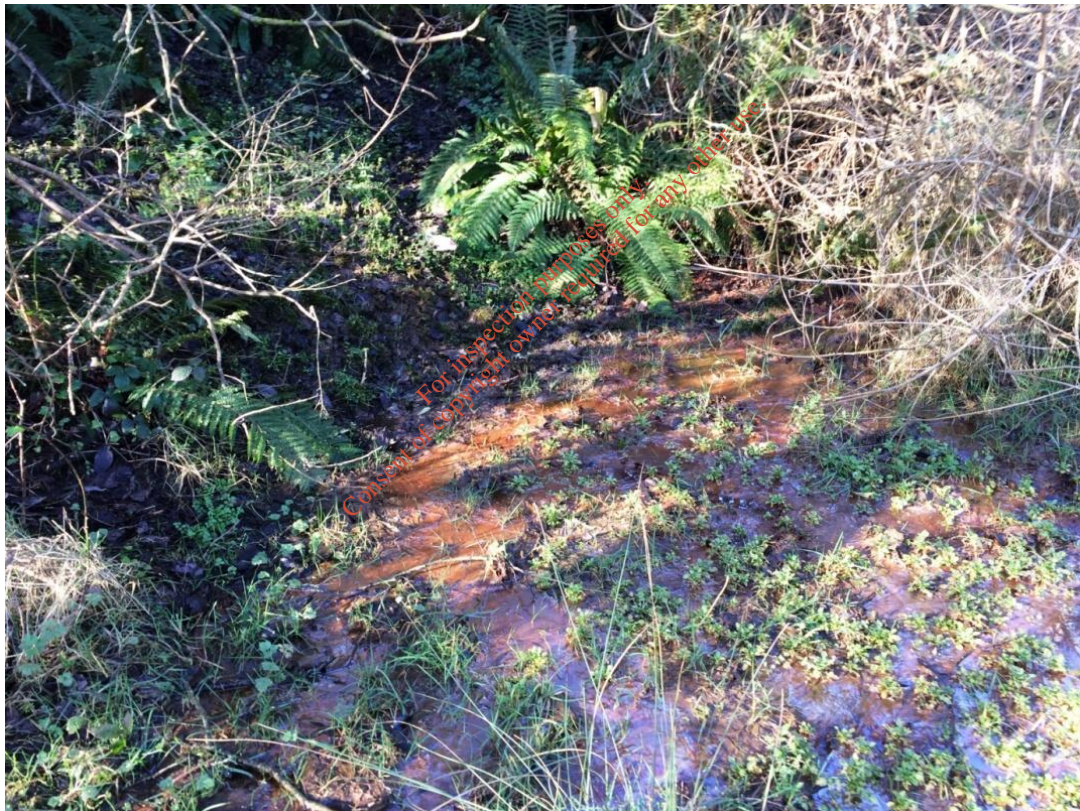
In total 9 discrete springs were noted along the southern river bank of the County Brook River (Fassaroe Stream) between Site 1 and Site 3a. Spring 1 (see Plate 1) is located at the base of a steep embankment adjacent the river. The ground was soft underfoot, with clear signs of ochre staining and hydrocarbon sheening at surface. Plate 2 shows Spring 3, which is more typical of the springs within the SAC that emerge as diffuse flow from the wet embankments and coalesce into a small channel with distance downstream.

Plate 1. Photograph of Spring 1 in October 2015 (SP1)

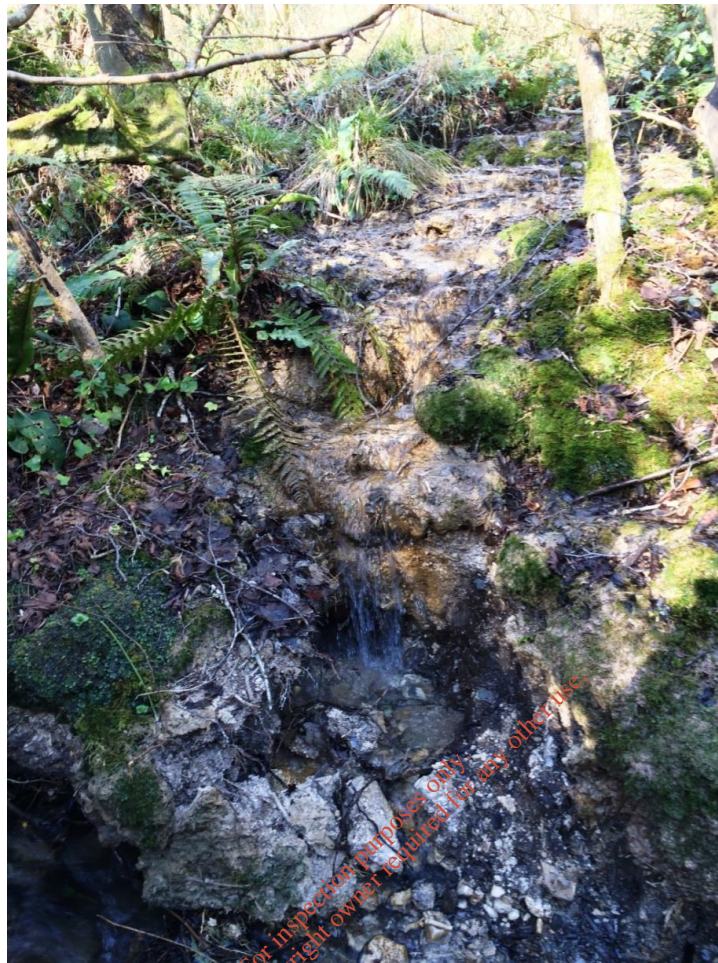
Plate 2. Photograph of Spring 3

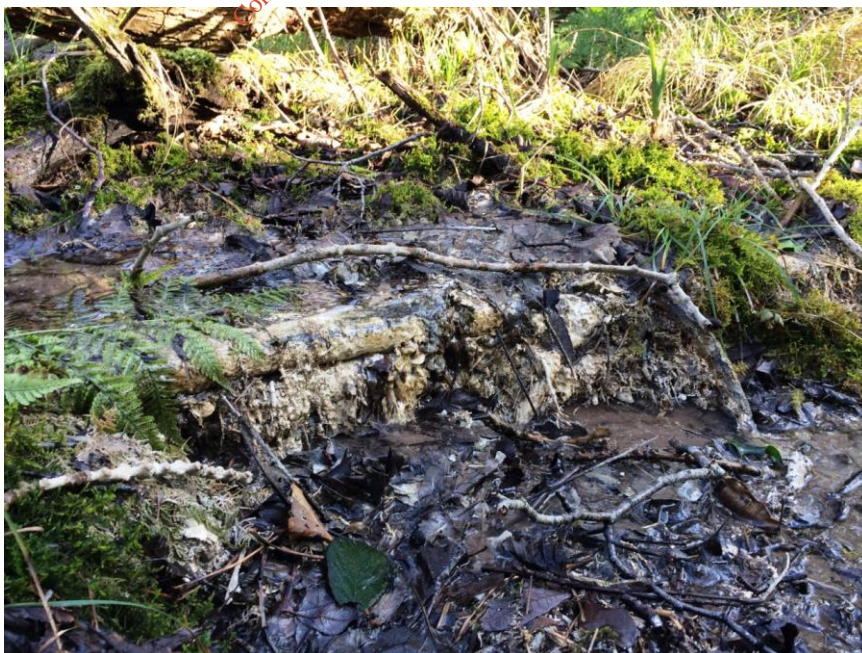
Emerging groundwater spring flows feed the tufa deposits and alkaline fen and therefore constitute a Groundwater Dependant Terrestrial Ecosystems (GWDTE) receptor as identified in the EPA Code of Practice and protected through the Water Framework Directive (WFD). An example of tufa deposits observed on the southern bank of the river is shown below in Plate 3.

Plate 3. Photograph of Tufa Deposit near river bank (off-white deposit in the centre of the picture)

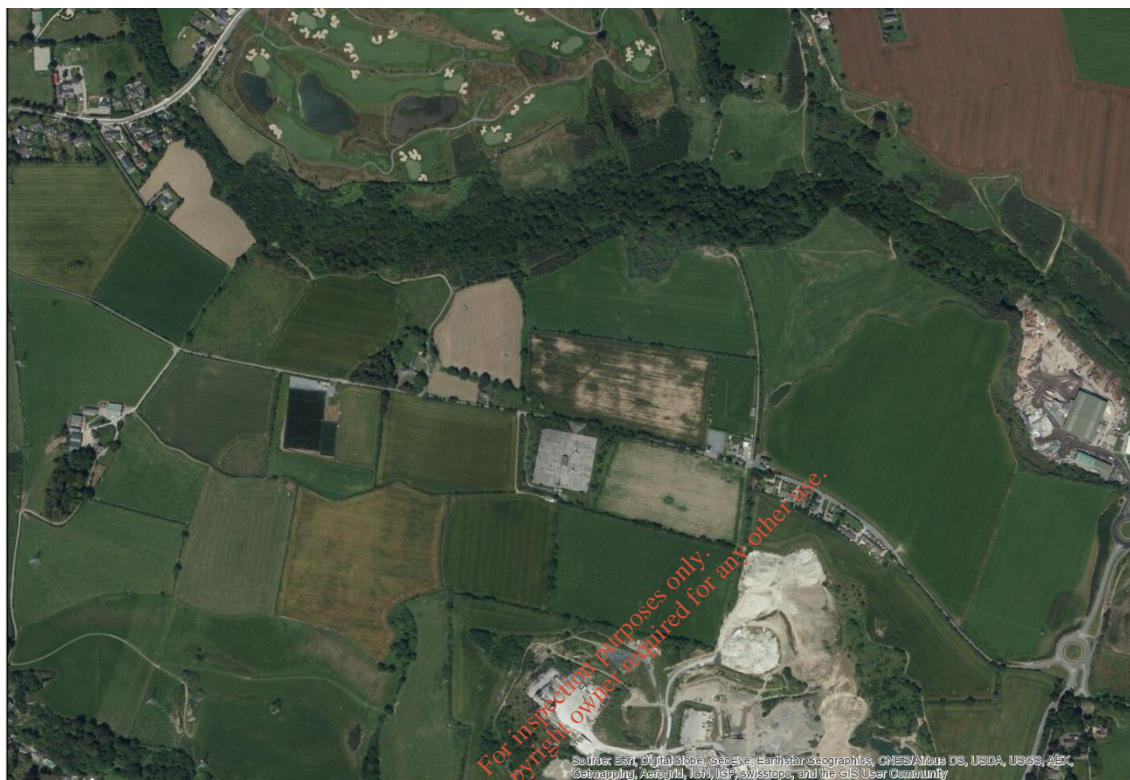
Figure 6 Aerial Photography

Aerial photography indicates that the Site 2 and 3A – 3C are grassed with evidence of vegetation die back. Site 1 consists of scrub and Gorse with some surface debris.

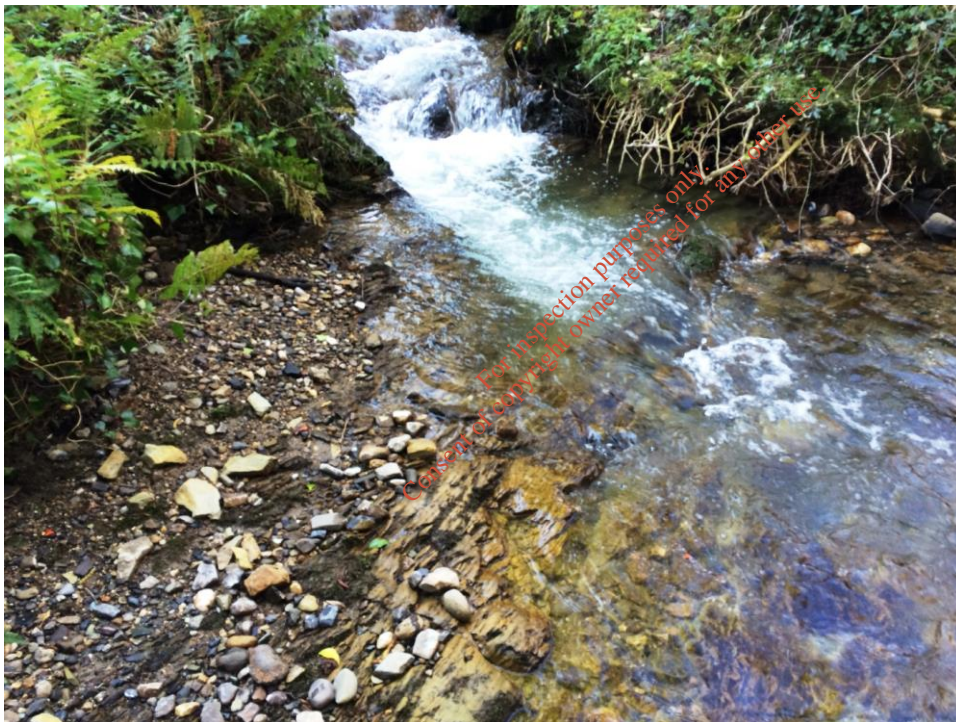
Depth to bedrock has not been proven at the site to date, albeit occurrences of shale/ schist outcrops were observed along the adjacent river at a small number of locations. In particular outcrop was noted directly north of Site 1 at approximately 55m above Ordnance Datum (aOD), see Plate 4 below.

Plate 4 Bedrock outcrop within the river north of Site 1

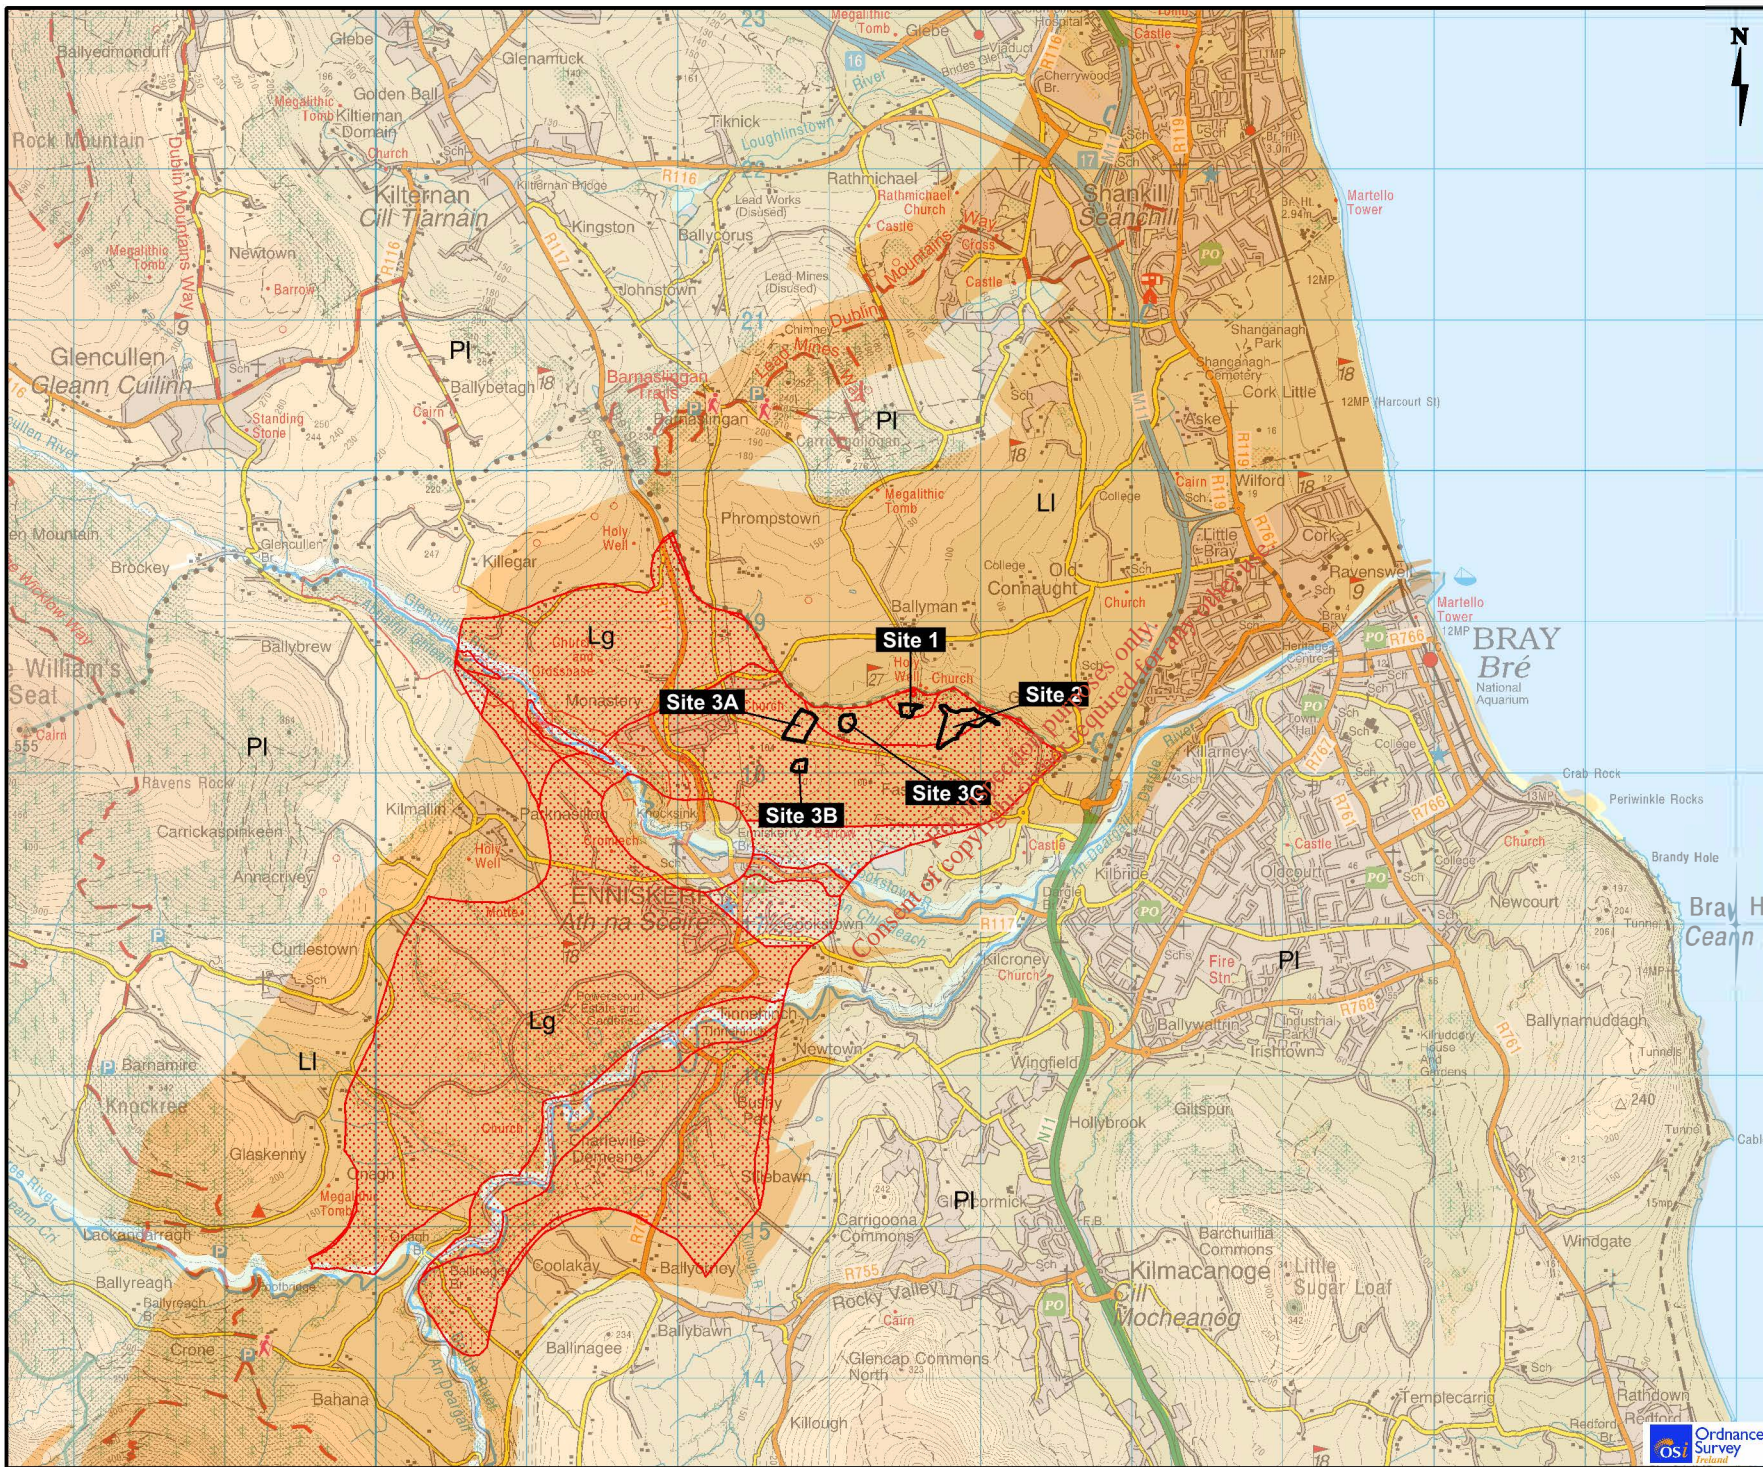
- Sites
- Gravel
- LI Locally Important Aquifer - Bedrock which is Moderately Productive only in Local Zones
- PI Poor Aquifer - Bedrock which is Generally Unproductive except for Local Zones

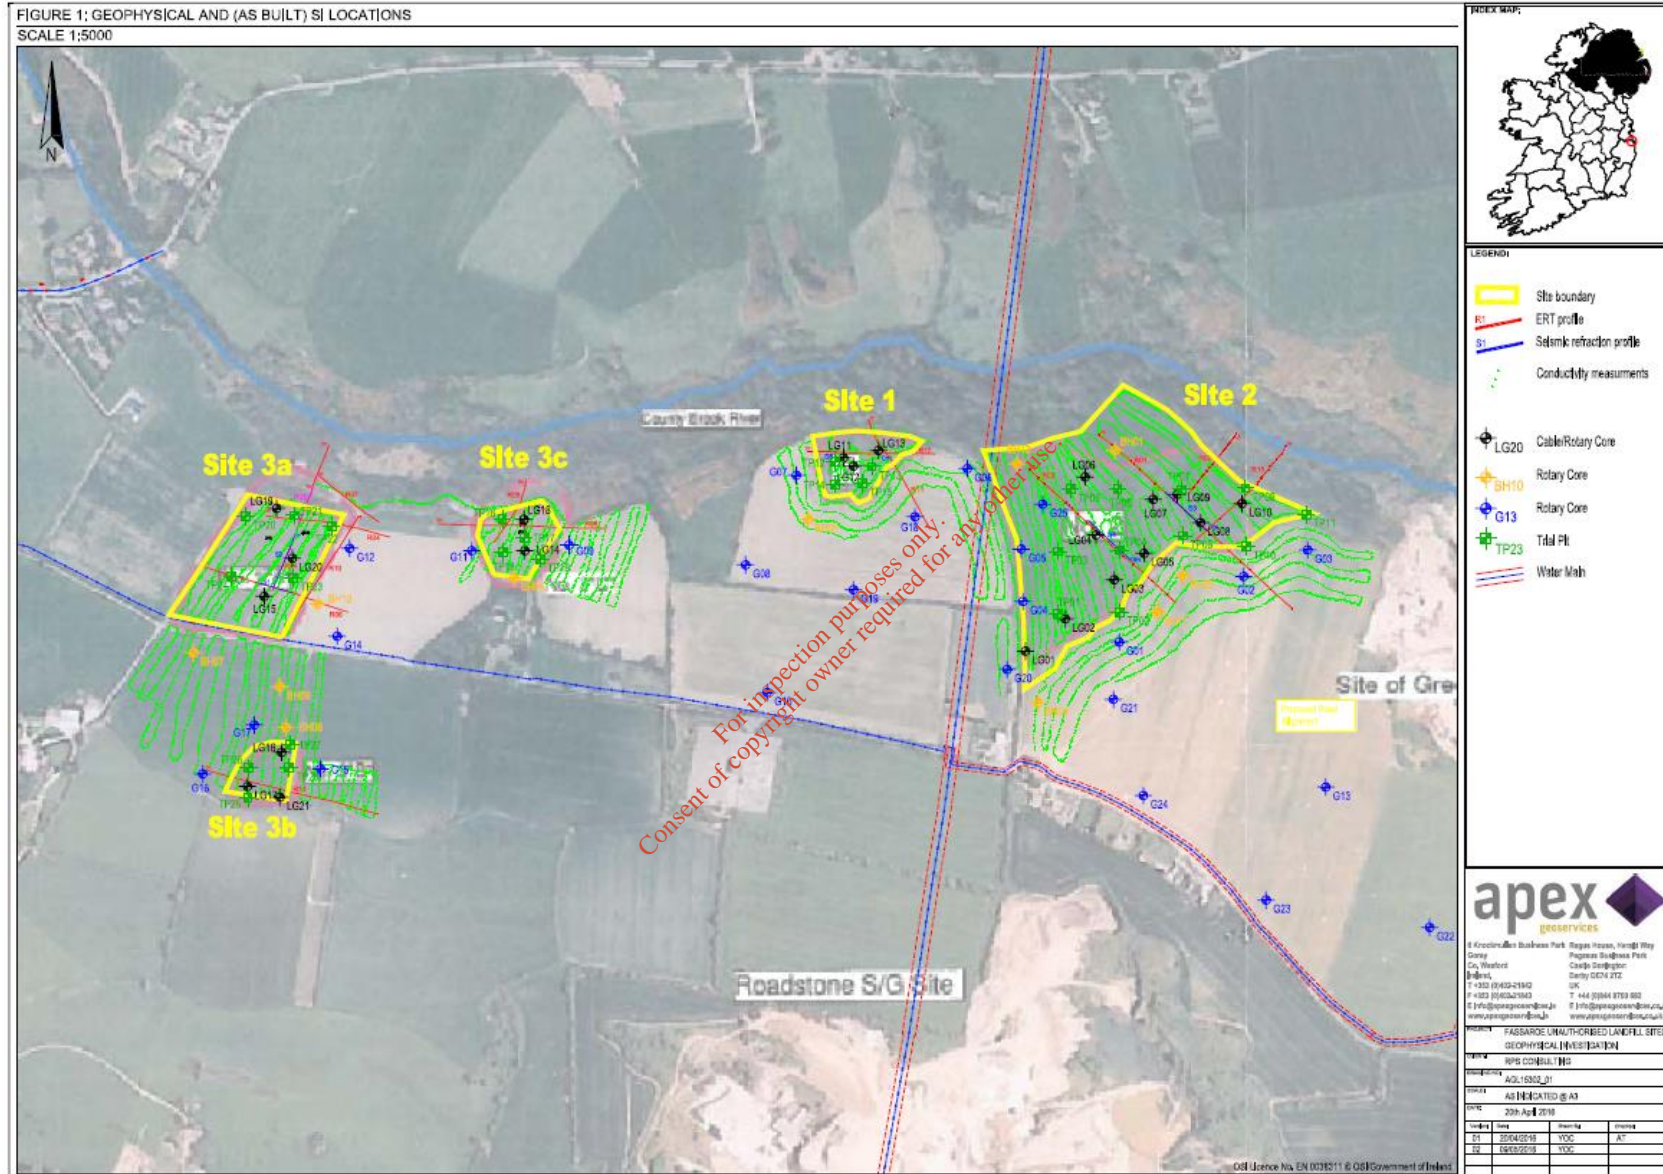
Figure 12 Geophysical Survey Locations (Apex Geoservices 2016)

The full report is presented in **Appendix C**.

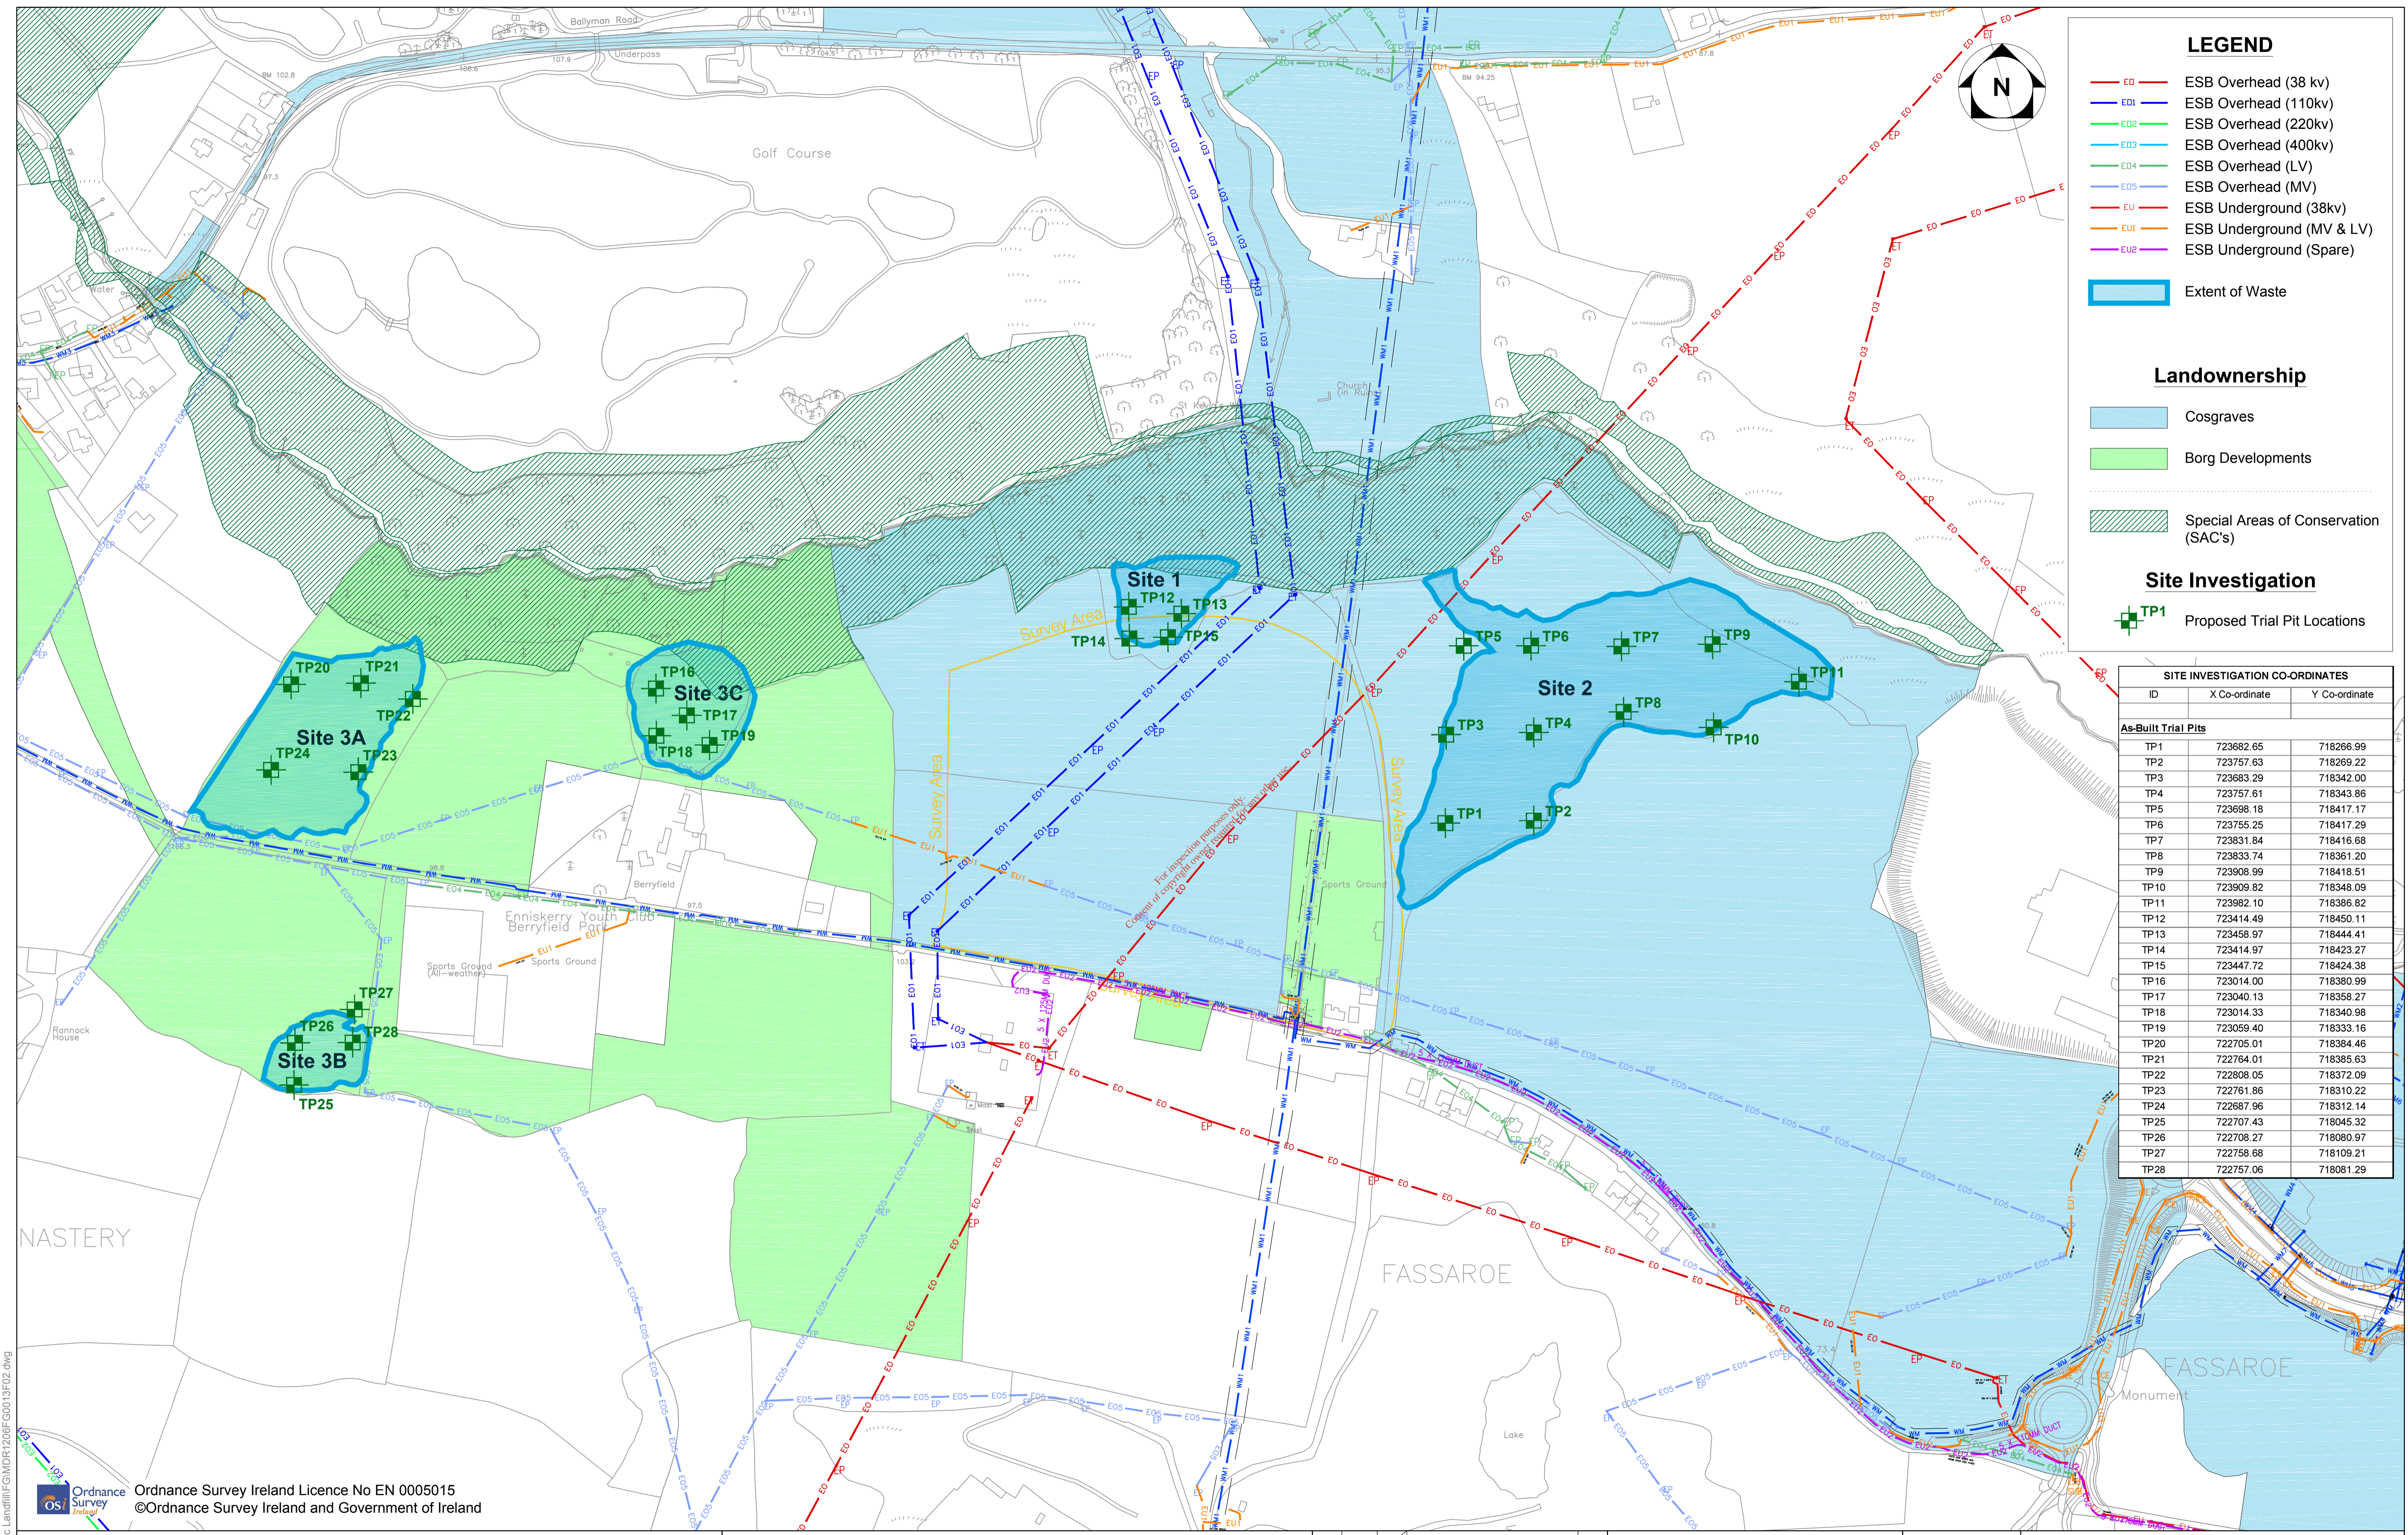
All trial pits were excavated using a mechanical excavator. The trial pits were excavated, under the supervision of Priority Geotechnical Limited, between 7th and 10th December 2015 and were back-filled on completion by replacing material in the order in which it was excavated. The locations of the trail pits are presented in **Figure 13**.
