# Fassaroe Historic Landfills

## Environmental Risk Assessment

May 2018

Client:	Wicklow County Council		
Project Title:	Fassaroe Historic Landfills		
Document Title:	Environmental Risk Assessment		
Document No:	MDR1206Rp0007		
Text Pages:	194	Appendices:	13

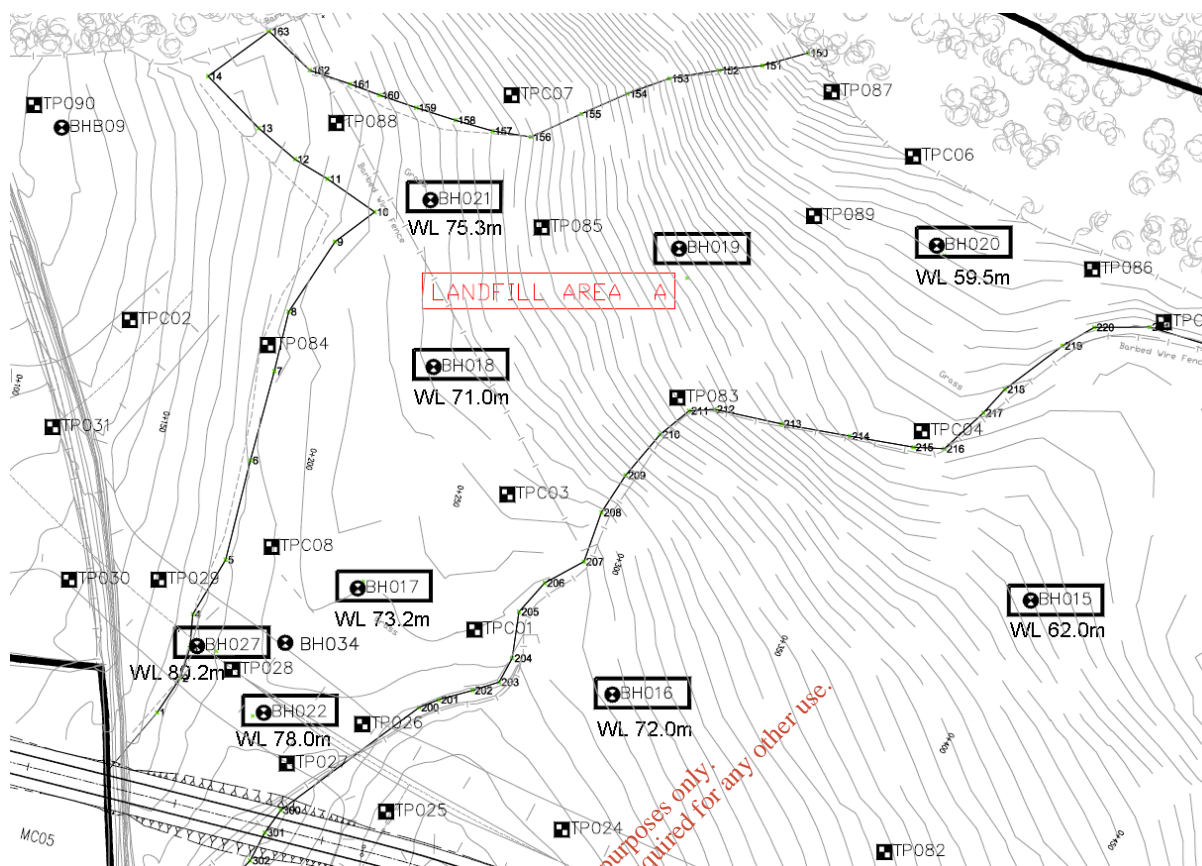
**Figure 4 Site 2: Historic SI Locations**

Source: Extract from Atkins Drawing 1739GE001 Site Investigation Borehole and Trial Pit Locations.  
 Note Landfill Area A equates to Site 2

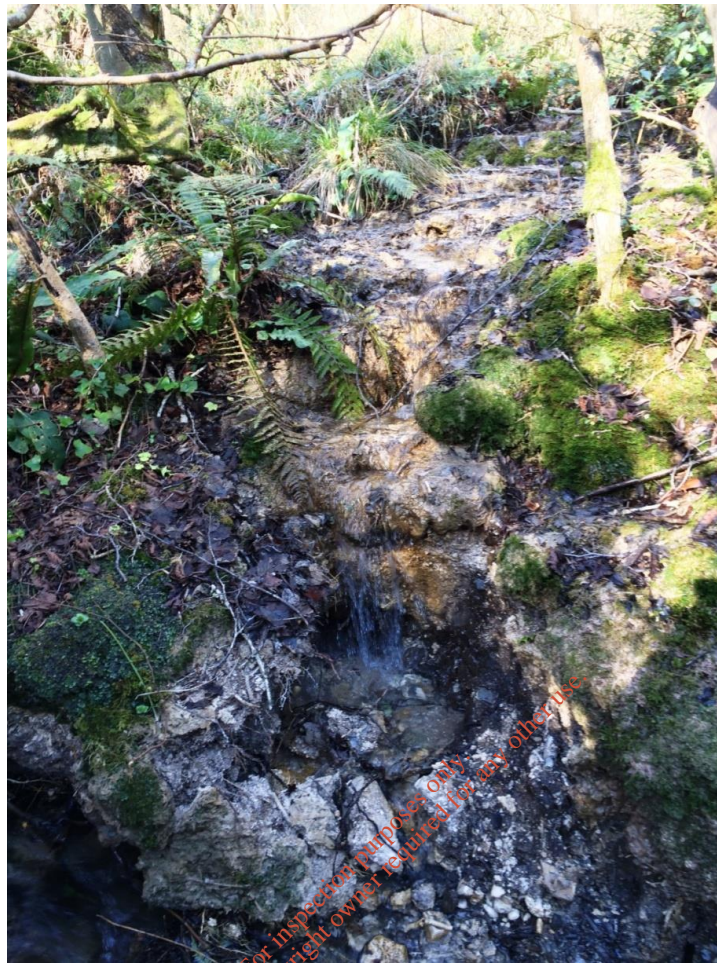
**Plate 2. Photograph of Spring 3**

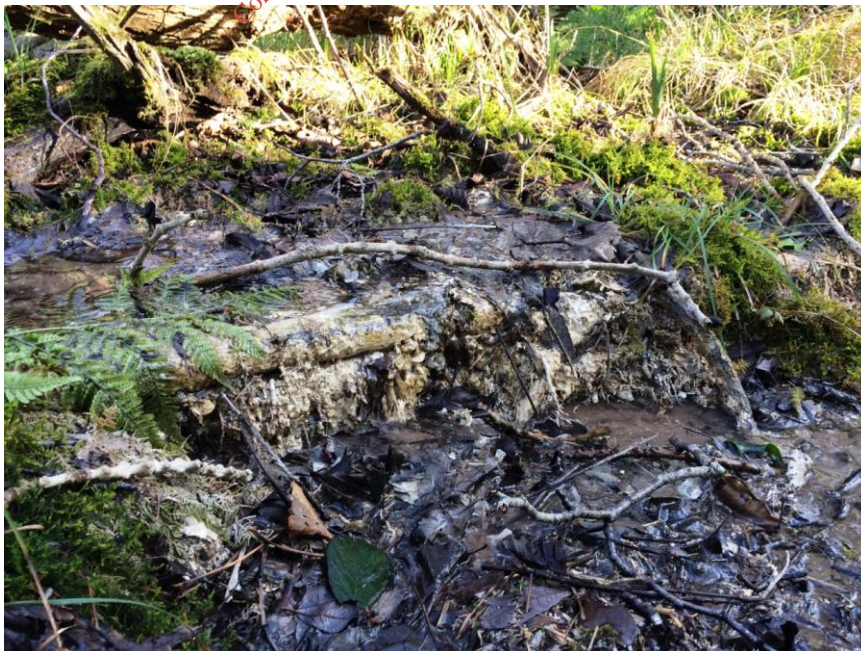
**Plate 3. Photograph of Tufa Deposit near river bank (off-white deposit in the centre of the picture)**

Emerging groundwater spring flows feed the tufa deposits and alkaline fen and therefore constitute a Groundwater Dependant Terrestrial Ecosystems (GWDTE) receptor as identified in the EPA Code of Practice and protected through the Water Framework Directive (WFD). An example of tufa deposits observed on the southern bank of the river is shown below in Plate 3.

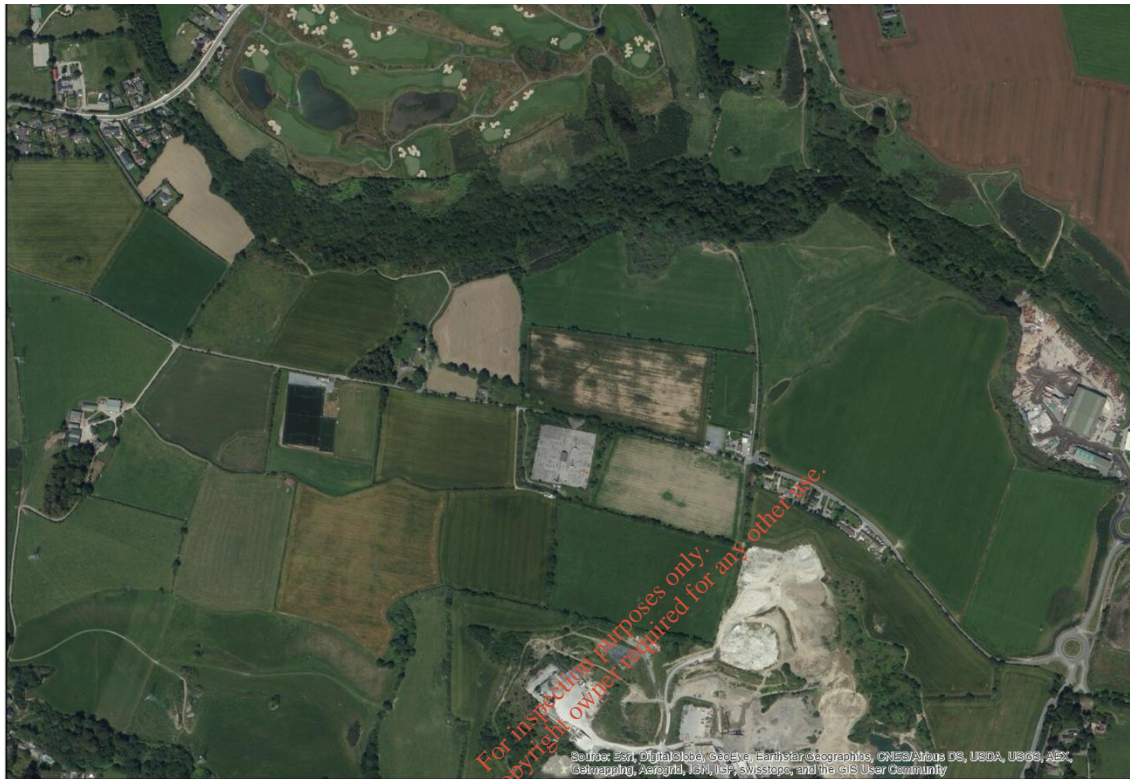
**Figure 6** Aerial Photography

Aerial photography indicates that the Site 2 and 3A – 3C are grassed with evidence of vegetation die back. Site 1 consists of scrub and Gorse with some surface debris.

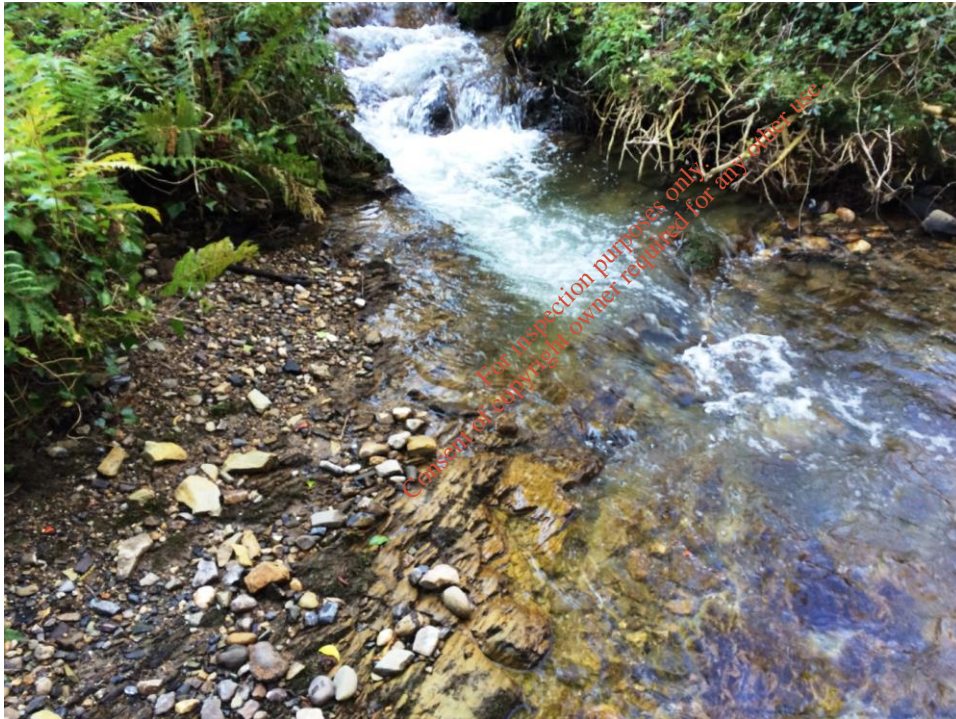
**Plate 4** Bedrock outcrop within the river north of Site 1

Depth to bedrock has not been proven at the site to date, albeit occurrences of shale/ schist outcrops were observed along the adjacent river at a small number of locations. In particular outcrop was noted directly north of Site 1 at approximately 55m above Ordnance Datum (aOD), see Plate 4 below.

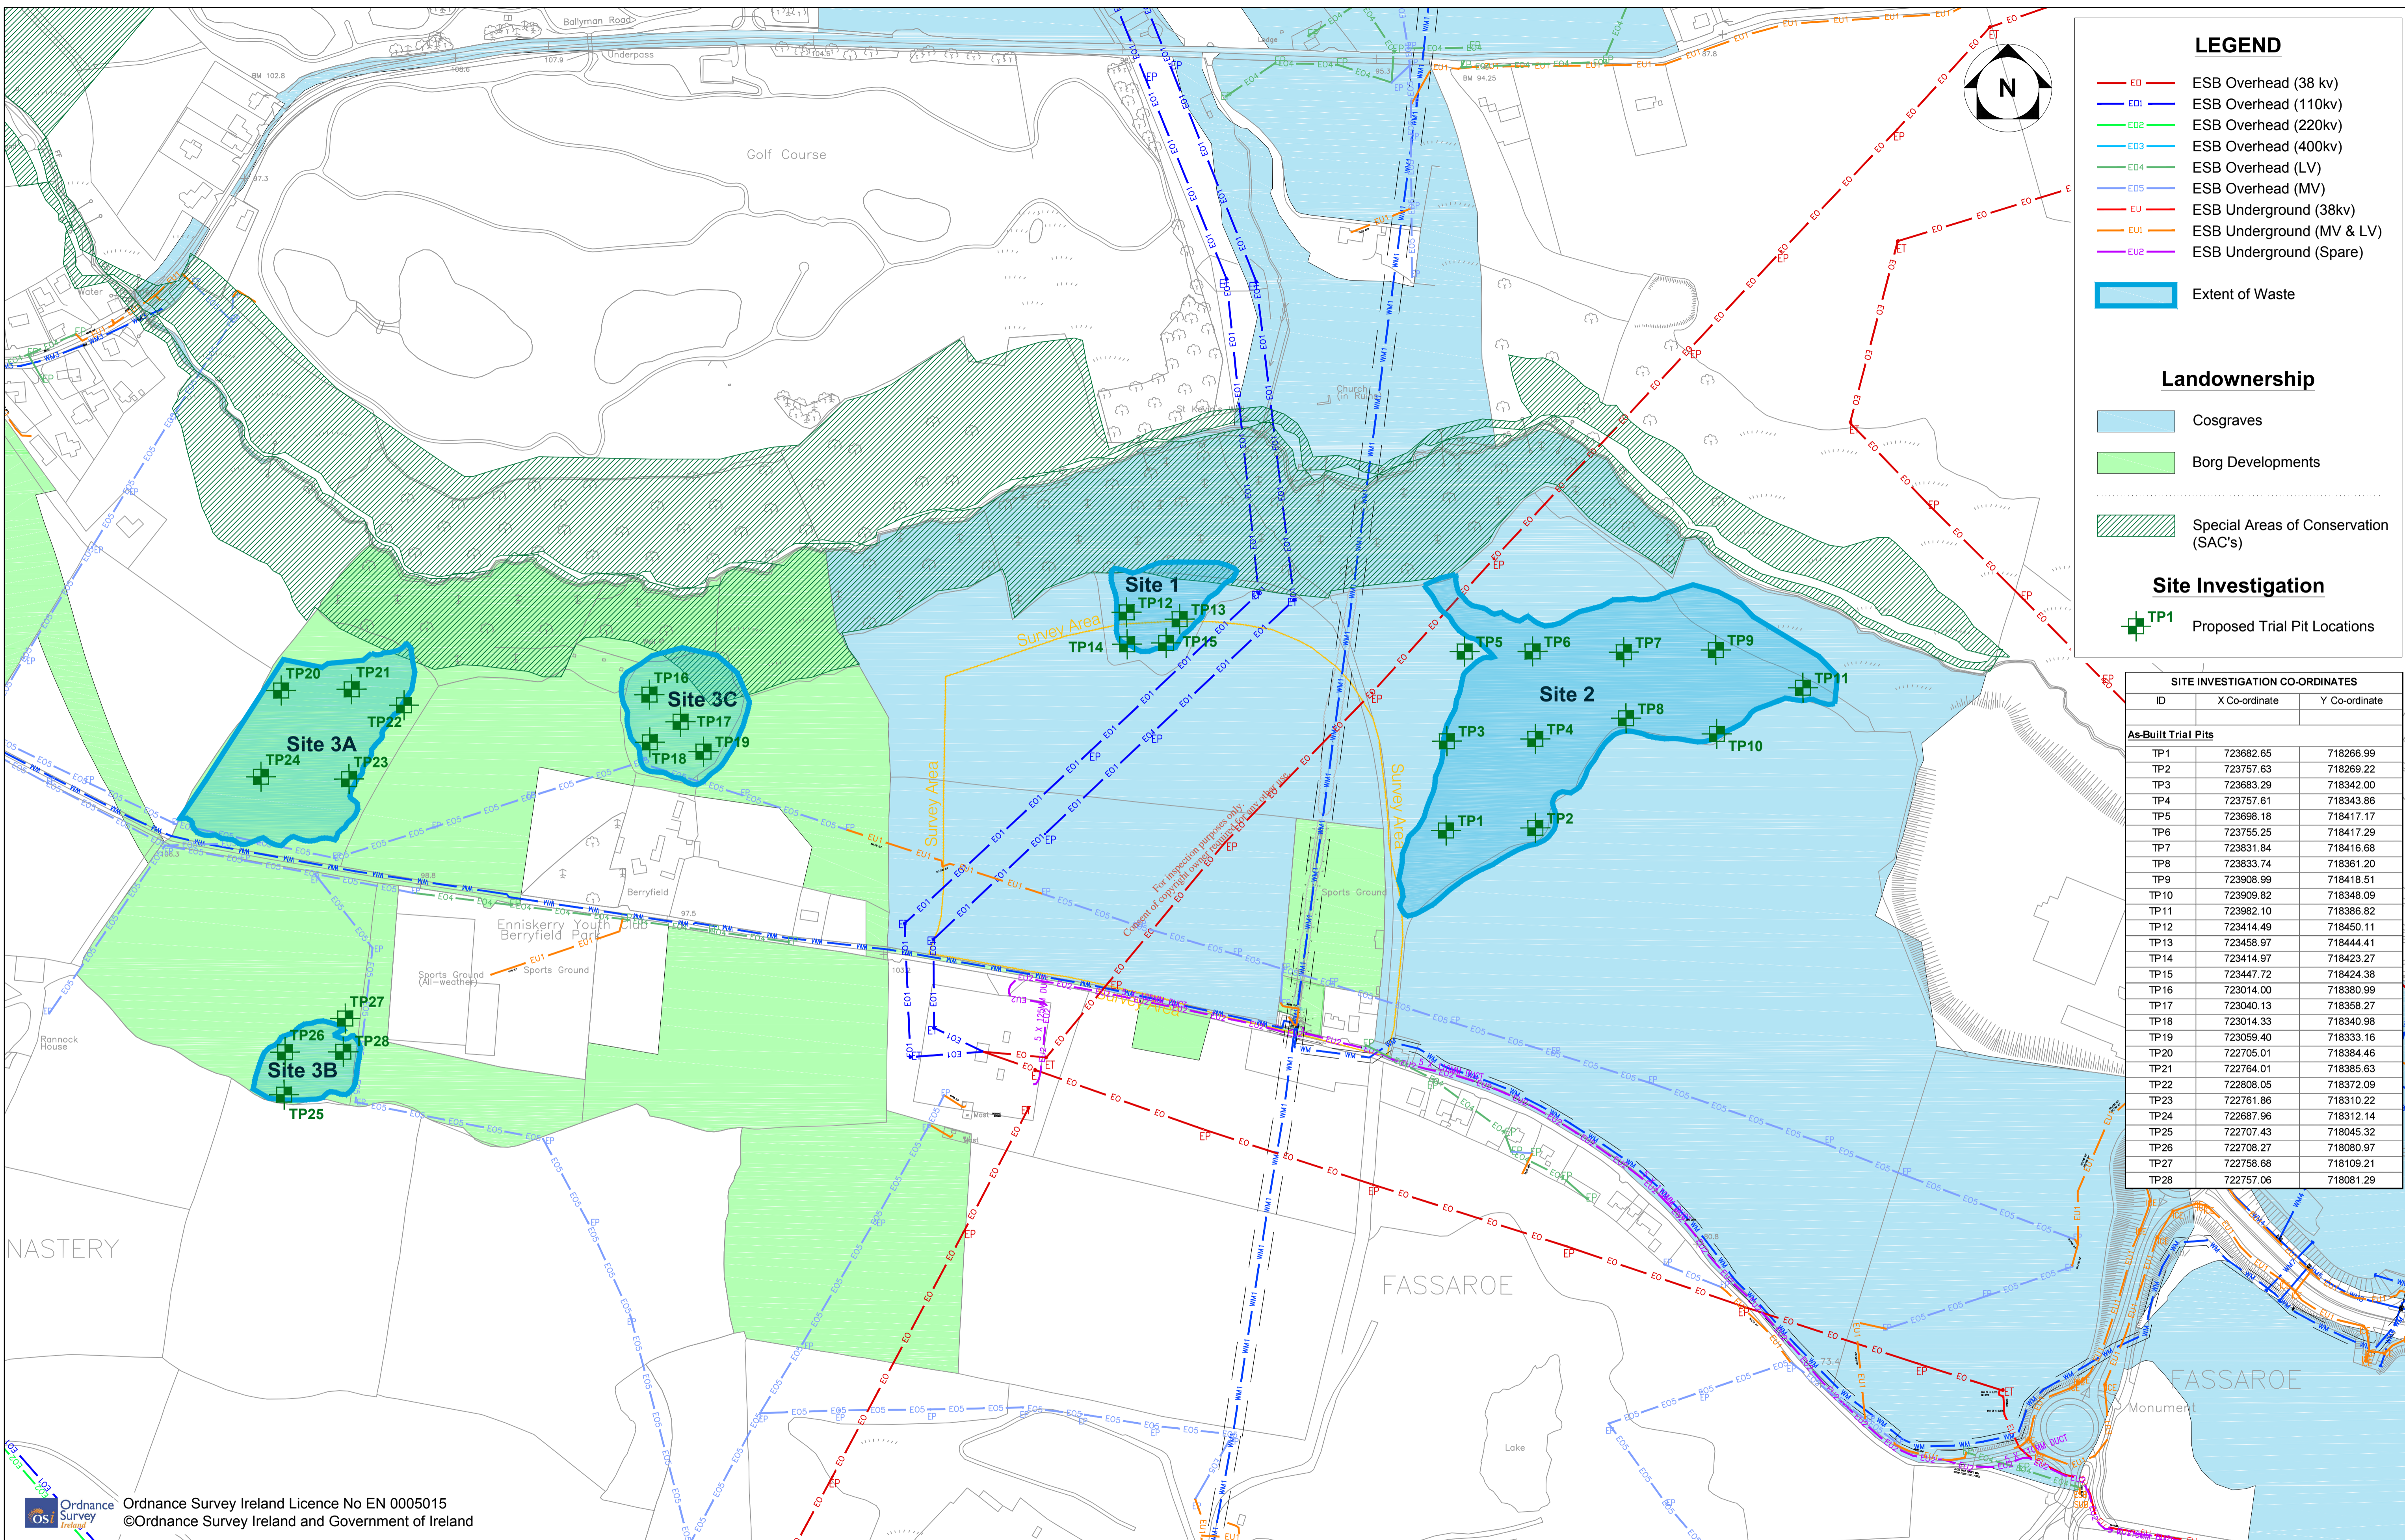
All trial pits were excavated using a mechanical excavator. The trial pits were excavated, under the supervision of Priority Geotechnical Limited, between 7<sup>th</sup> and 10<sup>th</sup> December 2015 and were back-filled on completion by replacing material in the order in which it was excavated. The locations of the trail pits are presented in **Figure 13**.
