**Application for a Certificate of Authorisation for Knocknacarriga Landfill as per Waste Management (Certification of Historic Unlicensed Waste Disposal and Recovery Activity) Regulations, 2008. SI No. 542 of 2008**

**Ref: H0277-01**

## Revised Non-technical Summary

Knocknacarriga Landfill Reg. No. H0277-01

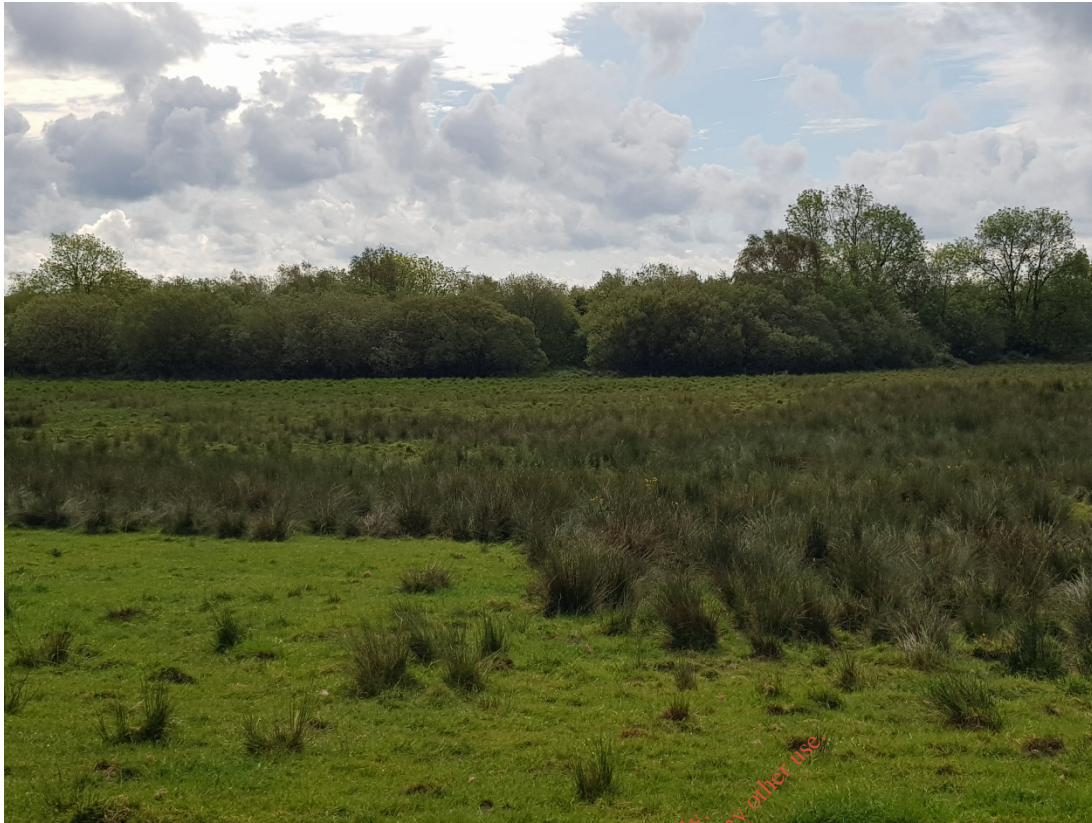
On consultation with the landowner, he stated that this area is never covered in water or inaccessible at any time of the year. By definition a wetland is an area of land that is saturated with water either permanently or seasonally, and where the water table is near or at the surface.<sup>1</sup>

On discussion with the landowner and observing site conditions during our site inspection Limerick City and County Council are of the opinion that this area does not fall under the definition of a natural wetland. I attach photographs taken in Appendix 1.

Photograph 1: Photograph of poorly drained land (site inspection 22/5/19)

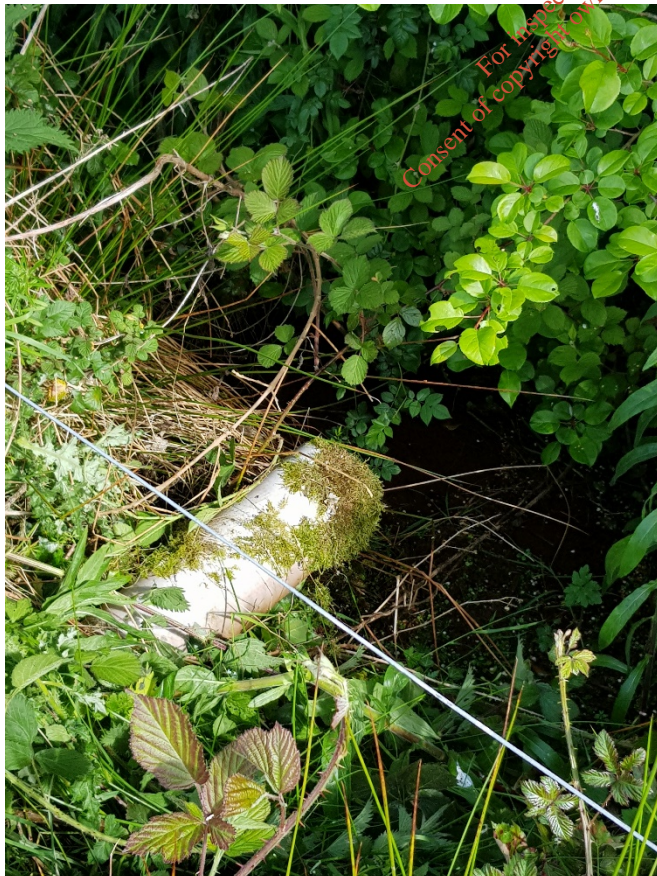
Photograph 2: Pipe (Site inspection 22/5/19)

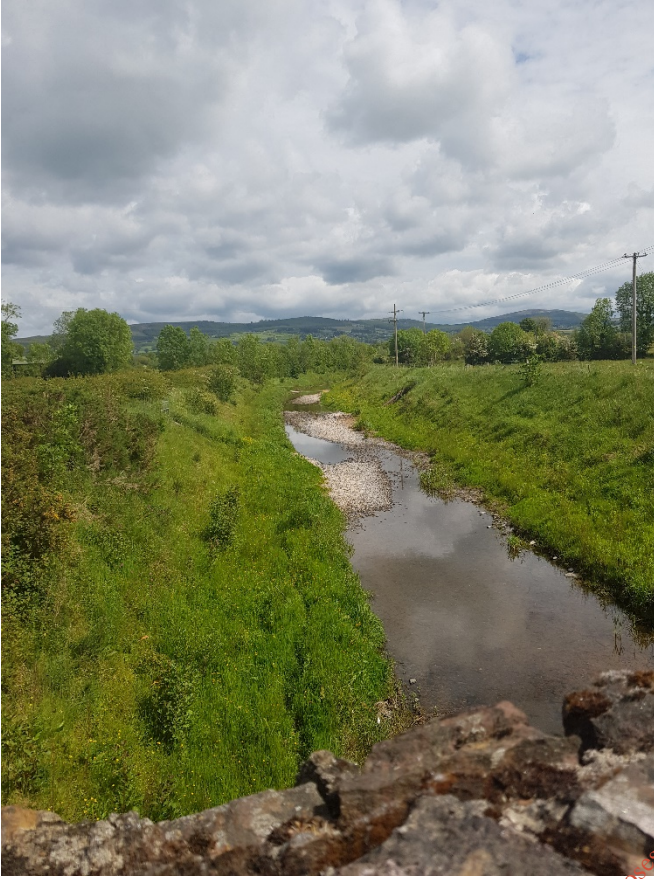
The drainage drain located at the north east of the waste body on the day of our inspection had a minimal flow and a small amount of water was observed in the drainage ditch (photograph in appendix 1)

Photograph 3: Discharge point (site inspection 22/5/19)
