**APPLICATION TO THE EPA FOR A CERTIFICATE OF AUTHORISATION**

**FORMER KINGSCOURT HISTORIC LANDFILL**

**KINGSCOURT**

**Prepared By:**

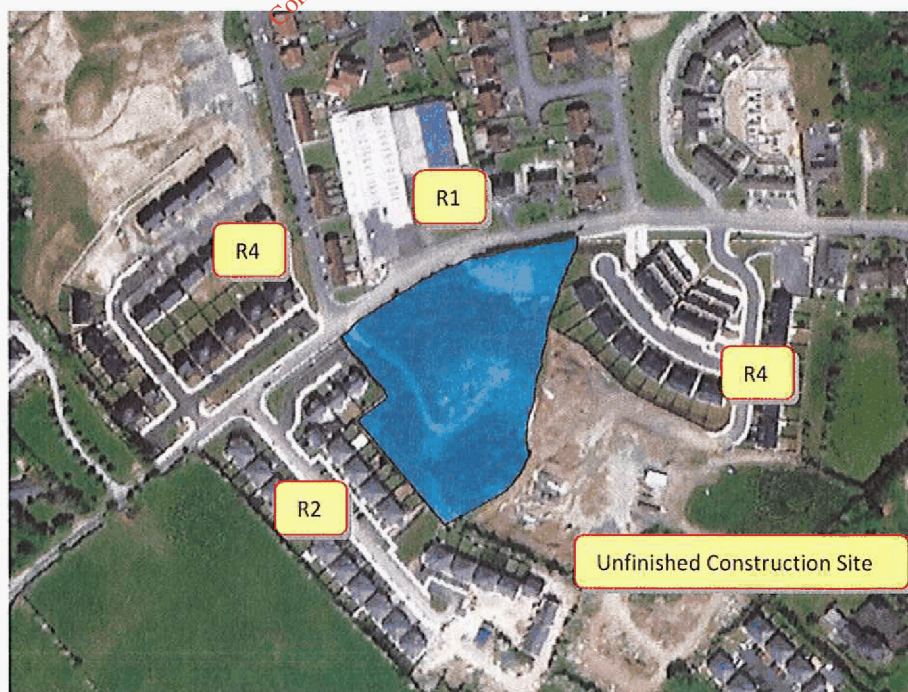
The site encompasses an area of approximately 1.2 hectares. The land surrounding the site slopes moderately in a north easterly direction towards the town of Kingscourt. The boundaries are marked by local road L-3536-0 to the Northwest. The area to the West and East consist of domestic dwellings. The land to the Southeast is an undeveloped construction site. The surrounding land use is predominantly urban housing and a small number of industrial units. Receptors R1, R2, R3, and R4 identified during the Tier 1 risk assessment can be seen below.

- R1 - Commercial premises and housing estate on the northern aspect approx. 30 m from the site boundary;
- R2 - Housing estate on the south western aspect immediate to the site boundary;
- R3 - Housing estate on the western aspect approx. 30m from the site boundary;
- R4 - Housing estate on the north eastern aspect immediate to the site boundary;
