**ENVIRONMENTAL RISK ASSESSMENT**

**FORMER MUNICIPAL HISTORIC LANDFILL**

**POTTLEBOY**

**DECEMBER 2014**

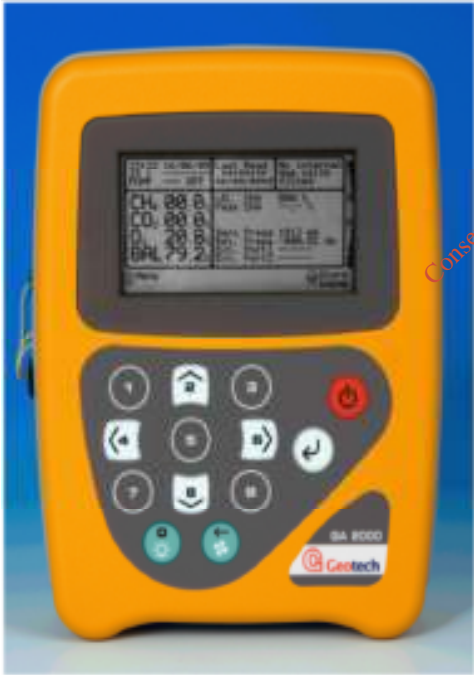
GA 2000 landfill gas analyser		
	Features:	Main Application

<ul style="list-style-type: none"> <li>• ATEX certified</li> <li>• 5 gases standard</li> <li>• Peak CH<sub>4</sub> recording</li> <li>• Simultaneous display of all gases</li> <li>• Storage of site and ID questions</li> <li>• Field proven</li> <li>• Standardises monitoring routines</li> <li>• Easy transfer of data</li> <li>• Optional Internal Flow</li> <li>• Optional Event Log</li> <li>• Data storage 2000 readings and 1000 IDs</li> <li>• 0-500ppm H<sub>2</sub>S reading</li> <li>• Technician Log-in</li> </ul>	<ul style="list-style-type: none"> <li>• Landfill sites</li> <li>• Brownfield</li> <li>• Site investigation</li> </ul>

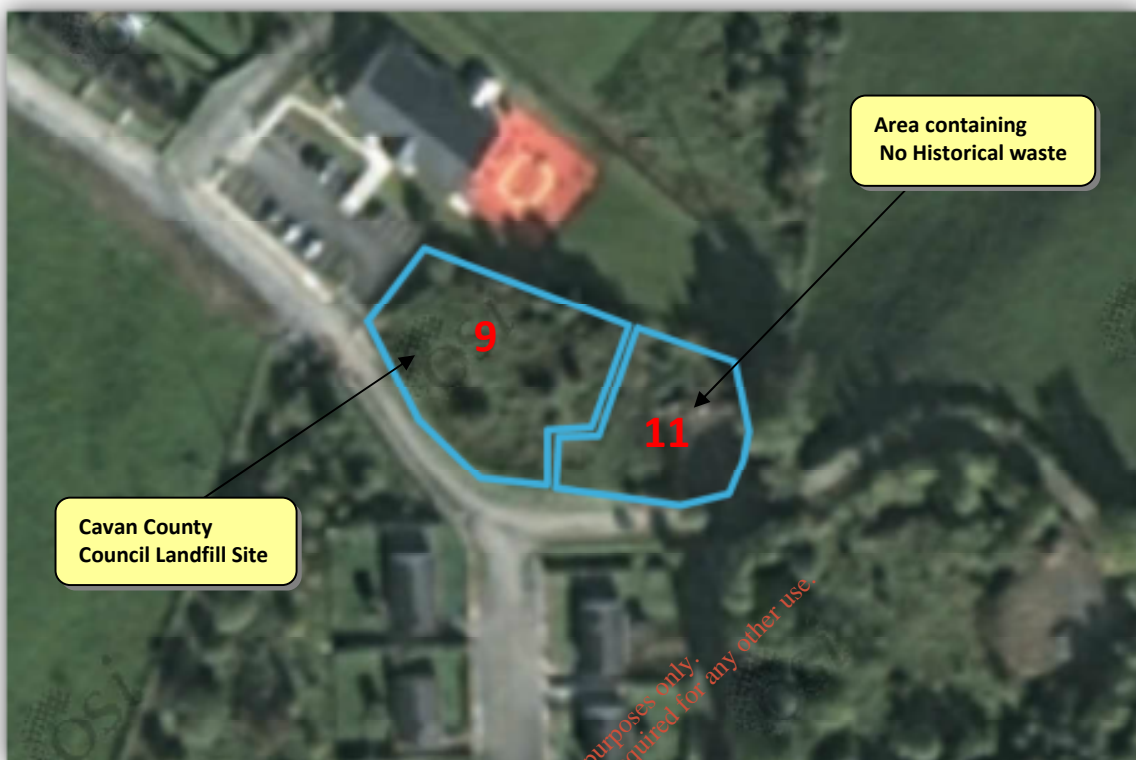
Figure No. 4 - Map showing the Location of adjoining site marked 11 as per folio map.

The most extensive quantities of waste were encountered towards the west and central area of the Cavan County Council landfill site which is elevated. The waste extends from the westerly boundary (TH 1 & TH 2) to the top of the slope (TH 14 & TH 15) in an easterly direction. The lateral extent of the waste is shown in Drawing No. 14.248.111 - Appendix F and covers an area of approximately 1700 m<sup>2</sup>. Using a conversion factor of 1, and an average waste depth of 2.2m it is estimated, that approximately 3740 tonnes of waste is deposited at the site.

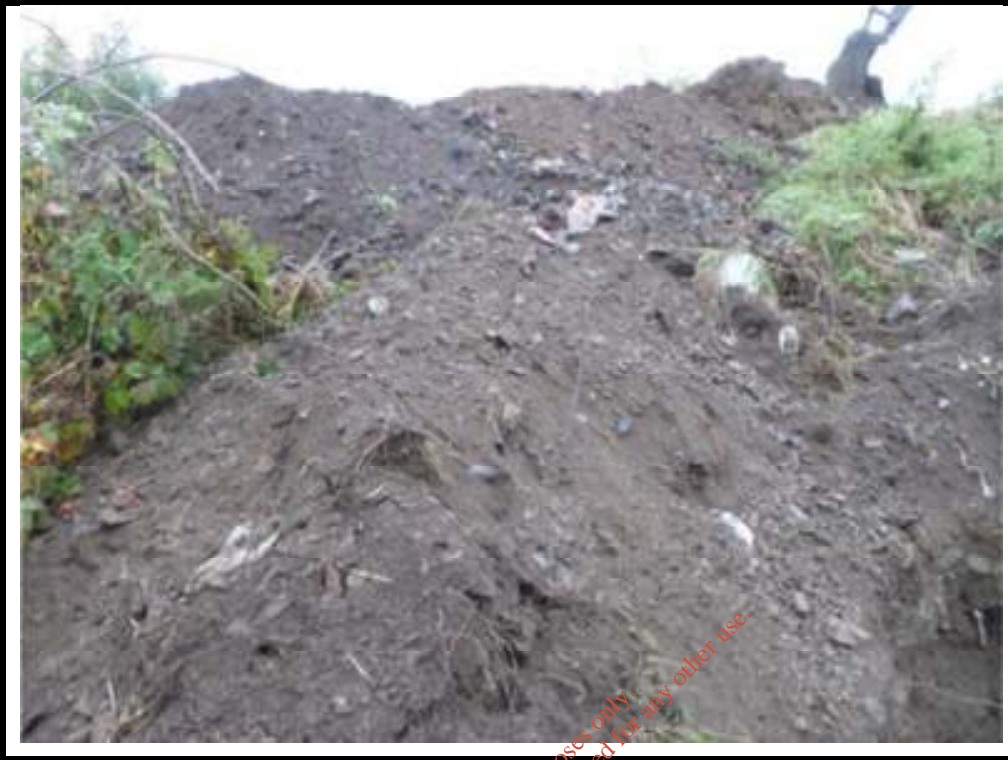
**Photograph 2: Waste Contained in Trial Hole 1 (TH 1).**

The waste comprised mainly of plastics, paper, glass, metal and textiles all of which were supported by a stony clay matrix. From soil sample results analysis it has been determined that trace amounts of hazardous waste in the form of asbestos were found in TH 10. The hazardous waste was deemed to be, Chrysotile (white asbestos), a trace amount of 1-2 fibres. A large number of animal bones were also unearthed during trial hole excavations. Photographs 2 - 20 which follow illustrate the types of waste encountered. Full trial holes assessment and logs can be found in Appendix A.

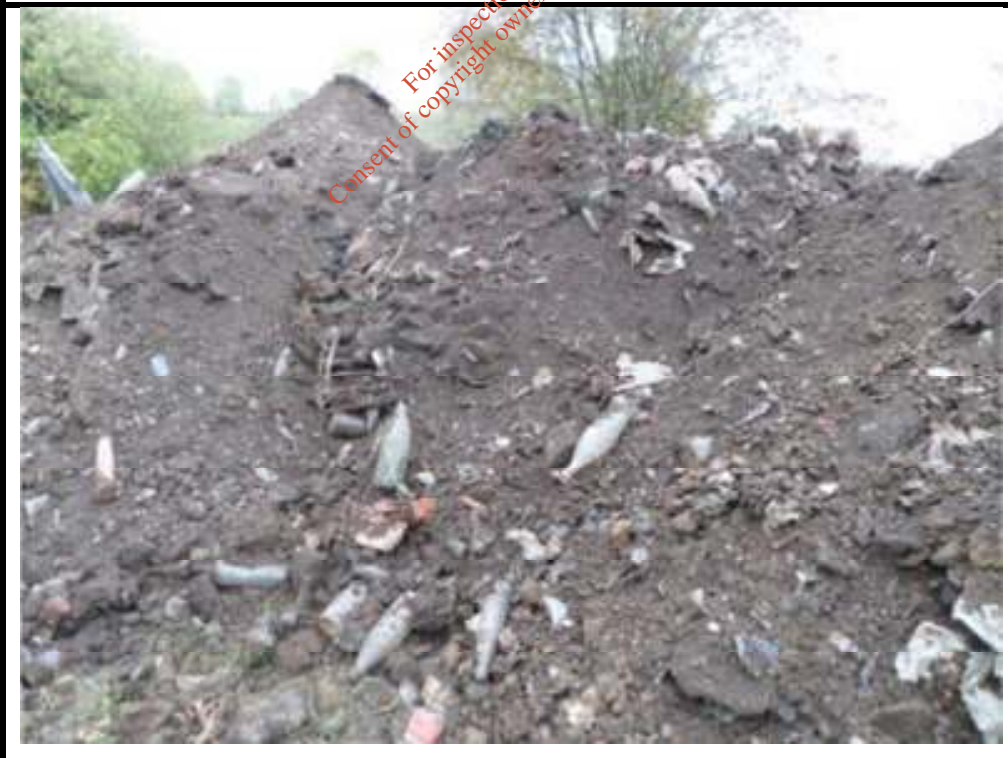
Photograph 11: Waste Contained in Trial Hole 10 (TH 10).

Trace amounts of asbestos were found in TH 10. The hazardous waste was deemed to be, Chrysotile (white asbestos), a trace amount of 1-2 fibres. Asbestos soil sample results are contained in table No. 14. From 5 no. of samples sent to the lab for analysis, three were identified as containing trace amounts of crushed brick and construction and demolition waste e.g. concrete, therefore it was deemed necessary to carry out further testing on these three samples (Sample no. 1 (TH25), Sample no.3 (TH23), Sample no. 4 (TH10) for Hazardous Waste.

From soil sample analysis it has been determined that trace amounts of hazardous waste in the form of asbestos were found in TH 10. The waste type is deemed as Chrysotile (white asbestos), a trace amount which typically contains small amounts of 1-2 fibres. The nature of waste observed is typical of municipal waste that has been buried for more than 20 years and which has undergone considerable biodegradation.

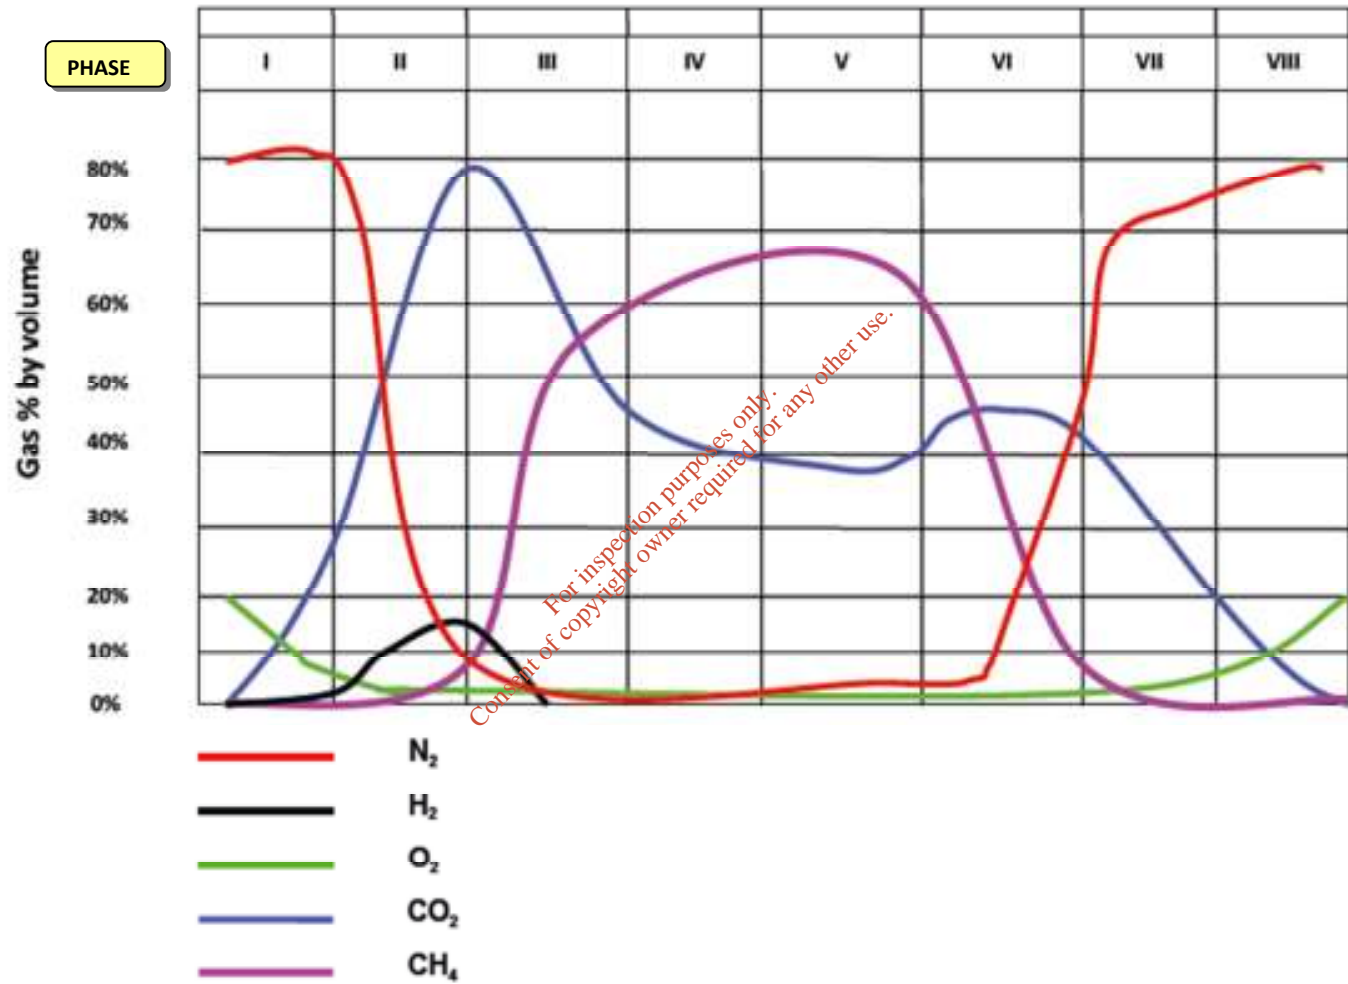
Figure No. 6 Changes in the Production and Composition of Landfill Gas over Time

<sup>(3)</sup> **Phase I: Aerobic** – follows waste deposition in which the residual oxygen is used up. This phase typically lasts for a few days to a number of months, depending on local factors such as temperature and moisture availability. Preliminary changes in environmental components occur in order to create favourable conditions for biochemical decomposition.

**Phase II: Acid** – populations of facultative and fermentative anaerobic bacteria develop, producing volatile (aliphatic) acids, CO<sub>2</sub> and H<sub>2</sub>, displacing the remaining N<sub>2</sub> entrained with the waste. This phase may last from weeks to years, depending on conditions.

**Phase VII: CO<sub>2</sub>** – return of aerobic conditions. At this stage, the rate of landfill gas formation has almost ceased because of substrate limitation; anaerobic decomposition becomes inhibited by the ingress of O<sub>2</sub> in the air. This allows the aerobic decomposition of solid organic matter resistant to anaerobic decomposition.

**Phase VIII: Soil air** – the final phase occurs when degradable organic matter has been oxidised and the landfill gas resembles that of typical soil air."

From the comprehensive gas monitoring program and review of the results (tables 21 - 29 ) with particular reference to methane and carbon dioxide, Cootehill historic landfill falls into the **phase VII**. When waste deposition has discontinued at the site, rates of landfill gas production significantly decrease and is slowly replaced by air in the waste body. Consequently the composition of gases within the waste body gradually assume that of atmosphere air. This is demonstrated on the graph in figure No. 6 above. Extractable volumes of landfill gas become insignificant and levels of methane significantly decrease, as landfill gas mix with air in the waste body.

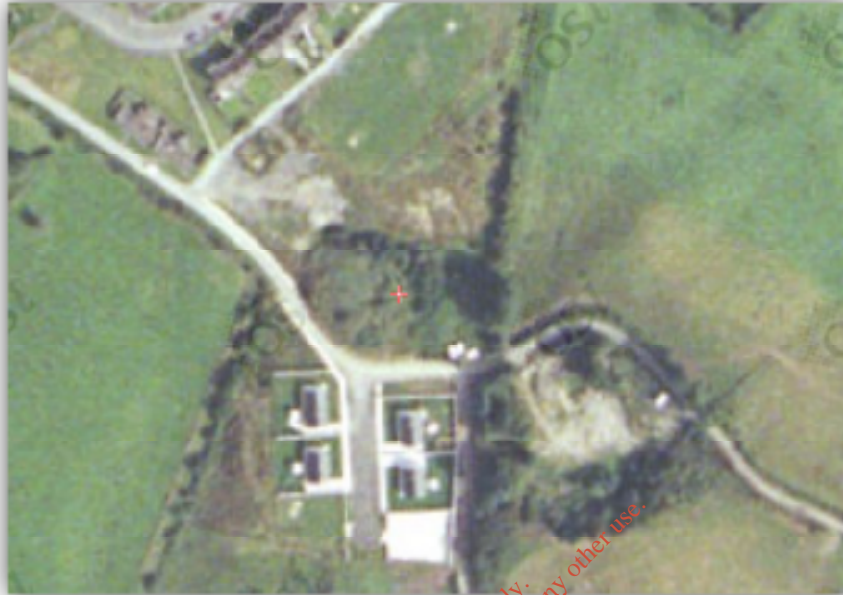
**Figure No. 10 - Ordnance Survey Ireland Map showing the vegetation cover on the site in 2000**

There are no Natura 2000 sites within 10km of this proposed development. The closest Natural Heritage Area to the site is the Dromore Lakes (pNHA 000001). This is located approximately 1km north of the landfill site. The main vegetated habitats on the site of the disused landfill include hedgerows, treelines, scrub and un-improved grassland. Site boundaries consist of hedgerows and tree lines and species such as Common (ash) *Fraxinus excelsior*, (hawthorn) *Crataegus monogyna*, (sycamore) *Acer pseudoplatanus* and (Leyland Cypress), *Cupressus x leylandii* occur. Scrub areas within the site are dominated by (gorse) *Ulex europaeus* and (bramble) *Rubus fruticosus* agg. Aerial photographs from Ordnance Survey Ireland 2000 show that the vegetative cover has been established for years.

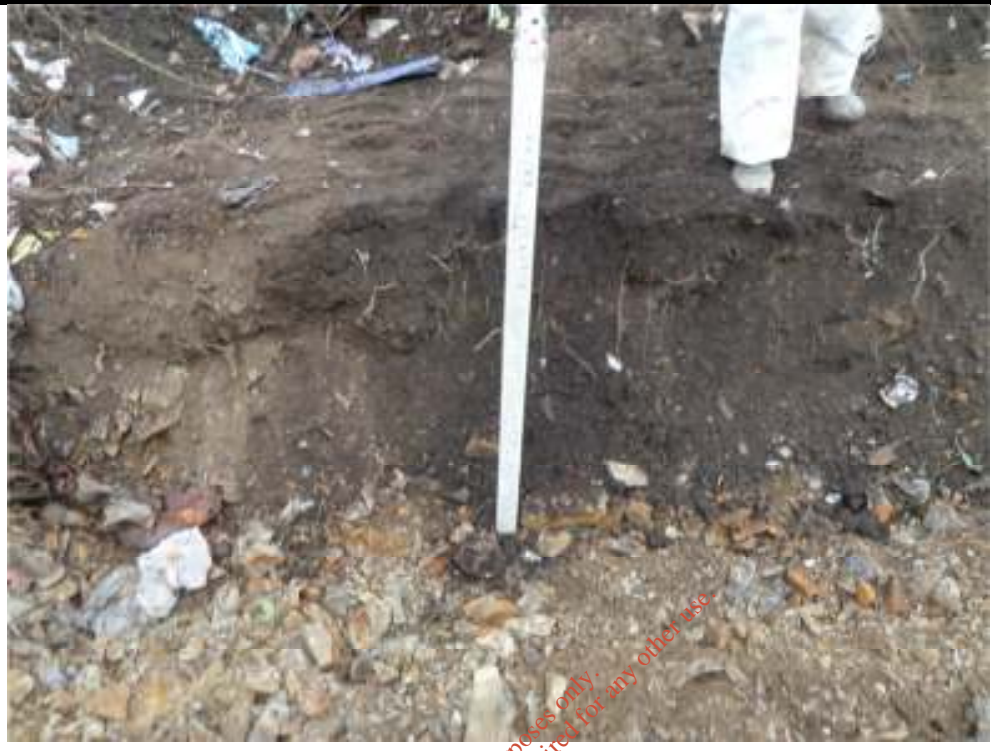
No leachate was encountered at Cootehill historic landfill site during trial hole investigation. From trial hole investigations bed rock was reached at a shallow depth in some parts of the landfill (0.6m). It is likely that any of the rainfall which may reach the base of the waste ultimately discharges along or through the bed rock. The Pottleboy stream runs adjacent/immediate to the landfill site along the northern and western boundary, however this section of the stream is piped. From analysis of surface water taken both up stream and downstream of the landfill site no evidence of leachate migration was found. Refer to table's No. 15 to 17

Photograph 21: Shallow Bedrock located in TH 16

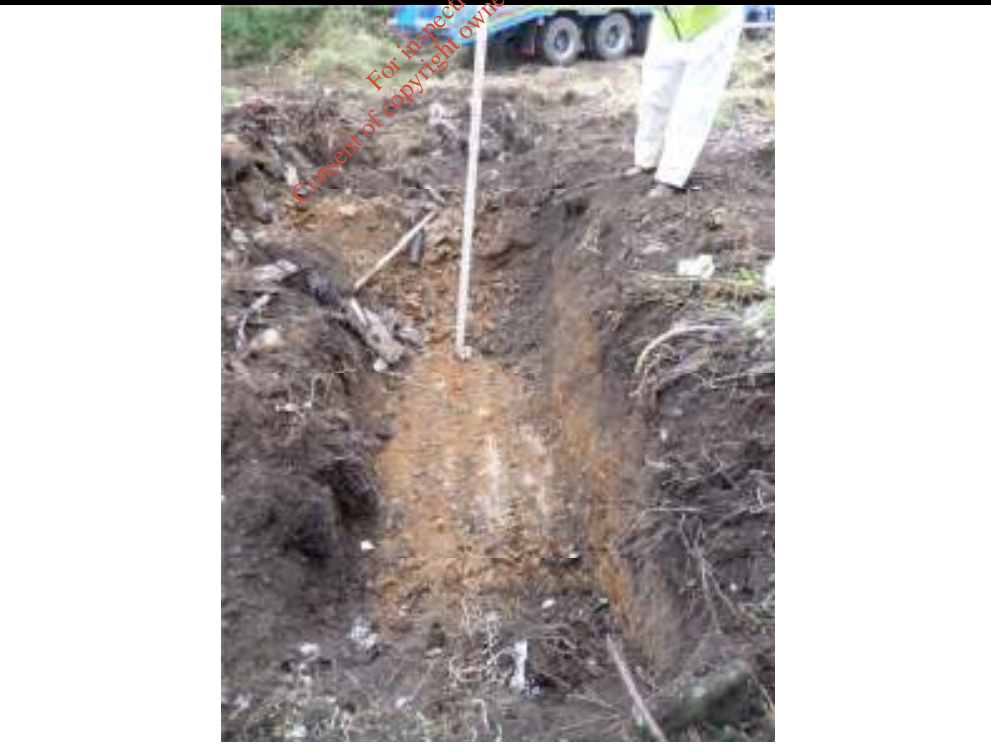
Photograph 22: Shallow Bedrock located in TH 17
