TIER 2

ENVIRONMENTAL RISK ASSESSMENT

APPENDIX A

TRIAL HOLE DESCRIPTION & LOGS

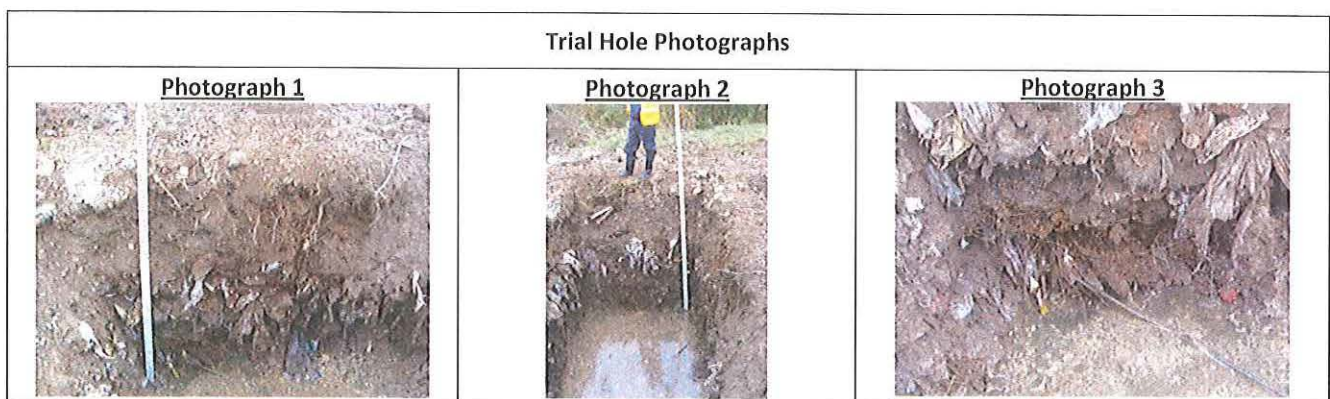
0.60m	0%:100%	The top 0.00m to 0.60m of the trial hole does not have any waste present. It appears to be natural ground used for capping.
Clay intermixed with Plastic, steel Grey colour

1.00m	70%:30%	0.60m to 1.00m soil meets with the waste material. A significant amount of plastic waste with steel wire present.
Clay intermixed with Plastic and steel Grey colour Groundwater Level @ 1.60m

1.60m	90%:10%	1.00m – 1.60m large portion of steel wire with less plastic in the final 1.30m – 1.60m. Groundwater level at 1.60m BGL. Groundwater contaminated with waste oil

1.90m	90%:10%	1.60m – 1.90m large portion of steel wire with a significant amount of plastic.
Peaty Clay (Natural Ground) Dark Brown Colour End of Trial Hole @ 2.10m

2.10m	0%:100%	The final 1.90m to 2.10m of the trial hole does not have any waste present. It appears to be natural ground.

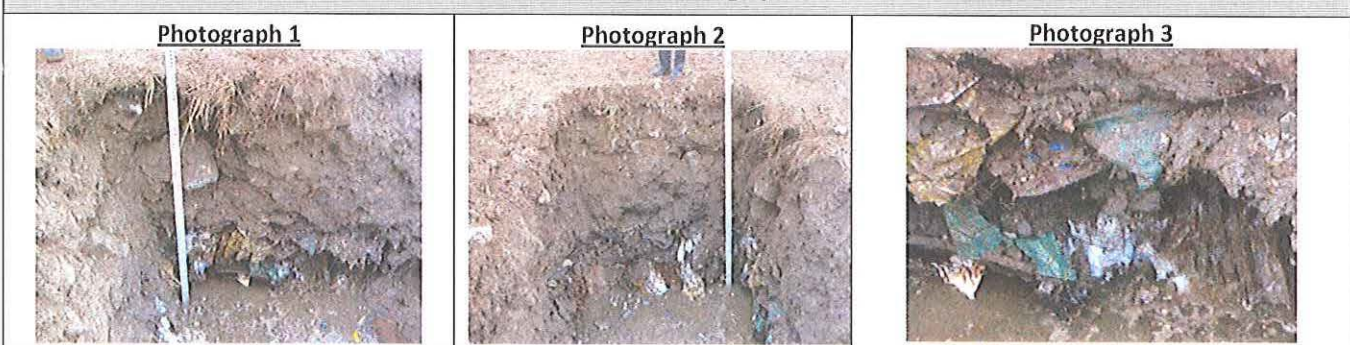
Trial Hole Photographs

1.00m	0%:100%	The top 0.00m to 1.00m of the trial hole does not have any waste present. It appears to be natural ground used for capping.
Silt/Clay intermixed with Plastic, steel Grey colour

1.40m	70%:30%	1.00m to 1.40m soil meets with the waste material. A significant amount of plastic waste with a steel barrel present.
Silt/Clay intermixed with Plastic and steel Groundwater Level @ 1.70m

1.70m	90%:10%	1.40m – 1.70m large portion of plastic from 1.40m – 1.70m. Groundwater contaminated with waste oil

1.90m	90%:10%	Large portion of plastic in the final 1.70m – 2.00m.
Peaty Clay (Natural Ground) Dark Brown Colour End of Trial Hole @ 2.20m

2.20m	0%:100%	The final 2.00m to 2.20m of the trial hole does not have any waste present. It appears to be natural ground.

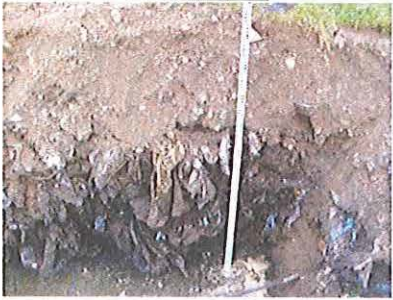
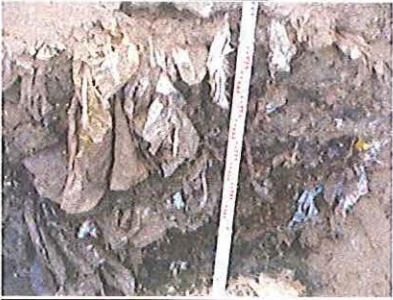
Trial Hole Photographs		
Photograph 1

0.50m	0%:100%	The top 0.00m to 0.50m of the trial hole does not have any waste present. It appears to be natural ground used for capping.
Clay intermixed with Plastic, steel, drain pipes, oil, municipal waste, glass bottles. Grey colour

1.40m	90%:10%	0.50m to 1.40m soil meets with the waste material. A significant amount of plastic waste and pipes present.
Clay intermixed with Plastic, steel, drain pipes, oil, municipal waste, glass bottles. Groundwater Level @ 1.60m

1.60m	70%:30%	Large portion of plastic and pipes in 1.40m – 1.60m layer. Groundwater contaminated with waste oil

1.90m	70%:30%	1.60m – 1.90m large portion of plastic with a significant amount of piping.
Peaty Clay (Natural Ground) Dark Brown Colour End of Trial Hole @ 2.70m

2.70m	0%:100%	The final 1.90m to 2.70m of the trial hole does not have any waste present. It appears to be natural ground.

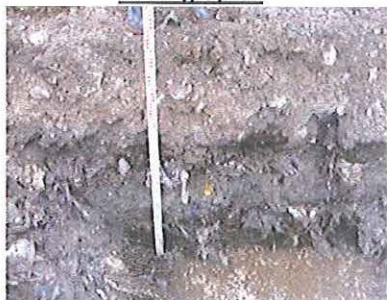
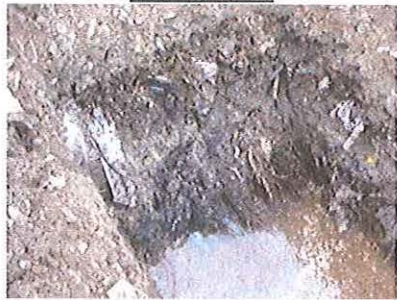
Photograph 2

0.30m	0%:100%	The top 0.00m to 0.30m of the trial hole does not have any waste present. It appears to be natural ground used for capping.
Clay Intermixed with Stone Grey Colour and Sticky in nature

0.50m	0%:100%	0.30m to 0.50m of the trial hole does not have any waste present. It appears to be natural ground used for capping.
Clay intermixed with Plastic, steel, oil, and wire from tyres. Grey colour

1.00m	90%:10%	0.50m to 1.00m soil meets with the waste material. A significant amount of wire from tyres present.

1.40m	70%:30%	Large portion of wire from tyres in the 1.00m – 1.40m layer. Groundwater contaminated with waste oil
Clay intermixed with Plastic, steel, drain pipes, oil, municipal waste, glass bottles. Grey colour End of Waste @ 1.90m

1.90m	90%:10%	1.40m – 1.90m large portion of steel wire with a significant amount of plastic.
Peaty Clay (Natural Ground) Dark Brown Colour End of Trial Hole @ 2.10m

2.10m	0%:100%	The final 1.90m to 2.10m of the trial hole does not have any waste present. It appears to be natural ground.

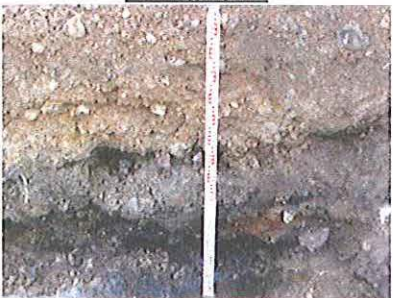
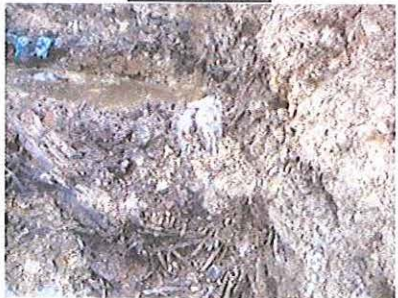
Trial Hole Photographs		
Photograph 1

0.30m	0%:100%	The top 0.00m to 0.30m of the trial hole does not have any waste present. It appears to be natural ground used for capping.
Clay Intermixed with Stone Grey Colour and Sticky in nature Winter Groundwater Level @ 0.50m		0.50m	0%:100%	0.30m to 0.50m of the trial hole does not have any waste present. It appears to be natural ground used for capping.
Clay intermixed with Plastic, steel, oil, fibre. Grey colour

1.00m	70%:30%	0.50m to 1.00m soil meets with the waste material. A significant amount of steel and fibre present.

Clay intermixed with Plastic, steel, oil, fibre. Grey colour Groundwater Level @ 1.40m		1.40m	90%:10%	Large portion of steel, waste oil and fibre in the 1.00m – 1.40m layer. Groundwater contaminated with waste oil
Clay intermixed with Plastic, steel, oil, fibre. Grey colour End of Waste @ 1.80m		1.80m	90%:10%	1.40m – 1.80m Large portion of steel, waste oil and fibre.
Peaty Clay (Natural Ground) Dark Brown Colour End of Trial Hole @ 2.10m		2.10m	0%:100%	The final 1.80m to 2.10m of the trial hole does not have any waste present. It appears to be natural ground.

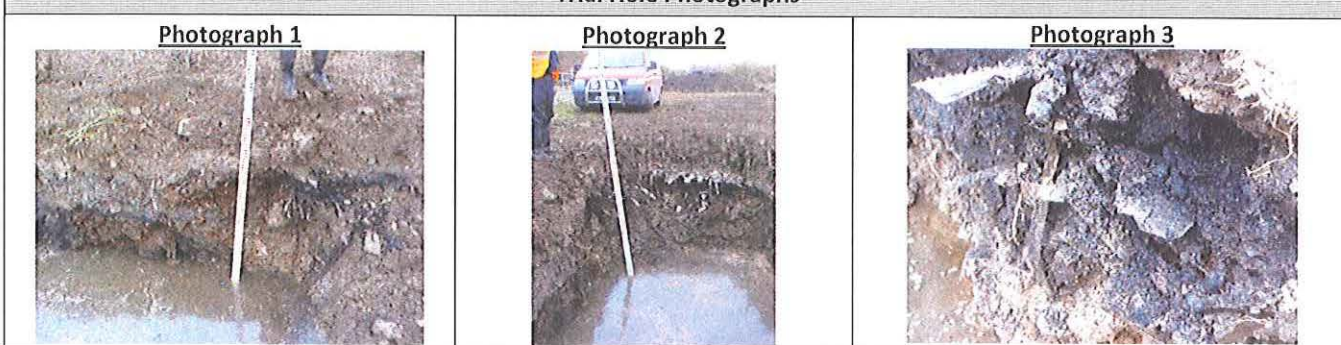
Trial Hole Photographs

0.30m	0%:100%	The top 0.00m to 0.30m of the trial hole does not have any waste present. It appears to be natural ground used for capping.
Clay Intermixed with Stone Grey Colour and Sticky in Nature		0.50m	0%:100%	0.30m to 0.50m of the trial hole does not have any waste present. It appears to be natural ground used for capping.
Burnt layer with Plastic, Steel, Oil. Grey Colour

0.90m	90%:10%	0.50m to 0.90m soil meets with the burnt waste material. A small portion of steel and oil present.

1.30m	40%:60%	1.00m – 1.30m. Small portion of steel, waste oil and fibre Groundwater contaminated with waste oil
Clay intermixed with Plastic, Fibre and Steel Grey colour End of Waste @ 1.70m

1.70m	40%:60%	1.30m – 1.70m Small portion of steel and fibre
Peaty Clay (Natural Ground) Dark Brown Colour End of Trial Hole @ 2.20m

2.20m	0%:100%	The final 1.70m to 2.20m of the trial hole does not have any waste present. It appears to be natural ground.

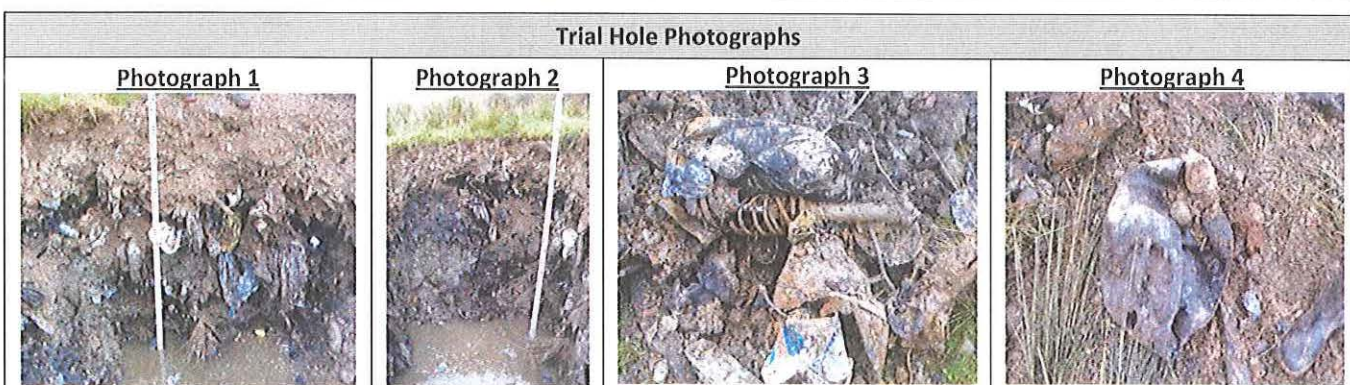
0.40m	0%:100%	The top 0.00m to 0.40m of the trial hole does not have any waste present. It appears to be natural ground used for capping.
Burnt layer with Plastic, steel, oil. Grey colour

0.60m	90%:10%	0.40m to 0.60m soil meets with the burnt waste material. A significant amount of steel, plastic and oil present.
Clay intermixed with Plastic, steel, tyre. Vehicle suspension, 20L drum, oil, municipal waste, timber, glass bottles. Grey colour

1.40m	90%:10%	0.60m to 1.40m soil meets with the waste material. A significant amount of plastic waste and pipes present.

1.90m	80%:20%	Large portion of waste plastic, steel, oil, municipal waste in the 1.40m–1.90m layer. Groundwater contaminated with waste oil
Clay intermixed with plastic, steel, oil, municipal waste, glass bottles. Grey colour End of Waste @ 2.10m

2.10m	80%:20%	1.90m – 2.10m of the trial hole has a large portion of steel wire with a significant amount of plastic.
Peaty Clay (Natural Ground) Dark Brown Colour End of Trial Hole @ 2.40m

2.40m	0%:100%	The final 2.10m to 2.40m of the trial hole does not have any waste present. It appears to be natural ground.

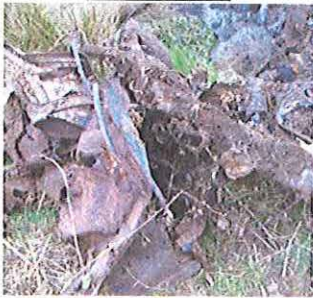
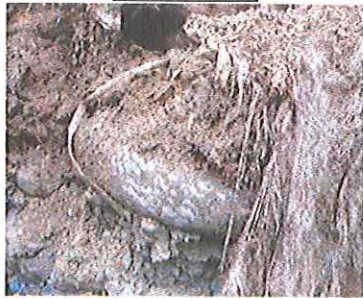
Trial Hole Photographs			
Photograph 1

0.40m	0%:100%	The top 0.00m to 0.40m of the trial hole does not have any waste present. It appears to be natural ground used for capping.
Burnt layer with Plastic, steel, oil. Grey colour

0.70m	90%:10%	0.40m to 0.70m soil meets with the burnt waste material. A significant amount of steel, plastic and oil present.
Clay intermixed with Plastic, steel, tyres, vehicle parts, 20L drum, oil, municipal waste, timber, wire, glass bottles. Grey colour

1.40m	90%:10%	0.70m to 1.40m soil meets with the waste material. A significant amount of vehicle parts, 20L drum, oil, municipal waste, timber, wire present.

2.00m	80%:20%	Large portion of waste plastic, steel, oil, municipal waste in the 1.40m–2.00m layer. Groundwater contaminated with waste oil
Clay intermixed with plastic, steel, oil, municipal waste, glass bottles. Grey colour End of Waste @ 2.20m

2.20m	70%:30%	2.00m – 2.20m of the trial hole has a large portion of steel with a significant amount of plastic and tyres.
Peaty Clay (Natural Ground) Dark Brown Colour End of Trial Hole @ 2.50m

2.50m	0%:100%	2.20m to 2.50m of the trial hole does not have any waste present. It appears to be natural ground.

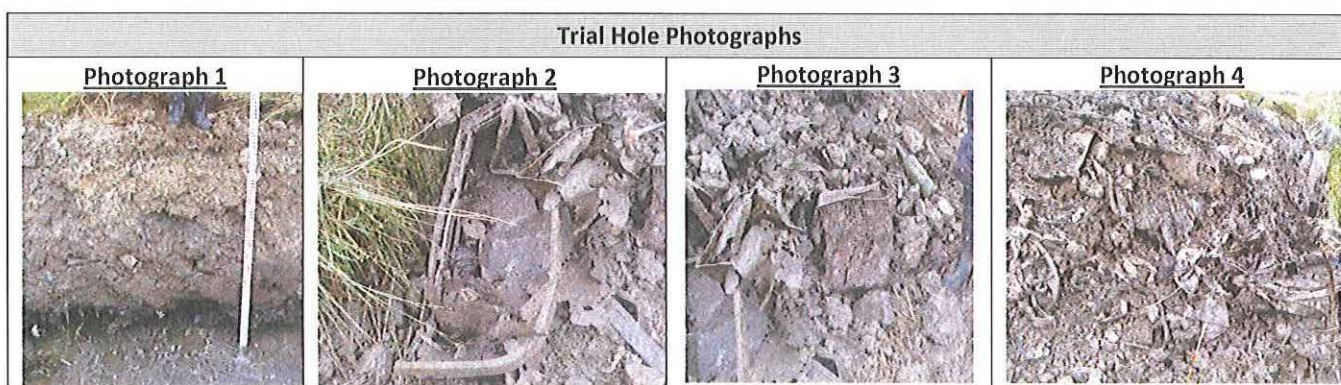
0.40m	0%:100%	The top 0.00m to 0.40m of the trial hole does not have any waste present. It appears to be natural ground used for capping.
Clay Intermixed with Stone Grey colour

1.00m	0%:100%	0.40m to 1.00m of the trial hole does not have any waste present. It appears to be natural ground.
Clay intermixed with Plastic, steel, tyres, vehicle parts, 20L drum, oil, municipal waste, timber, wire, glass bottles. Grey colour Groundwater Level @ 1.30m

1.30m	90%:10%	1.00m to 1.30m soil meets with the waste material. A significant amount of vehicle parts, 20L drums, oil, municipal waste, timber, wire present. Groundwater contaminated with waste oil

1.80m	90%:10%	1.30m – 1.80m of the trial hole has a significant amount of vehicle parts, 20L drums, oil, municipal waste and wire present.
Peaty Clay (Natural Ground) Dark Brown Colour End of Trial Hole @ 2.40m

2.40m	0%:100%	The final 1.80m to 2.40m of the trial hole does not have any waste present. It appears to be natural ground.

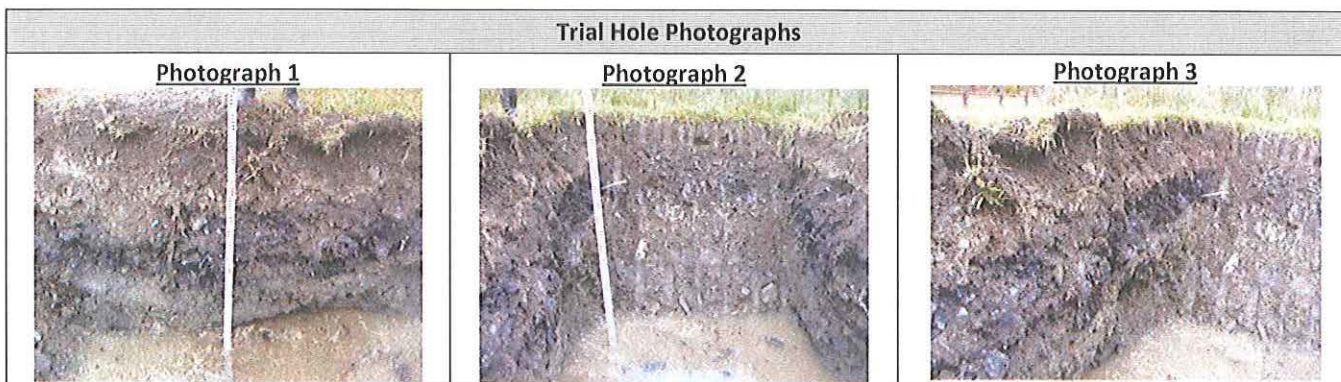
0.30m	0%:100%	The top 0.00m to 0.30m of the trial hole does not have any waste present. It appears to be natural ground used for capping.	
Clay Intermixed with Stone Grey colour, Sticky soil structure

0.70m	0%:100%	0.30m to 0.70m of the trial hole does not have any waste present. It appears to be natural ground.	
Clay intermixed with plastic, steel, oil, municipal waste, timber, wire, glass bottles. Grey colour Groundwater Level @ 1.40m

1.40m	90%:10%	0.70m to 1.40m soil meets with the waste material. A significant amount of plastic, oil, municipal waste, timber, wire present.

1.80m	70%:30%	1.40m – 1.80m of the trial hole has a large portion of steel with a significant amount of plastic and municipal waste.	
Peaty Clay (Natural Ground) Dark Brown Colour End of Trial Hole @ 2.30m

2.30m	0%:100%	The final 1.80m to 2.30m of the trial hole does not have any waste present. It appears to be natural ground.

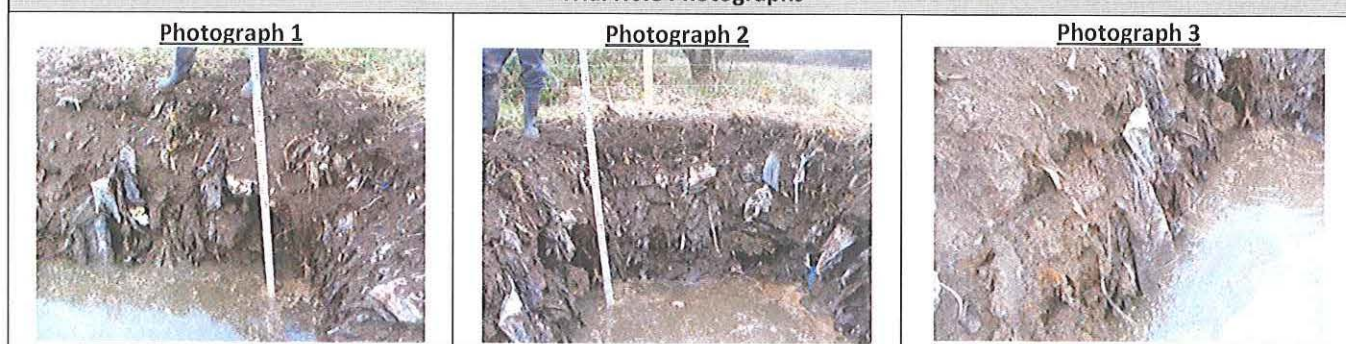
Trial Hole Photographs

2.00m	0%:100%	1.70m to 2.00m of the trial hole does not have any waste present. It appears to be natural ground.

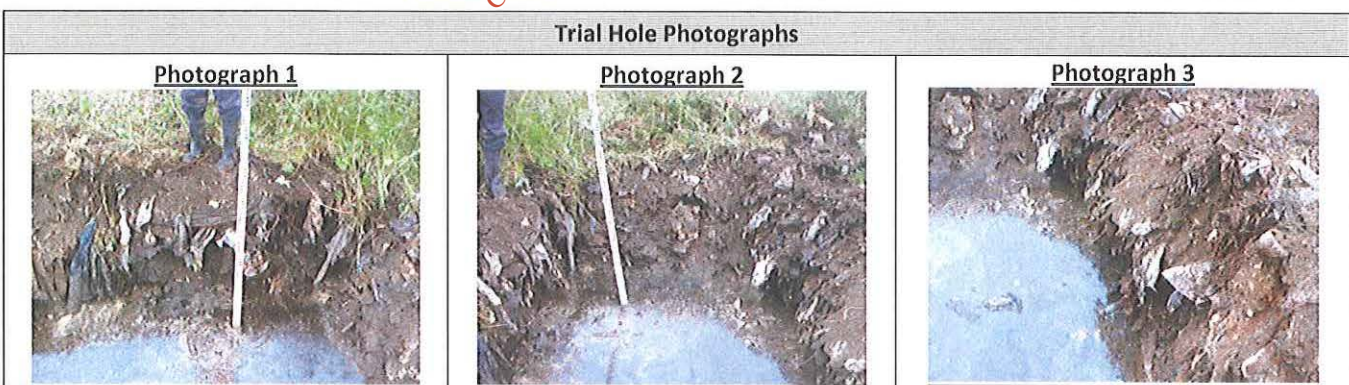
Clay intermixed with plastic, steel, oil, municipal waste, glass bottles. Grey colour End of Waste @ 1.50m

1.80m	0%:100%	1.50m to 1.80m of the trial hole does not have any waste present. It appears to be natural ground.

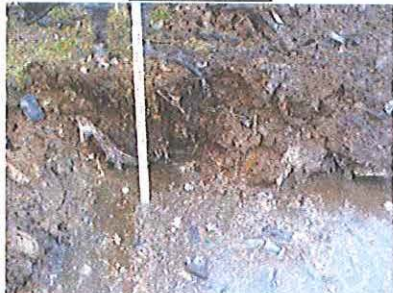
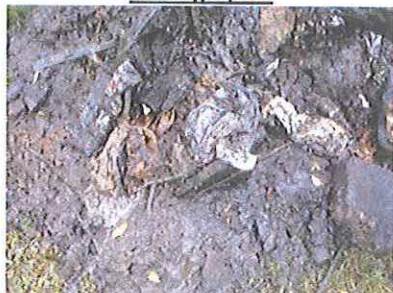
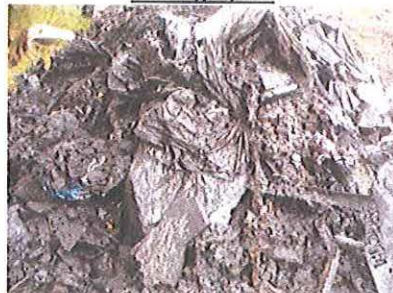
Trial Hole Photographs		
Photograph 1

1.60m	0%:100%	1.30m to 1.60m of the trial hole does not have any waste present. It appears to be natural ground.

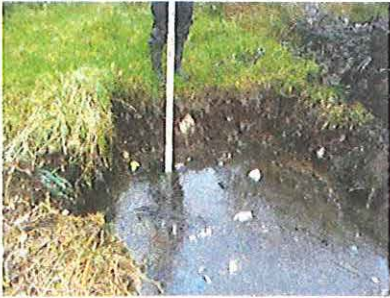
Trial Hole Photographs		
Photograph 1

1.20m	70%:30%	0.60m – 1.20m of the trial hole has a significant amount of plastic, oil, municipal waste, timber, bottles present.
Peaty Clay (Natural Ground) Dark Brown Colour End of Trial Hole @ 1.50m		1.50m	0%:100%	1.20m to 1.50m of the trial hole does not have any waste present. It appears to be natural ground.

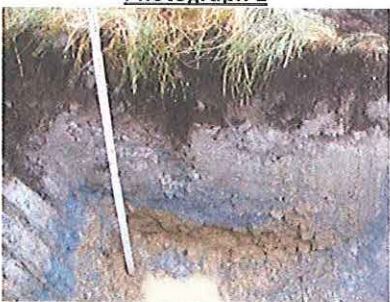
Trial Hole Photographs	
Photograph 1

Clay High Density Orange Colour and Sticky in Structure End of Trial Hole @ 2.10m		2.10m	0%:100%	1.80m to 2.10m of the trial hole does not have any waste present.
