**TIER 3**

**ENVIRONMENTAL RISK ASSESSMENT**

**FORMER MUNICIPAL HISTORIC LANDFILL**

**POTTLEBOY**

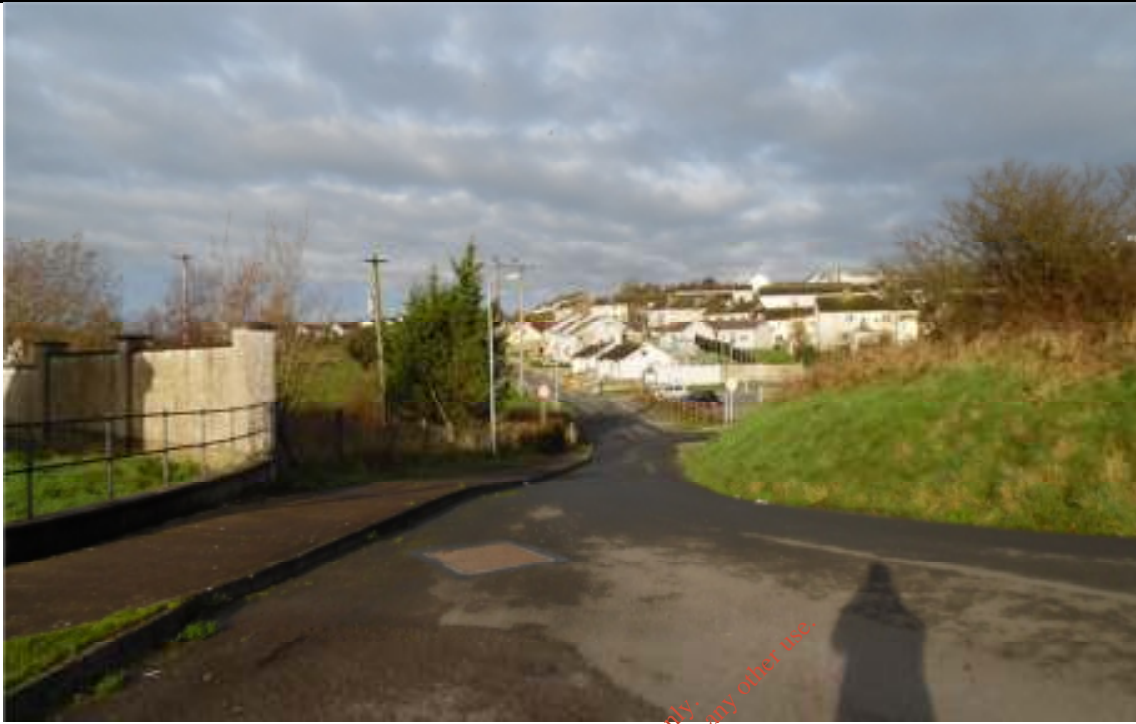
**Photograph 1 : Location No 1 - Eircom Service Duct outside the southern Boundary.**

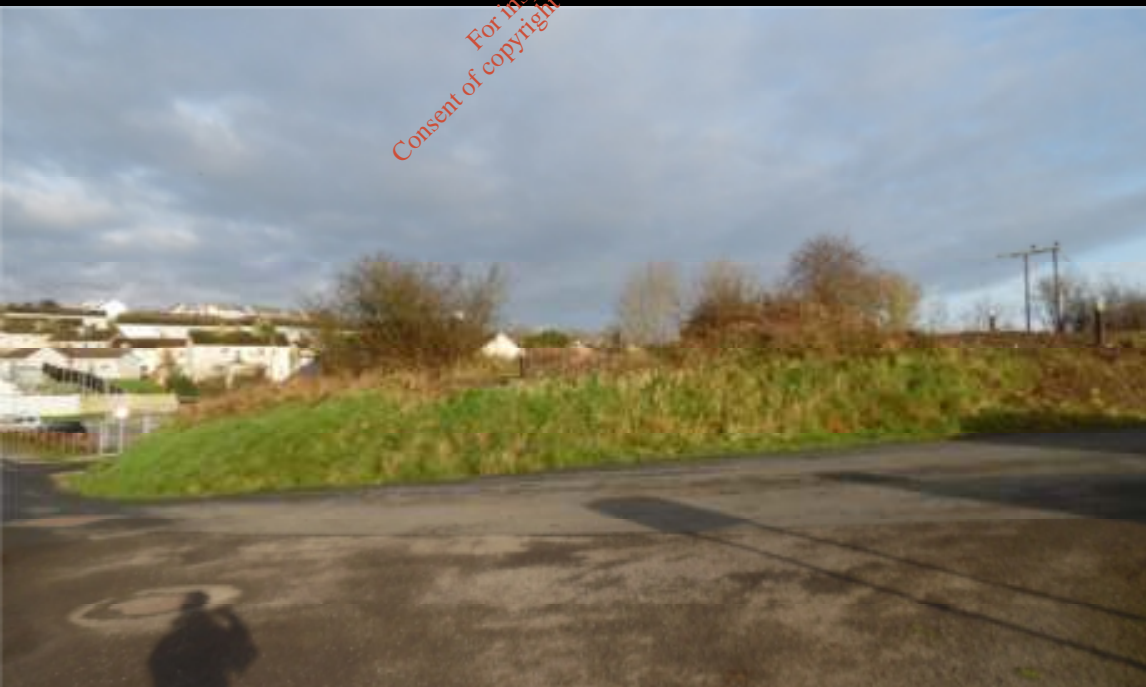
**Photograph 2: Location No. 2 Eircom Service Duct outside the southern Boundary.**

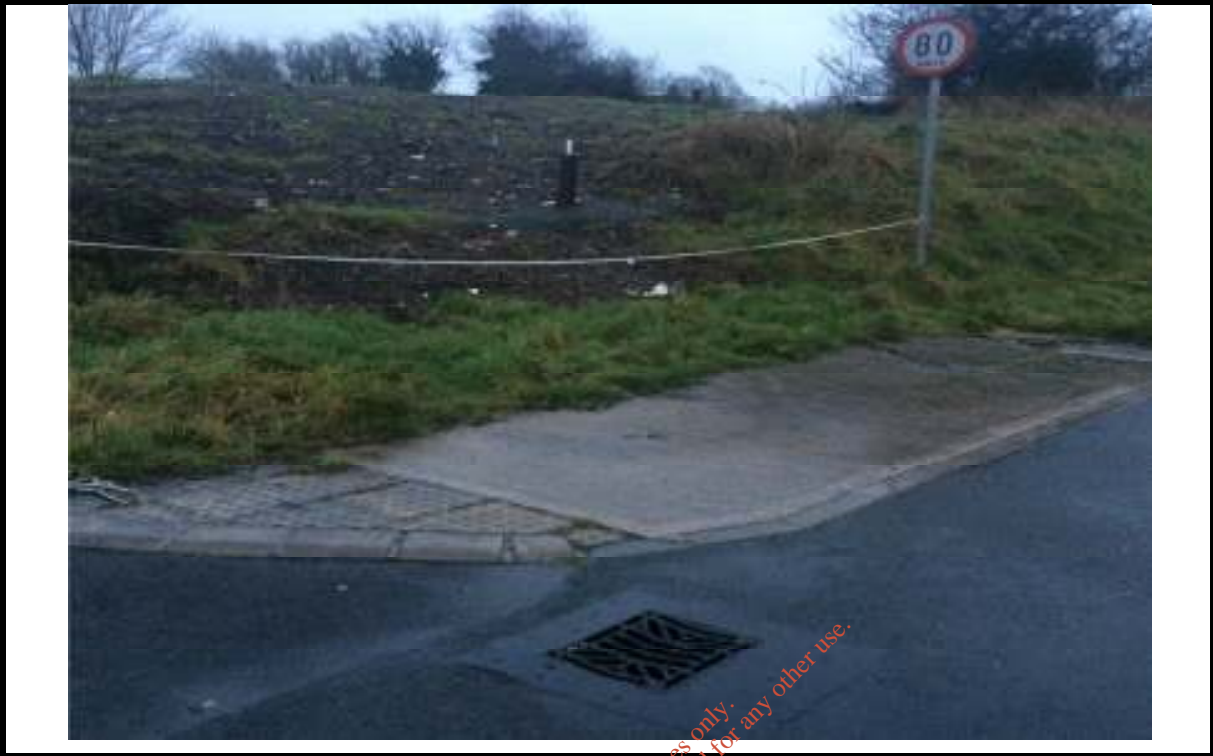
**Photograph 3: Location No. 3 Surface Water Road Gully outside the Westerly Boundary.**

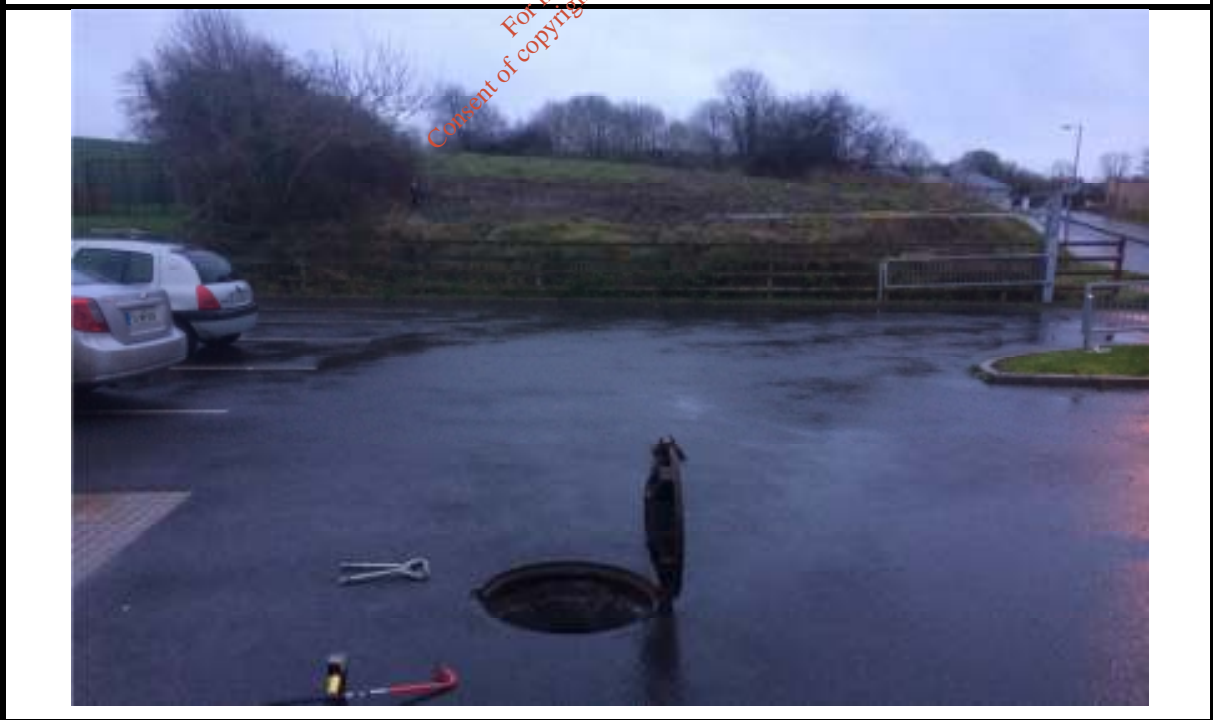
**Photograph 4: Location No. 4 Inspection Manhole for Foul water.**

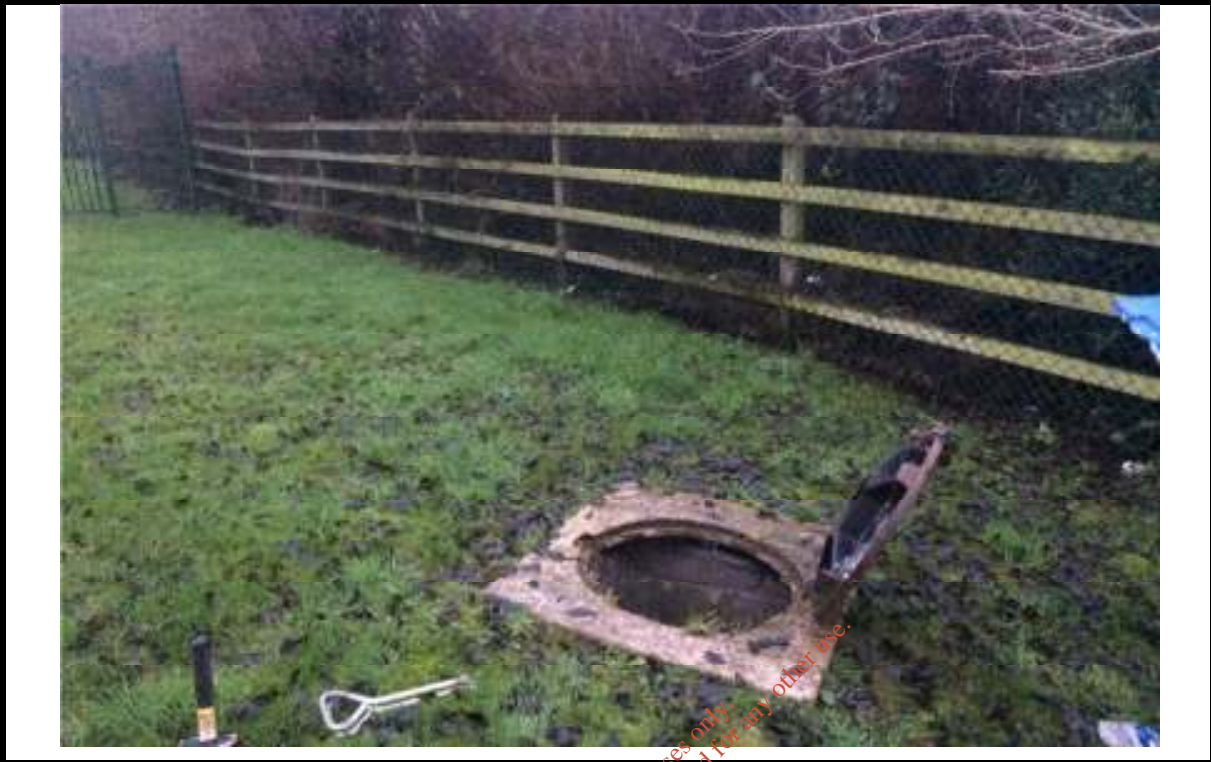
**Photograph5 : Location No. 5 Surface Water Inspection Manhole.**

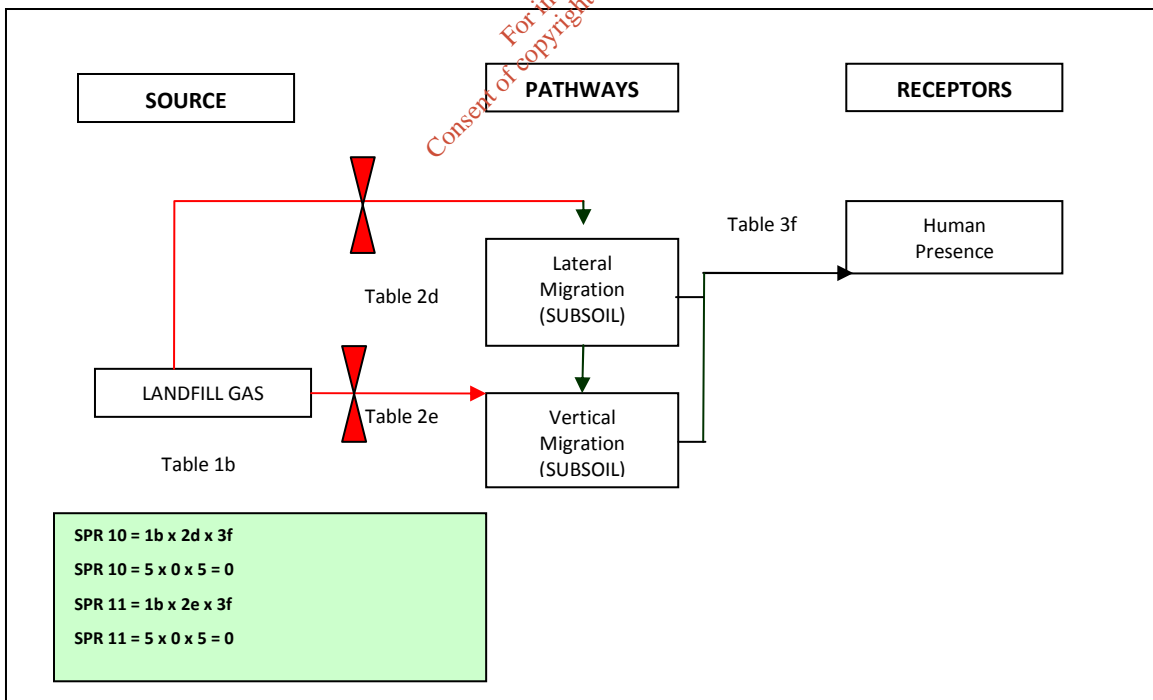
Diagram 1 – SPR Linkage Diagram showing the break in the linkage before and after the venting of the landfill gas.

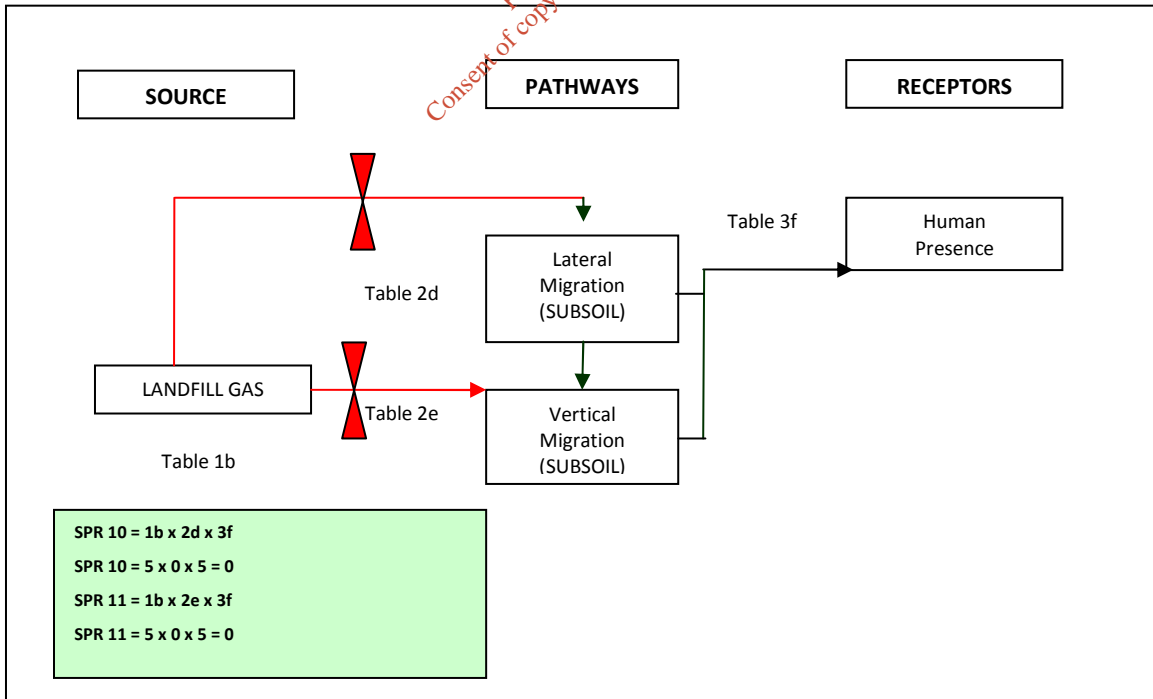
Diagram 2 – SPR Linkage Diagram showing the break in the linkage before and after the venting of the landfill gas.

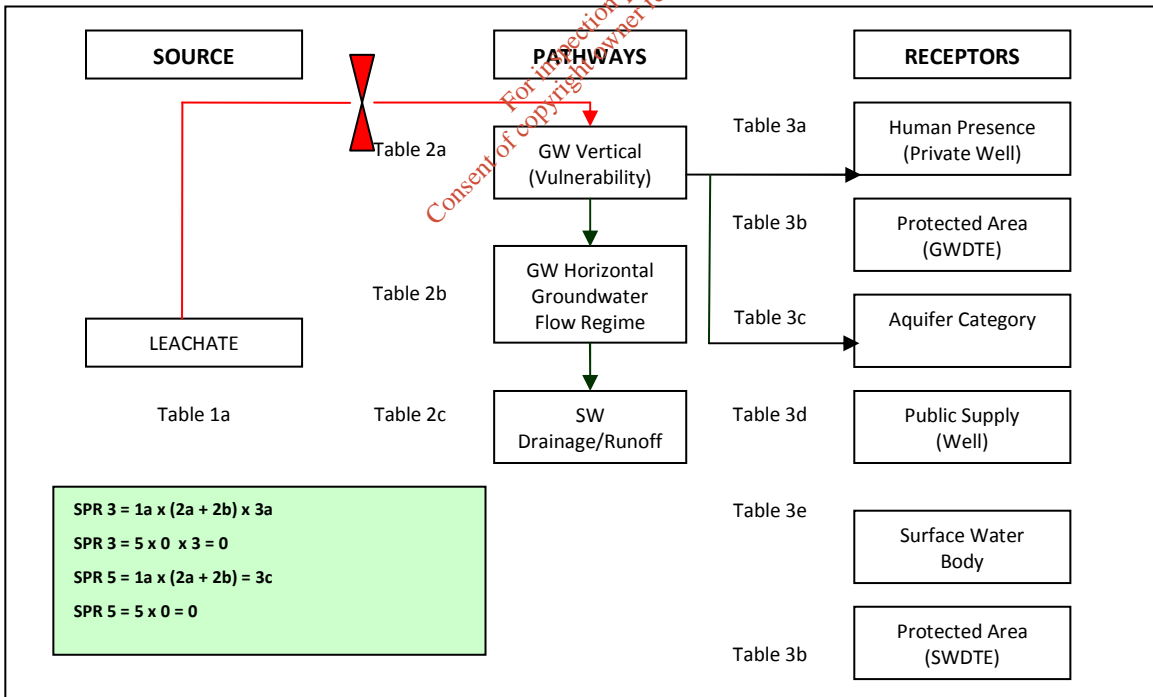
3.2.5.7 Diagram 4 –SPR Linkage Diagram showing the break in the linkage after the control of Surface water entering the Landfill.

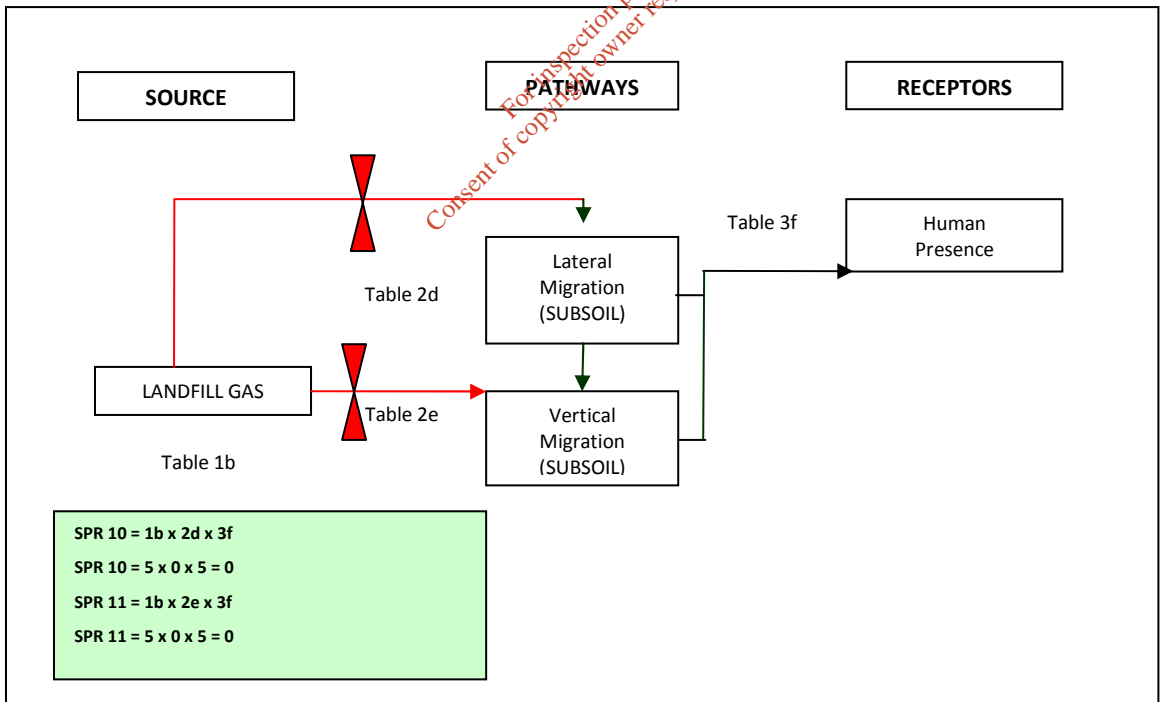
SPR Linkage Diagram 5 showing the break in the linkage before and after the removal of the Waste Material.
