ENVIRONMENTAL RISK ASSESSMENT

APPENDIX B

ECOLOGICAL ASSESSMENT

BIOLOGICAL WATER QUALITY ASSESSMENT OF THE POTTLEBOY STREAM AT COOTEHILL, CO. CAVAN

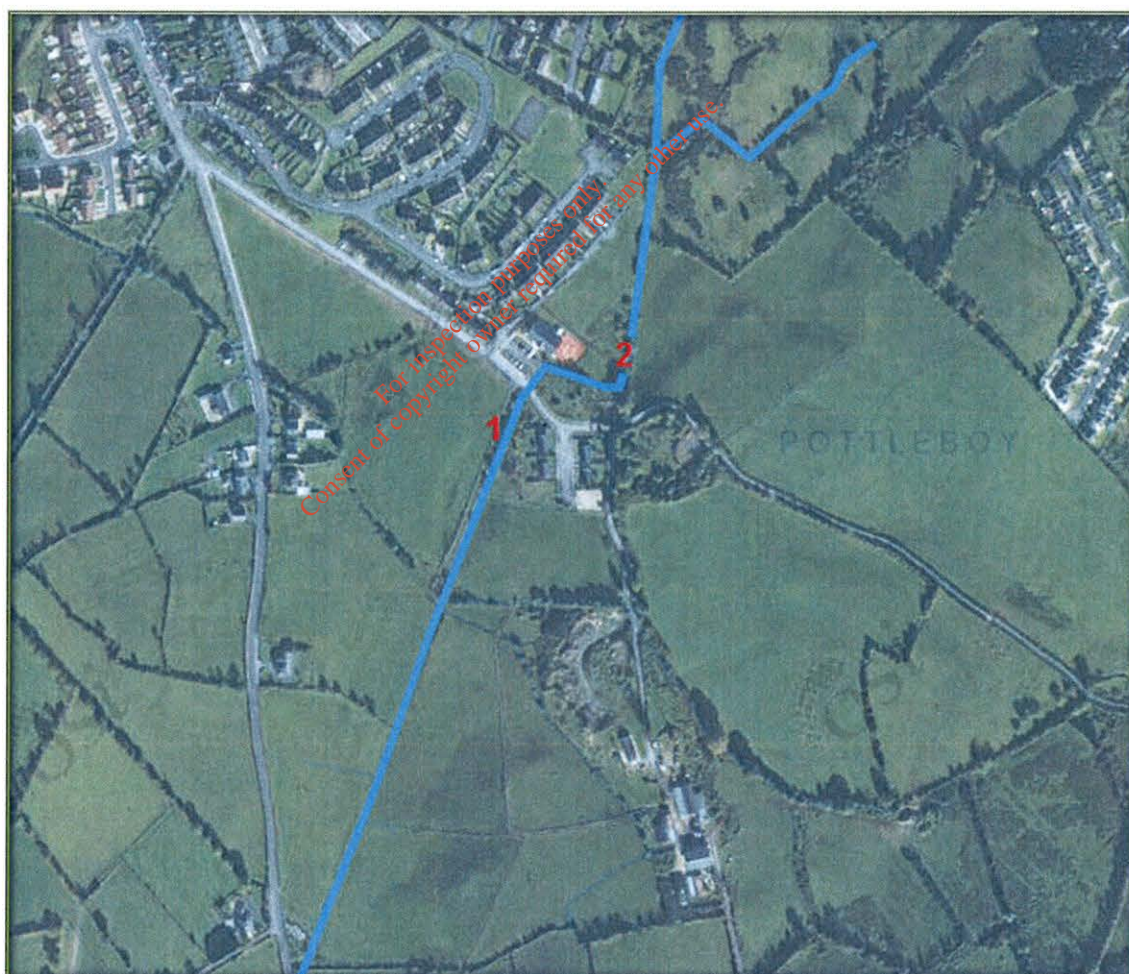
Station No.	Location	Grid Reference
1	~ 40m downstream of landfill	H 60666 13580
2	~ 18m upstream of landfill	H 60562 13529

Figure 2 – Sampling Points Along the Pottleboy Stream (Numbered in Red)
