**Attachment 4.8.3 – Site Condition Report**

## **SITE CONDITION REPORT**

### **KNOCKHARLEY LANDFILL**

**September 2019**

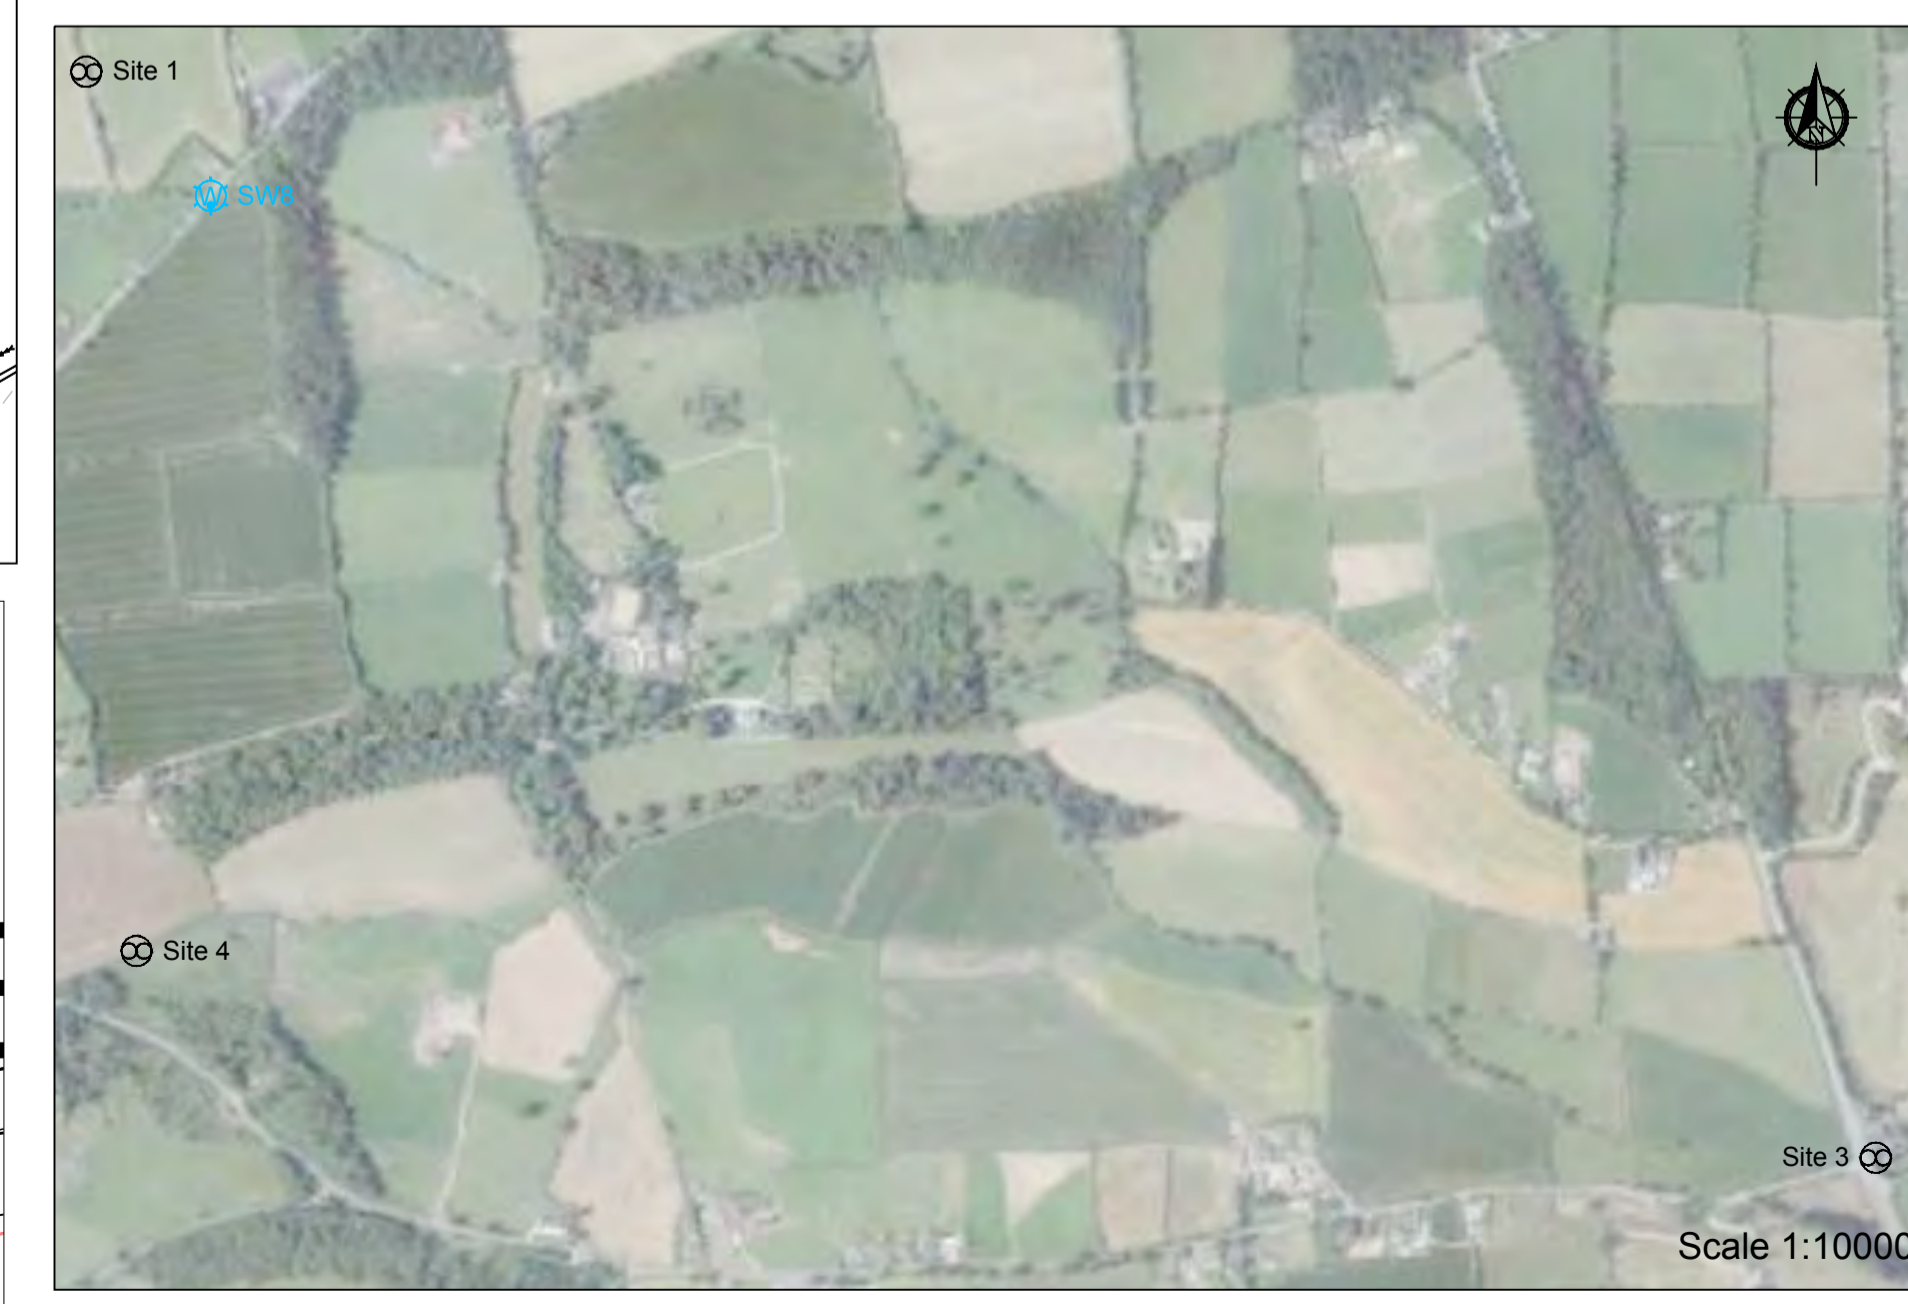
Dwg. No.  
**LW14-821-01-P-0050-001**

Note: MW17D, MW18D and MW19D were installed in 2016 for baseline monitoring for proposed development

Title of Drawing  
**EXISTING MONITORING POINTS**

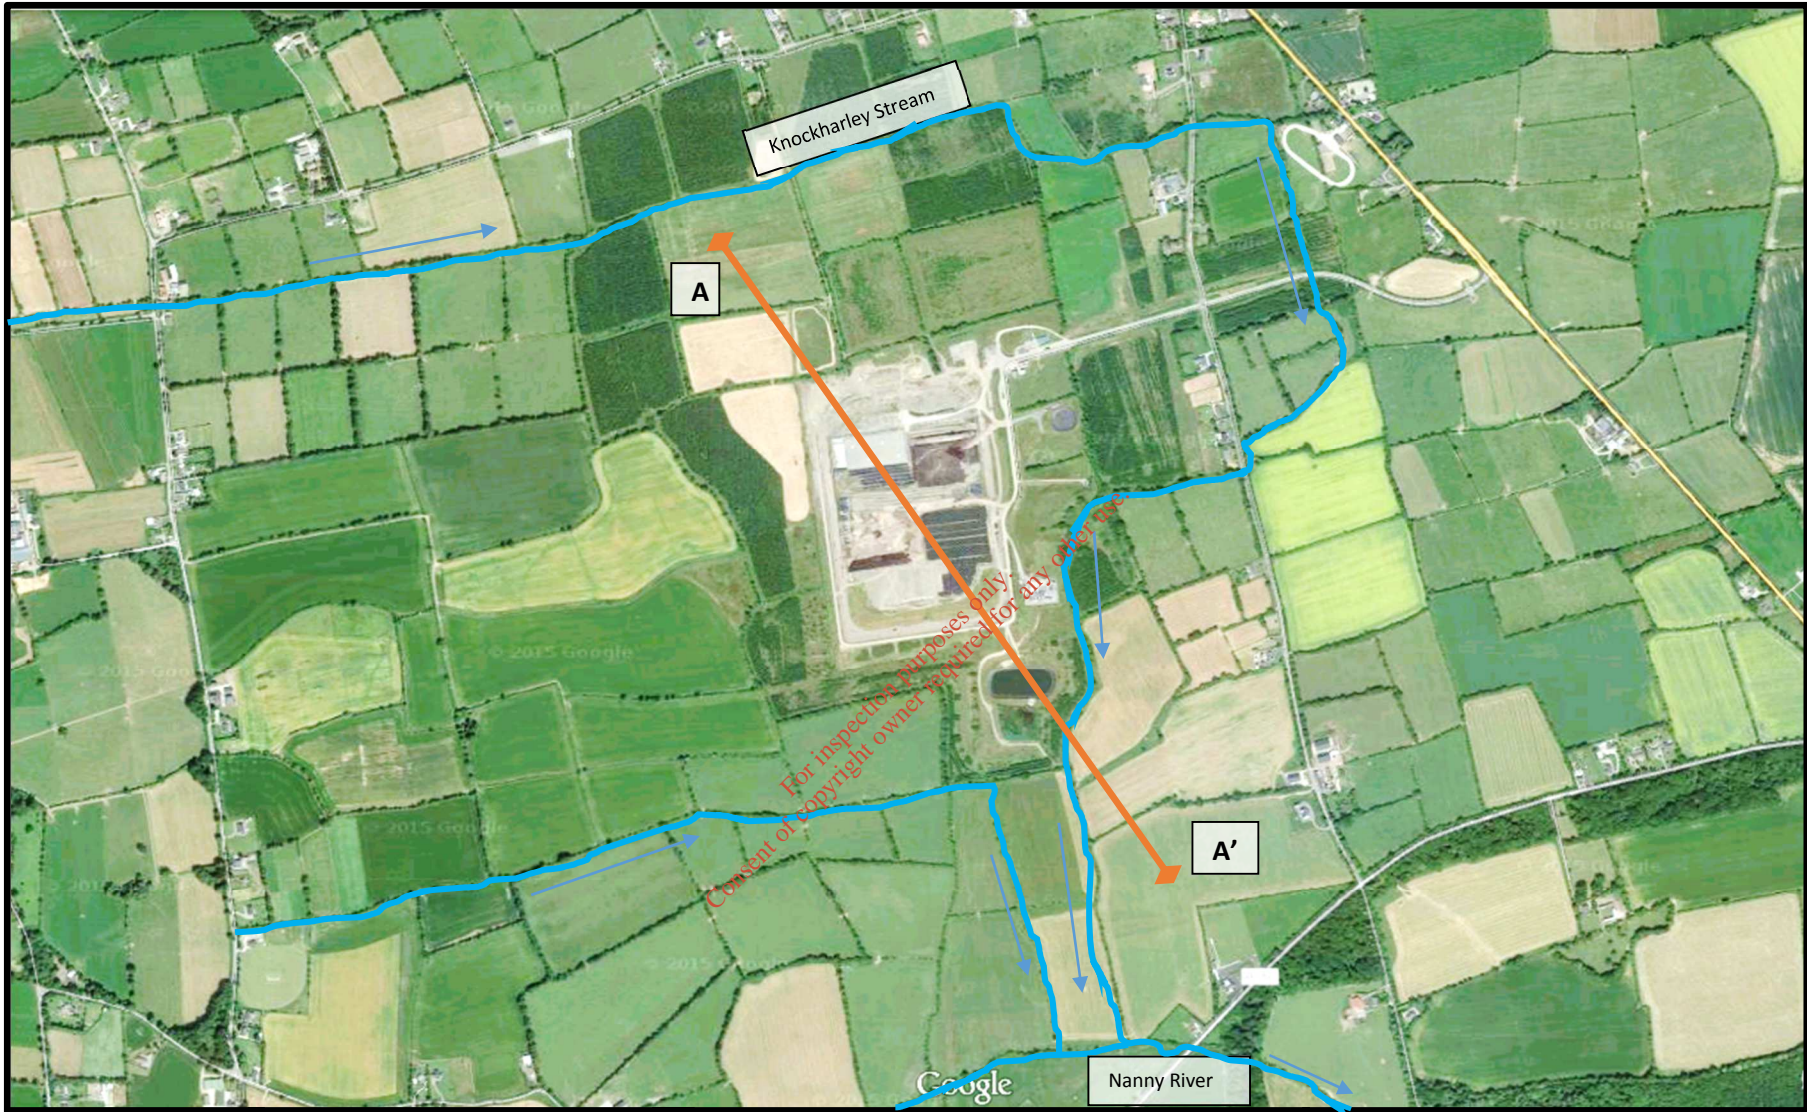
**Ref:**  
**Figure 6.1**

Figures 6.1 and 6.2 are schematics of Conceptual Site Model in Plan and Section respectively. The site is situated at an elevation of between 96 and 98m Ordnance Datum (OD). It is relatively flat with a gentle slope toward the river Nanny to the south of the site. The Knockharley Stream, which is a tributary of the Nanny, flows around the northern and eastern site perimeter before joining the Nanny River c2km to the southeast.

**Title:**  
**Conceptual Site Model – Plan View**
