Arran Chemicals Limited
Athlone, Co. Roscommon.

Baseline Report 2019

In accordance with Article 22(2) of Directive 2010/75/EU on Industrial Emissions

Report Reference Number: 4750-19-01
Version: 1
Date of Issue: 26-09-2019

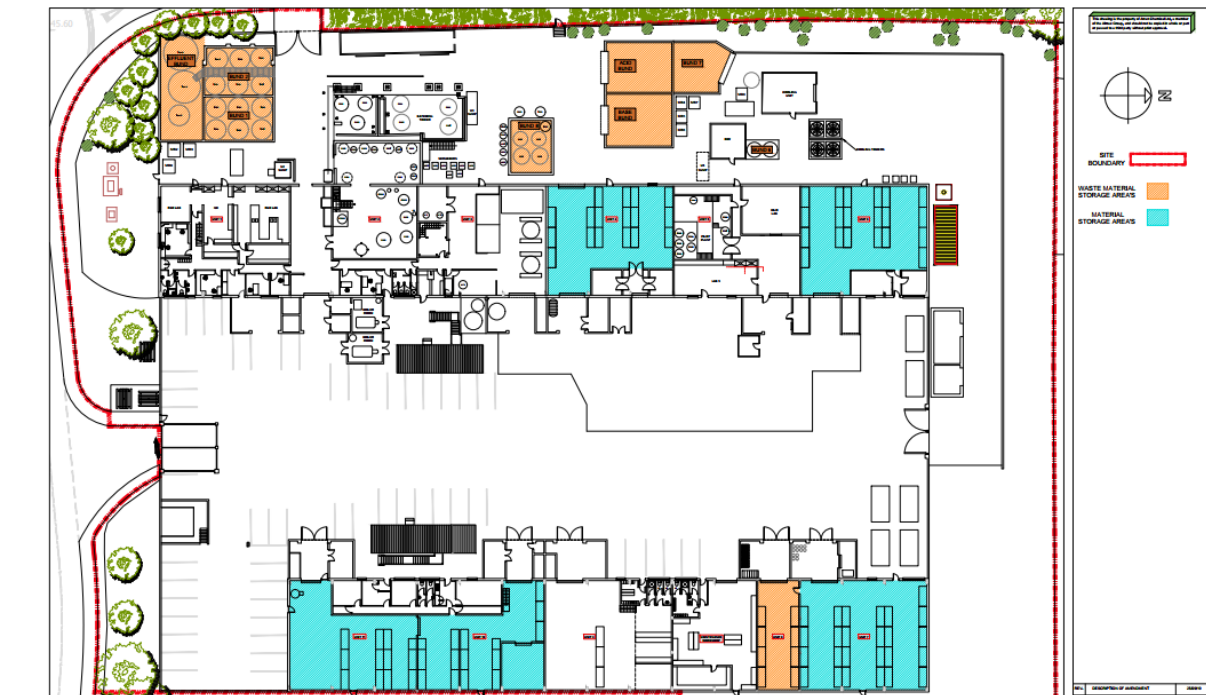
Figure 3

The design of the facility and storage of chemicals are highlighted on the map below, Figure 3.

Bulk liquid chemical storage takes the form of a tank farm and an open chemical storage area for the IBCs/drums at the rear of Units 1 to 6. The area is covered by reinforced concrete bunding and the gradient is such that liquids are directed towards one of three sumps serving the area. The main sump adjacent to the tank farm has a 3,000L capacity. The sump operates on a high-level switch and pumps to the effluent tank when the level of liquid rises sufficiently. Any surface water from the bunded area or liquid which enters these sumps is pumped via the main sump into the standby effluent tank for balancing and containment. Two effluent tanks run as duty and standby, one filling whilst one discharges to the Monksland Wastewater Treatment facility under permission and limits from Irish Water.

Storage of Dry Materials, packaging stores, engineering equipment and dry product goods outdoors are contained in Units 7-11 on the eastern boundary of the facility.

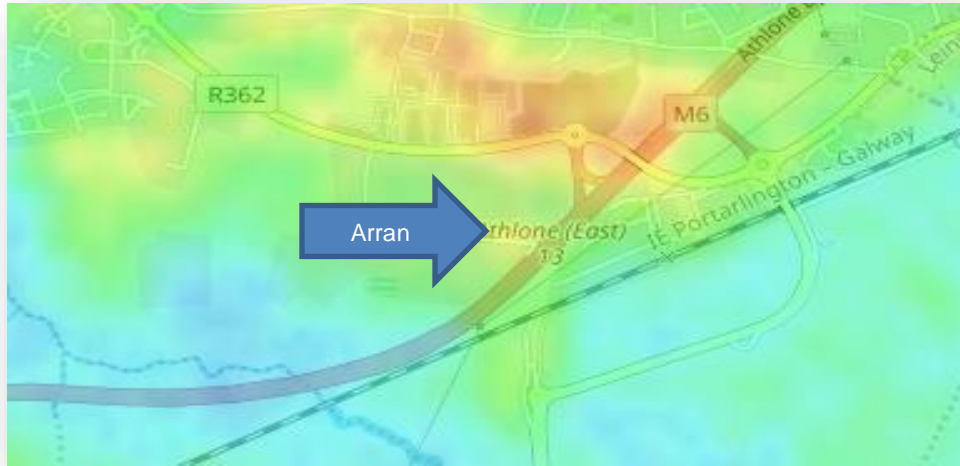
Figure 6 Topography

The majority of the site is concrete hardstand. The topography of the site slopes in a southerly direction, see Figure 6

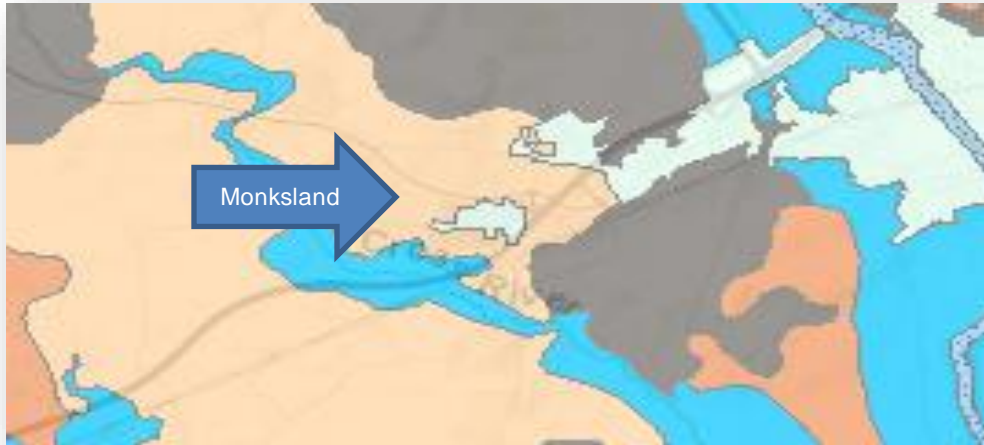
Figure 8 Soils

The GSI classify the soils of Monksland Industrial Estate as Urban (Urban) which is substantially modified and has low permeability. The surrounding soils composition are a combination of Mullabane, Burren and Crush all of which are defined as loamy drift over limestone.

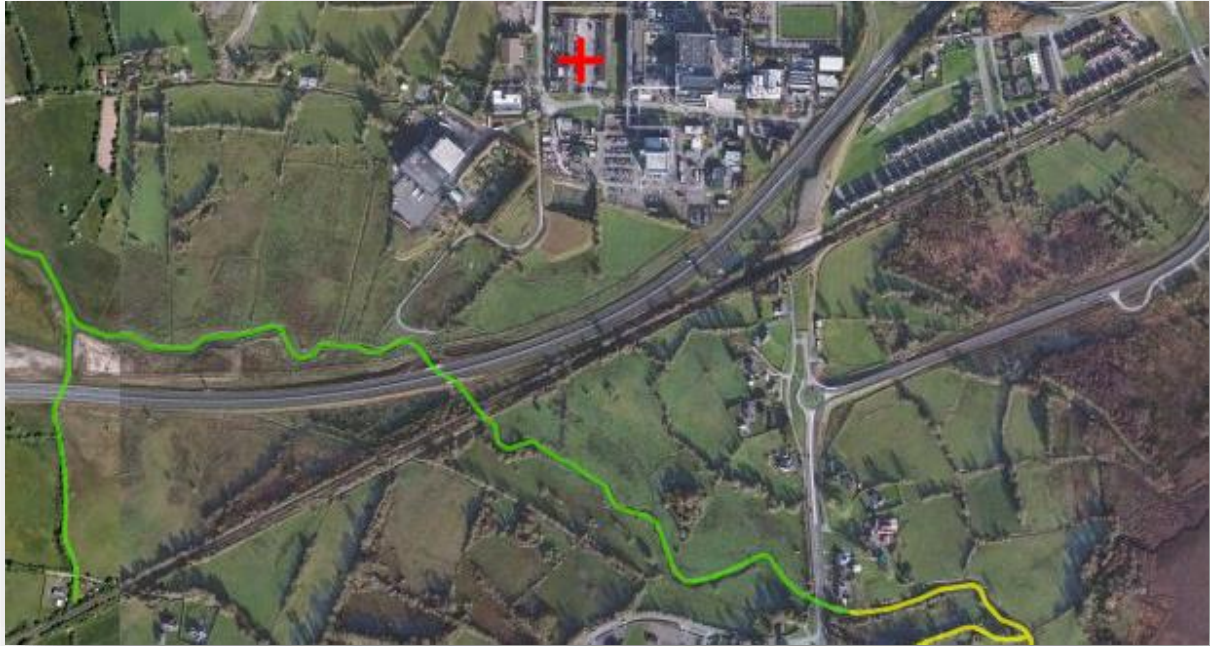
Figure 11 River System

The site is located in an industrial estate with the nearest river over 400m south of the site. Surface water quality at the Cross Stream most southerly to the Arran facility is classified as high and changes to moderate beyond the point of the R446 road. The Cross (Roscommon)_040 which connects downstream to the River Shannon (Upper)_120 are both classified 'AtRisk' of not attaining their objectives under the Water Framework Directive

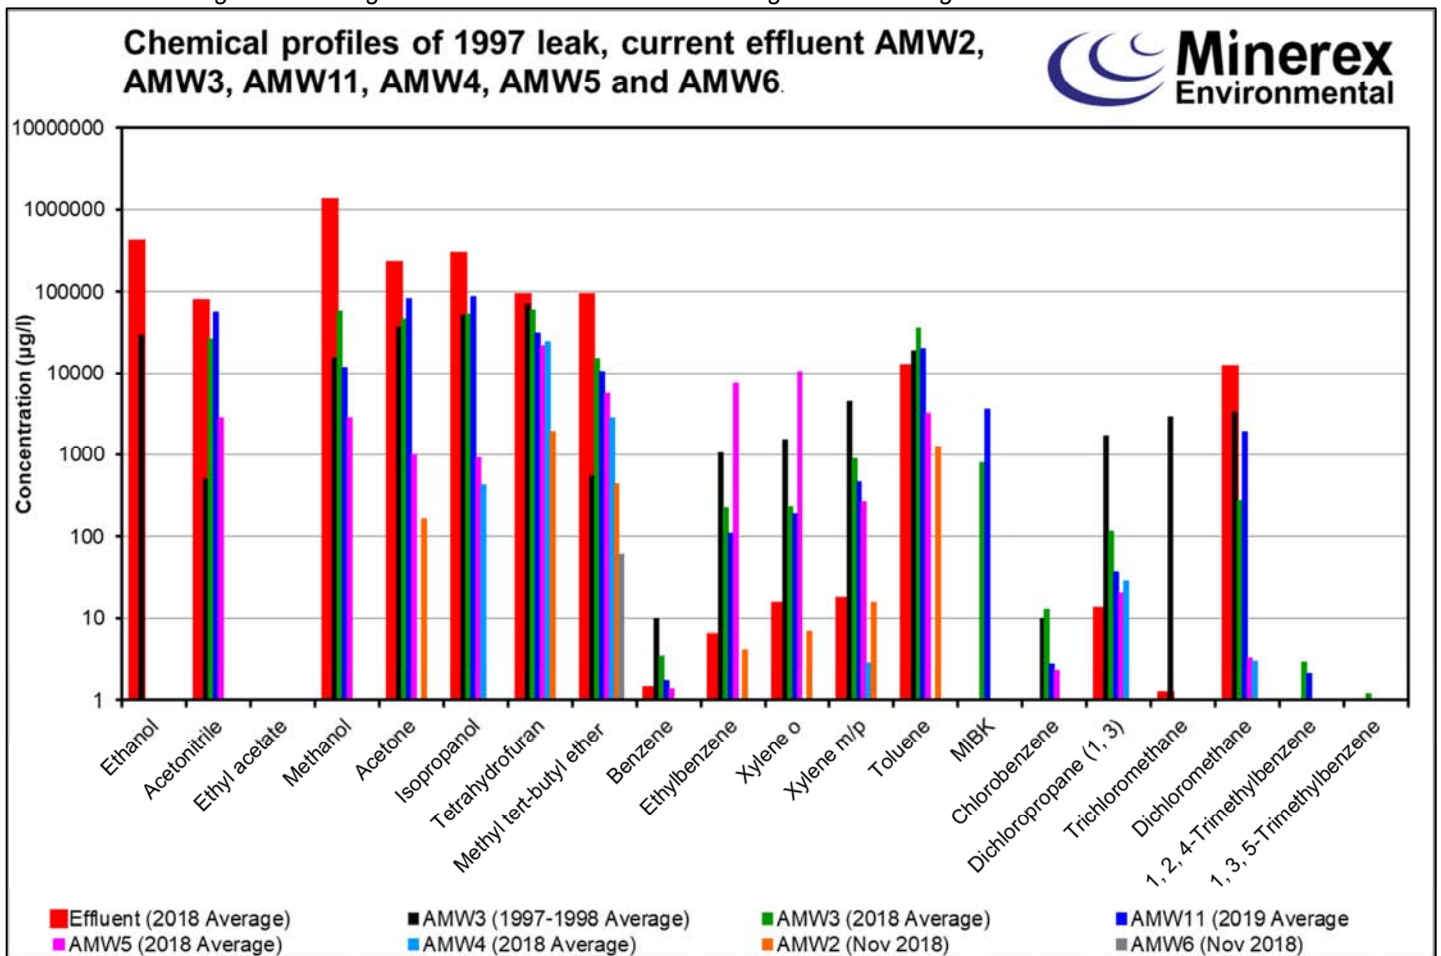
Figure 1.2 – Signature of the effluent in red vs. signature of the groundwater CoPCs.

ACCL effluent is characterised by having high levels for 9 compounds including Ethanol, Acetonitrile, Methanol, Acetone, Isopropanol, Tetrahydrofuran (THF), Methyl-tert butyl ether (MTBE), Toluene and Dichloromethane (DCM).

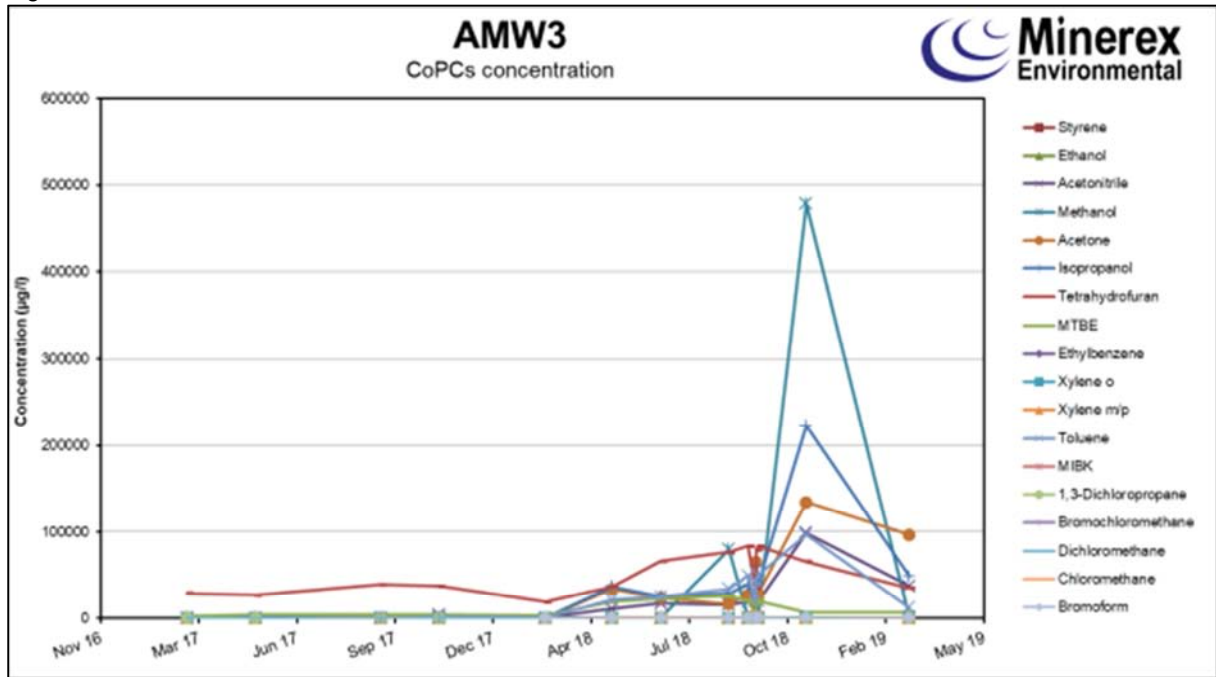
Figure 3.8 – AMW3 CoPCs concentrations

Well AMW3 (depth: 6.9m, screened in the overburden) has shown a downwards trend in all the CoPCs concentrations since the pumping started.

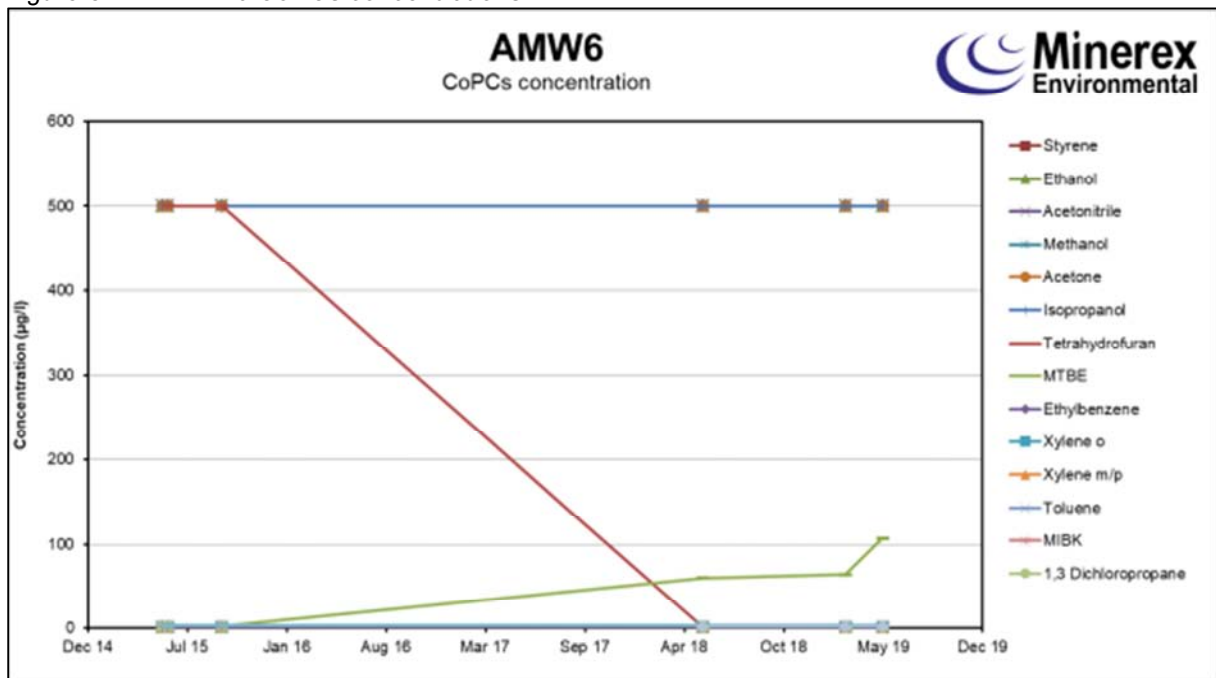
Figure 3.17 – AMW6 CoPCs concentrations

MTBE shows an upward trend in AMW6 (depth 23.73m, screened in bedrock) in the last year, the rest of the CoPCs are below LOD.
