# Bohernabreena Landfill

## Environmental Risk Assessment (Appendices)

ENVIRONMENTAL ASSESSMENT OF THE  
QUALITY OF GROUNDWATERS AT THE  
FRIARSTOWN LANDFILL SITE AT  
BOHERNABREENA, CO. DUBLIN.

***ENVIRONMENTAL ASSESSMENT OF THE  
QUALITY OF SURFACE WATERS AT THE  
FRIARSTOWN LANDFILL SITE AT  
BOHERNABREENA, CO. DUBLIN .***

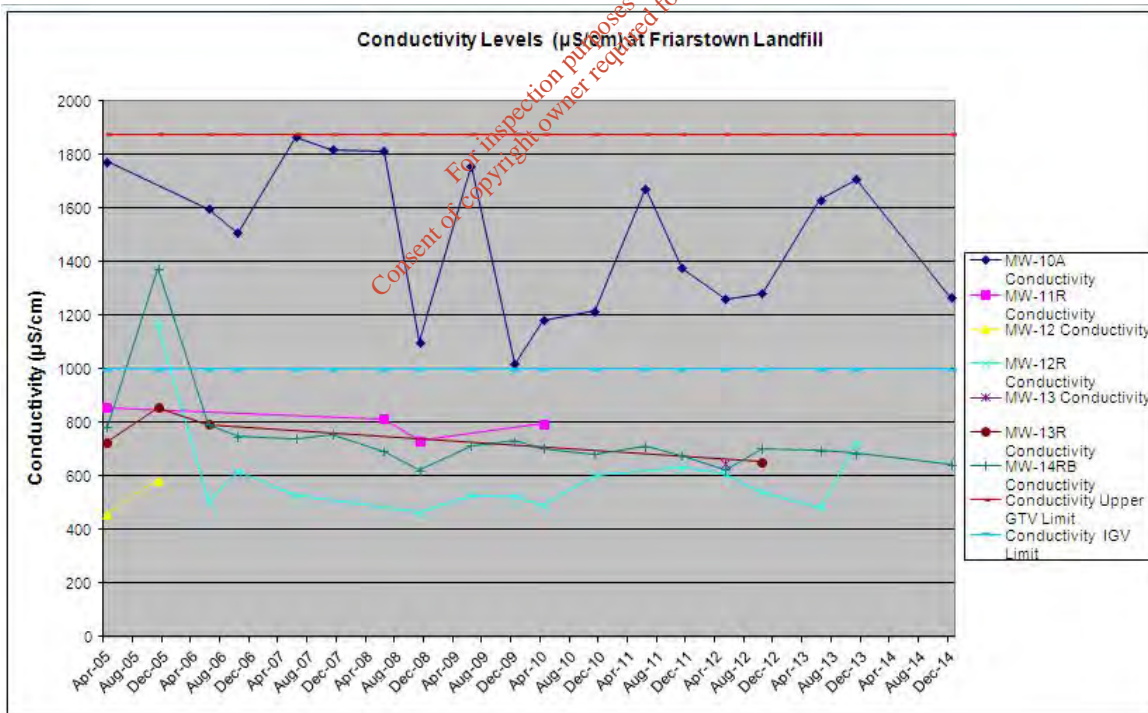
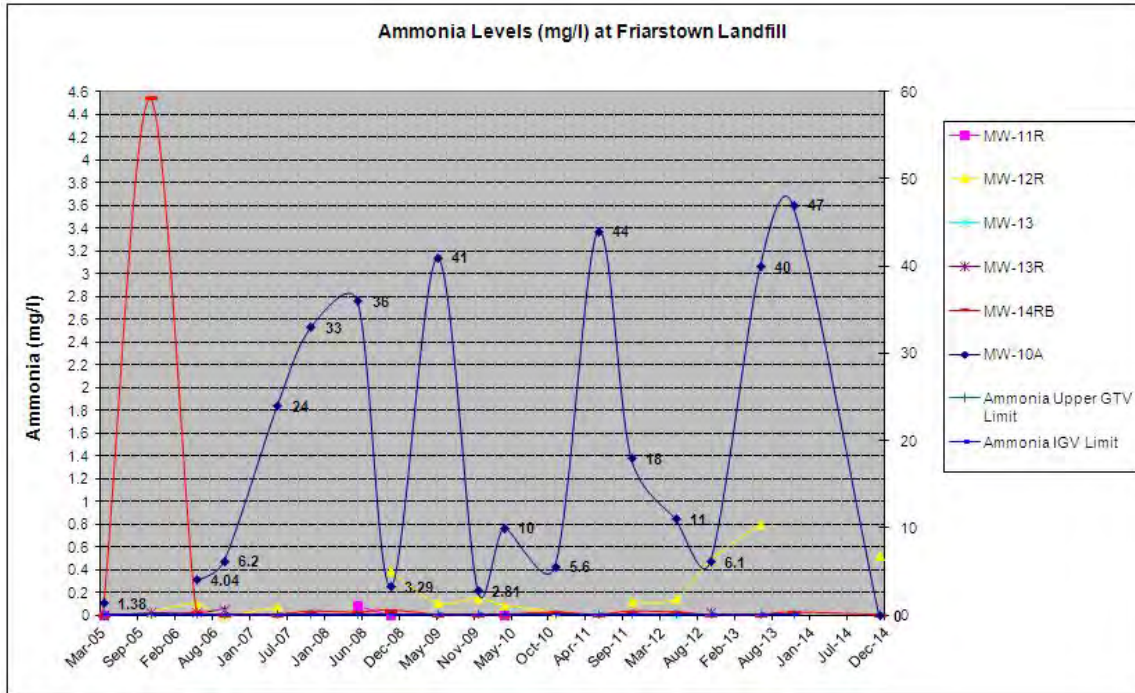
## Trended Graphs

Groundwater sample were obtained from three boreholes (MW-10A MW-12R and MW-14RB) at the Friarstown Landfill during this monitoring event. In general, the readings at each location are similar to those levels observed in previous monitoring events (see trended graphs in Appendix 1).

Historical trended data displays exceedences of GTV and IGV levels in previous monitoring events (see Appendix 1) for most of the fore mentioned parameters. A number of parameters have seen their concentration decrease since the last monitoring event:
