# Bohernabreena Landfill

## Environmental Risk Assessment

Client:	South Dublin County Council
Project Title:	Bohernabreena Landfill
Document Title:	Environmental Risk Assessment
Document No:	MDR1489Rp0001

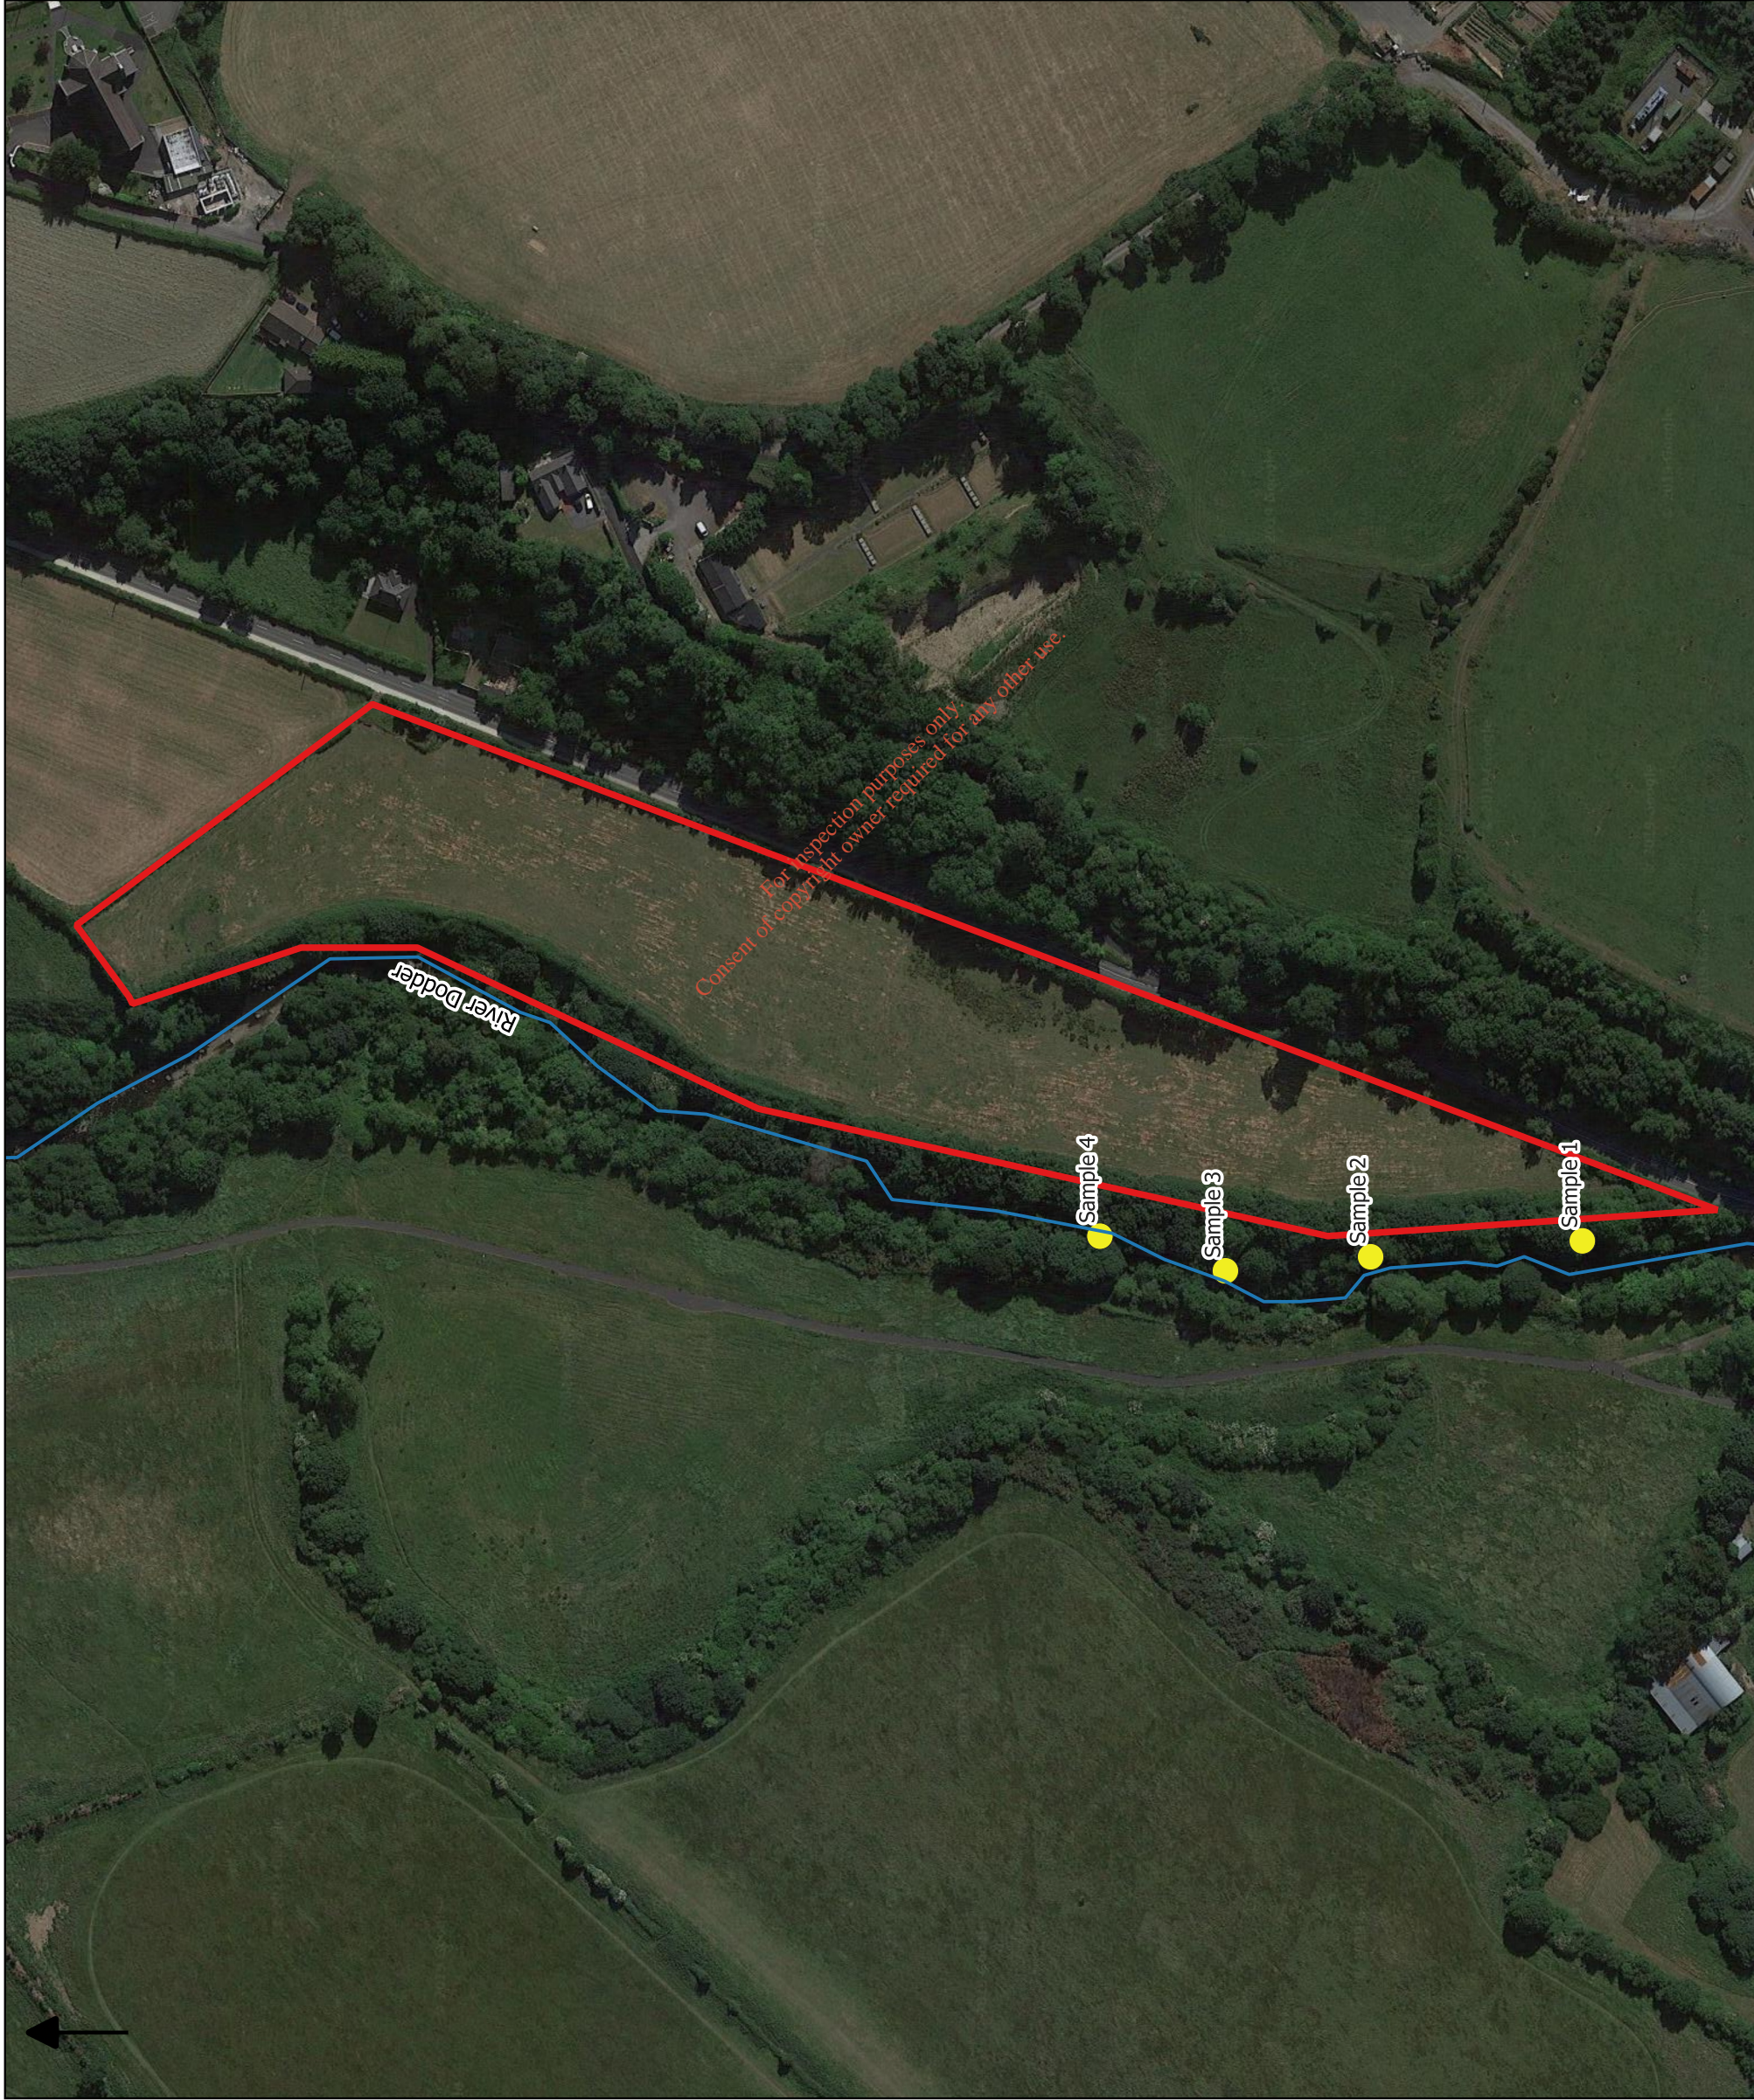
**Title: Figure 2.1 SDCC Leachate Sampling**

subsequently sampled leachate at 4 No. locations along the Dodder river bank (**Figure 2.1**). The results are included in **Appendix A** and summarised in **Table 2.2** and indicate an exceedance of relevant statutory limits for Ammoniacal Nitrogen and Biological Oxygen Demand (BOD).

Identifying leachate sample locations of previous investigation.

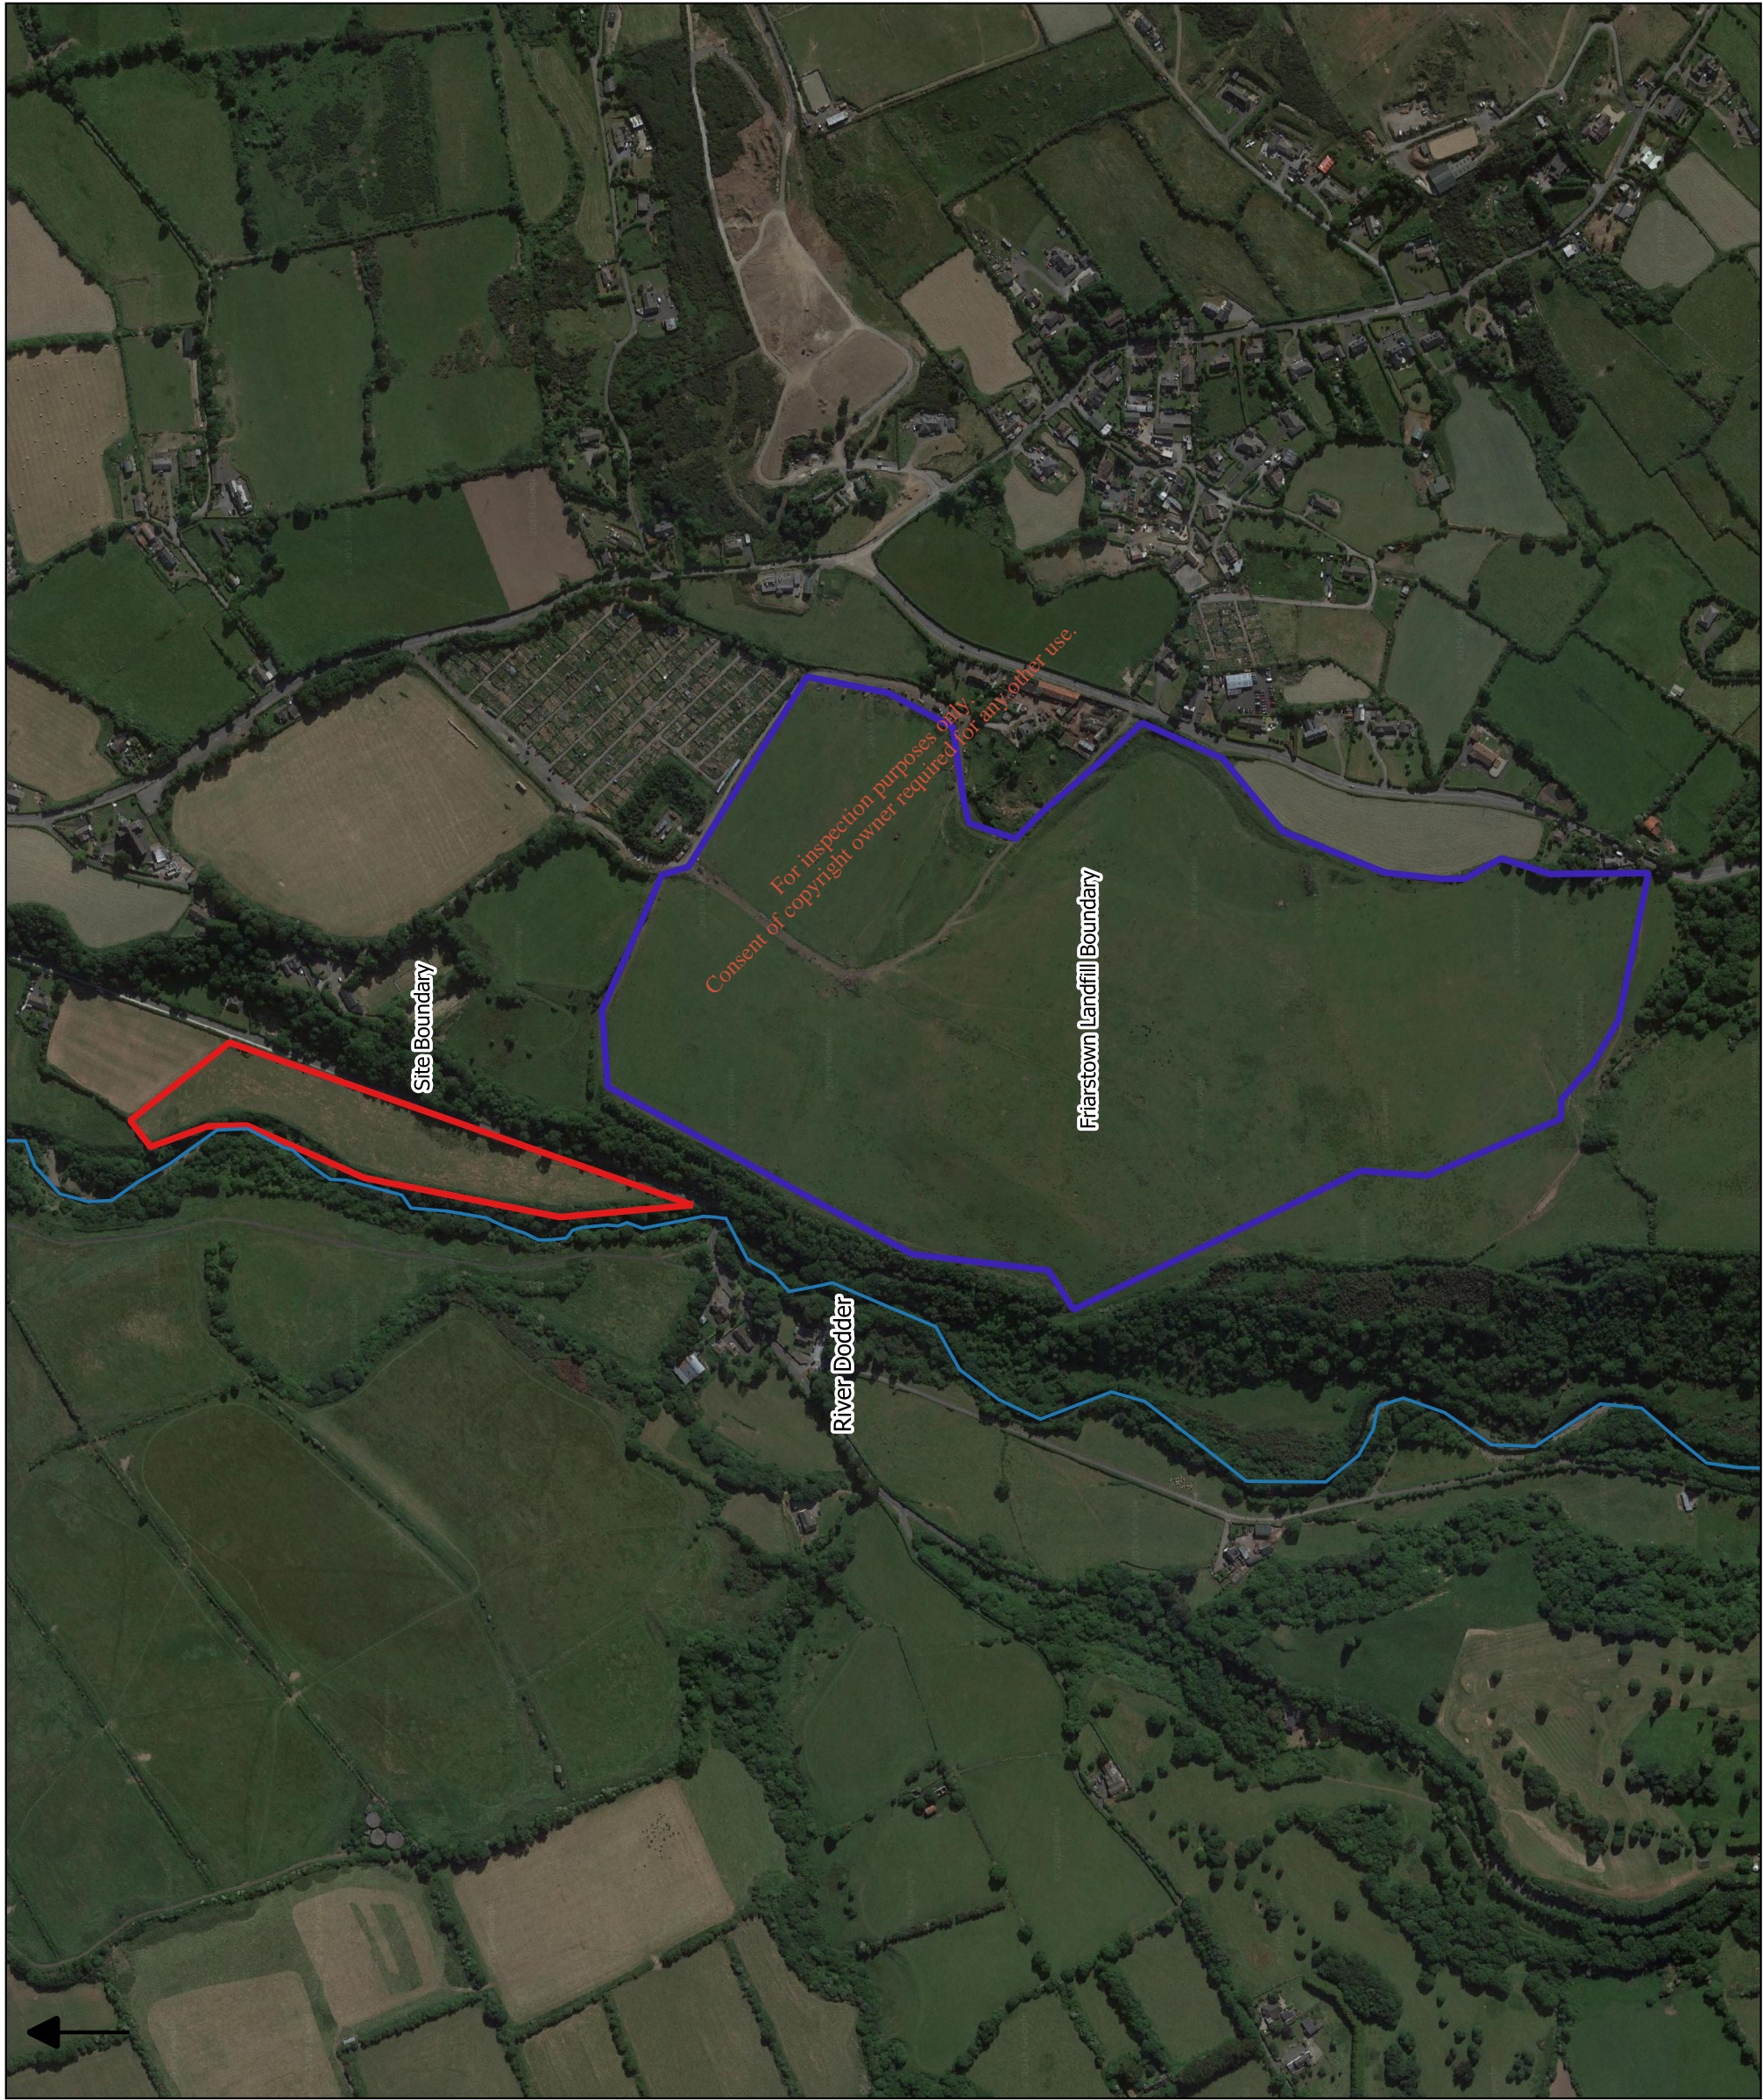
Title: **Figure 2.2 Adjacent Landfills**

Map shows the 2 No. adjacent landfills in the Bohernabreena area.

Adjacent to the northern boundary of the Bohernabreena landfill site is an additional landfill, also named the Bohernabreena landfill S22-02767 - Bohernabreena Ref B 216 Class C (Low Risk). There is no information available on this site and it is not mapped in **Figure 2.2**.

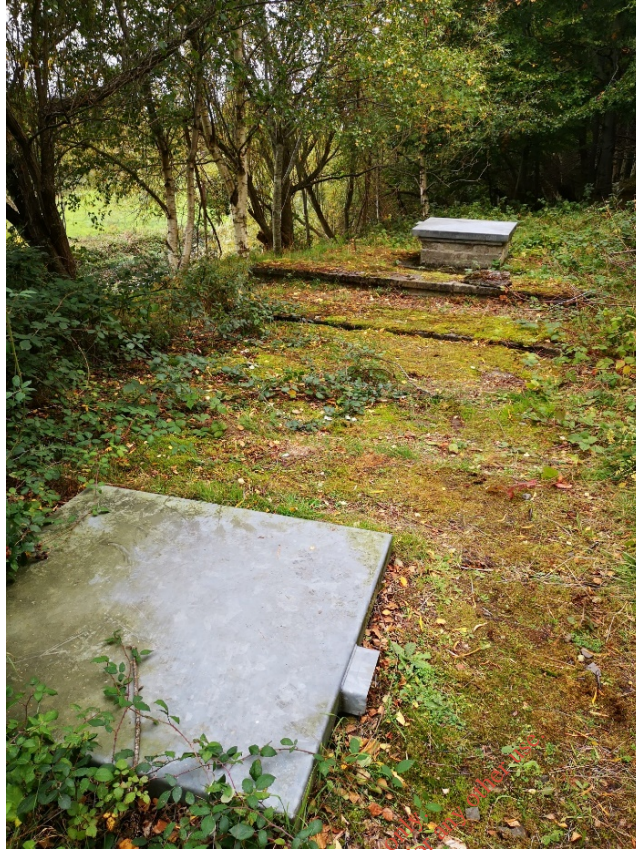
Plate 2.1 Friarstown Landfill Leachate Holding Tanks

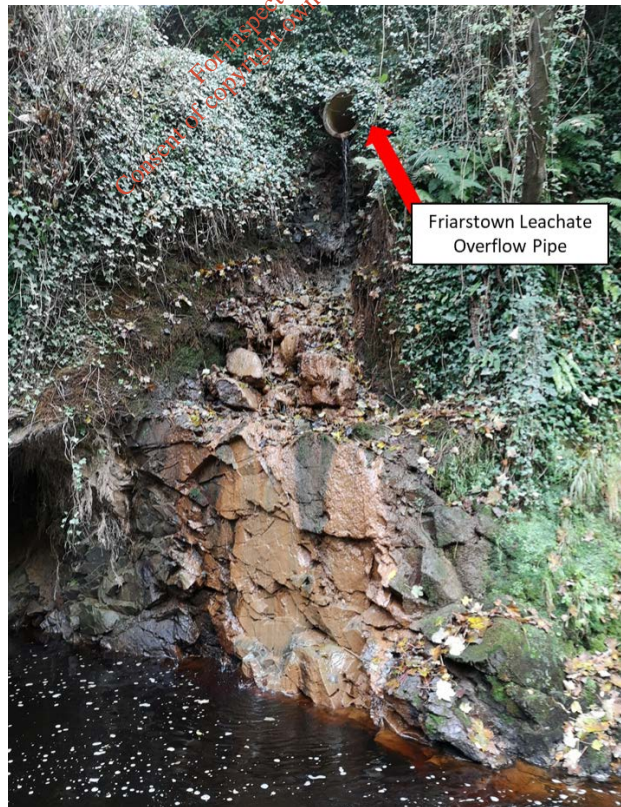
Plate 2-2 Friarstown leachate tank overflow pipe discharging into the River Dodder

It is also recommended that the Friarstown landfill overflow pipe is removed from flowing into the River Dodder.

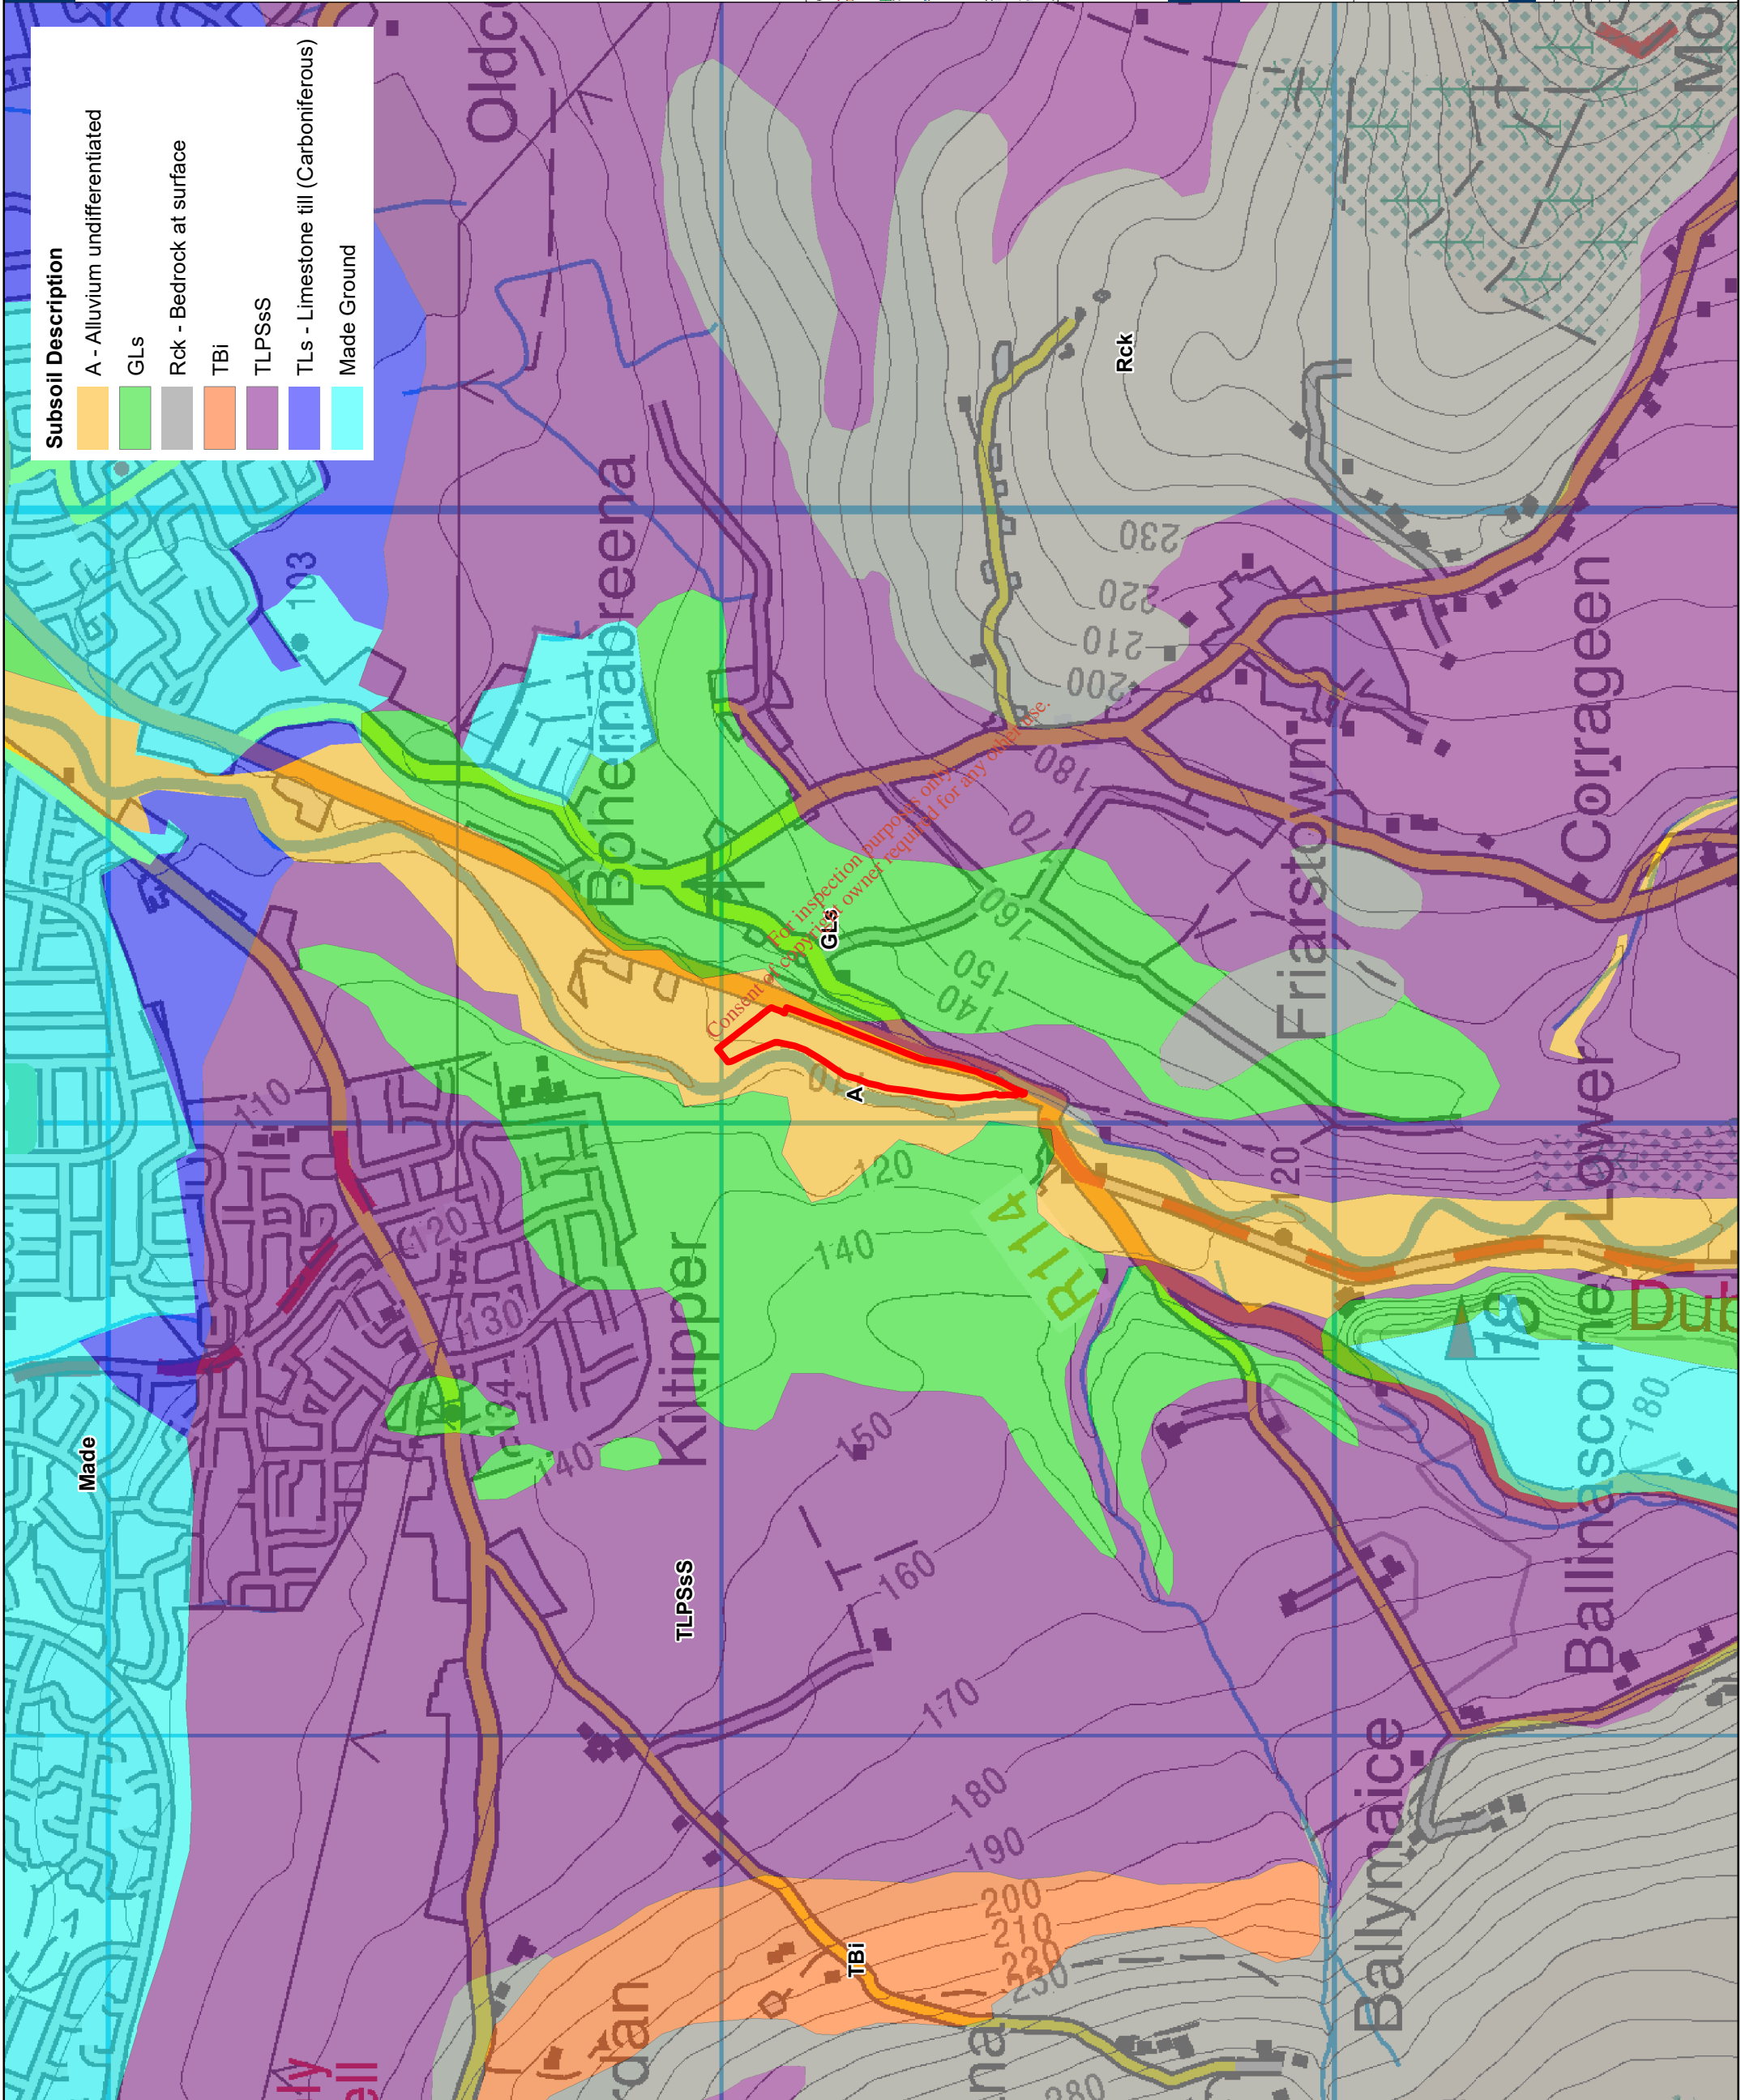
### Subsoil Description

- A - Alluvium undifferentiated
- GLs
- Rck - Bedrock at surface
- TBI
- TLPSSs
- TLs - Limestone till (Carboniferous)
- Made Ground
