2.4.3 Hydrogeology & Hydrology

Project Bohernabreena Landfill
Environmental Risk Assessment

2.5 TIER I – CONCEPTUAL SITE MODEL

3 TIER II EXPLORATORY AND MAIN PHASE

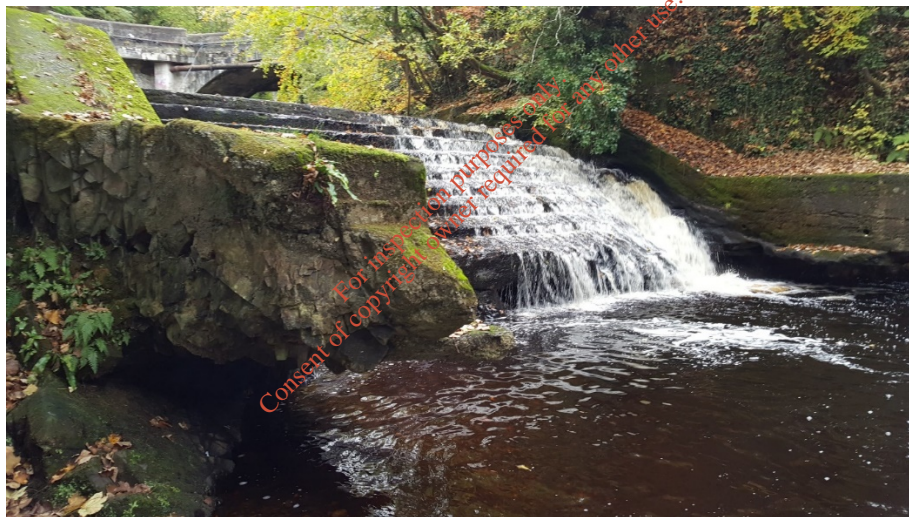
Plate 2.3 Bridge apron upgradient of the site

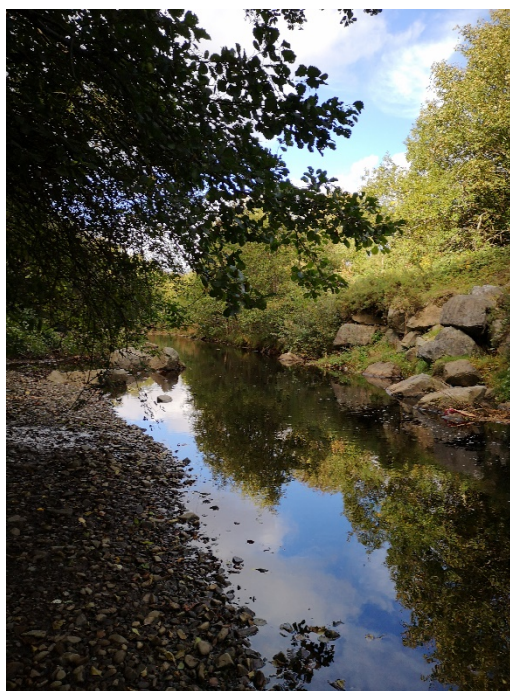
Plate 2.4 River armour along the site river bank
