Title: **Figure 3.3 SW Sampling Locations**

**Project:** Bohernabreena Landfill  
**Client:** South Dublin County Council

## 3.9 TIER II EXPLORATORY SITE INVESTIGATION RESULTS

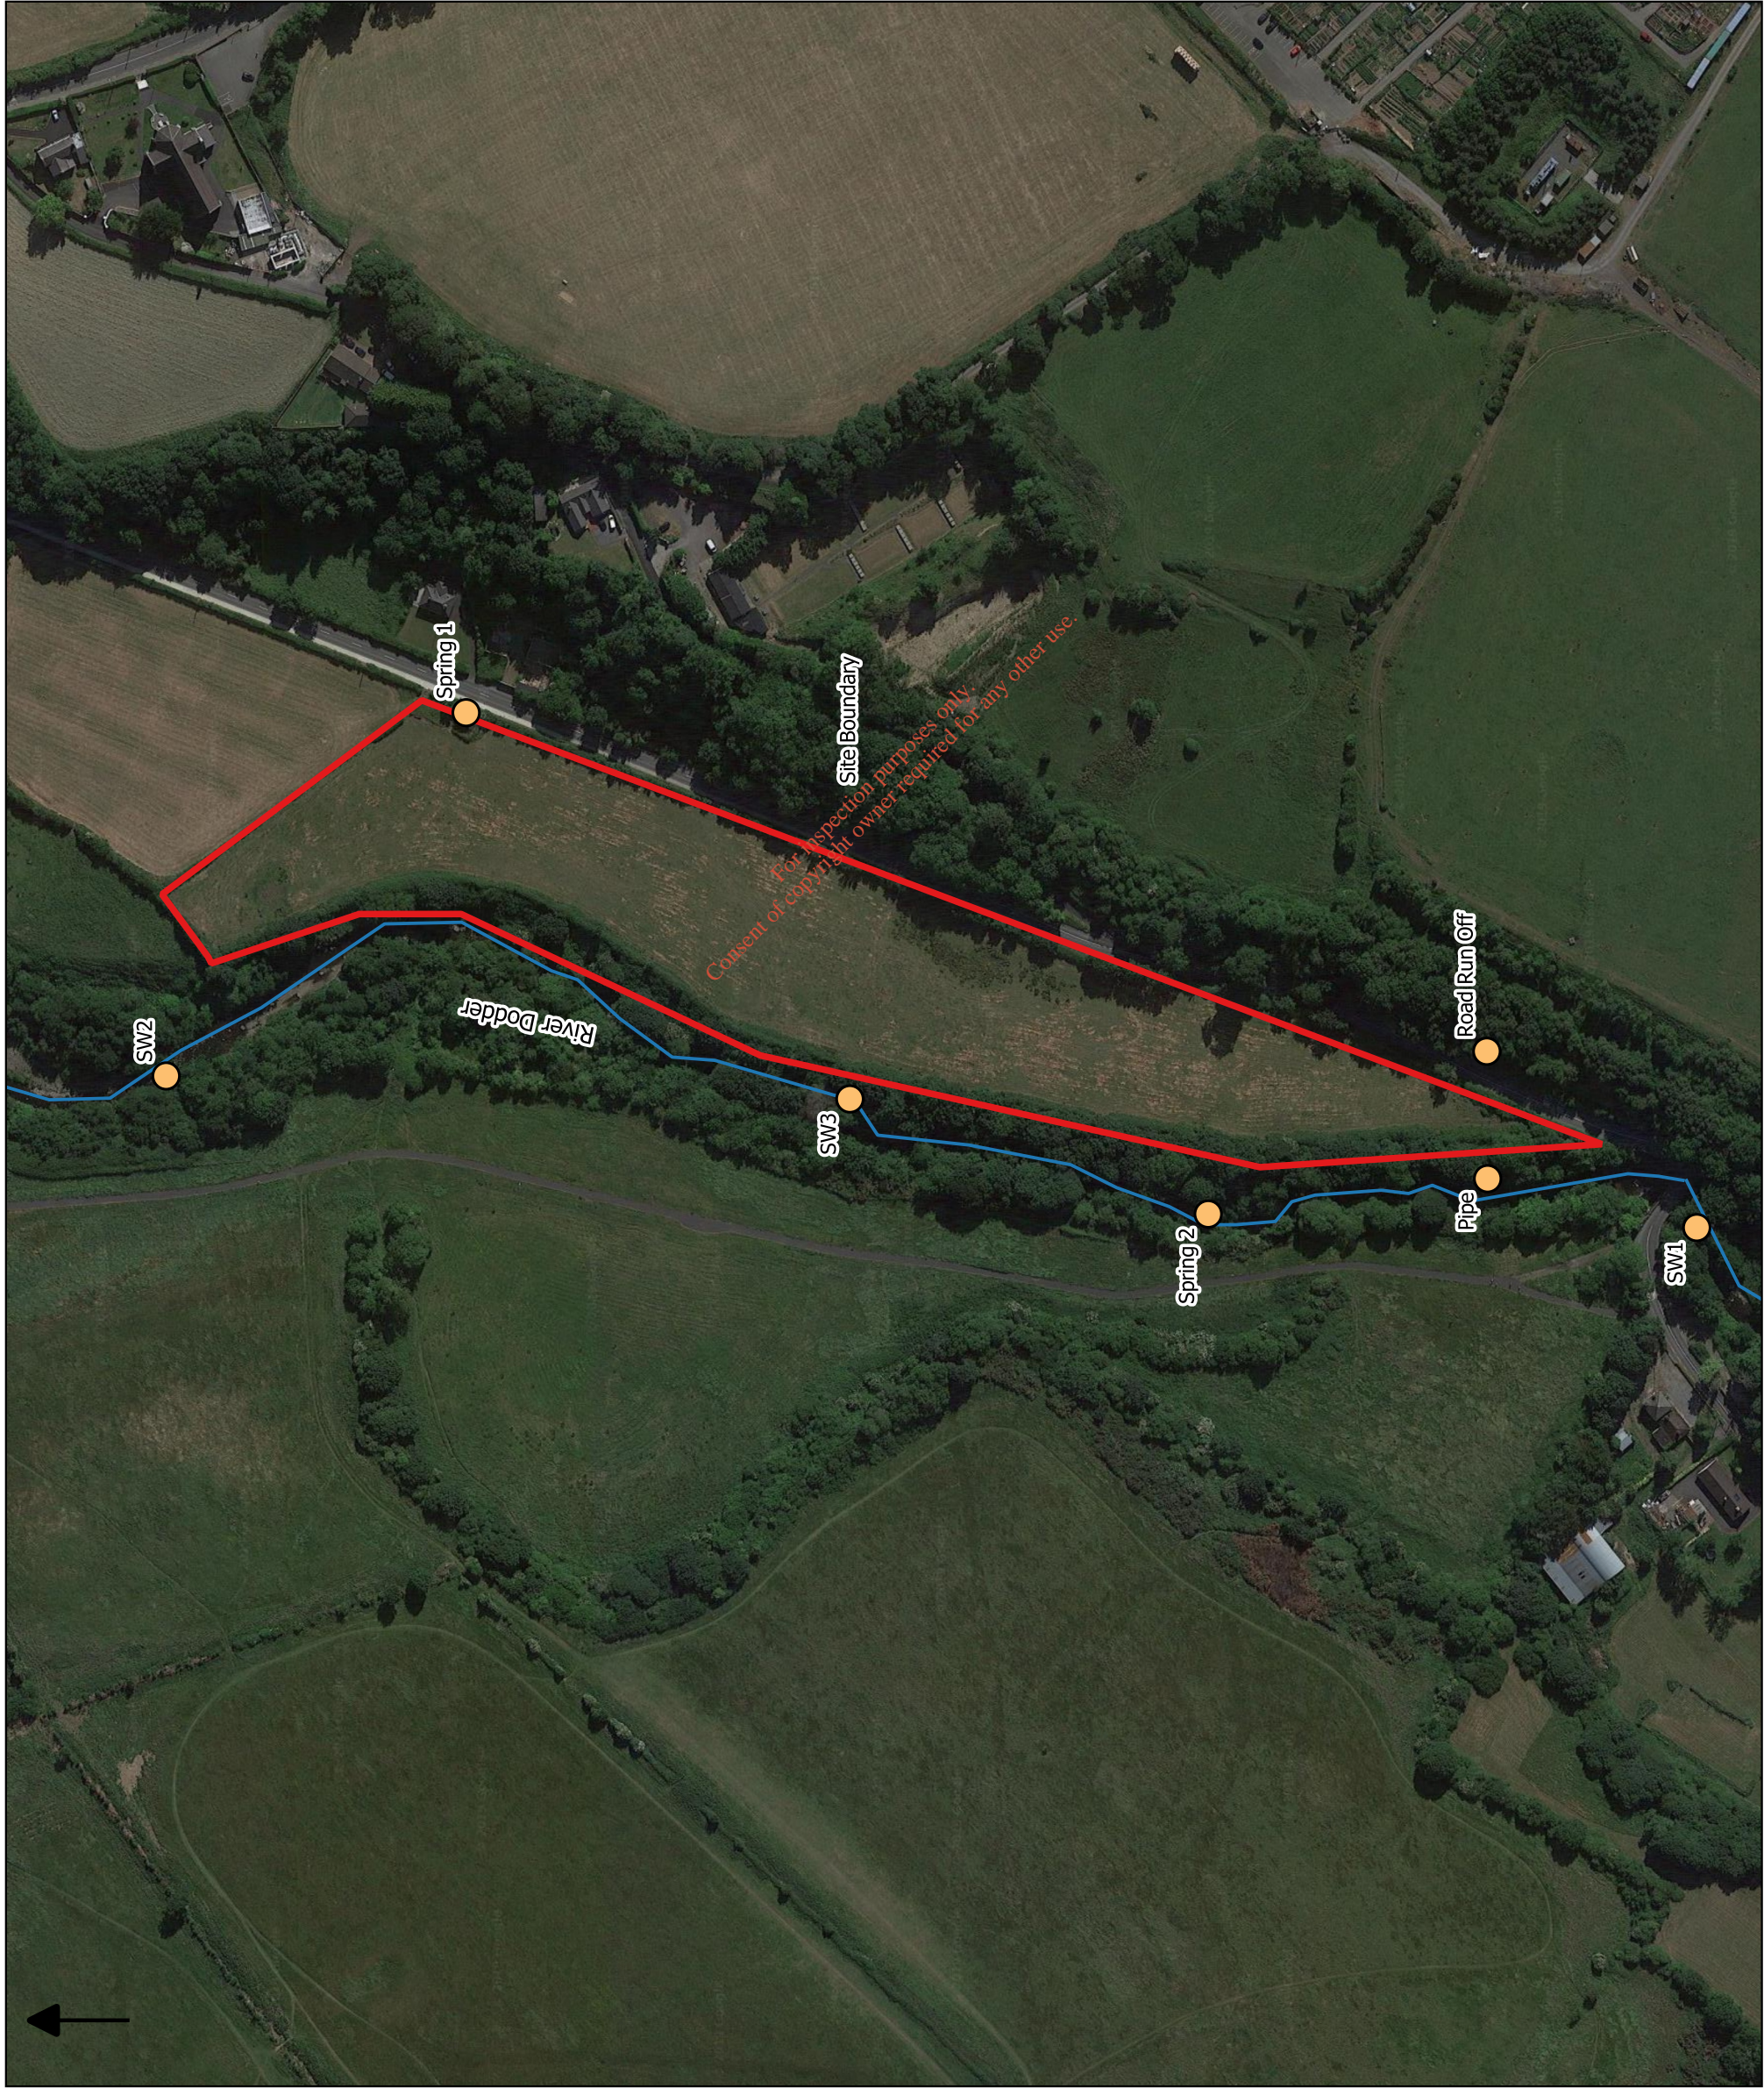
**Google Map**  
Map shows the locations for leachate sampling

- Surface water monitoring at the locations shown in **Figure 3.3** should be undertaken monthly during the capping works and quarterly thereafter for a period of five years.
- Groundwater monitoring at the locations shown in **Figure 3.2** should be undertaken annually for a period of five years.
- While landfill gas is considered a low risk on the site, this was based on monitoring within a limited time frame. It is recommended to take a conservative approach and carry out additional gas monitoring in accordance with industry best practice (EPA Landfill Manual) over a longer period to fully assess seasonal trends.

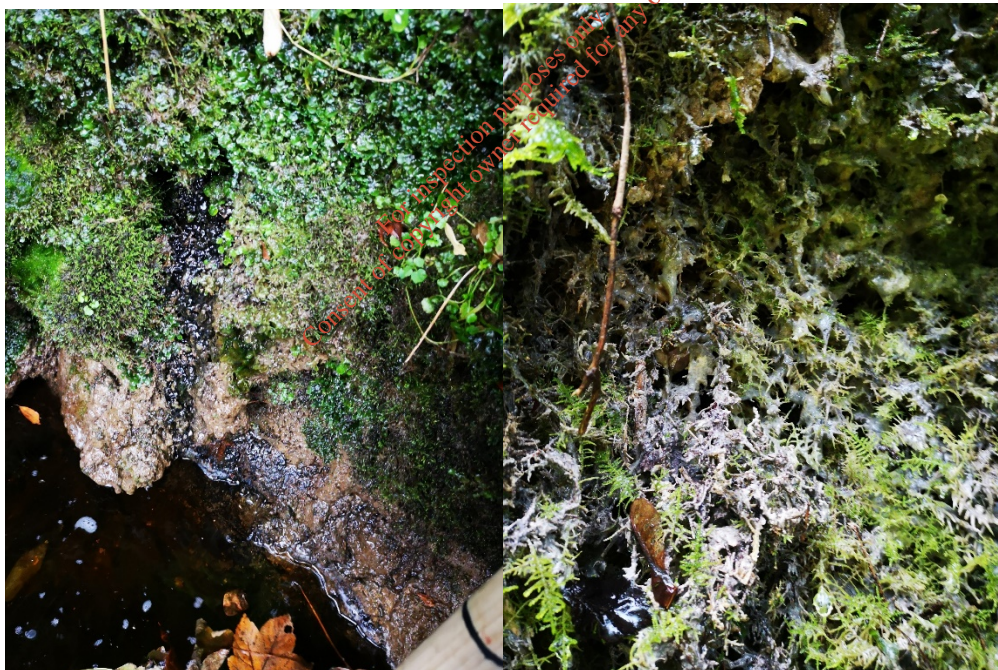
During a walkover along the River Dodder, tufa deposits were noted along both sides of the river banks, adjacent and downstream from the site boundary (**Plates 3.1**). General rubbish (plastic bottles, litter) was noted along the river.

**Plate 3.1** Tufa deposits along the River Dodder

There is also an observed localised impact on tufa and water quality of the springs identified on the area on the western boundary of the site.

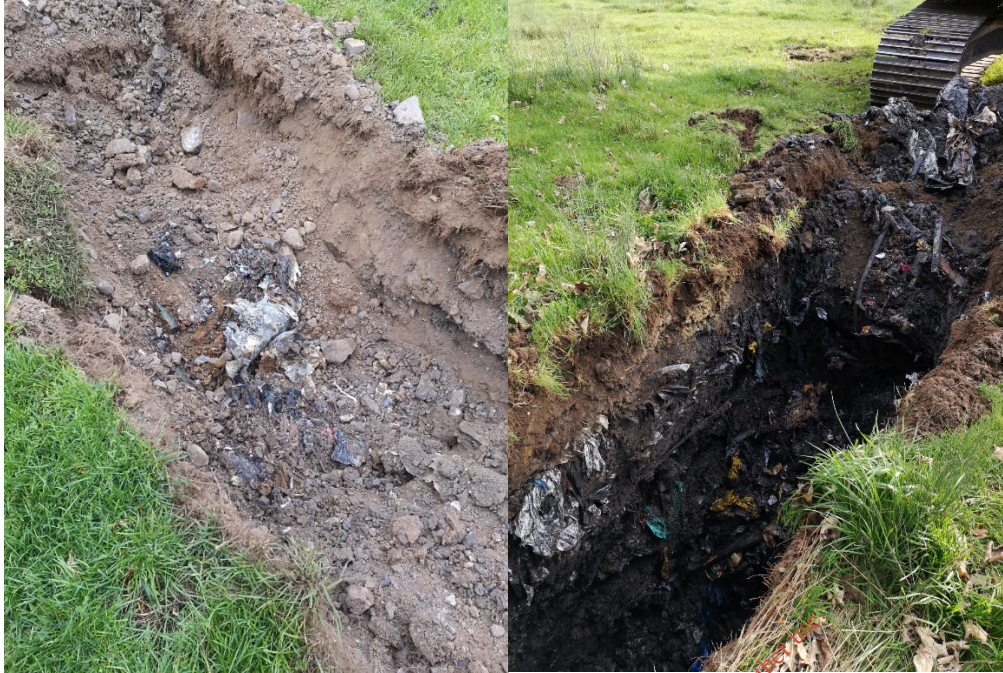
Trial pit observations detailing the subsurface conditions include the presence of any waste, superficial deposits are presented in **Table 3.3** with a series of photos in **Plates 3.2 and 3.3**. Detailed trial pit logs are presented in **Appendix F**. Grass and an overlying layer of topsoil (sandy silty clay) was encountered across the site. The depth of the topsoil varied from 0.2-1.0 mbgl. Underlying the topsoil

waste was encountered at all trial pit locations across the site. Bedrock was not encountered at any location.

**Plate 3.2 Trial Pit excavation**

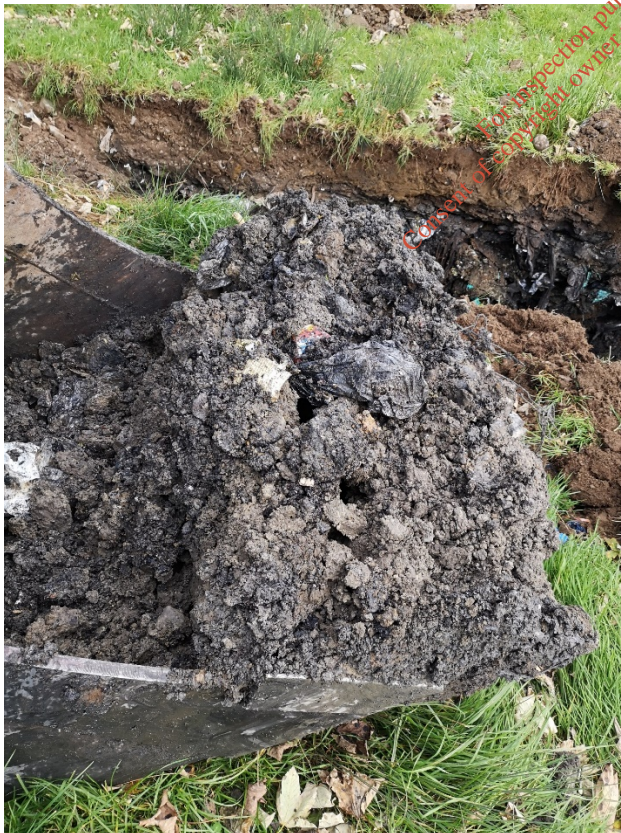
**Plate 3.3 Trial Pit material extracted**

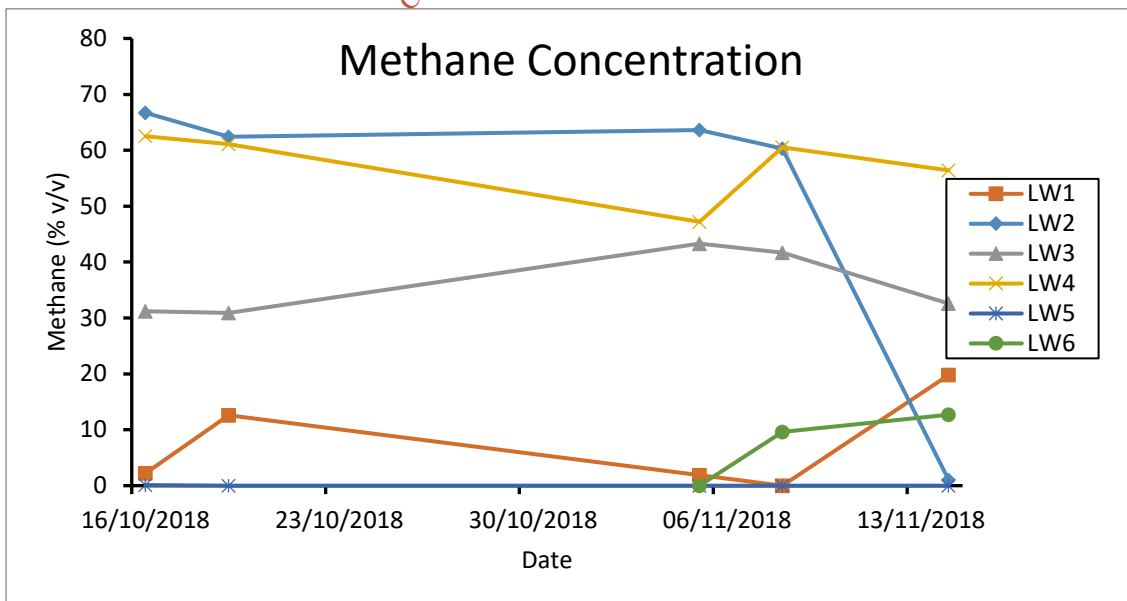
Methane concentrations recorded within gas/leachate monitoring boreholes located within the waste body ranging from 0.0% v/v – 19.8% v/v (LW1), 1.0% v/v – 66.7% v/v (LW2), 30.9% v/v – 43.3% v/v (LW3), 47.2% v/v – 62.5% v/v (LW4), 0.0% v/v – 0.1% v/v (LW5) and 0.0% v/v – 12.7% v/v (LW6). Methane concentrations are presented in **Figure 3.7**.

**Figure 3.7 Methane Concentrations within the Waste Body**

- Elevated levels of concentrations of methane and carbon dioxide (the principal landfill gases) were observed across the site, with the highest concentrations localised to within the centre of the landfill waste body. Gas flow rates are used to predict surface emissions and can refer to either the volume of gas being emitted from a monitoring well per unit time or the rate of movement of gas through permeable strata. Given the age of the landfill, the composition and the levels of landfill gas with no measurable flow, it would be considered that the landfill is within Phase IV, anaerobic. The risk from landfill gas is considered low.

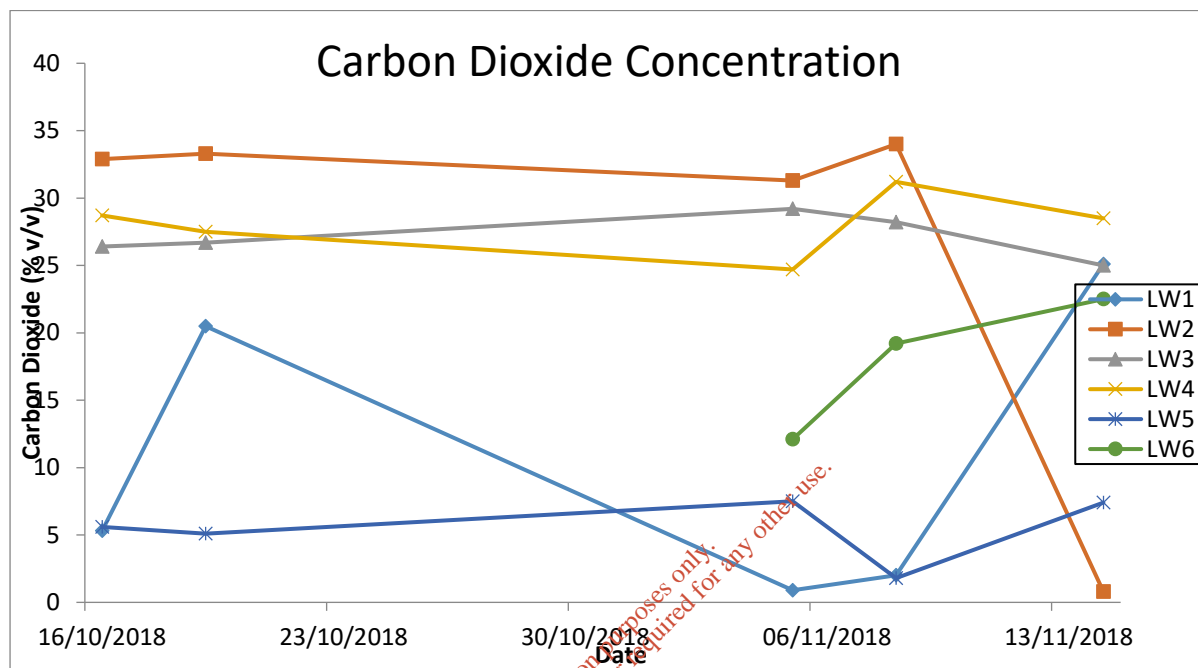
Carbon dioxide concentrations were recorded within all gas/leachate monitoring boreholes within the waste body ranging from 0.9% v/v – 25.1% v/v (LW1), 0.8% v/v – 34.0% v/v (LW2), 25.0% v/v – 29.2% v/v (LW3), 24.7% v/v – 31.2% v/v (LW4), 1.8% v/v – 7.5% v/v (LW5) and 12.1% v/v – 22.5% v/v (LW6) as shown in **Table 3.13** and **Figure 3.8**.

Figure 3.8 Carbon Dioxide concentration within the Waste Body

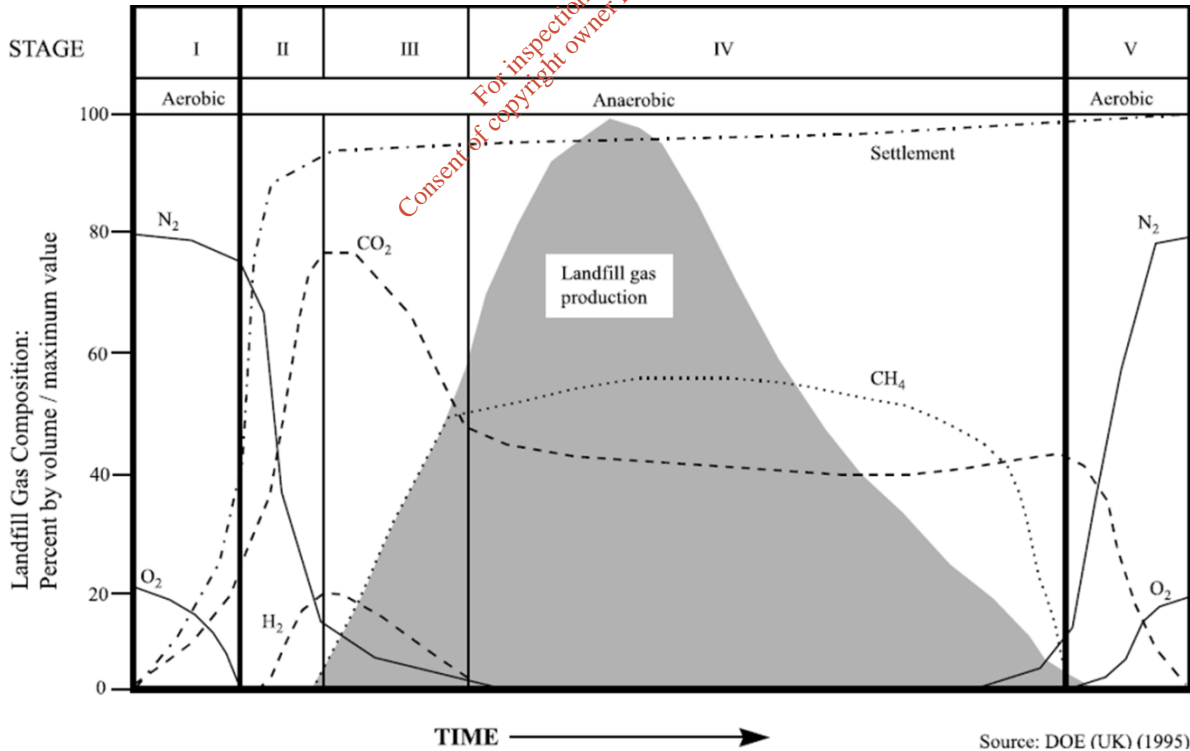
Based on the EPA Landfill Manual, Landfill Operational Practices, 1997, gas production is divided into four phases as shown in **Figure 3.9**. Phase I is aerobic with Phases II – IV anaerobic. Based on the low flow and the ratio of methane to carbon dioxide concentrations monitored within the wells it would suggest that gas production is in the later stages of degradation and in line with late stage Phase IV. The lack of an engineered cap has resulted in gas being able to migrate to the atmosphere.

Little or no flow indicates that the waste body is not actively producing landfill gas. This is due to the biodegradable component of the waste having been degraded. Therefore, there is not an active source of landfill gas.

**Figure 3.9 Development of Landfill Gas Progression (Source: EPA Landfill Manual, Landfill Operational Practices, 1997)**
