**UPDATED TIER 2 AND TIER 3**

**ENVIRONMENTAL RISK ASSESSMENT**

**FORMER MUNICIPAL LANDFILL**

**CASTLEREA,**

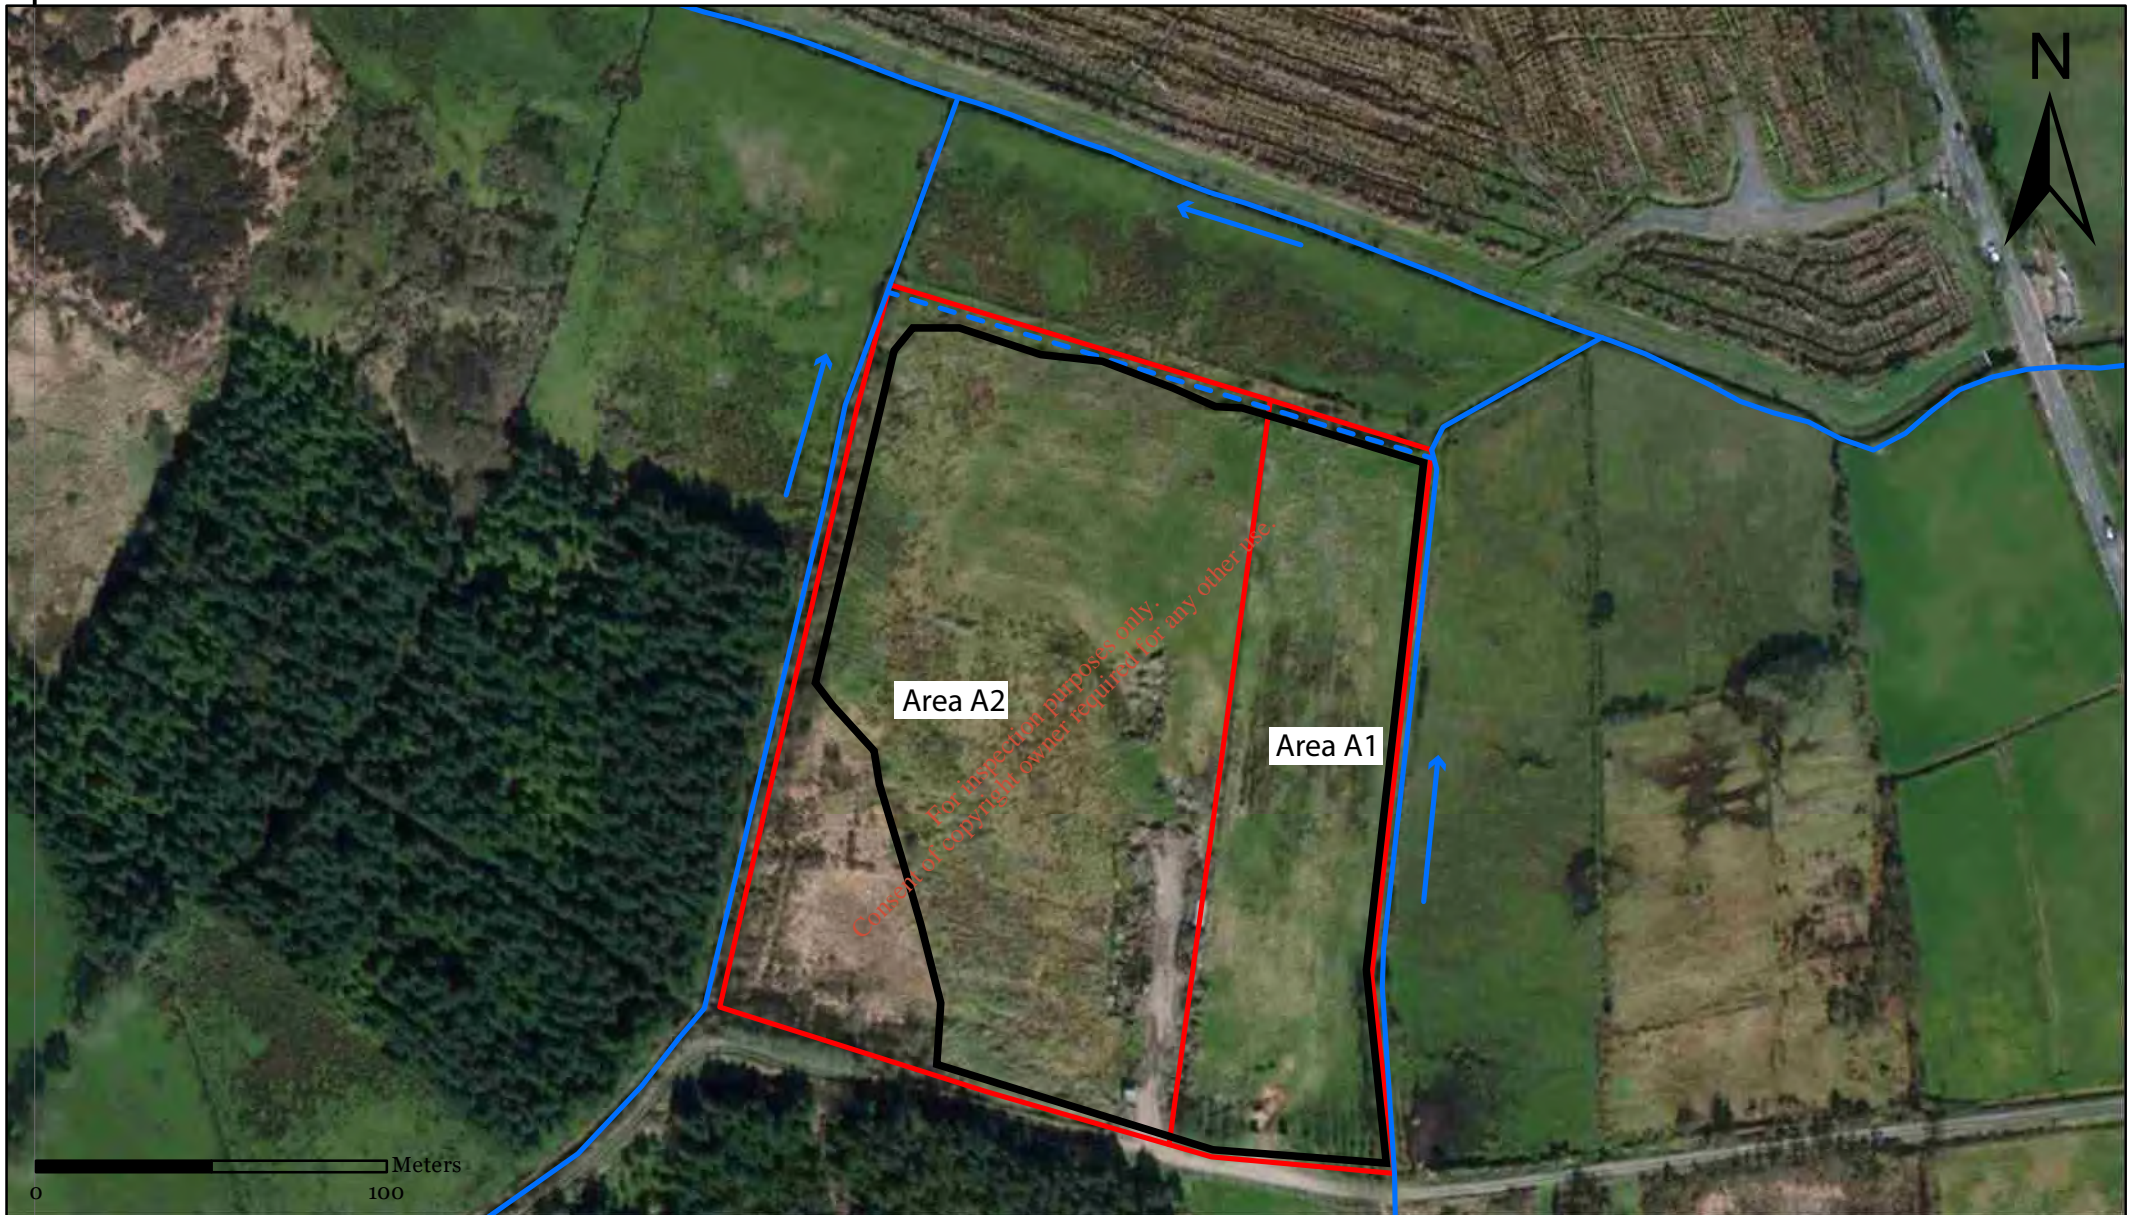
Figure 2.2

<p>O'Callaghan Moran &amp; Associates, Unit 15 Melbourne Business Park, Model Farm Road, Cork. Tel. (021) 4345366 email: info@ocallaghanmoran.com</p>	<p>CLIENT</p> <p>Roscommon County Council</p>	<p>Details:</p> <ul style="list-style-type: none"> <li><span style="color: red;">—</span> Site Boundary</li> <li><span style="color: black;">—</span> Extent of Infilled Area</li> <li><span style="color: blue;">—</span> Streams/drains</li> <li><span style="color: blue;">- -</span> Overgrown drain</li> </ul>
	<p>TITLE</p> <p>Site Layout</p>

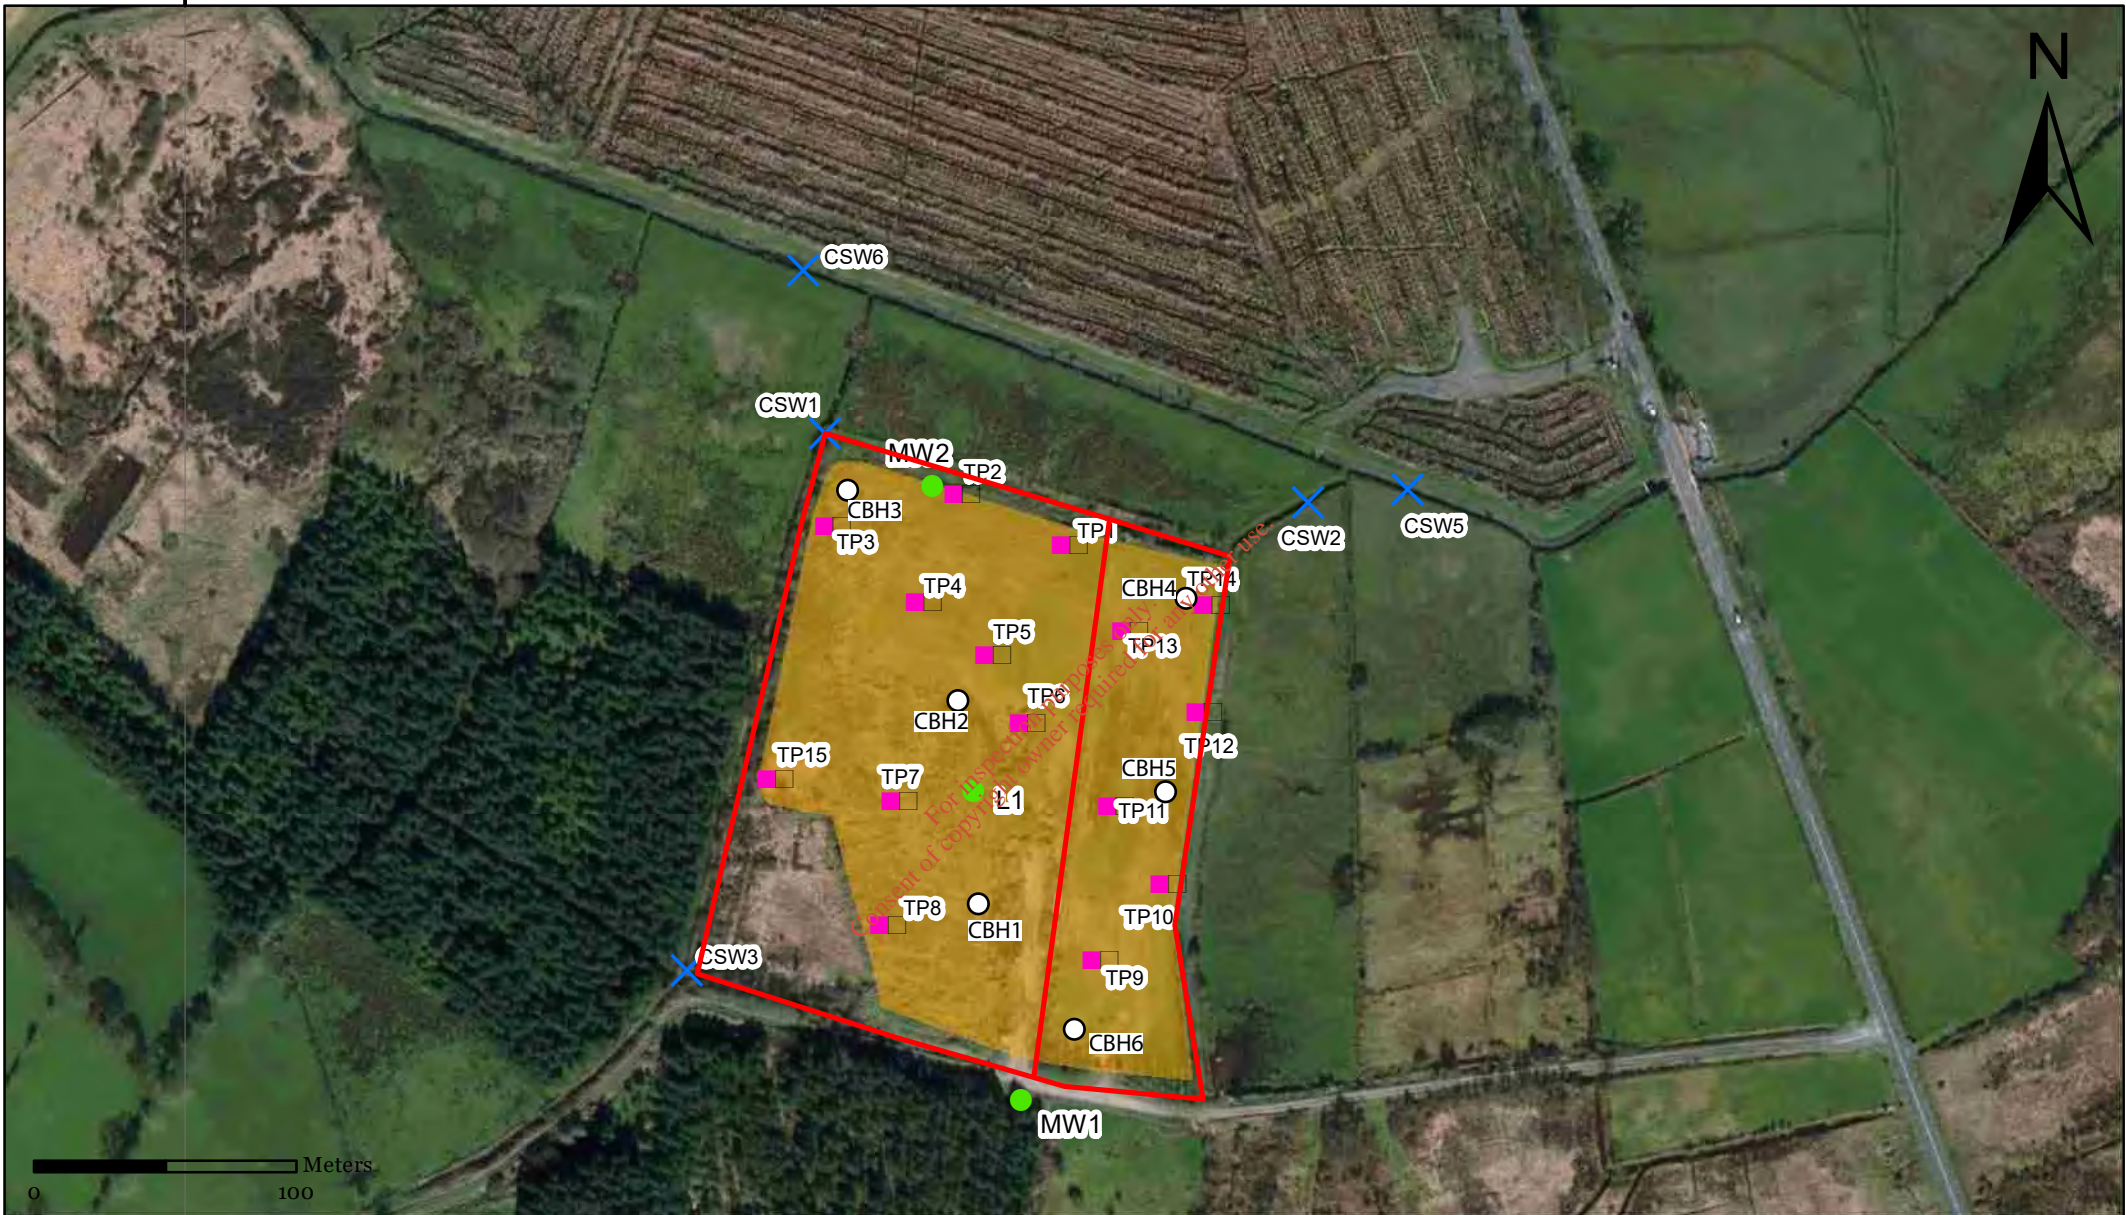
The locations of the OCM site investigation trial pits, monitoring wells and surface water sampling points are also shown on Figure 3.1.

OCM excavated 14 trial pits in 2017 to establish the lateral extent of the waste and the thickness of the capping layer. The trial pits were logged by an OCM Environmental Scientist who logged the pits in accordance with BS5930. The trial pit logs are in Appendix 4. The 2017 investigation confirmed that the waste body extends over the entire footprint of Area A1. The final extent of the waste body in Area A2 was found to extend beyond the boundary defined in the 1999 investigation and it covers c. 1.8 ha (Figure 3.1).

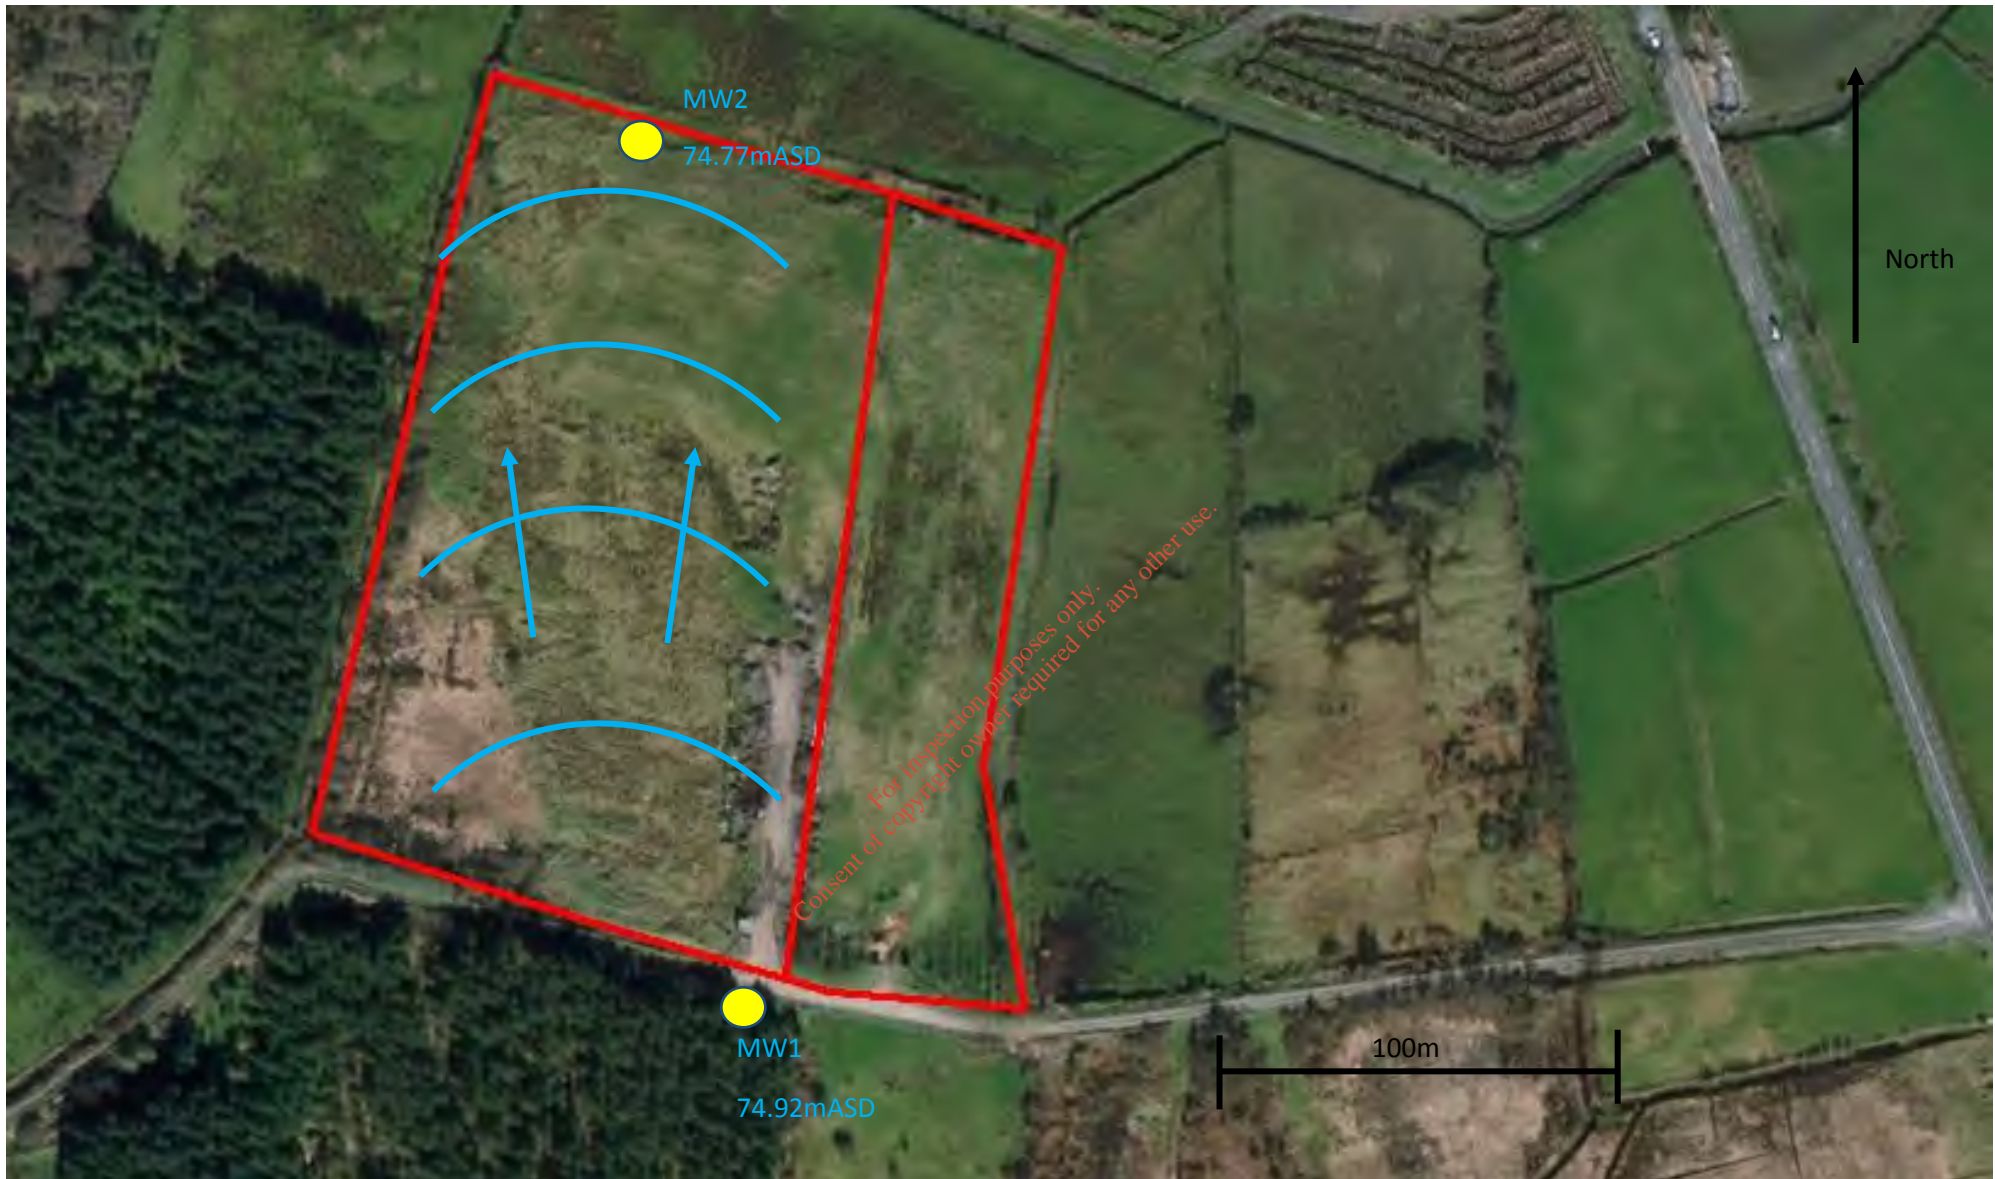
<p>O'Callaghan Moran &amp; Associates Unit 15 Melbourne Business Park, Model Farm Road, Cork. Tel. (021) 4345366</p>	<p><b>Title:</b></p> <p>Figure 4.1 Groundwater Contours</p>	<p><b>Legend</b></p> <p>
