SOIL WATER BASELINE REPORT FOR AMENDMENT OF SITE BOUNDARY FOR IE LICENCE P1011-01

TOM ROES POINT PORT TERMINAL

AOT/19/10737/R01

25th July 2019

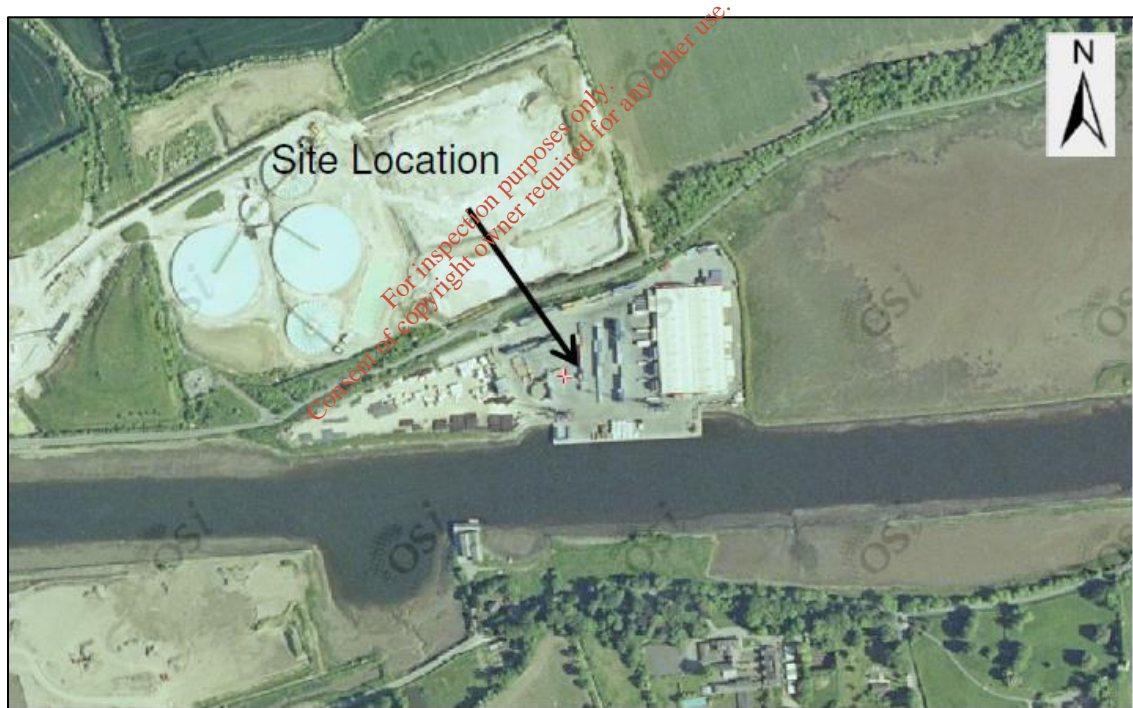
Figure 5.1 OSi Aerial Image (2005) (source www.osi.ie)

Aerial Imagery from the Ordnance Survey Ireland (OSi) from 2005 (Figure 5.1) and historic maps from 1830 and 1990 of the Port site at TRP (Figure 5.2) were analysed. The historical maps from 1830 and 1990, highlight that the entire port site used to comprise large mud flats between the low and high water mark along the Boyne River.

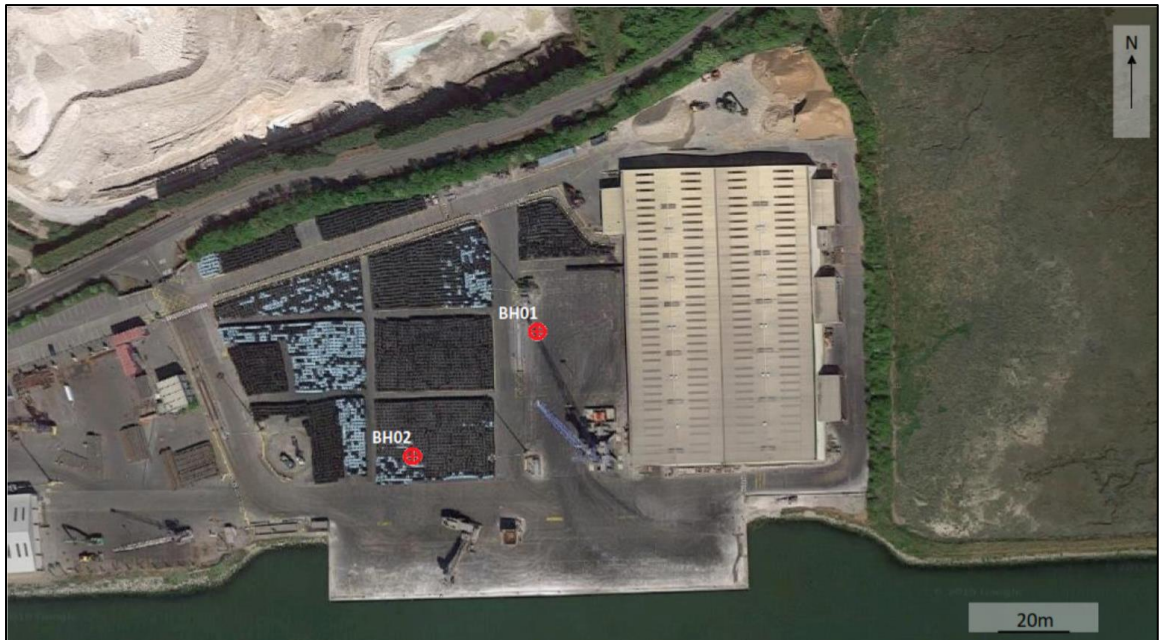
Figure 6.8 Exploratory Borehole Locations at TRP in 2019

A site investigation completed in May 2019 involved the drilling of 2 no. boreholes on the site at TRP (see Section 8.0) i.e. 1 no. location (BH01) in an area which will remain within the IE licensed boundary and 1 no. location (BH02) which will be removed from the site and will therefore be outside the IE licensed boundary. Figure 6.8 below presents the locations of these boreholes.

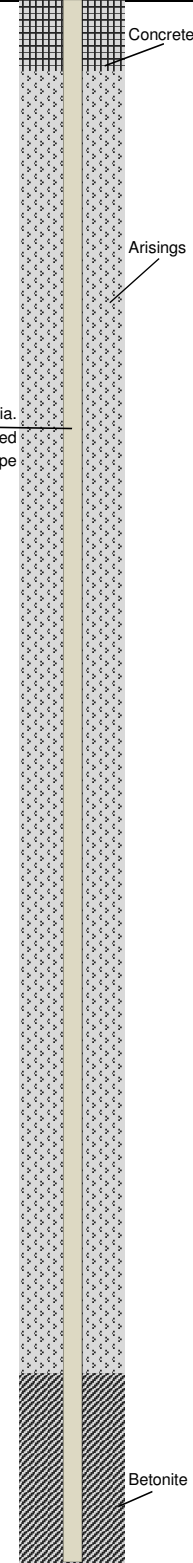
0.1	Concrete (MADE GROUND)

0.3		0.26 (3.70)			
0.5	Brown/grey slightly clayey, sandy Gravel FILL (MADE GROUND)				
0.7	Detail : Dry, NEC				
0.9

1.1		1.00 (2.96)	(1.0, 0.0)		
1.3	(Soft) Dark brown slightly sandy gravelly CLAY.				
1.5	Gravel is angular to subrounded fine to coarse (possible MADE GROUND)
