TIER 2 RISK ASSESSMENT

HISTORIC LANDFILL AT KILLYCRONAGHAN LANDFILL, CO. MONAGHAN

SEPTEMBER 2019

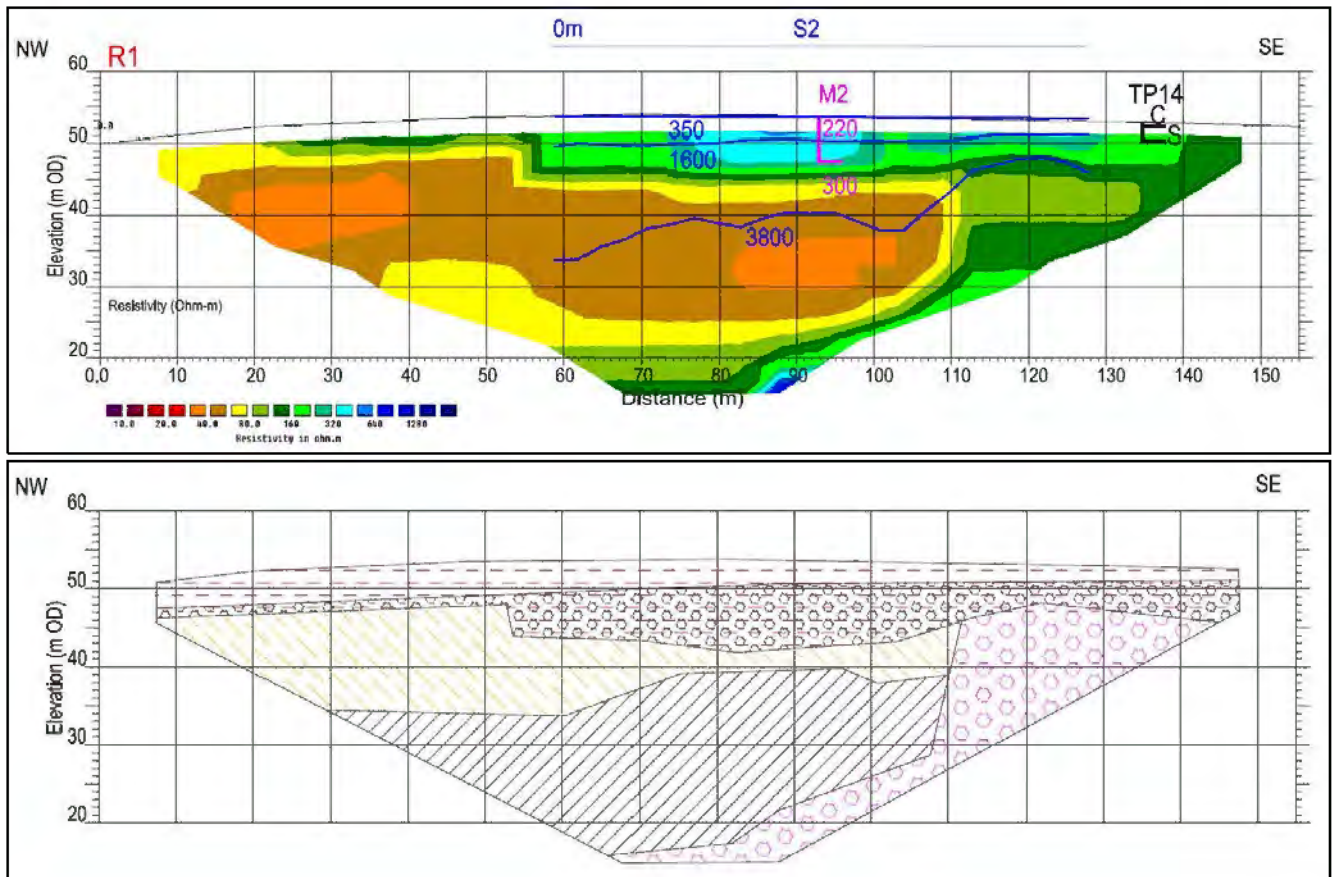
Figure 3-4: ERT Profile R1 Interpreted Cross Section

The modelled profiles and geophysical interpretations are presented in Figure 3.4 to Figure 3.12.

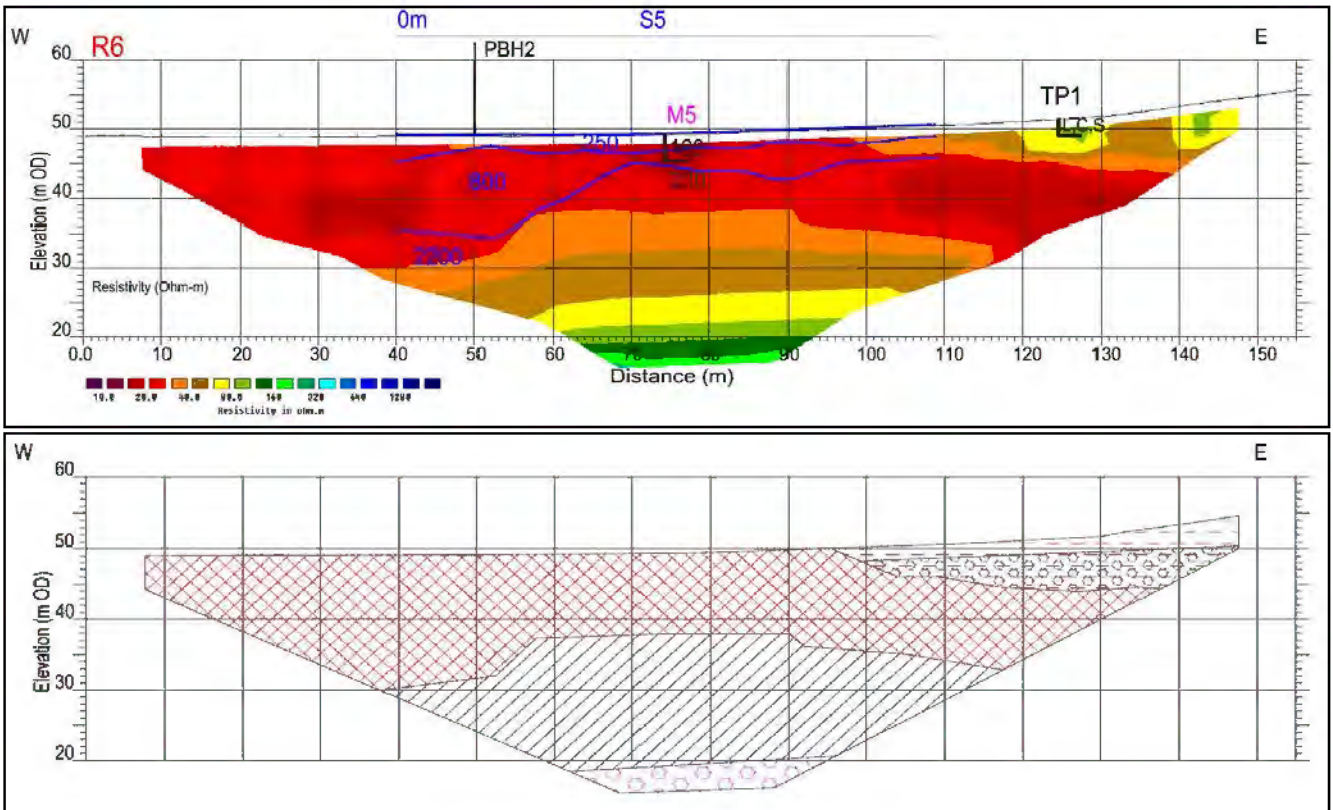
Figure 3-9: ERT Profile R6 Interpreted Cross Section

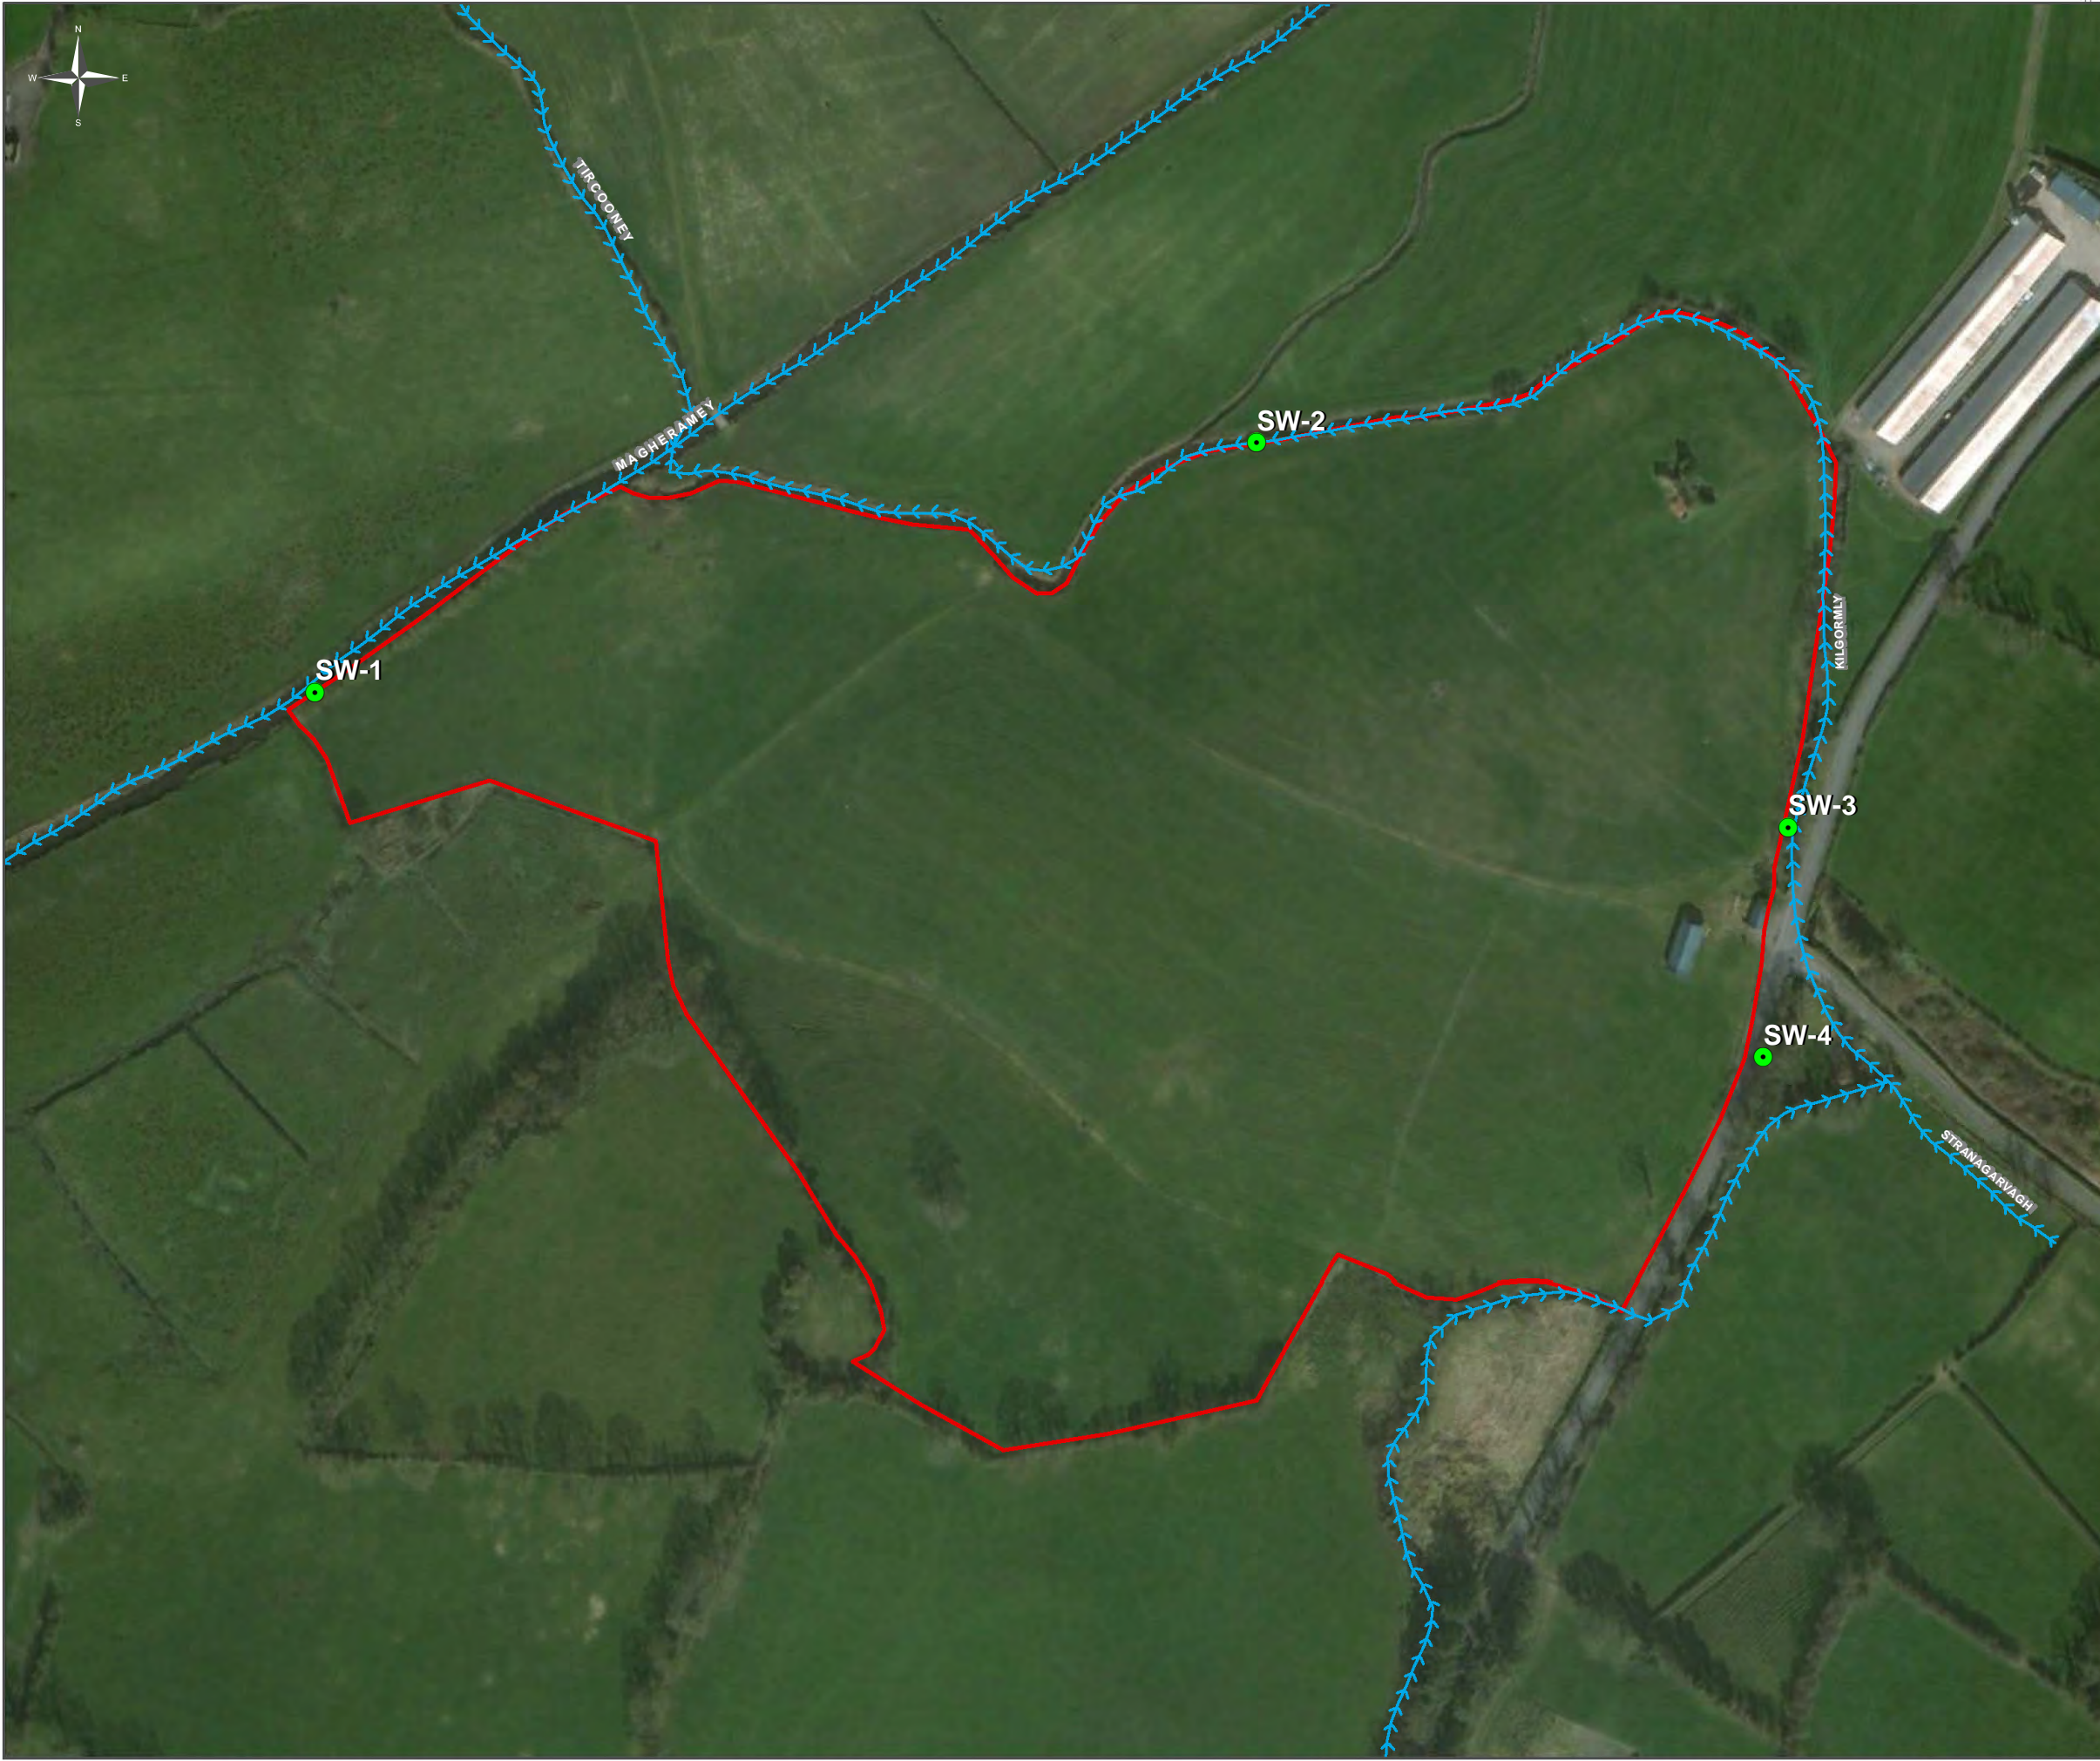
- Surface Water Sampling Locations
- Rivers
- Site Boundary

The results of the surface water monitoring from SW1 – SW4 show 1 No. exceedances of the EQS (2009) guideline limit values for ammonia. Results from sampling location SW1 detected an ammonia concentration of 0.258 mg/l. The presence of ammonia at these levels may be an indication of slurry spreading runoff from the surrounding agricultural fields in the area, rather than direct impact from the landfill.
