Figure Title	Groundwater Flow Direction
Figure No.	4.1
Project	ERA of Historic Landfill at Killycard, Co. Monaghan
Client	Monaghan County Council
Scale	1:1,500
Page Size	A3
Revision	A
Date	09/11/2018

**FIGURE 5.1 KILLYCARD HISTORIC LANDFILL
CONCEPTUAL SITE MODEL**

HISTORIC LANDFILL AT KILLYCARD LANDFILL CO. MONAGHAN

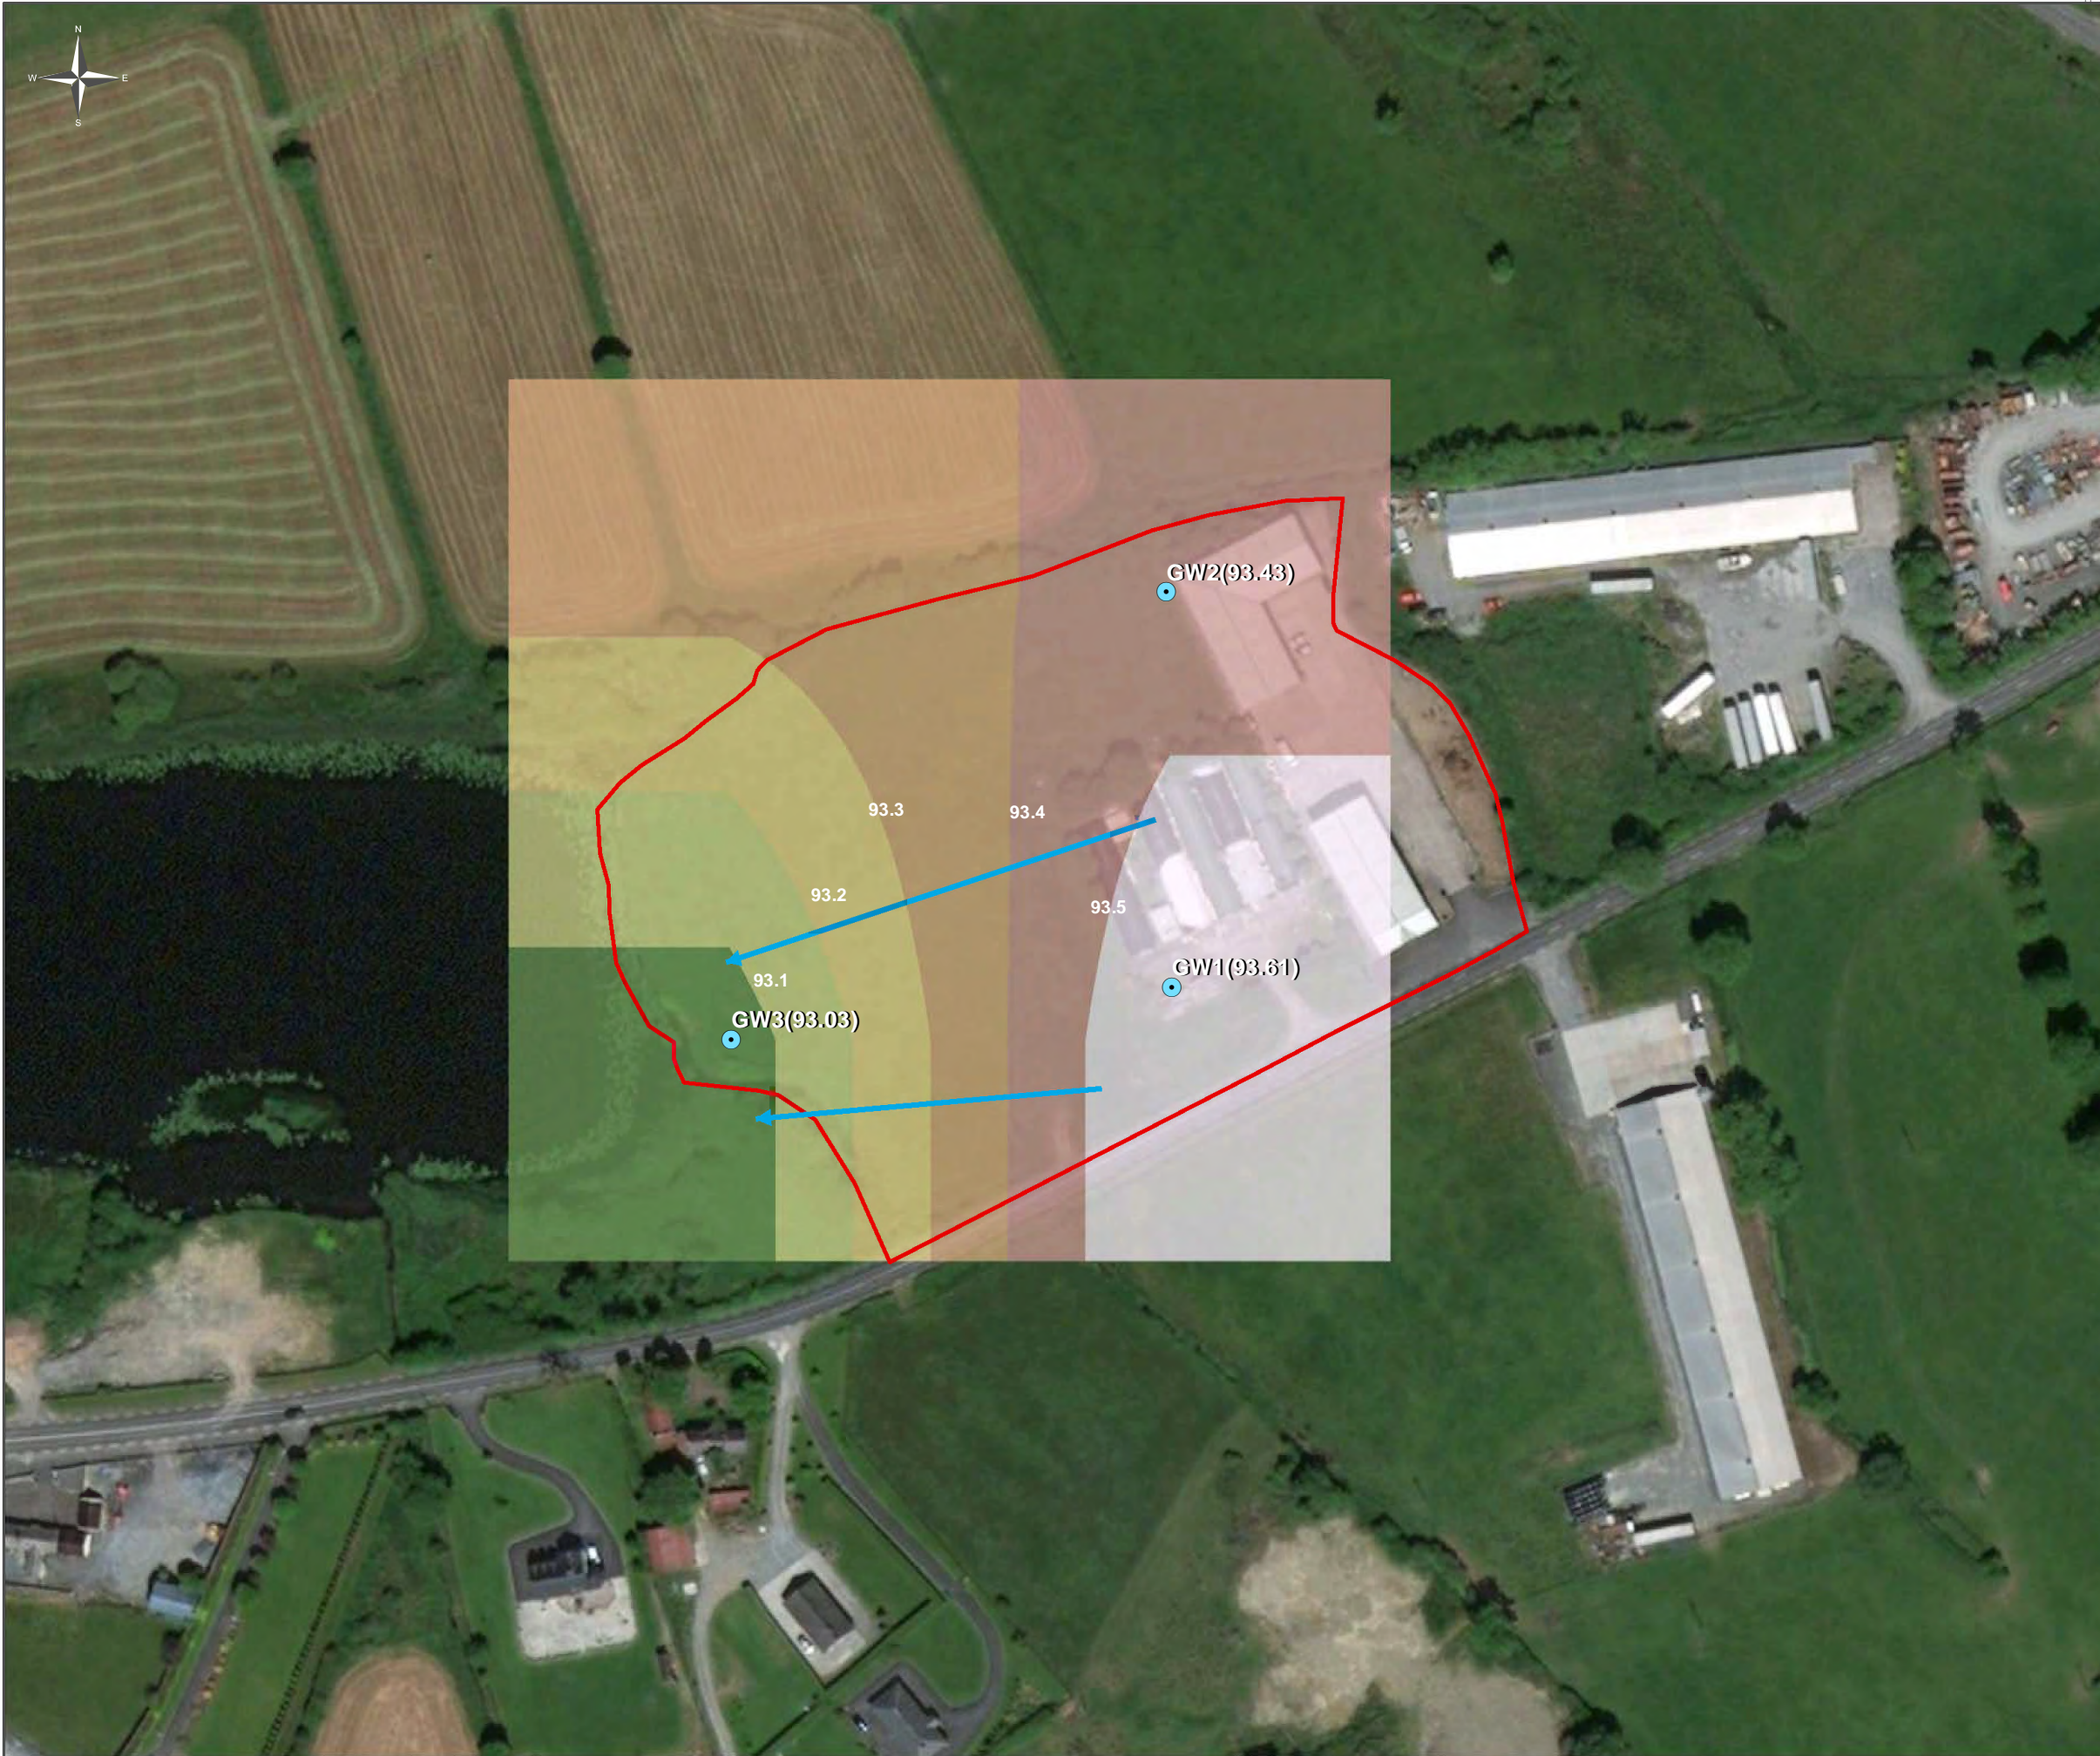
Based on the above field survey measurements, the groundwater flow direction is assumed to be west-south-west. A potentiometric map illustrating the hydraulic gradient and the direction of groundwater flow is presented in Figure 4.1.

The location of the groundwater boreholes installed at the site were based on the anticipated groundwater flow direction. The potentiometric mapping indicates the likely groundwater flow direction is west to south-west.

GW03 is located to the west of the waste mass i.e. downgradient.

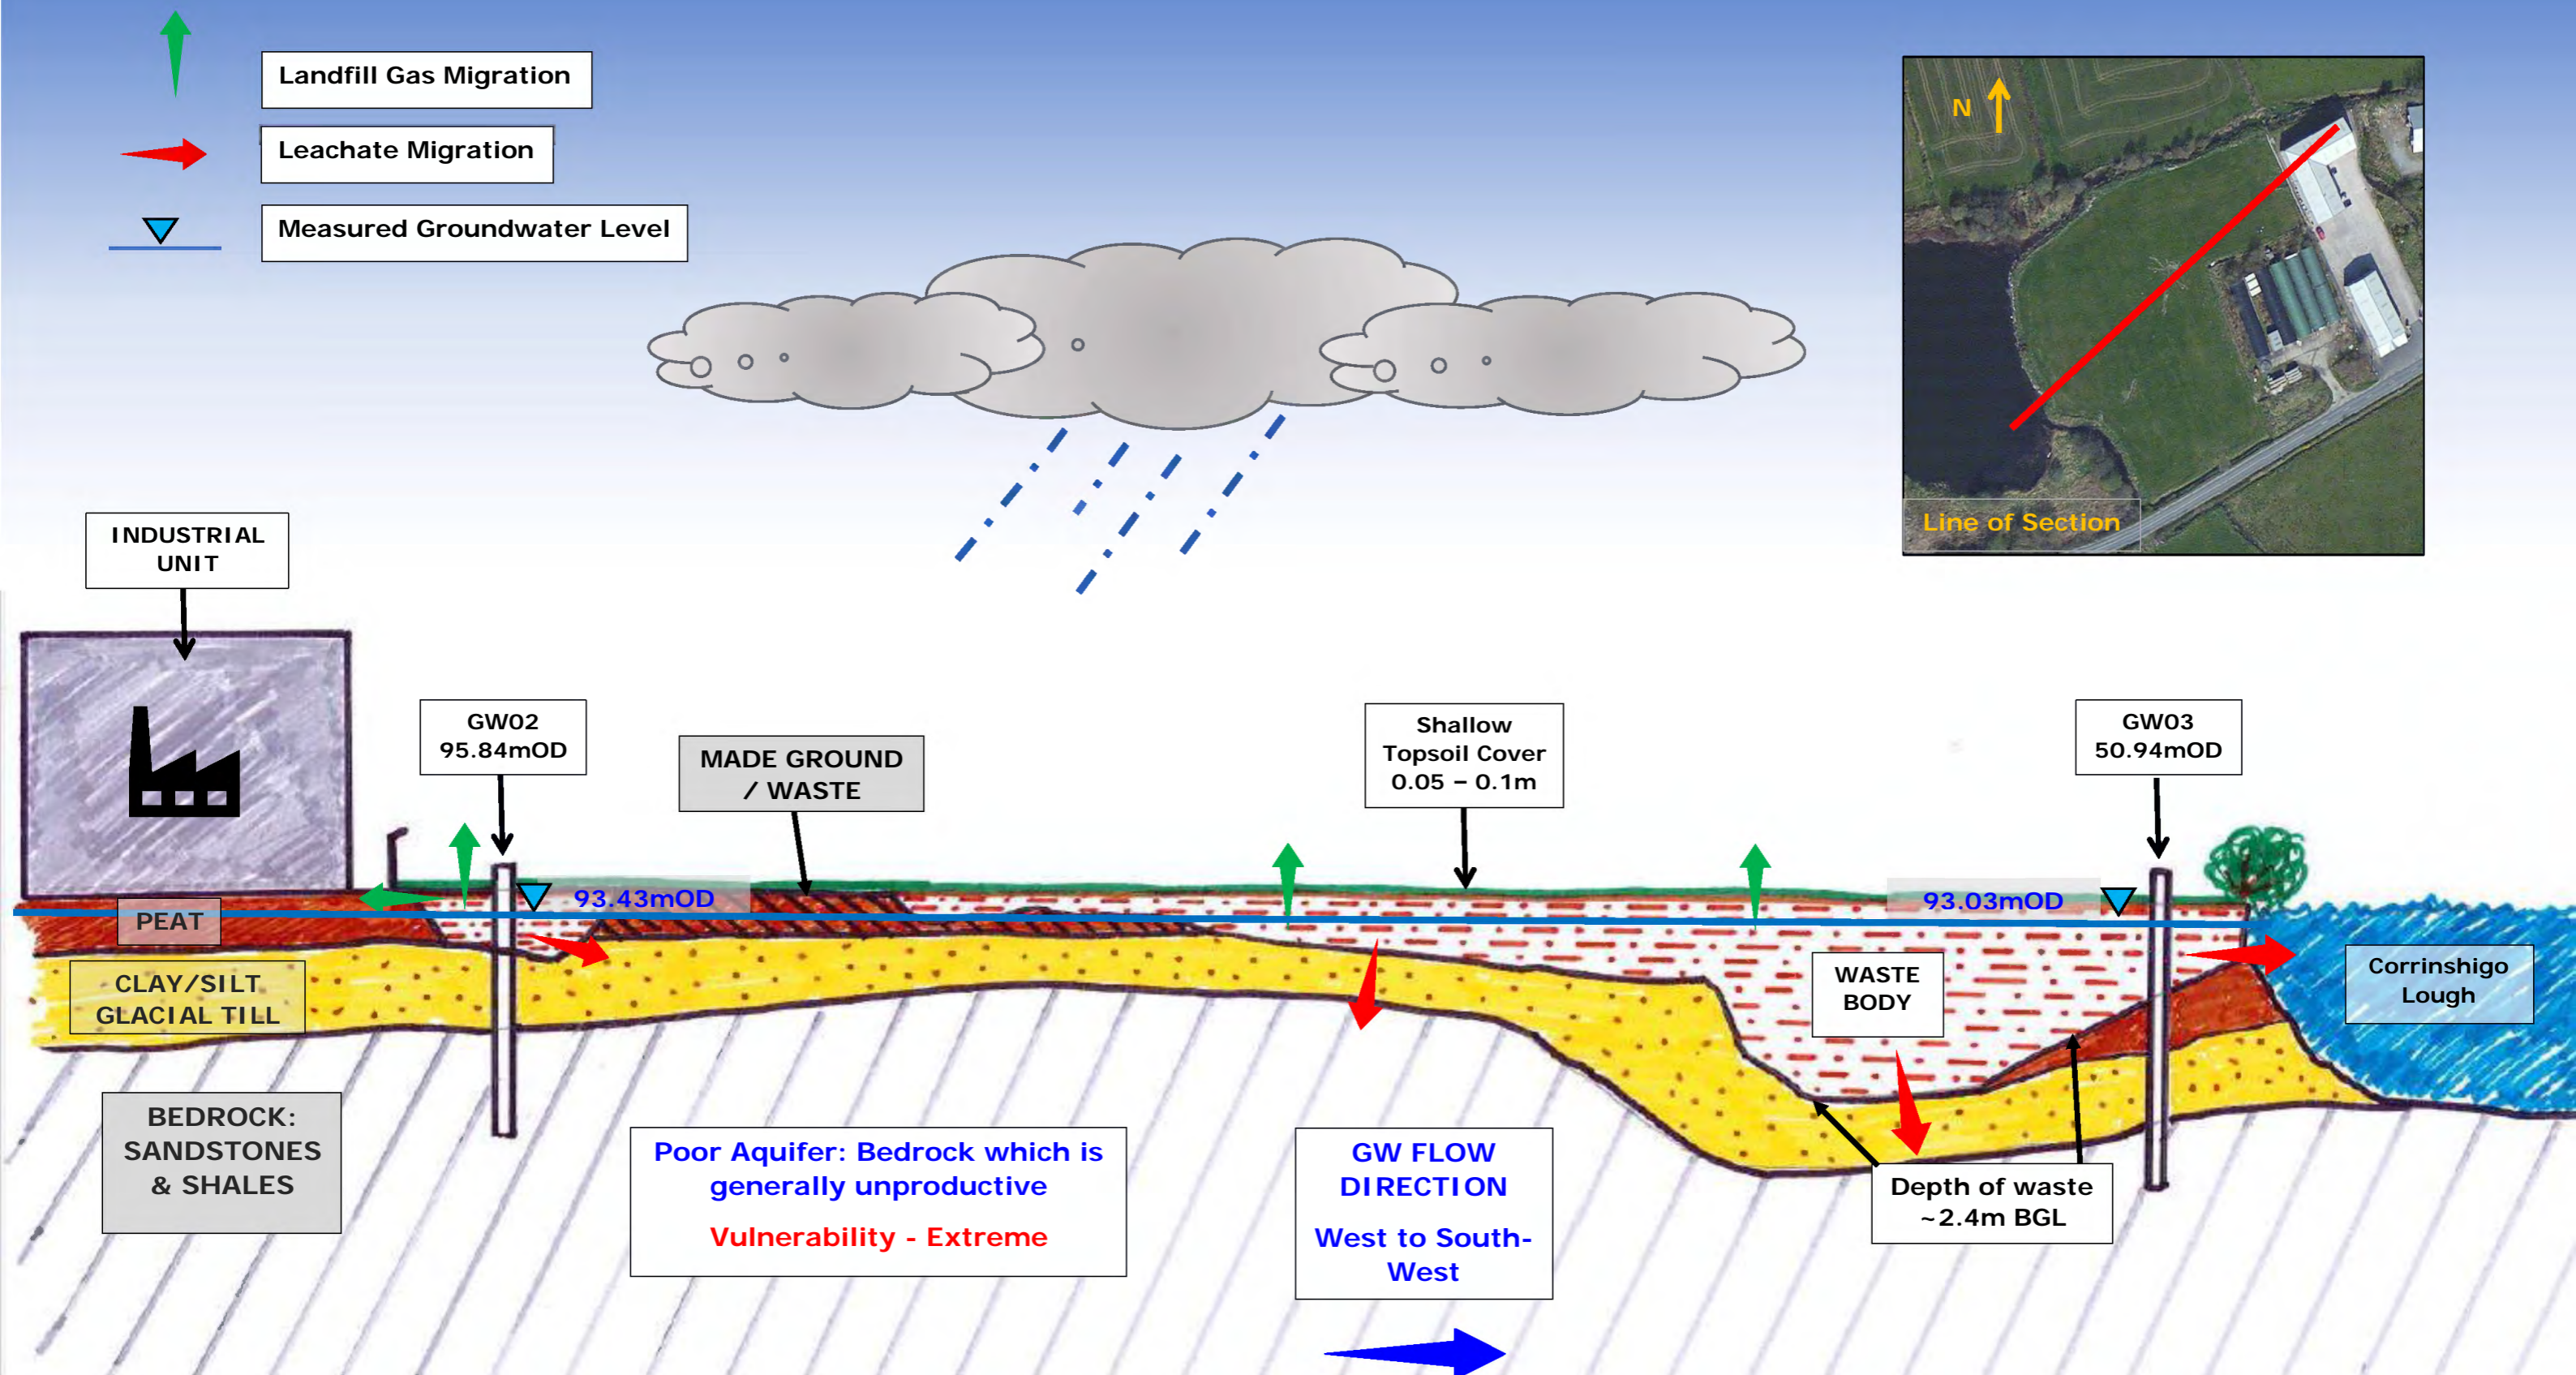
Based on the review of the Tier 1 assessment and site investigation works undertaken for Killycard Historic Landfill, an assessment of the risk is made to confirm the source – pathway – receptor (S-P-R) linkages identified in the preliminary investigation. The results and analysis of the investigation has enabled a revised conceptual model to be produced for the site, which is presented in Figure 5.1, overleaf.

CROSS SECTION NORTH-EAST / SOUTH-WEST

It is recommended by FTC that a Tier 3 DQRA be undertaken for the site in conjunction with an application for a Certificate of Registration for this site.
