TIER 1 ENVIRONMENTAL RISK ASSESSMENT

HISTORIC LANDFILL AT KILLYCARD LANDFILL CO. MONAGHAN

JUNE 2018

Abstract: This report represents the findings of a Tier 1 risk assessment conducted at the historic landfill at Killycard Landfill, Co. Monaghan in accordance with the EPA Code of Practice on Environmental Risk Assessment for Unregulated Waste Disposal Sites.

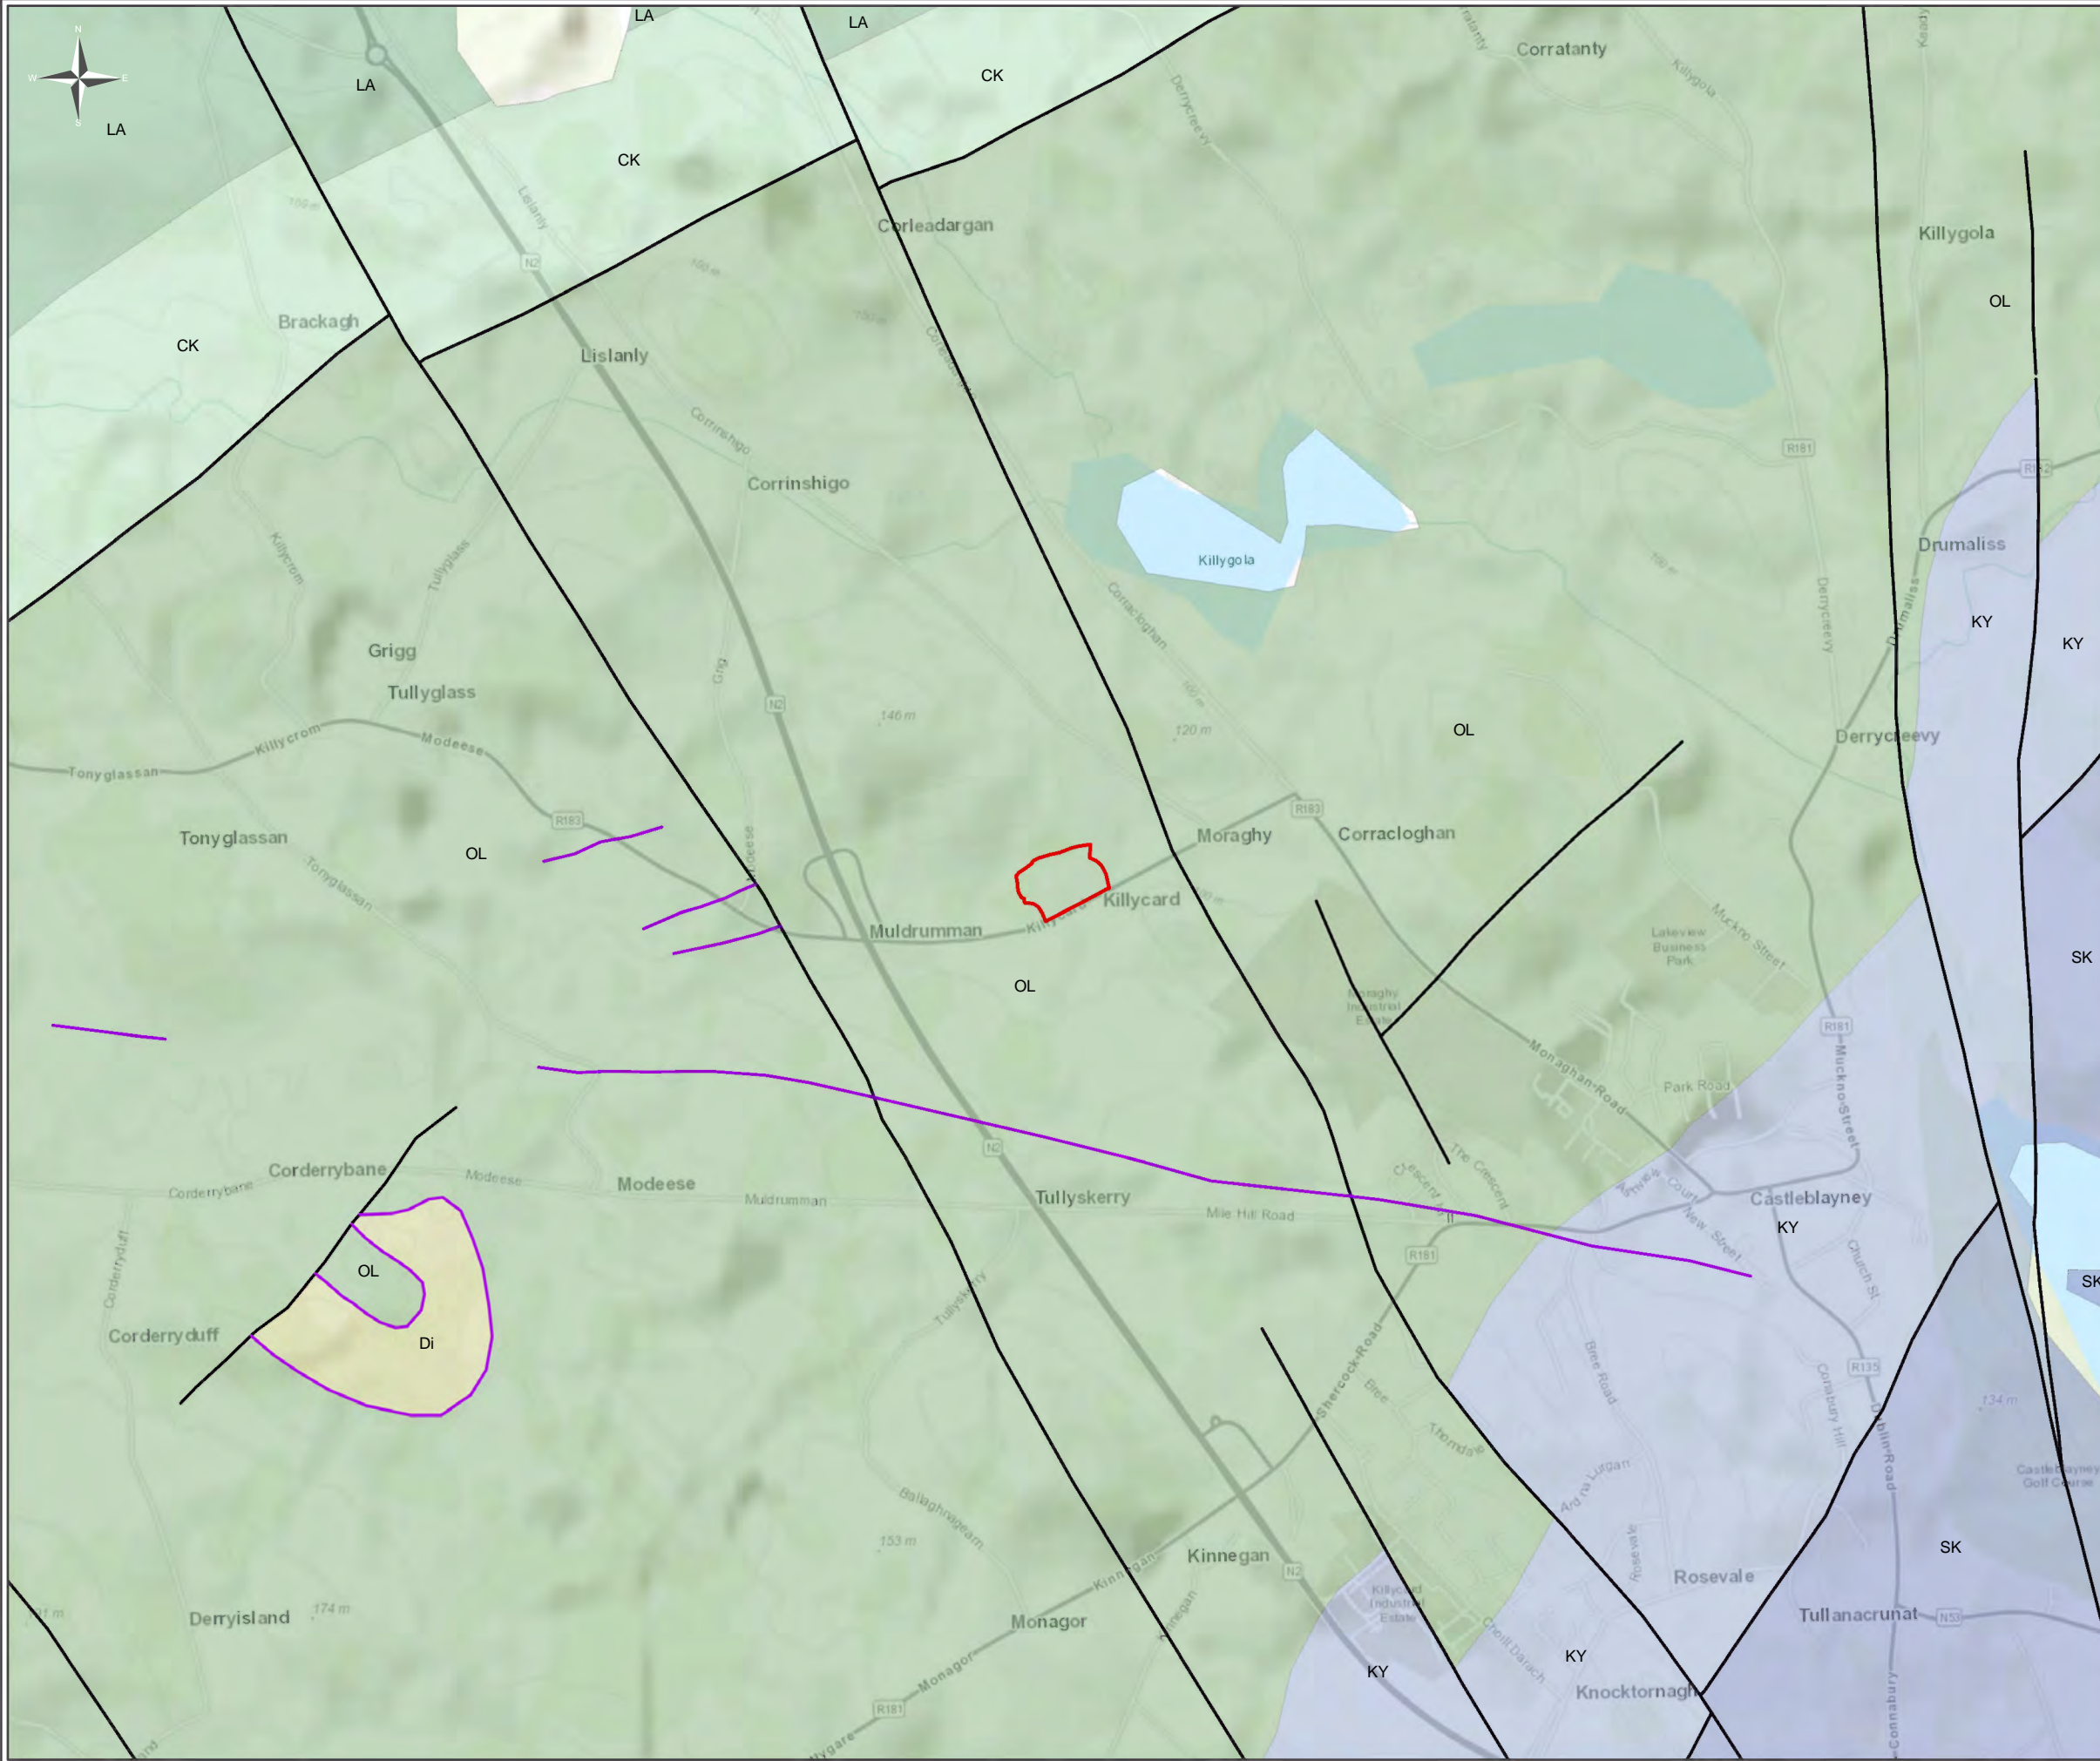
Figure No. 2.2

The GSI bedrock geology map shows a fault travelling north-south across the eastern area of the site.

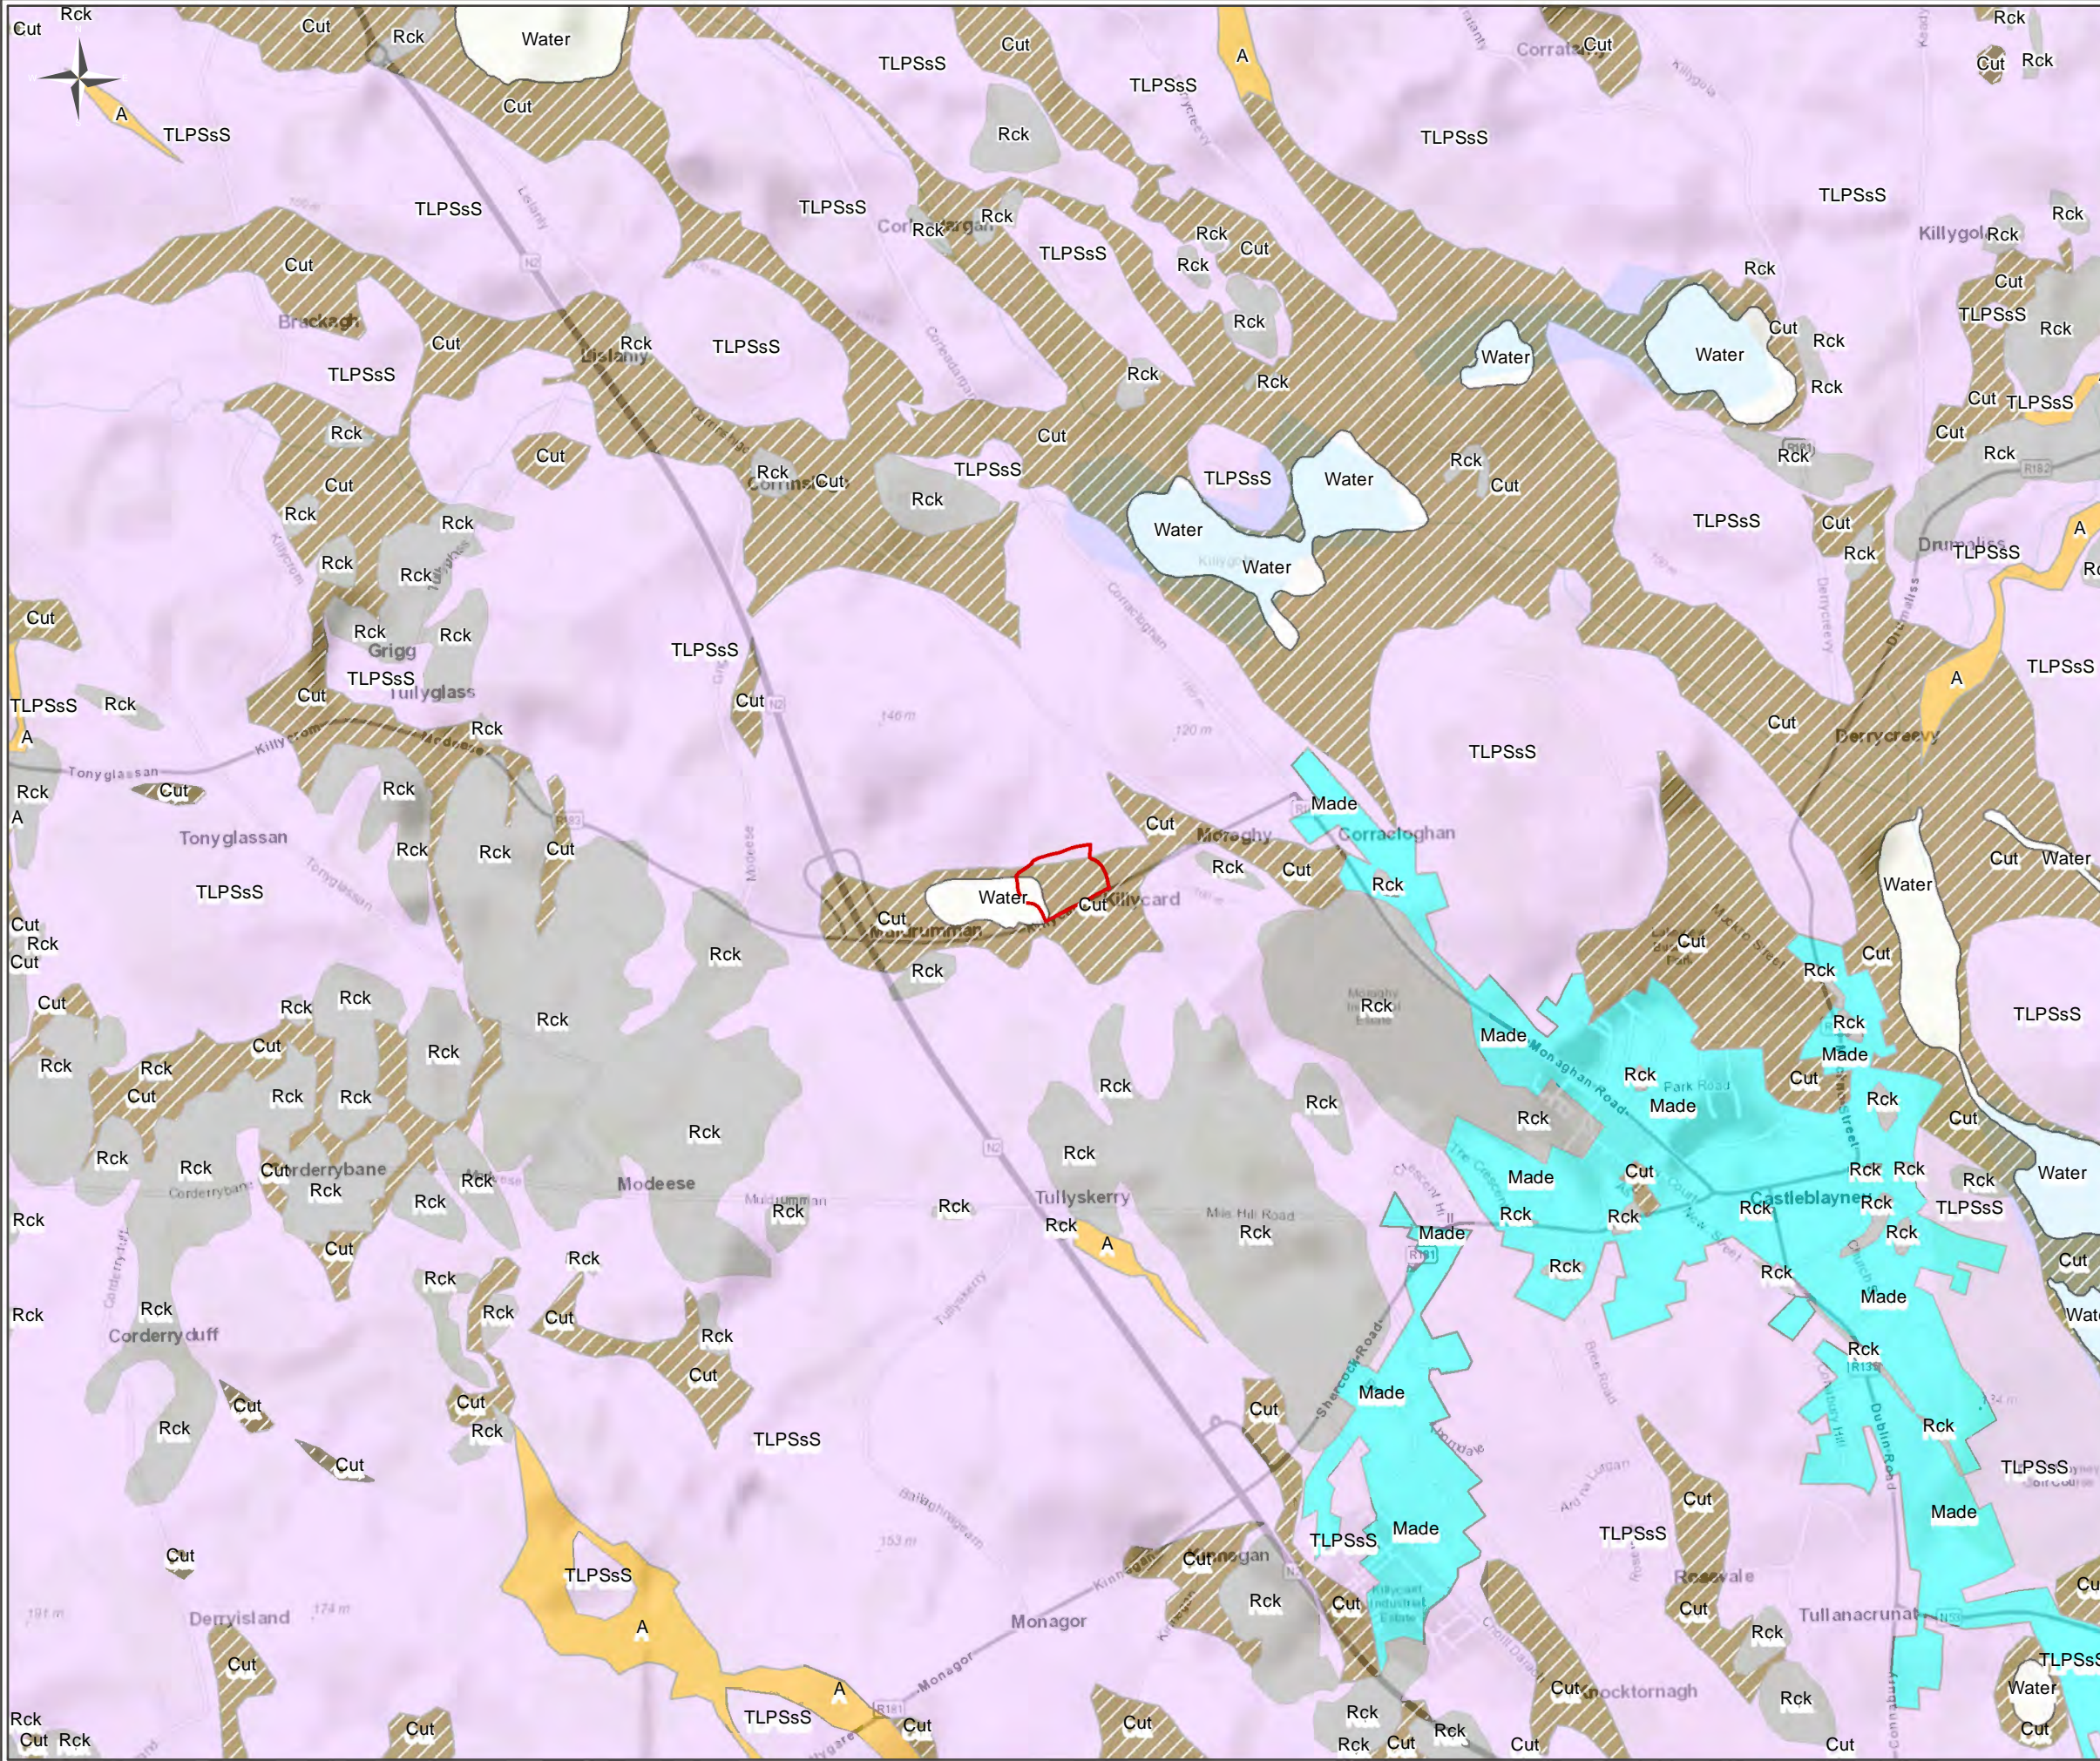
Figure Title	Quaternary Geology Killycard
Figure No.	2.3
Project	Tier 1 Assessment of Historical Landfills in Monaghan
Client	Monaghan County Council
Scale	1:15,000
Page Size	A3
Revision	A
Date	15/06/2018

The landfill site is underlain by cut over raised peat overlying a poorly productive bedrock aquifer. The subsoils are typically of cutover/cutaway peat. According to the GSI, the glacial overburden is mapped as 'Cut over raised peat', as shown in Figure 2.3.

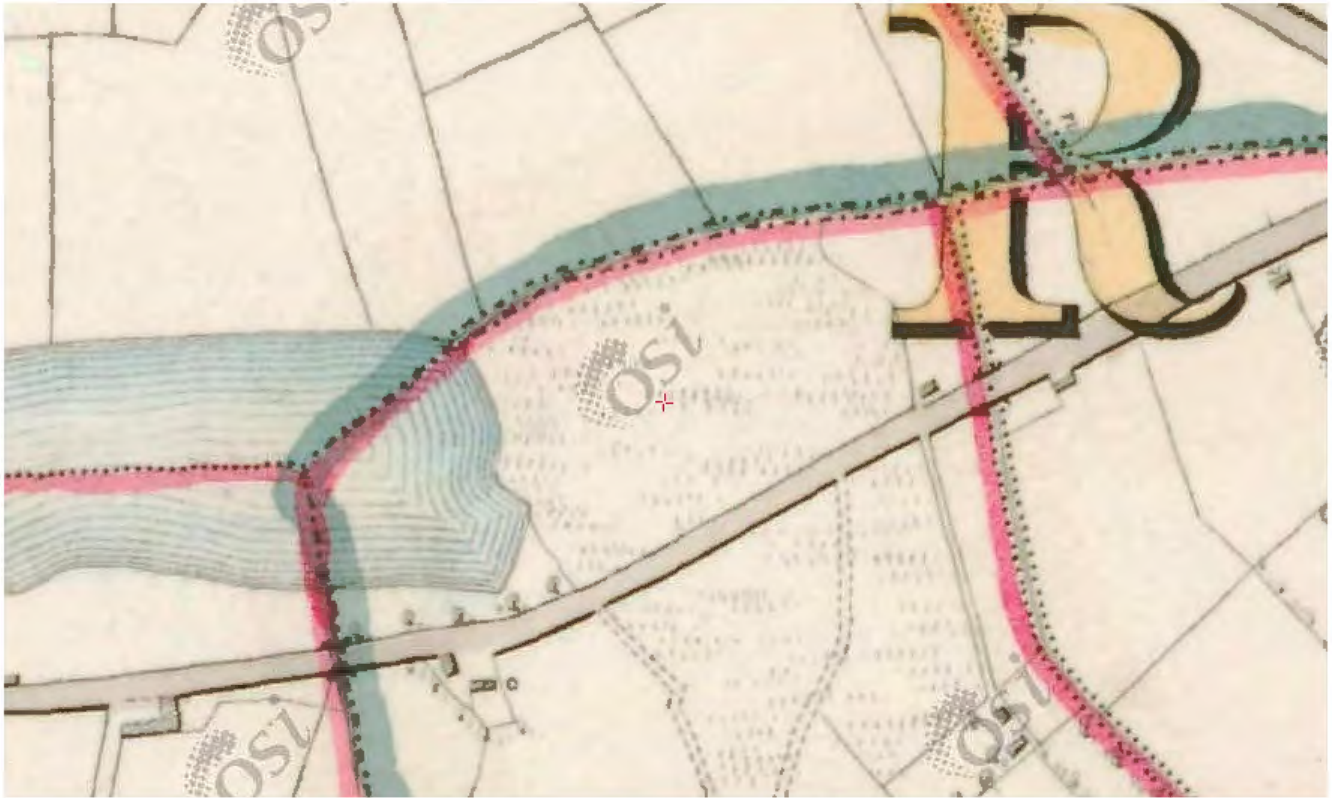
Figure 2.3.1:OSI Site Historic Map

OSI Historic Map (1888-1913 and 1837-1842) identifies that the land within the site boundary and the surrounding area was previously 'Bog or uncultivated land'. The historic map of the site is shown in Figure 2.4 below.

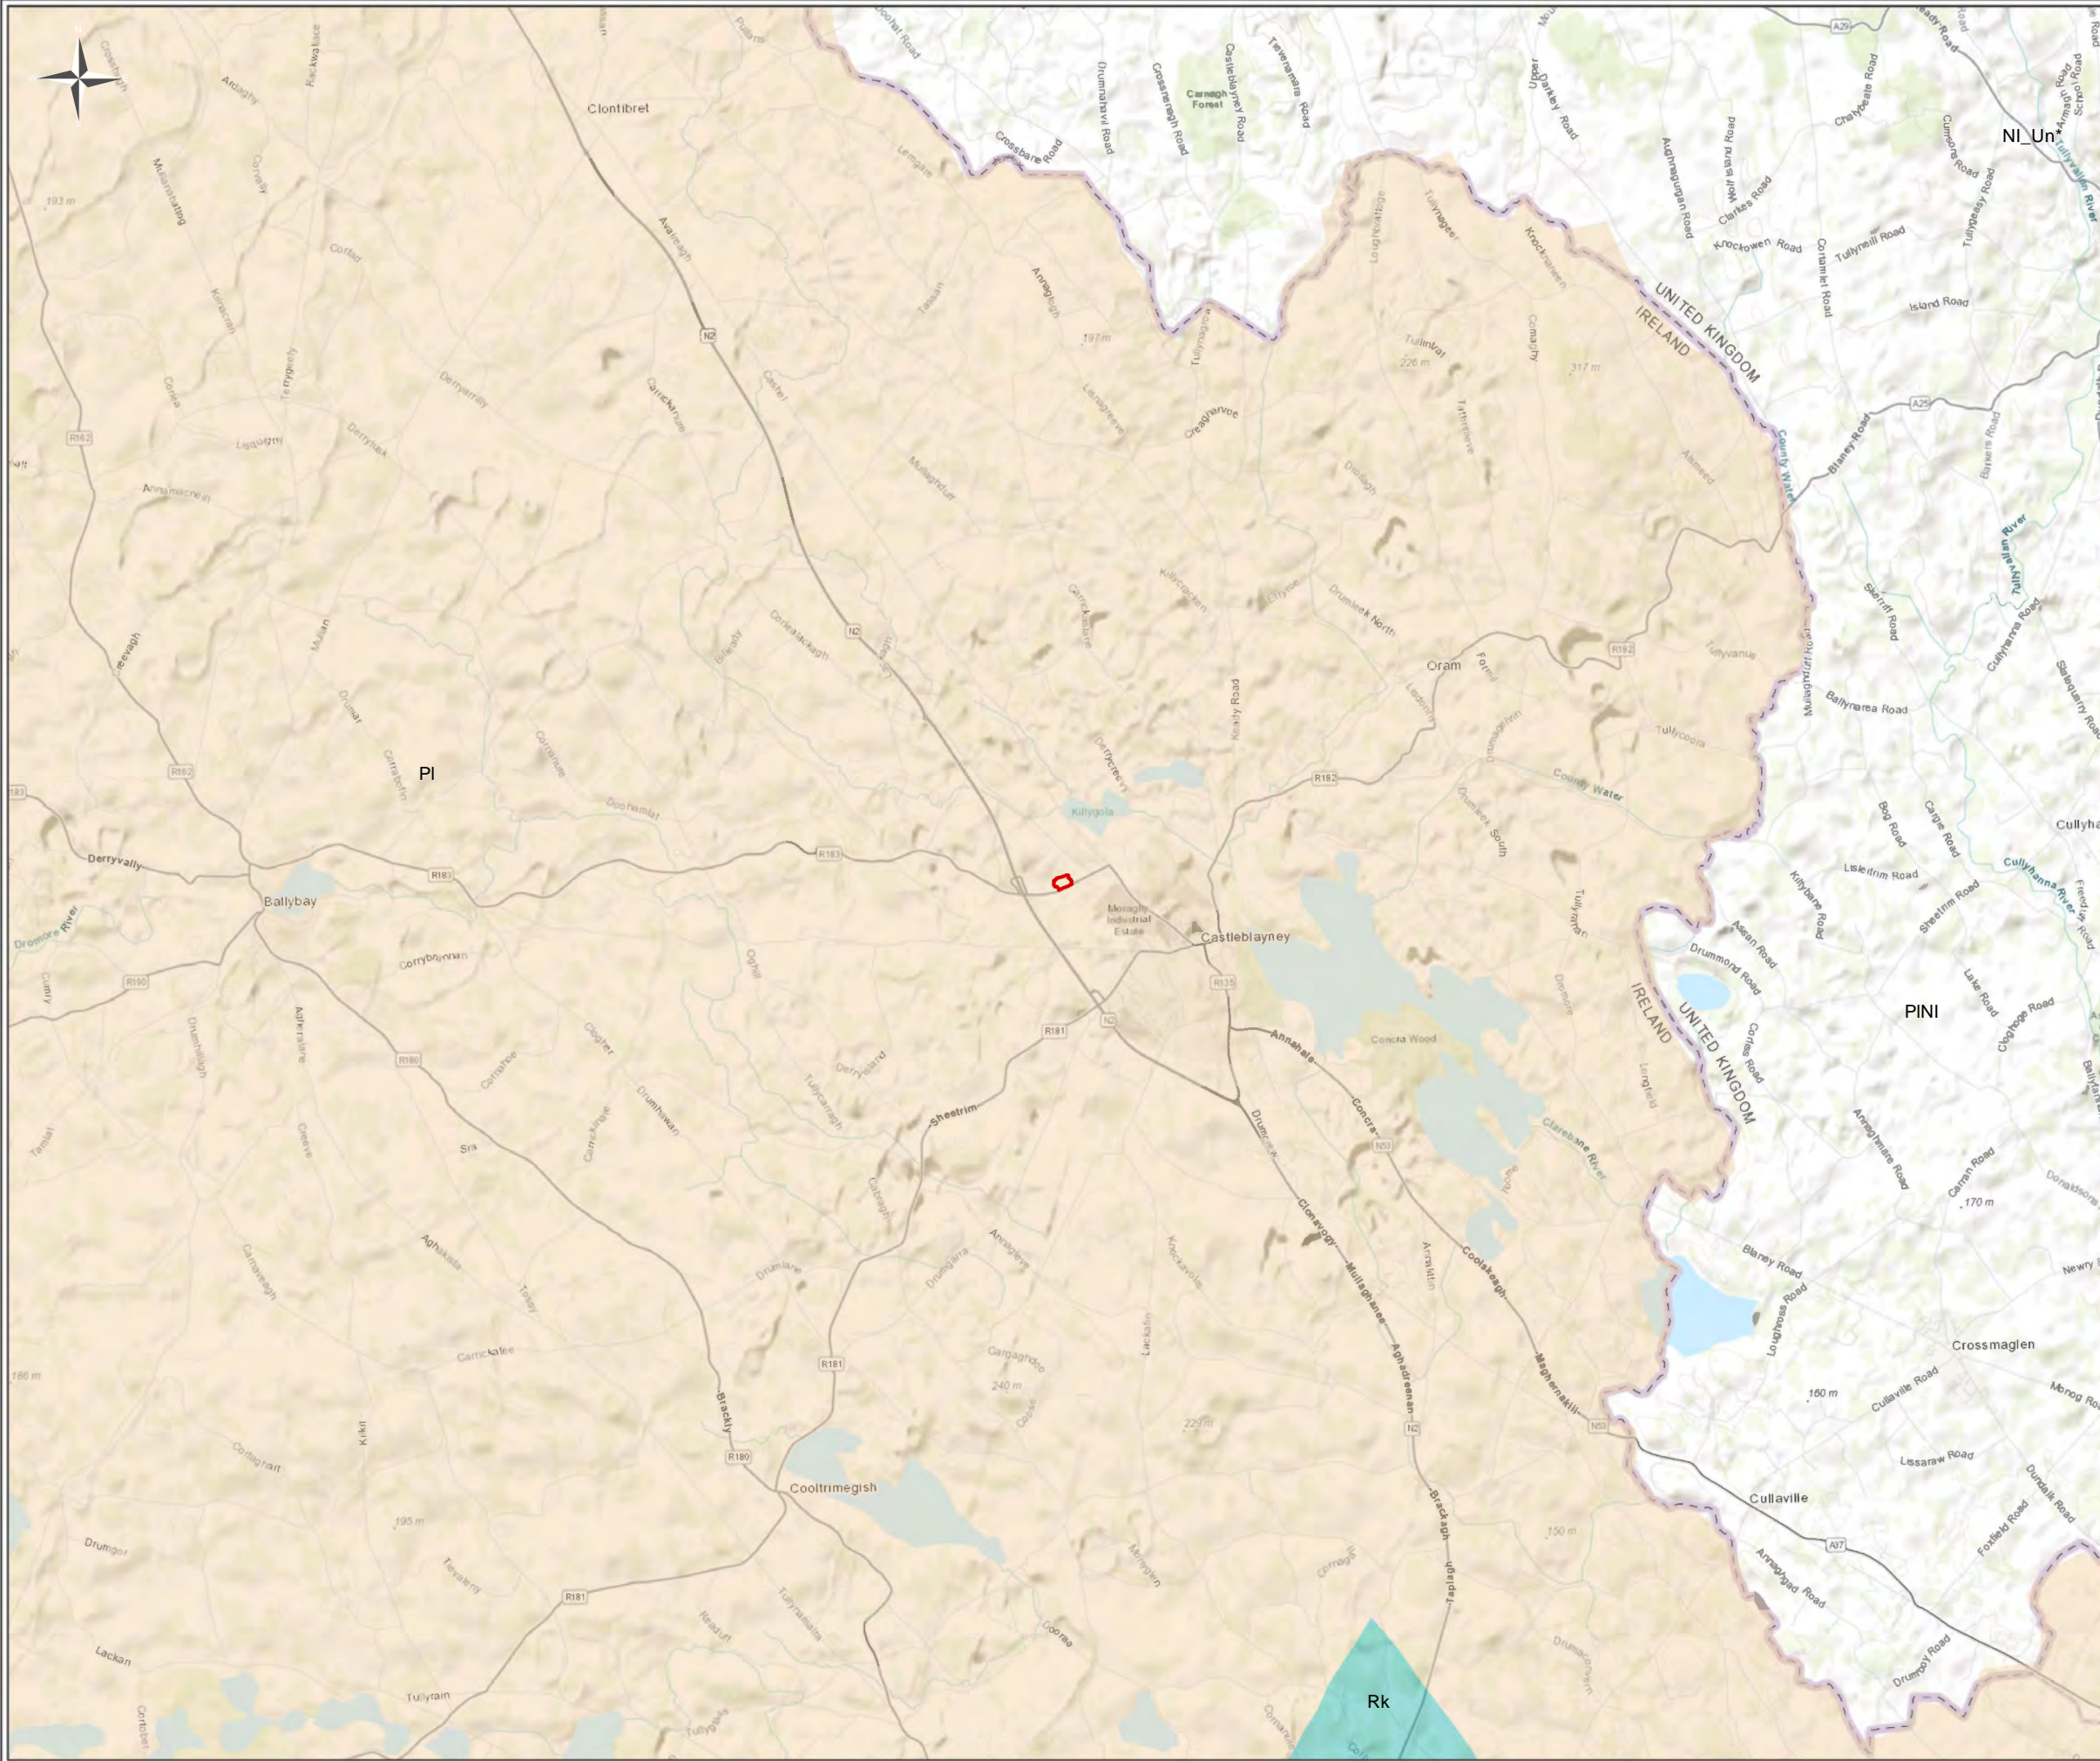
Figure Title	Aquifer Classification Killycard
Figure No.	2.4
Project	Tier 1 Assessment of Historical Landfills in Monaghan
Client	Monaghan County Council
Scale	1:75,000
Page Size	A3
Revision	A
Date	15/06/2018

The Oghill formation is classified as a Poor Aquifer (PI) that is generally unproductive except in local zones. The aquifer vulnerability of the site is Extreme.

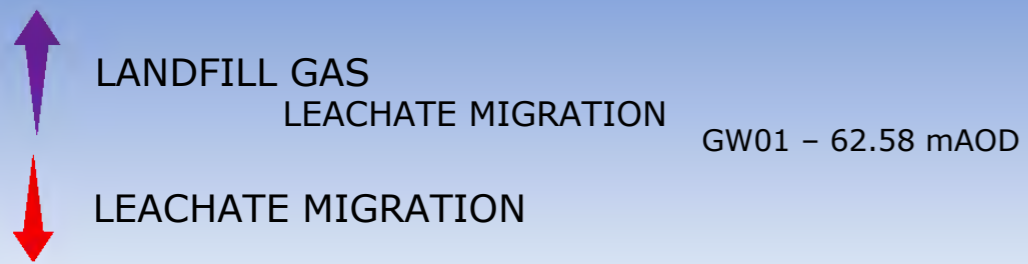
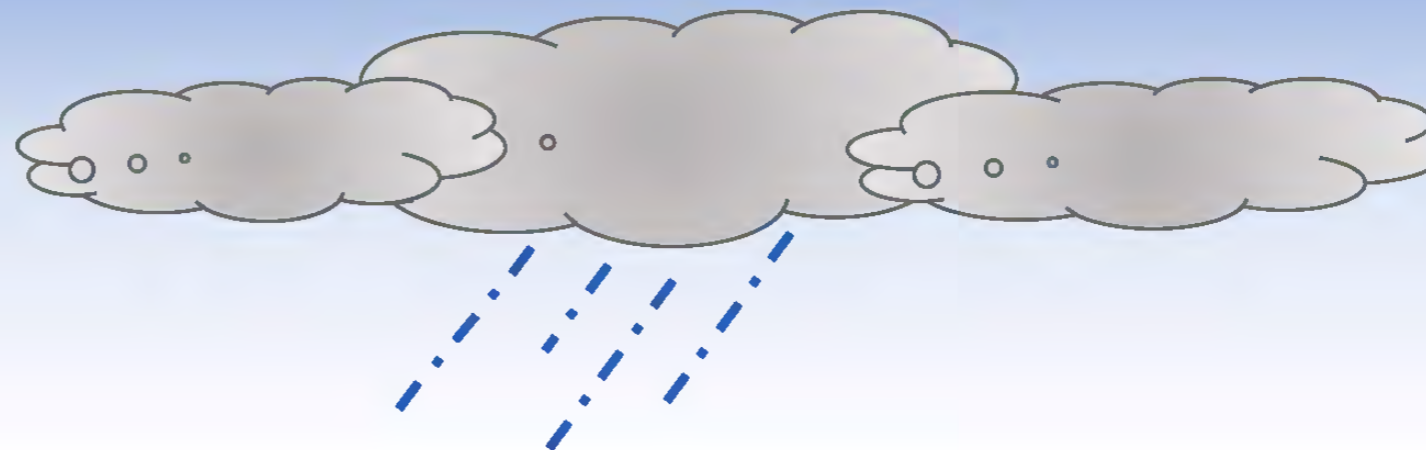
Based on the desktop investigation and site walkover undertaken, an assessment of the risk is made to confirm the source – pathway – receptor (S-P-R) linkages identified in the preliminary investigation. The results and analysis of the investigation has enabled a basic conceptual model to be produced, which is presented in Figure 3.1, overleaf.

HISTORIC LANDFILL
 APPROX AREA 2 Ha

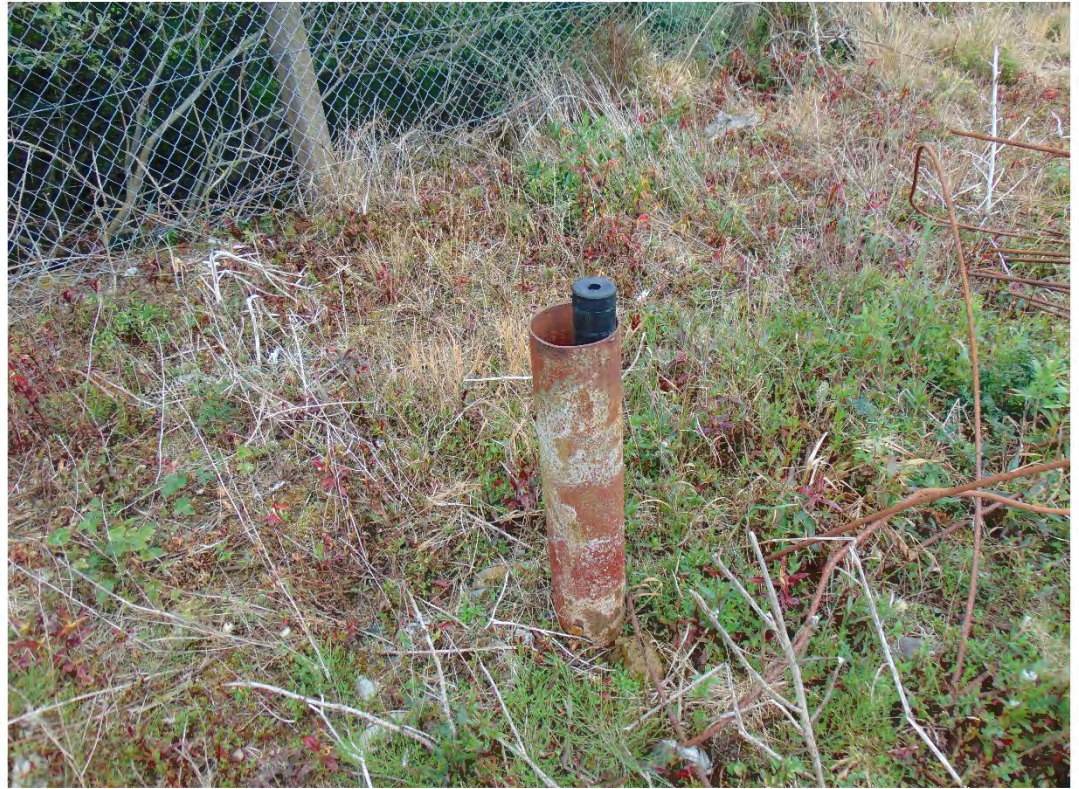
Old gas well near
industrial unit
carpark

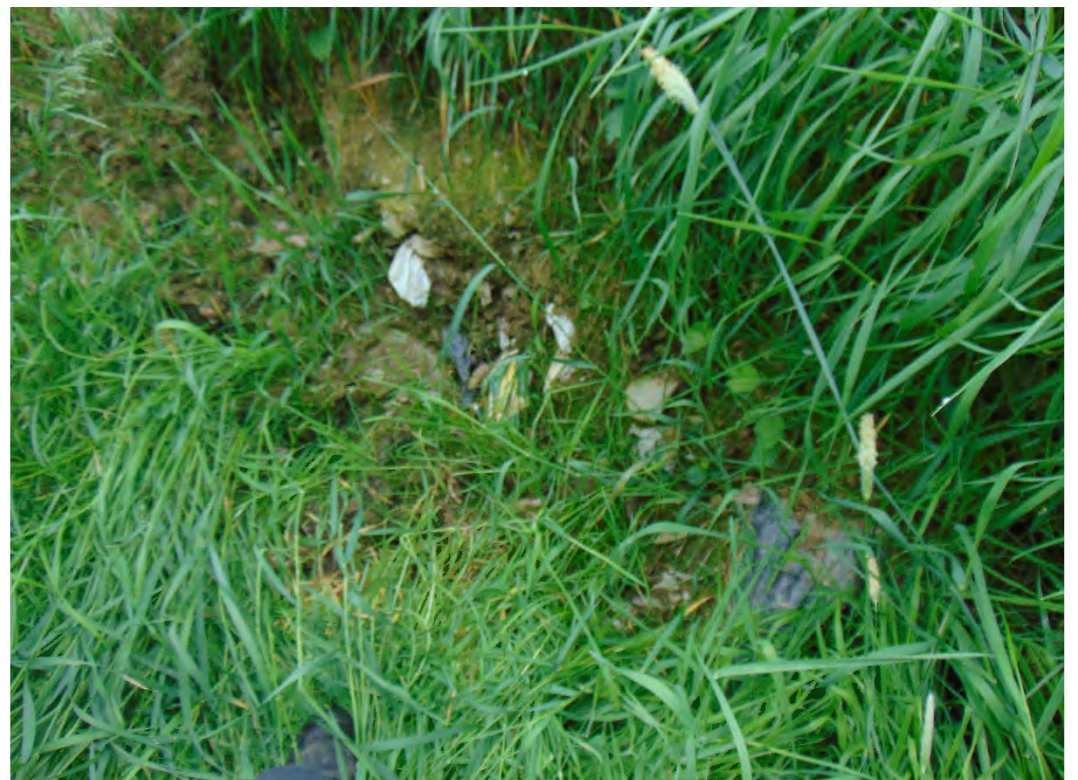
The site walkover noted evidence of recent erosion along large sections of the western landfill boundary with Corrinshigo lake. Waste material was found to be depositing directly into lake along the western edge of the site and also to the surface water ditch on the northern edge of the site. Waste material was found to be protruding from the soil surface along the site perimeter and throughout the site area, as shown in photos 10-14 of Appendix III.

Waste material protruding
from northern boundary
adjacent to surface water
ditch

FT recommends intrusive site investigations will be required, using trial pits, boreholes and slit trenches to confirm waste volumes, footprint and depths, and to assess and characterise waste types and compositions. An environmental monitoring program including surface water, groundwater, leachate sampling and landfill gas migration monitoring is also recommended.

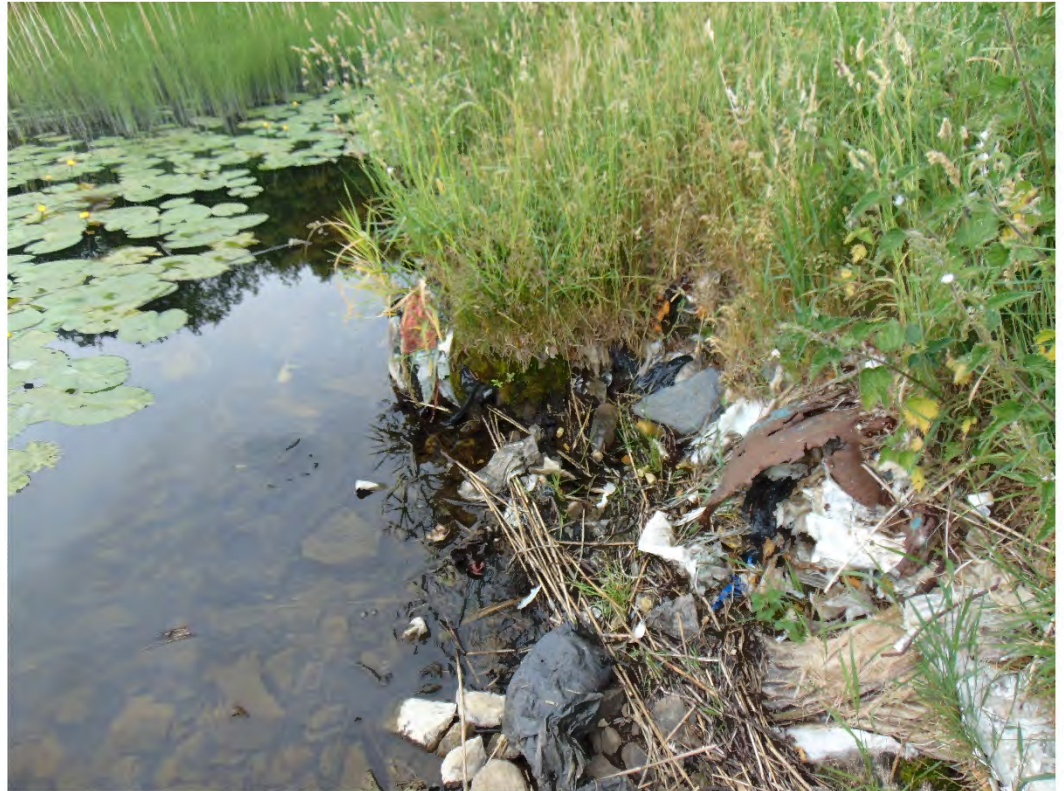
Exposed waste material at western boundary of Corrinshigo lake

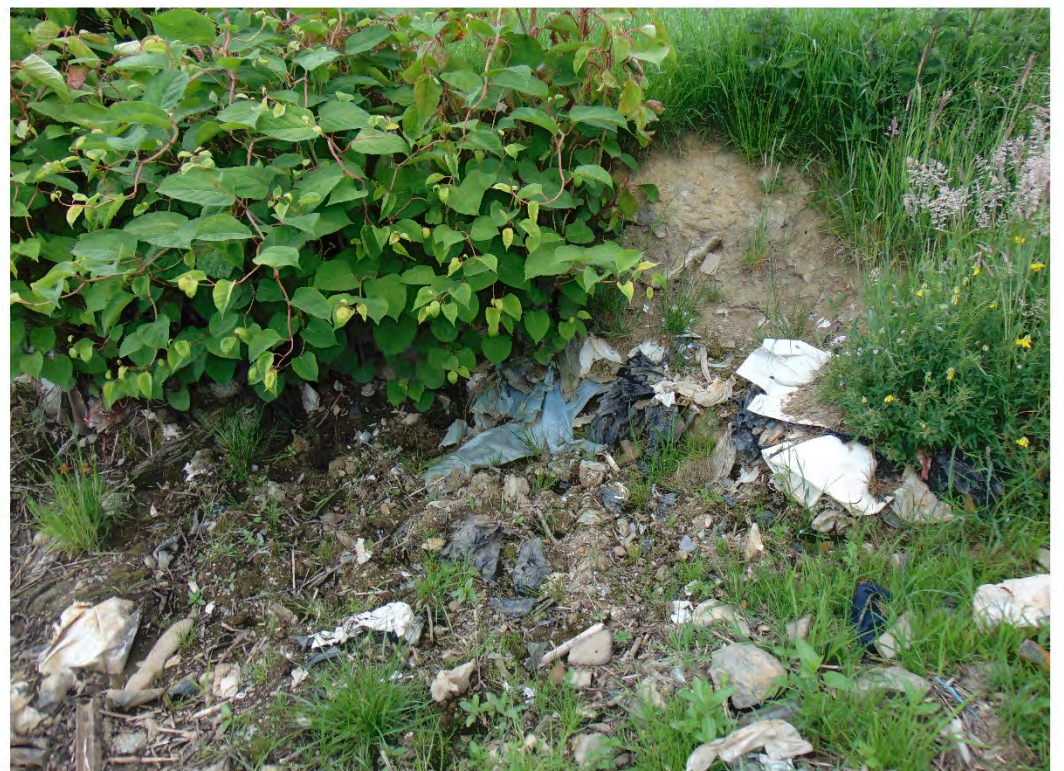
Exposed waste material at western boundary of Corrinshigo lake

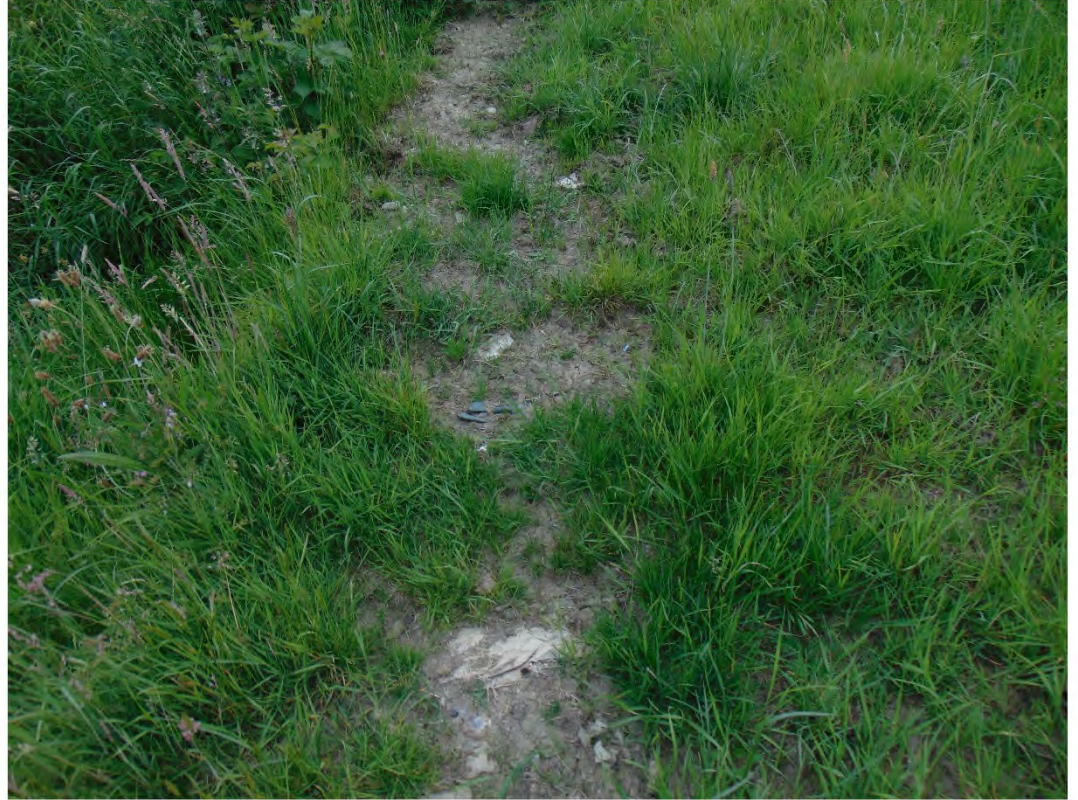
Waste material
protruding from soil
surface

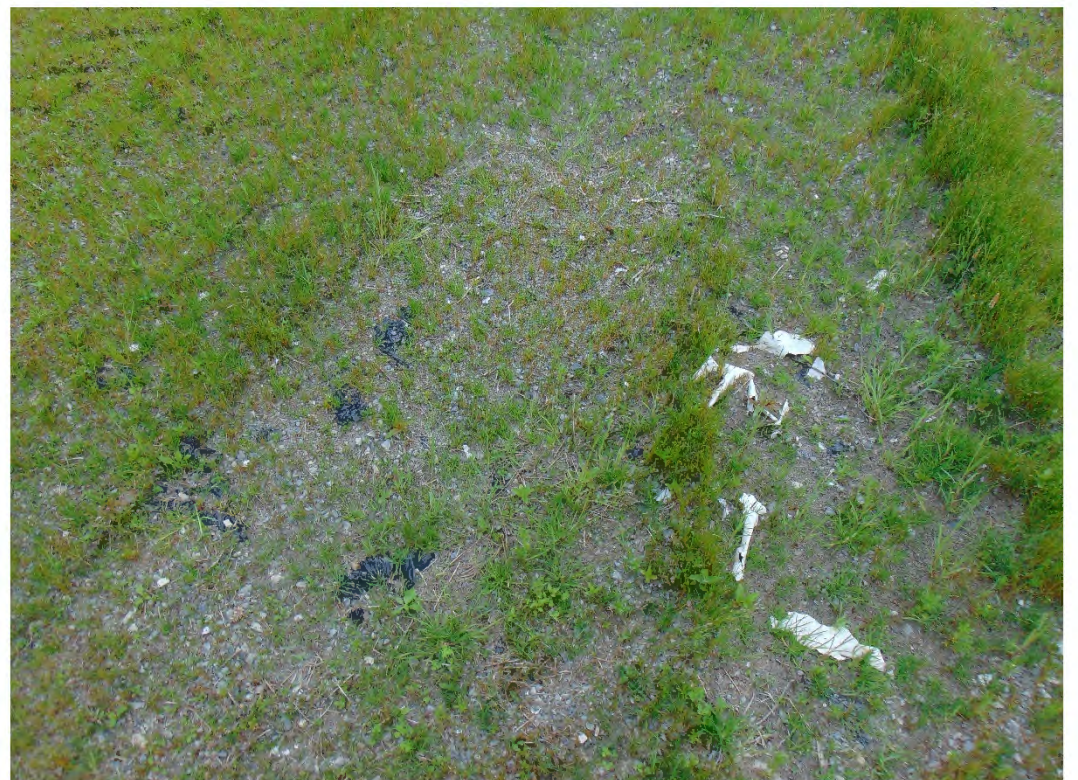
Waste material
protruding from soil
surface
