TIER 2 RISK ASSESSMENT

HISTORIC LANDFILL AT KILLYCARD,
CO. MONAGHAN

NOVEMBER 2018

Client: Monaghan County Council

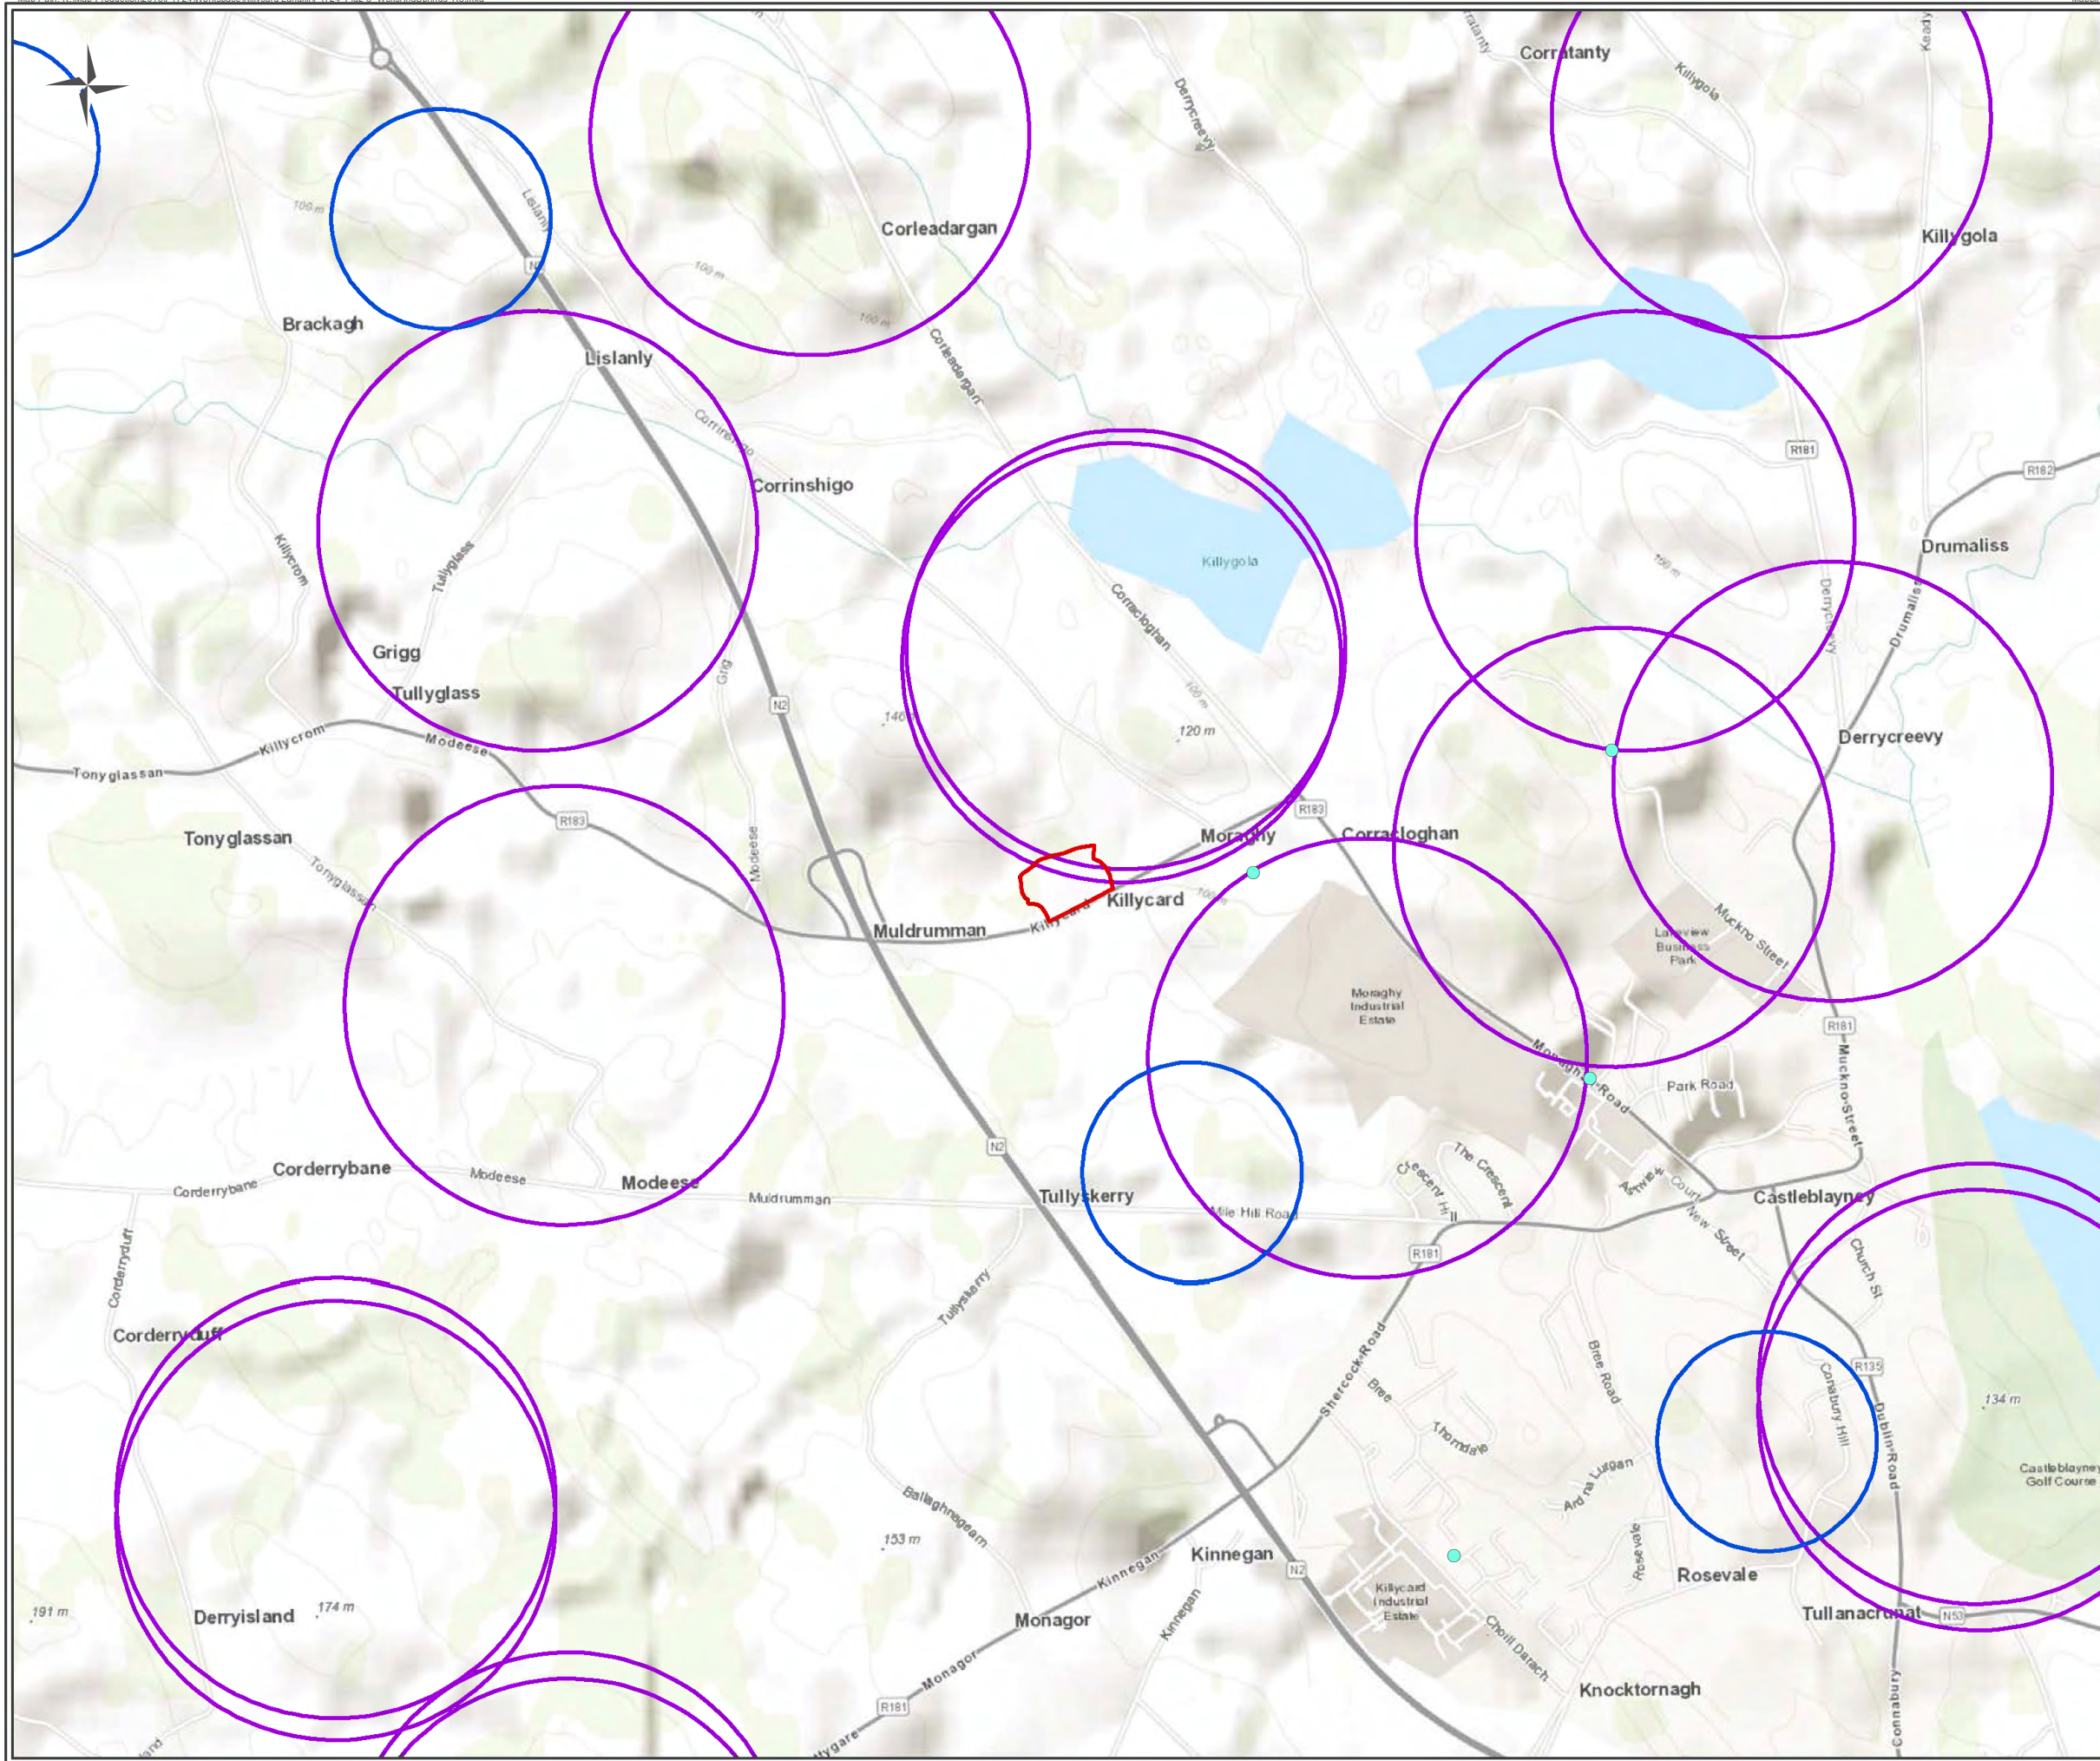
Figure Title	Wells and Springs
Figure No.	2.5
Project	ERA of Historic Landfill at Killicard, Co. Monaghan
Client	Monaghan County Council
Scale	1:15,000
Page Size	A3
Revision	A
Date	17/10/2018

Locations of wells and springs are presented in Figure 2.5.

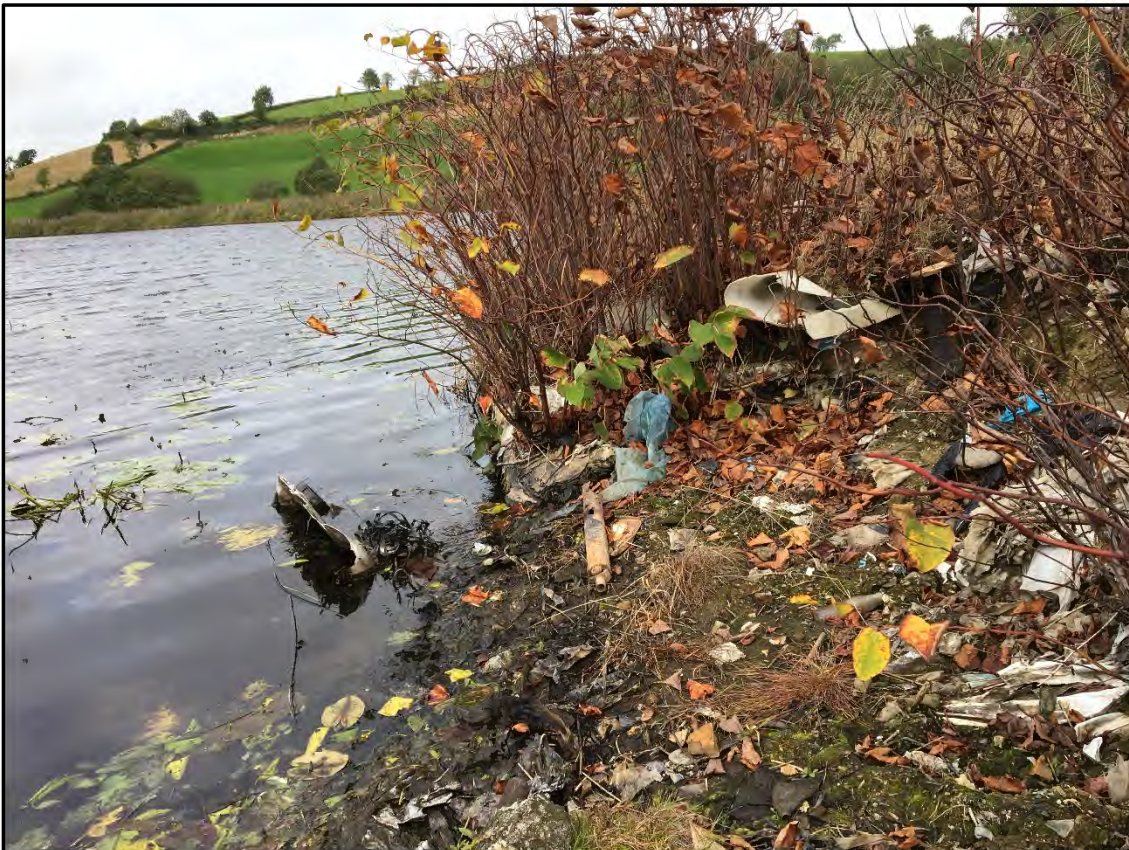
During the site walkover, Japanese Knotweed was identified along the western banks of the site and evidence of eradication was identified, see Plate 2-1. The lake is eroding the banks of the site exposing the interred waste.

Plate 2-1: Japanese Knotweed and exposed waste material
