11.3.2 Terrestrial Flora and Habitats

12.3 Baseline Conditions

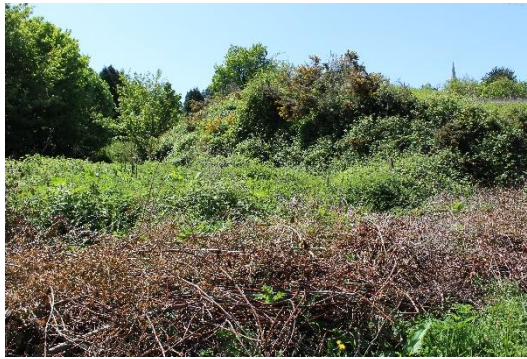
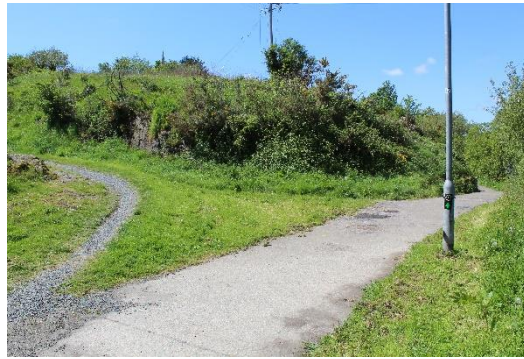
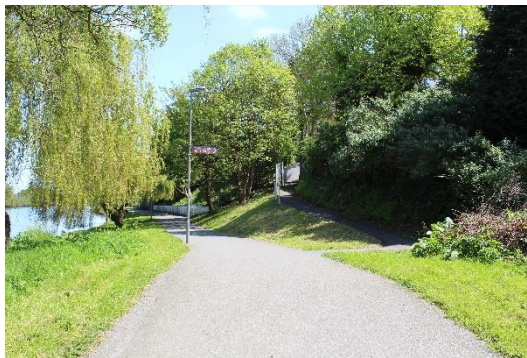
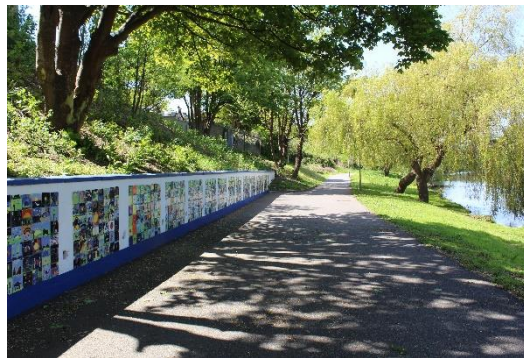
Plate 11.1: Views of the Alps site and surrounding areas

1. View into the Alps site from River Walk
2. River Walk immediately west of the Alps, showing rock outcrops on both sides of the footpath to Vale Road

3. View eastwards from River Walk opposite the Alps site
4. View westwards along River Walk towards the Alps site

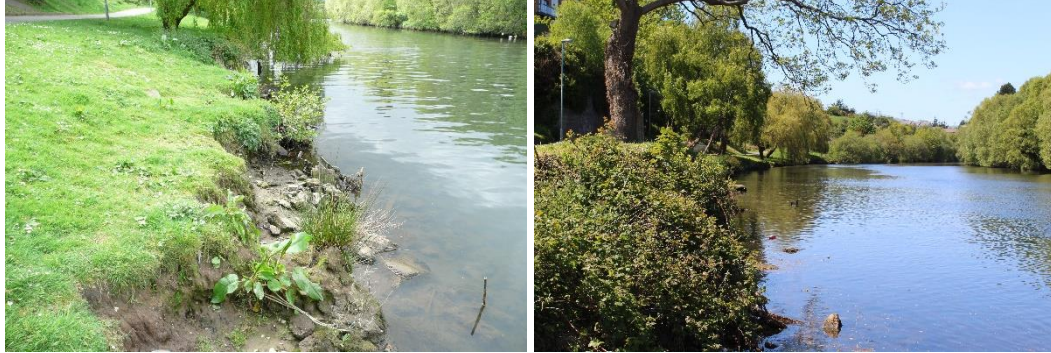
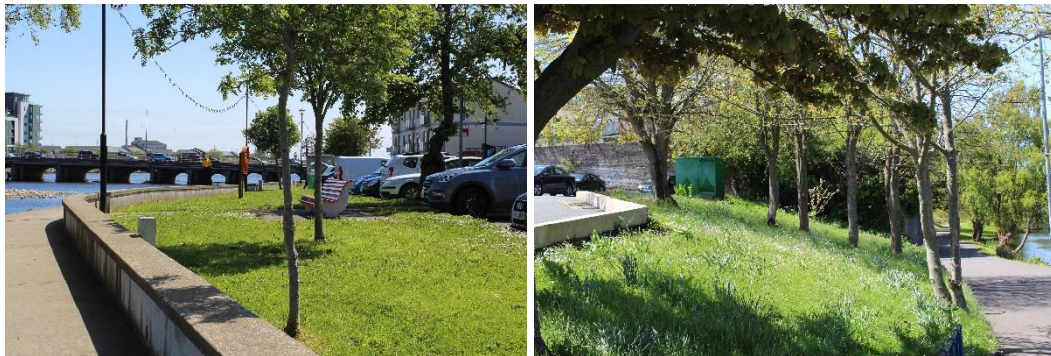
Plate 11.2: Views vegetation and habitats along River Walk

1. Erosion along the south bank of the Avoca River
2. Small area of Bramble along the south bank of the Avoca River

3. Amenity grassland and young trees adjoining River Walk
4. Amenity grassland with Daffodils and trees at the car park at River Lane

Within the area of the proposed development, a semi-continuous Treeline **WL2** planted along the river bank from the Alps to Arklow Bridge includes Weeping Willow *Salix* hybrids (Plate 11.2, 3 and 4), Ash, Hawthorn, Silver Birch *Betula pendula*, and Alder *Alnus glutinosa*. Self-sown Grey Willow shrubs were cut back during the winter of 2017 - 2018.

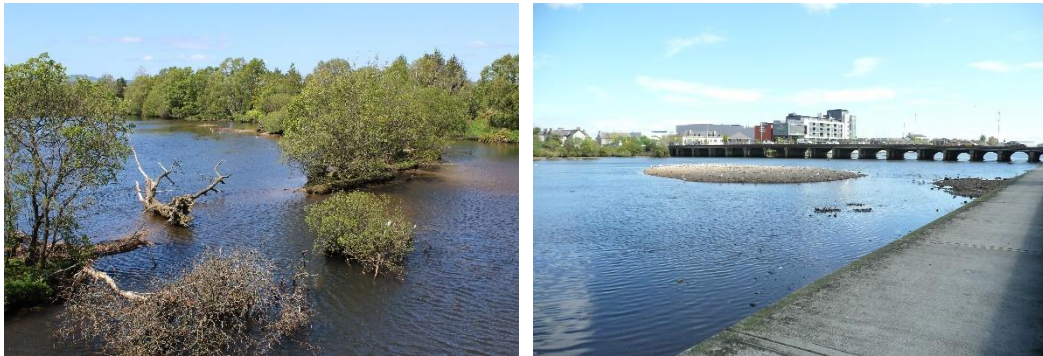
Avoca River viewed from Arklow Bridge, view of Riparian woodland on gravel and silt bank in the river channel near the north bank

Avoca River upstream of Arklow Bridge, gravel banks exposed at low tide

The Avoca River channel (**FW2**, **CW2**) upstream of Arklow Bridge is largely un-vegetated. Gravel banks in the centre and south of the channel expose during most of the tidal cycle and low river flows, and are not vegetated. Towards the northern side of the river channel, there is a linear gravel bank overlain with silt, and this supports a line of Grey Willow trees, corresponding to Riparian woodland **WN5**. Some areas of this woodland bank appear to have washed out during recent floods (Refer to Plate 11.3).

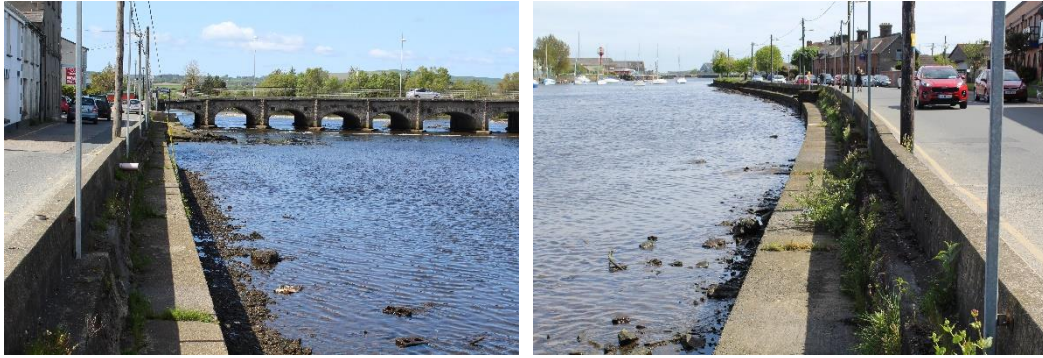
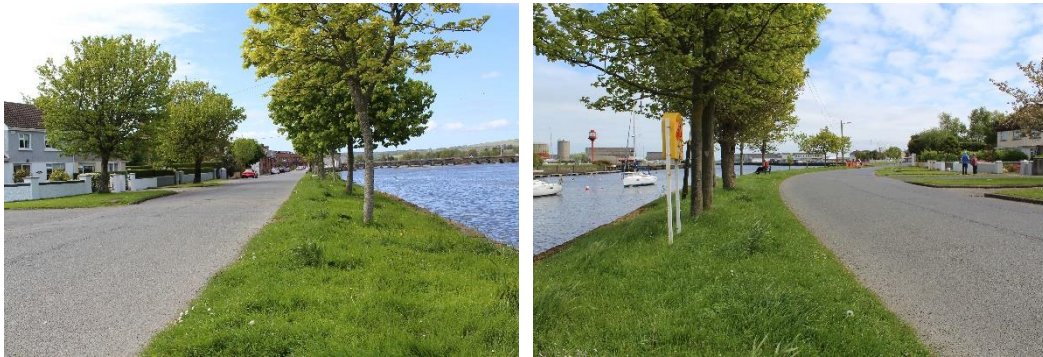
1. View along South Quay towards Arklow Bridge

2. View along South Quay towards South Green

3. Amenity grassland and trees at South Green, looking west

4. Amenity grassland and trees at South Green, looking east

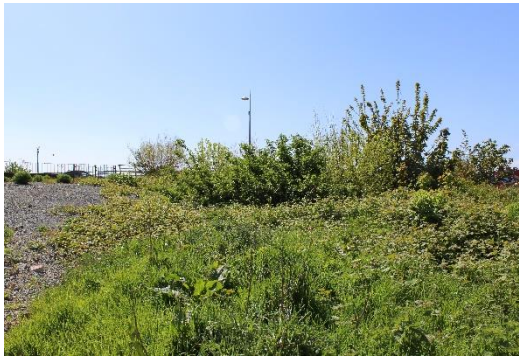
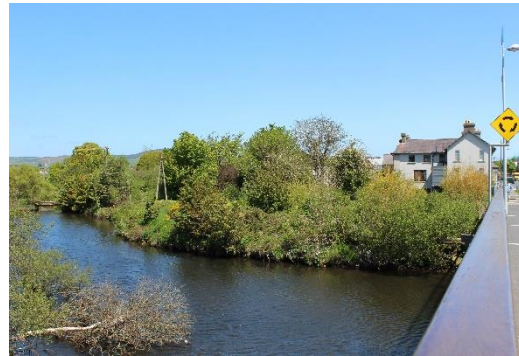
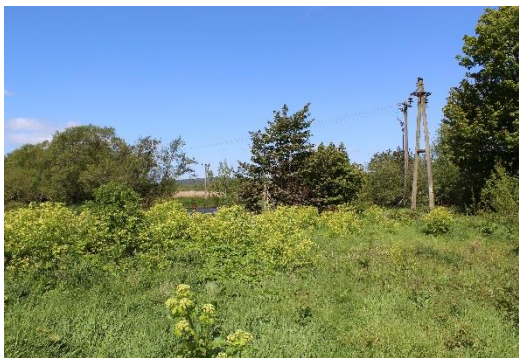
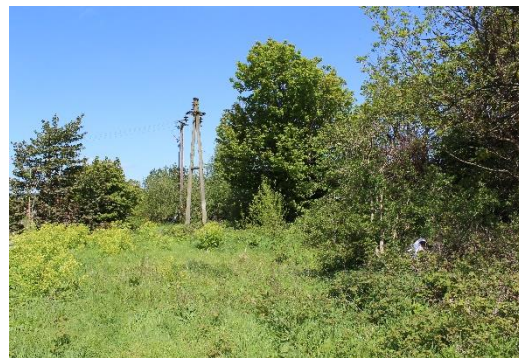
Plate 11.5: Habitat and vegetation cover in Working Area TSN1

1. Spoil and bare ground **ED2** and Scrub **WS1** in TSN1

2. Scrub **WS1** along the north bank of the Avoca River at TSN1

3. View west over overgrown amenity grassland towards Arklow Town Marsh pNHA

4 Scrub along the northern margin of overgrown amenity grassland

Working Area TSN1 is located on the north bank of the Avoca River, on the western side of Arklow Bridge (Plate 11.5). This site was partially cleared in late 2016 in connection with a road upgrade project. A line of Cypress trees and adjoining Willow, Ash and Sycamore were felled at that time, and a hard core working area installed adjoining the road. When re-surveyed in May 2018, the hard core surface was classified as spoil and bare ground **ED2**, with a sparse colonising vegetation of Buddleia seedlings, Bramble, Common Ragwort *Senecio jacobaea*, Groundsel *S. vulgaris*, Smooth Sow-thistle *Sonchus oleraceus*, and Common Mouse-ear *Cerastium fontanum*.

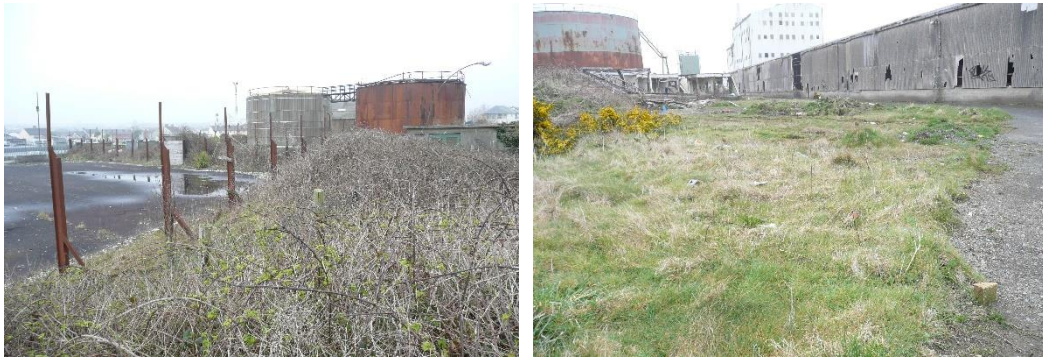
Plate 11.7: Existing vegetation and habitats on the WwTP site

1. Bramble Scrub WS1 along the site boundary with working area N14, to the left
2. Recolonising bare ground ED3 and Gorse and Bramble Scrub WS1 between the two existing buildings on site

Most of the existing vegetation on the site has developed as sparse cover on hard-core and tarmac surfaces, extending into the site from the site boundaries, from seed in gravel or hard-core brought in during site development, from wind-blown seed and seed transported by birds. Silver Birch has colonised sheltered parts of the site near the western boundary, with occasional Alder and Elder. Grey Willow occurs in sheltered and more exposed parts of the site. Bramble and Gorse Scrub **WS1** extends into the site from the western site boundary (Plate 11.7).

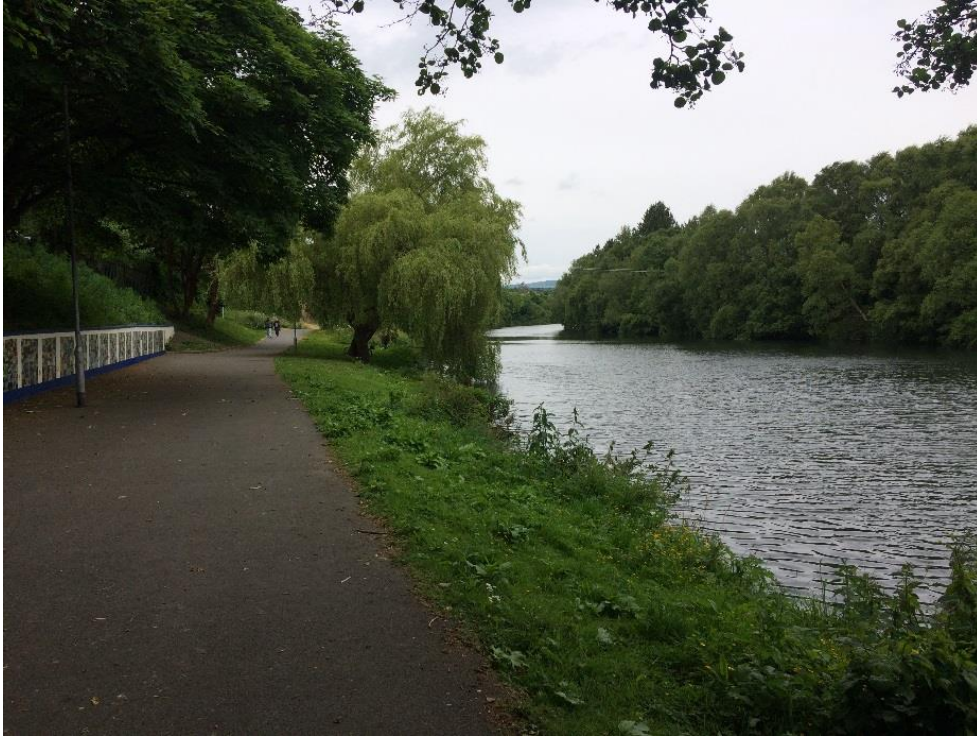
Figure 12.7: Route of proposed interceptor sewer adjacent to the Avoca River, facing west (upstream)

The proposed interceptor sewer runs in an easterly direction along the southern bank of the River Avoca. The first section is characterised by a modern footpath (Refer to Figure 12.7), which then joins River Lane and River Walk (Refer to Figure 12.8). This area represents made ground established to the north of the property boundaries to the south, which front onto Main Street. Although this section, the proposed development is located within the zone of archaeological potential for Arklow town and is in immediate proximity to the river, previous archaeological monitoring in this area failed to identify any features or deposits of archaeological potential.

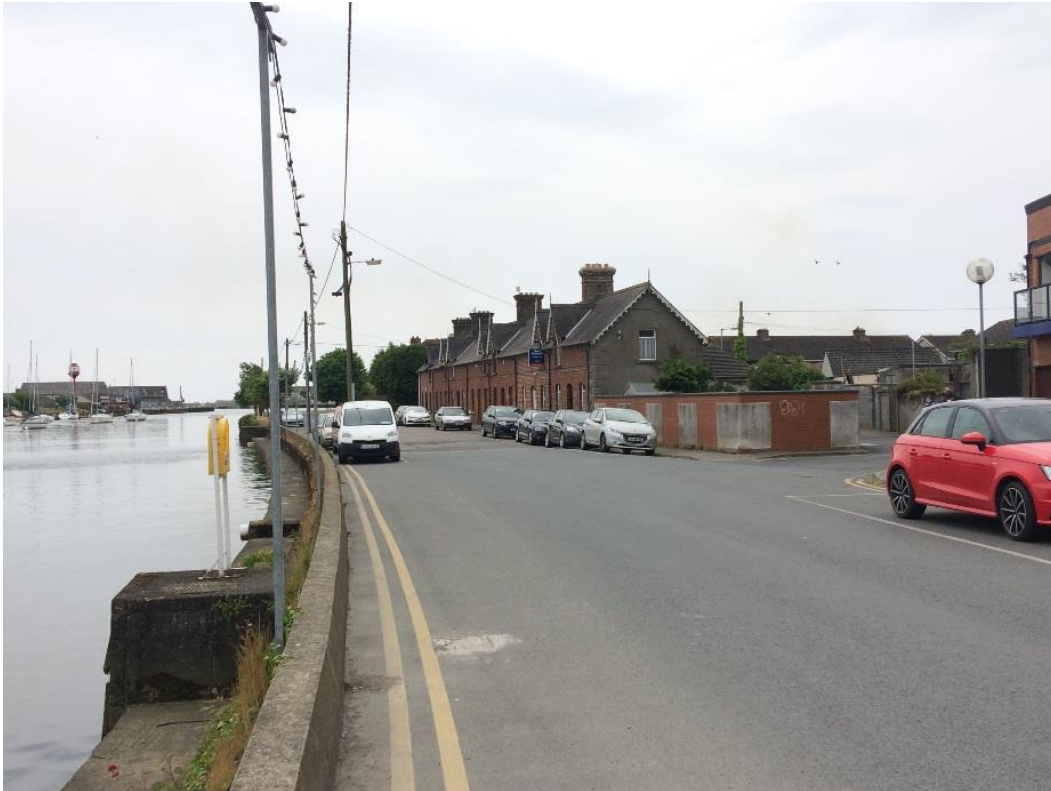
Figure 12.12: South Quay, facing southeast

The proposed interceptor sewer follows the path of South Quay as it re-joins the road from the river channel. This section of the roadway is bounded to the southwest by a mixture of modern and vernacular properties (**Figure 12.12**).

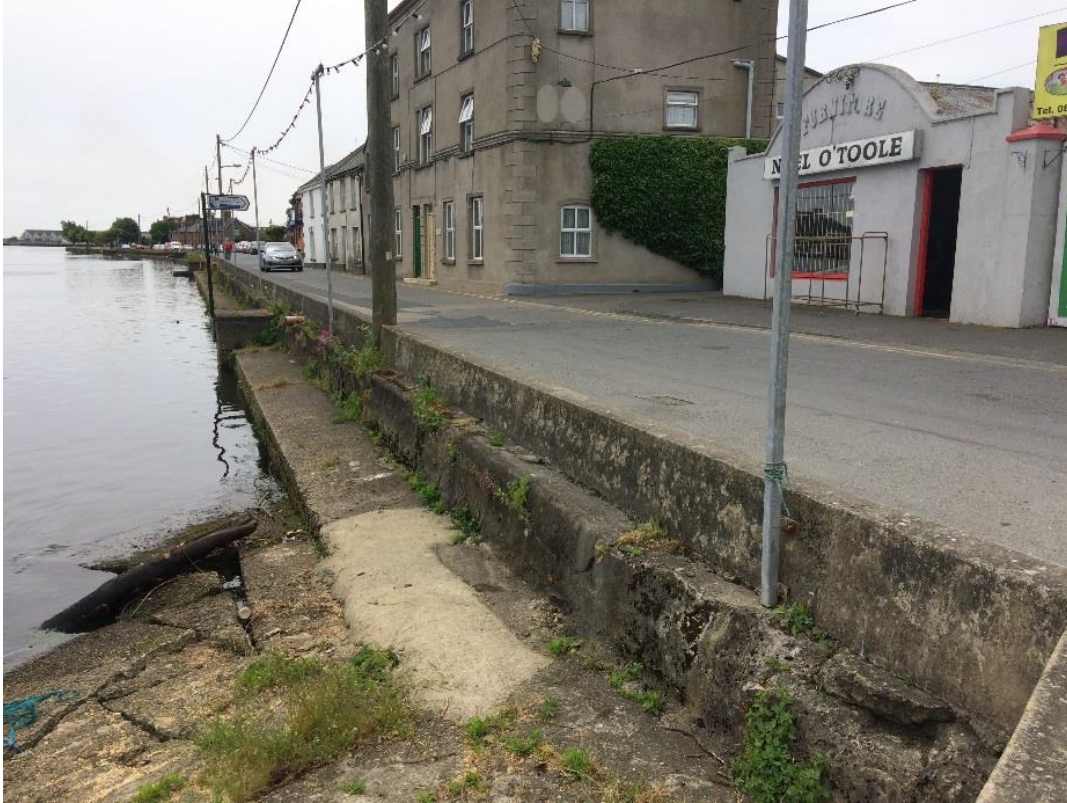
Figure 12.13: South Quay wall, facing south-southeast

The quay wall, although present in sections, has been subject to alteration and large sections have been rendered with cement (**Figure 12.13**). Just to the northwest of the harbour, the pipeline will be tunnelled across the river to the North Quay from South Quay.

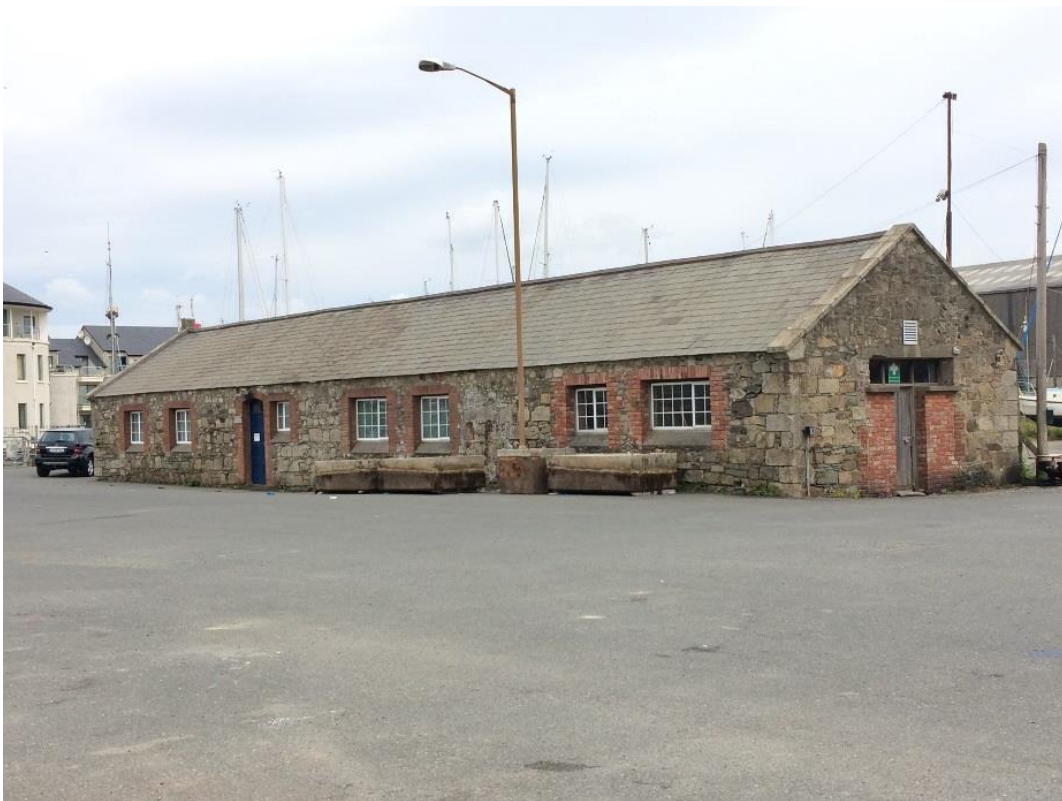
Figure 12.16: Early 19th century Salvage Store, facing north

The surrounding development is modern in nature. The only structures of heritage merit is the early 20th century shipping beacon (NIAH Ref.: 16322030) (**Figure 12.15**), located 60m to the northwest and the former Salvage Store, which is a structure that fronts onto North Quay and dates to the early 19th century. The Salvage Store building is single storey, of roughly coursed masonry construction. Larger windows have been inserted at a later date into the fabric with red brick reveals (**Figure 12.16**).

The original vehicular entrance in the eastern gable end has been blocked up and a pedestrian entrance inserted. The Salvage Store is located outside of the planning boundary.

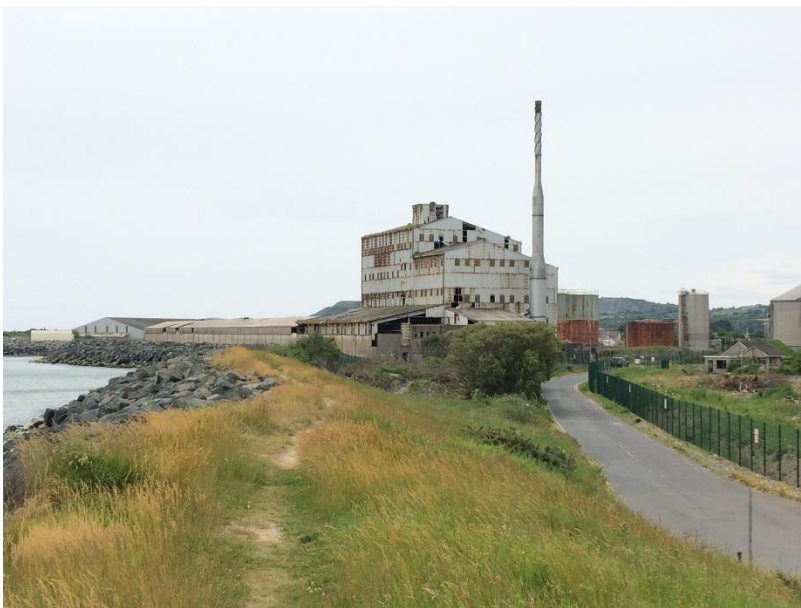
Figure 12.18: WwTP site with coastal rock armour, facing south

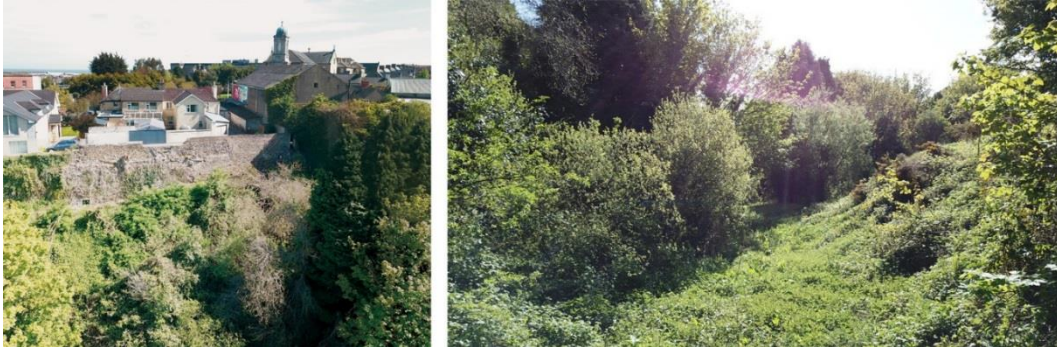
The Alps is an area of vacant land to the west of River Walk behind the properties on Upper Main Street (Refer to Figure 13.3), and adjoins the ruins of Arklow Castle (RMP No. WI040-029002). Part of the lands includes a deep escarpment that runs immediately to behind the buildings on the more elevated terrain of Upper Main Street. The base of the escarpment is typically at the same level as the river bank, beyond which the ground slopes up steeply again to meet the more elevated levels of the town. The escarpment area is heavily vegetated and overgrown with scrub, and includes a number of trees.

Figure 13.3: The Alps escarpment, from elevated and ground level, looking south towards the rear of the buildings on Upper Main Street

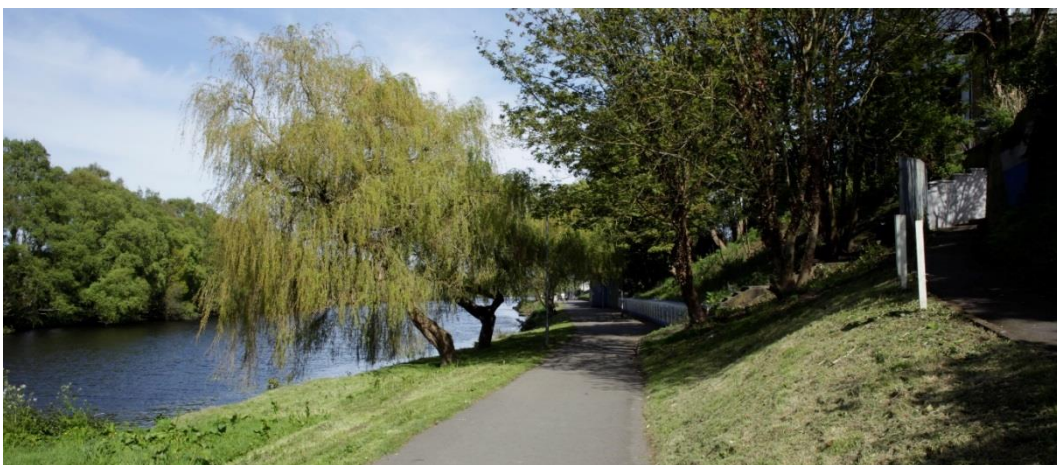
Upstream of the carpark, River Walk is an attractive riverfront amenity walkway, comprising a grass riverbank with occasional mature trees and shrubs affording open views of the river and the more strongly wooded northern riverbank as illustrated in Figure 13.4. Trees are generally in fair to good physical condition, typically fair structural condition, and provide moderate to good amenity value.

Figure 13.4: River Walk upstream of carpark, looking downstream

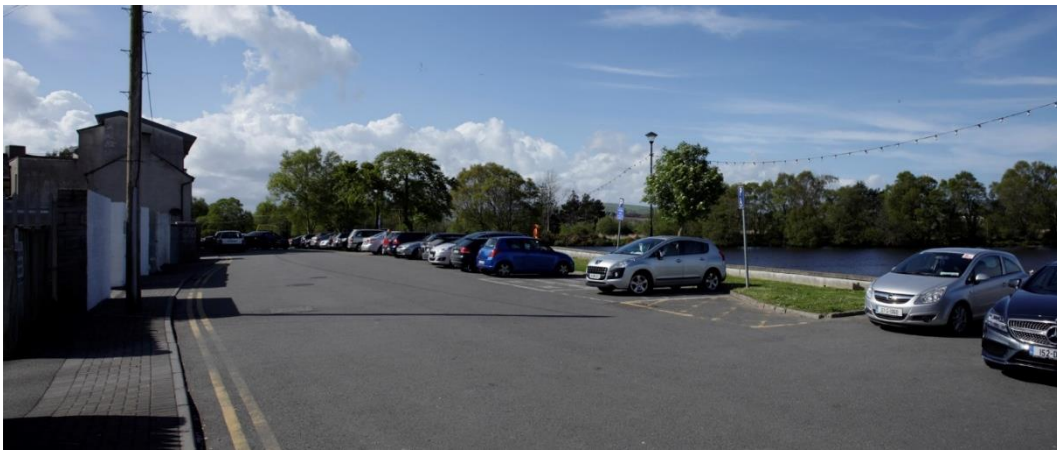
Downstream of the carpark, River Walk provides convenient pedestrian connection and local vehicular access. The walkway along the riverbank is formed in concrete, and a low concrete wall separates the walkway from the roadway and on-street parking as illustrated in Figure 13.5.

The walkway affords open views across the river to the mostly wooded edge of the Arklow Marshlands on the northern side of the river. The Arklow Bridge is also prominent from this location, however, the upstream side of the bridge incorporates extensive concrete piers and cappings that support substantial pipework and a concrete parapet that detracts from the appearance of the stone arched bridge. Trees in this area are typically smaller and younger, in fair physical condition, with fair to poor structural condition, and provide moderate amenity value.

Figure 13.5: River Walk upstream of Arklow Bridge, looking upstream

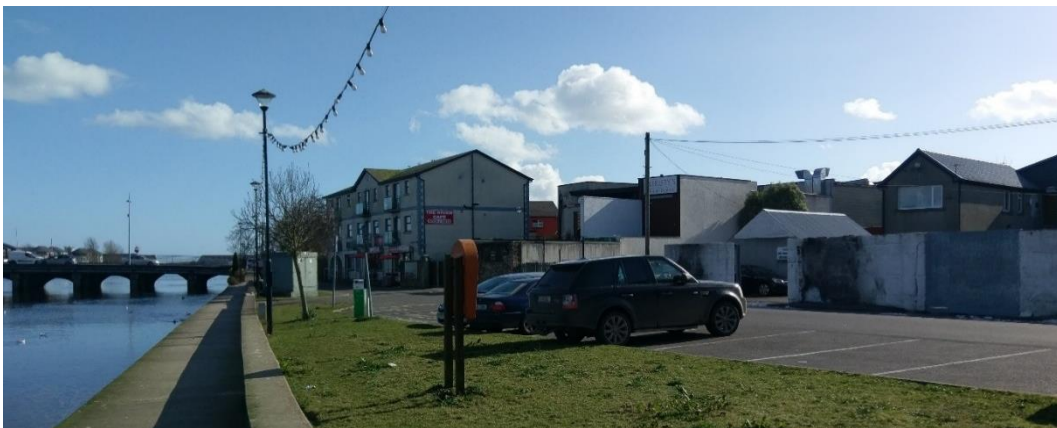
The built side of River Walk downstream of the carpark (Refer to Figure 13.6) includes occasional units that provide active frontage onto the walk, including at the carpark, Condren's Lane and approaching the Arklow Bridge, but the balance comprises rear walls of property boundaries and gates that present a piecemeal and haphazard elevation to the walk.

Figure 13.6: River Walk upstream of Arklow Bridge, looking downstream

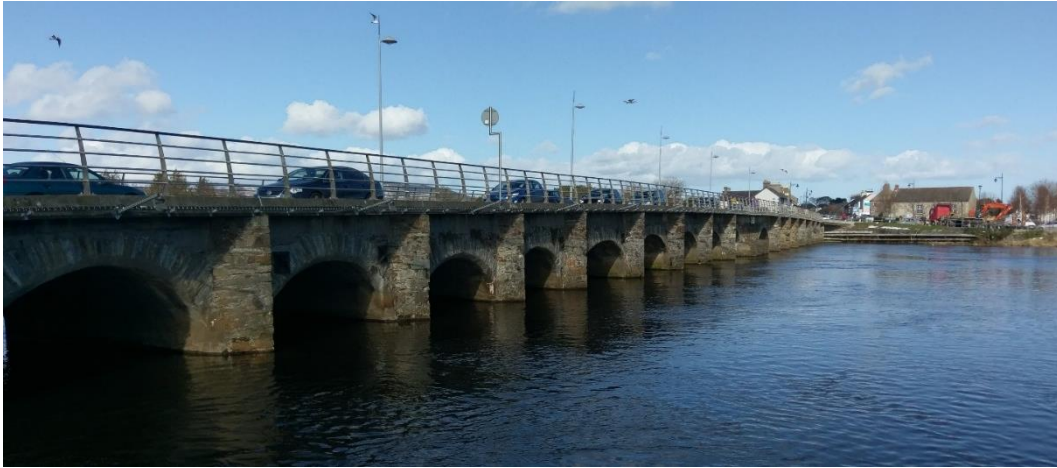
Arklow Bridge is one of the most impressive and defining built elements of Arklow town. Built in the middle of the 18th century, and comprising nineteen stone arches, it is the longest stone bridge in Ireland spanning approximately 150m (Refer to Figure 13.7).

Figure 13.7: Arklow Bridge seen from South Quay

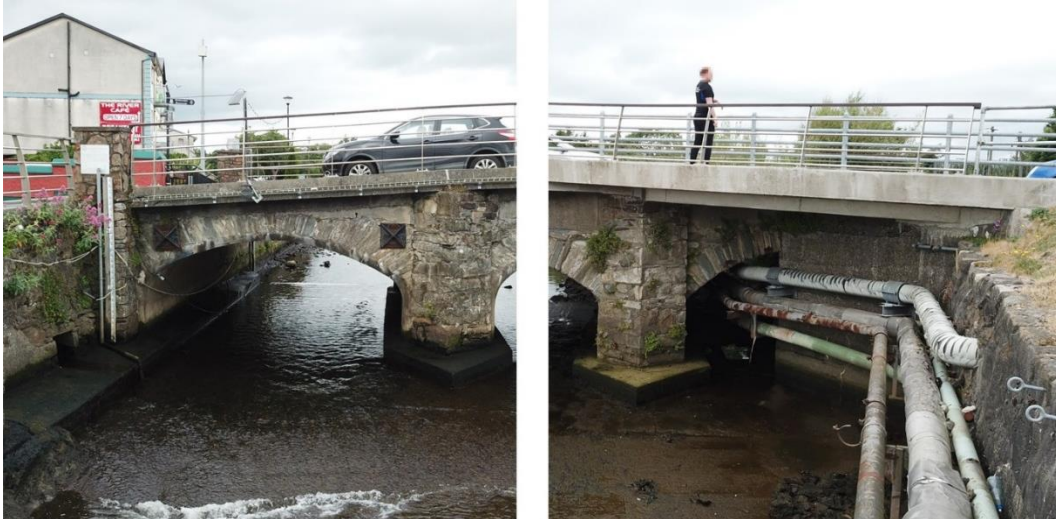
Arklow Bridge is best appreciated from the downstream side, as the stonework on the upstream side is substantially obscured with concrete piles and cappings that support extensive pipework and a concrete parapet. The nineteenth arch on the northern end of the bridge however has previously been compromised by the installation of a range of utilities pipework as illustrated in Figure 13.8. The proposed interceptor sewer will pass through the first arch on the southern side of the bridge, and will be appropriately integrated.

Figure 13.8: Downstream view of the first (southern) and nineteenth (northern) arch of the Arklow Bridge

Additionally, and arising from coordination of the proposed development with the proposed Arklow Flood Relief Scheme, the first two (most southern) arches of Arklow Bridge will require underpinning. The riverbed under these two arches will also be lowered by approximately 1m to mitigate against any potential flood risk associated with the proposed development. It should be noted that the riverbed under the first arch will accommodate the proposed sewer will be covered to the existing riverbed level. Once the sewer is installed, the riverbed under the first arch will be backfilled and finished to the existing riverbed level using salvaged granite flags from the South Quay wall further downstream. The granite flag finish will be similar to the existing riverbed detail under a number of the existing arches. The difference in riverbed levels at the first and second arch will be formed with a 1 in 2 slope that will be stone faced.

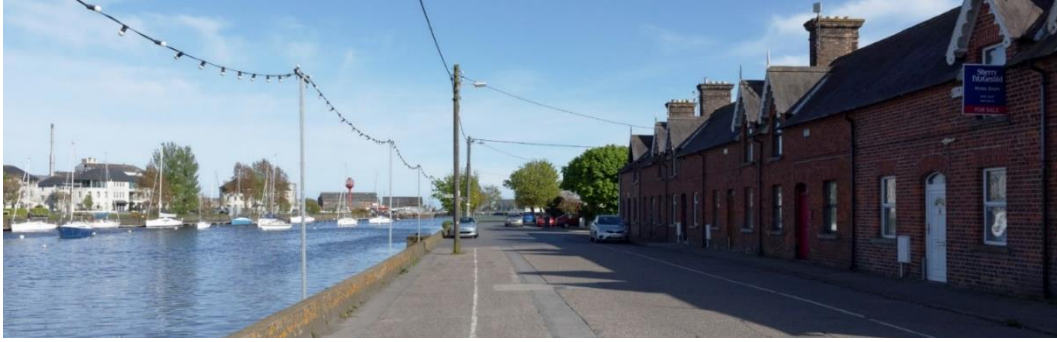
The roadway along South Quay varies considerably to include one-way single carriageway and wider two-way sections. There are minimal footpaths on one side only between Doyle's Lane and South Green (refer to Figure 13.9), beyond which there are frequently no footpaths on either side of the road. Depending on the width of the roadway, parking is generally defined on either one or both sides of the road. Further downstream, there is space for parking but it is not generally defined. South Quay is mostly used for residential access, however, a substantial number of heavy goods vehicles also use South Quay for access to and from the harbour area and the quarry at Arklow Rock to the south.

Figure 13.9: South Quay looking downstream, with residential buildings directly facing the quayside

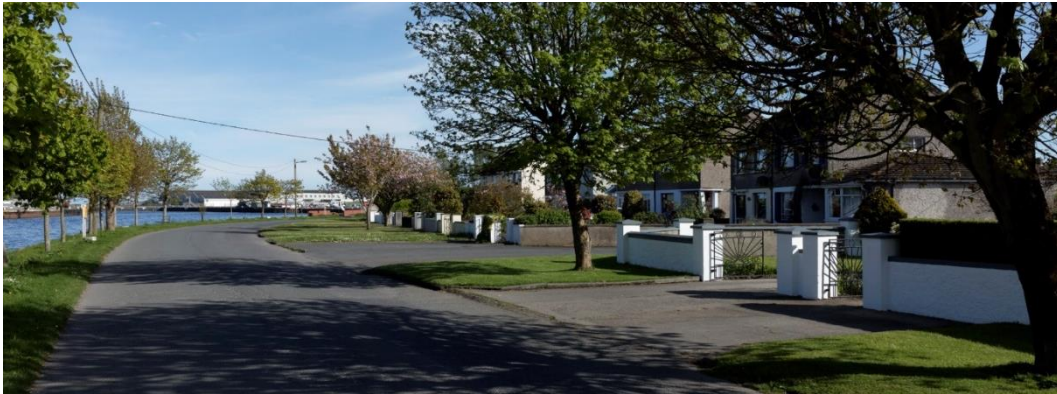
Starting at the junction with South Green, there is a grass verge along the quayside incorporating a row of mostly young Norway Maple trees interspersed with individual semi-mature Lime, Rowan, Cherry, White Poplar, Sycamore and Hawthorn trees as illustrated in Figure 13.10. Trees are generally in fair physical and structural condition, but are of low arboricultural quality and value. While they currently provide some amenity value, their poor growing environment is likely to limit their future value.

Figure 13.10: South Quay looking east from near junction with South Green

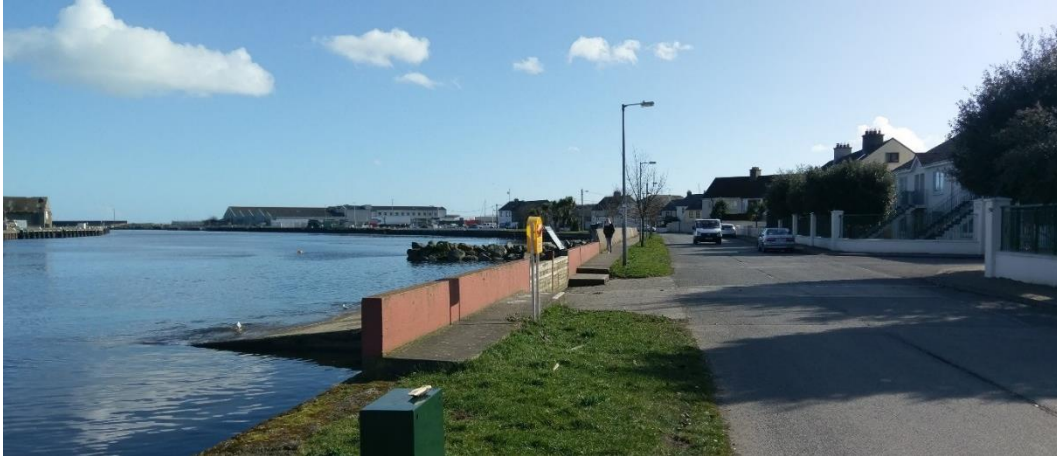
A slipway is located on South Quay directly opposite the Arklow Marina on South Quay as illustrated in Figure 13.11. The John Tyrell Boatyard once stood on South Quay directly behind the slipway where the Anchor Mews development now stands, and boats built at the boatyard made their way across South Quay to be launched from the slipway. An information panel is located on top of the slipway telling the story of the John Tyrell Boatyard. A concrete flood defence wall extends from this location eastwards (i.e. downstream) along South Quay.

Figure 13.11: South Quay slipway opposite the Anchor Mews development

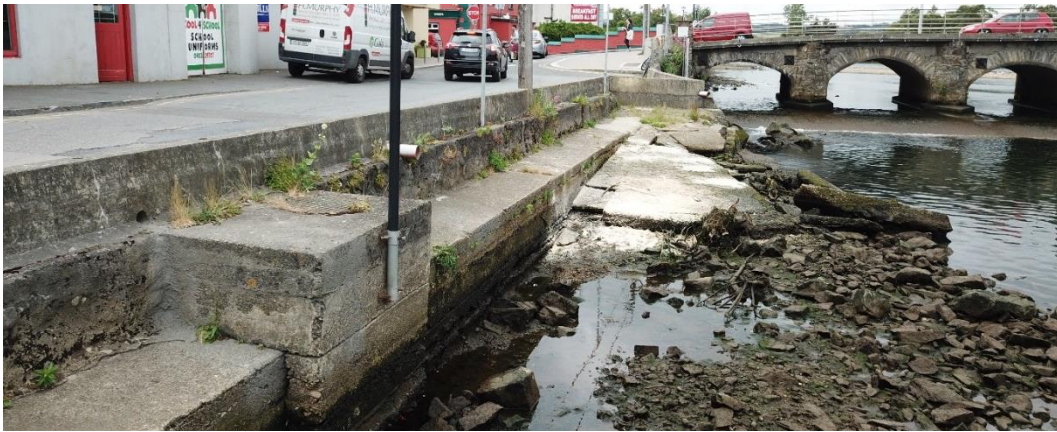
Figure 13.13: Poor condition and presentation of quay wall downstream of Arklow Bridge

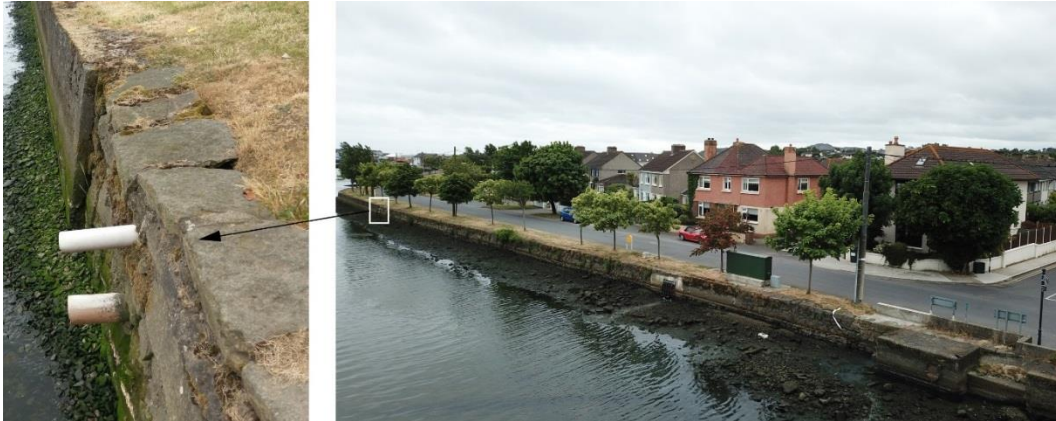
Figure 13.14: Section of quay wall where rubble stone remains visible and stone flags form top of wall

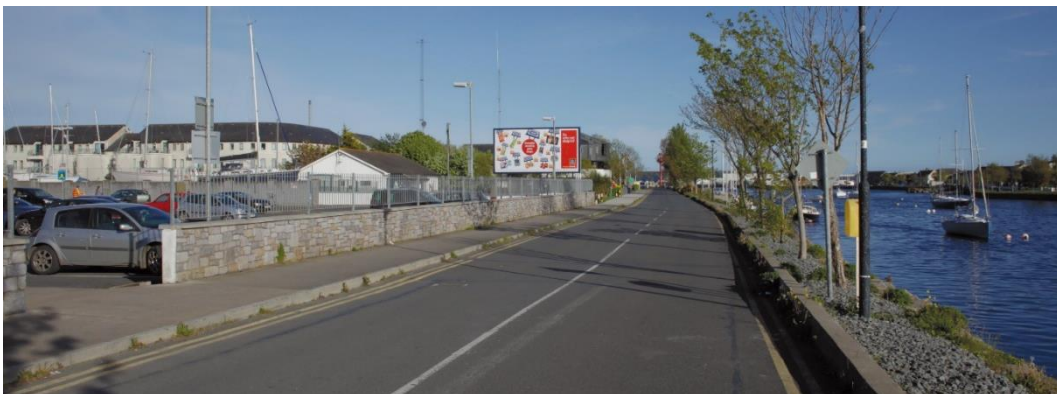
The quayside comprises either a simple low concrete stub wall or a galvanised steel crash barrier to protect vehicles from the quay edge. The space between the barrier and the actual quay wall ranges in width from 1.5 to 2.5m and trees are planted within this narrow space (Refer to Figure 13.16). The trees are mostly young Norway Maple with some early mature Hybrid Poplar. Many of the trees are in poor to fair condition – some are dead – and have low vitality as a result of the limited space available for root development.

Figure 13.16: North Quay carriageway, showing narrow roadway and limited space on quayside for tree establishment

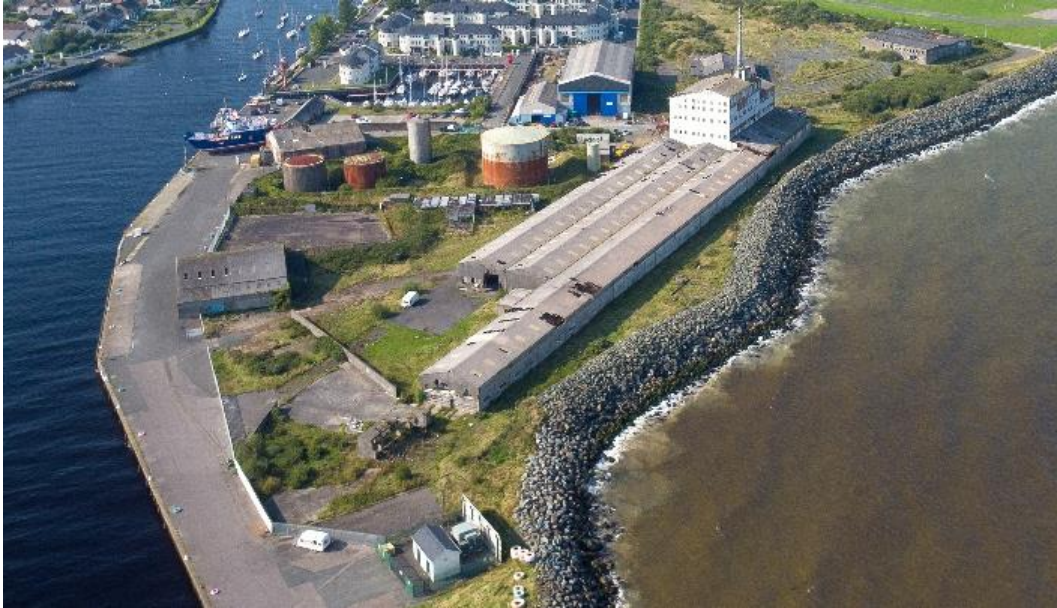
The Old Wallboard building is over 200m long and is located along the eastern side of this piece of land as illustrated in Figure 13.19. A grass strip of between 5 to 10m width runs between the eastern side of the building and the rock armour revetment. The northern part of the building, approximately 40m long and 35m wide, is the tallest part of the building with the ridge and stack rising to over 27m and 43m in height respectively. The remaining southern portion of the building is approximately 9.0m in height to the ridge, and is mostly a three bay structure approximately 40m wide, with the southernmost section reducing to a single bay of around 13m width.

Figure 13.19: Old Wallboard facility and other industrial structures at Ferrybank

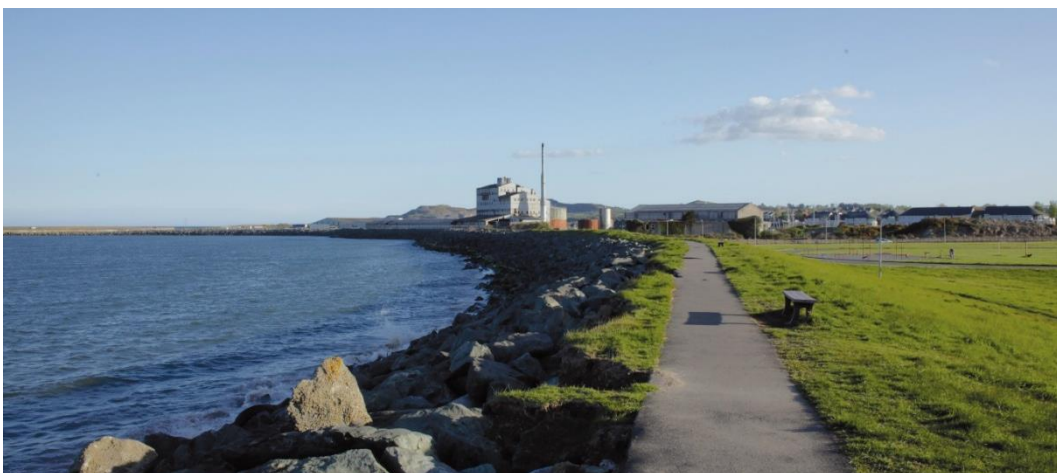
A rock armour revetment extends from the northern pier at the harbour mouth, towards the north-west for approximately 2km to Arklow North Beach. The revetment forms the seaward boundary of the Old Wallboard site, and is typically 3m higher than the adjoining land and at an average gradient of 1 in 2.

From Mill Road northwards, the landward side of the revetment is formed in earth with scrub grass cover and the revetment incorporates a pedestrian walkway along the top that continues as far as Arklow North Beach and provides expansive views of the coastline. The grassed landward side of the revetment is at a gentler gradient of approximately 1 in 4. See Figure 13.19

Figure 13.20: Pedestrian walkway on top of revetment looking south towards the Old Wallboard site

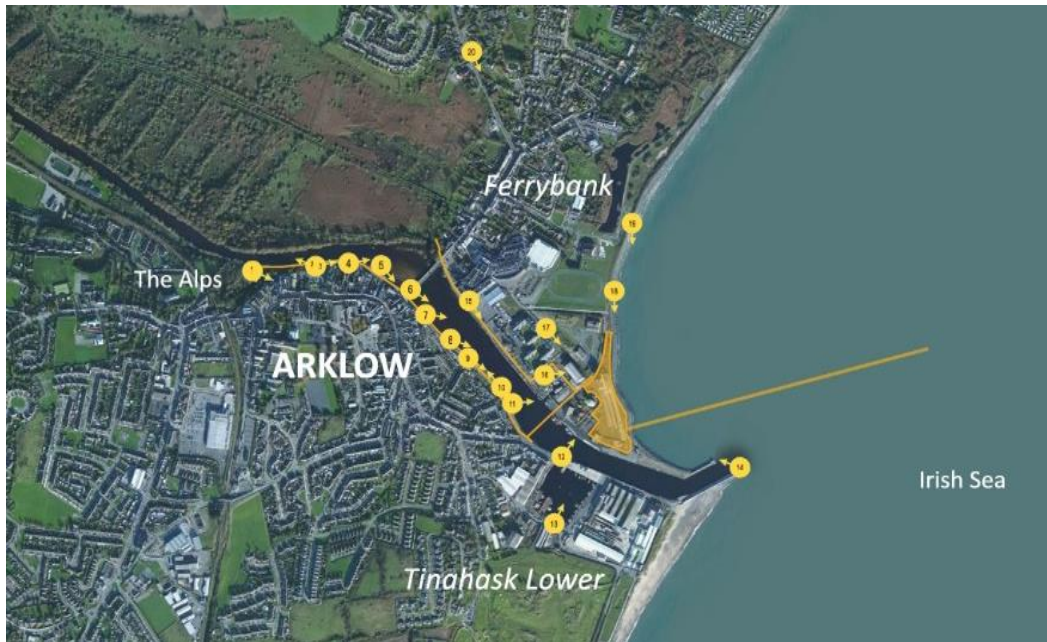
A series of photomontages, illustrating the physical and visual appearance of the proposed development, has been prepared from a range of publicly accessible locations that are representative of the river corridor within the town and of the more open views in the surrounding environment. The Photomontage views show the post construction scenario, and are included within **Appendix 13.1 and Volume 3**.

Figure 13.21: Location of photomontage viewpoints (Refer to **Appendix 13.1 and Volume 3** for further detail)
