INSPECTOR'S REPORT ON AN APPLICATION
FOR A CERTIFICATE OF AUTHORISATION
FOR A CLOSED LANDFILL

TO:	Dr. Eimear Cotter, Director	
FROM:	Ewa Babiarczyk, Inspector	Environmental Licensing Programme
DATE:	24 th January 2020	
RE:	Application by Cavan County Council for a Certificate of Authorisation for a closed landfill at Cootehill Landfill, Pottleboy, Cootehill, County Cavan . Certificate of Authorisation Register Number H0020-01 .

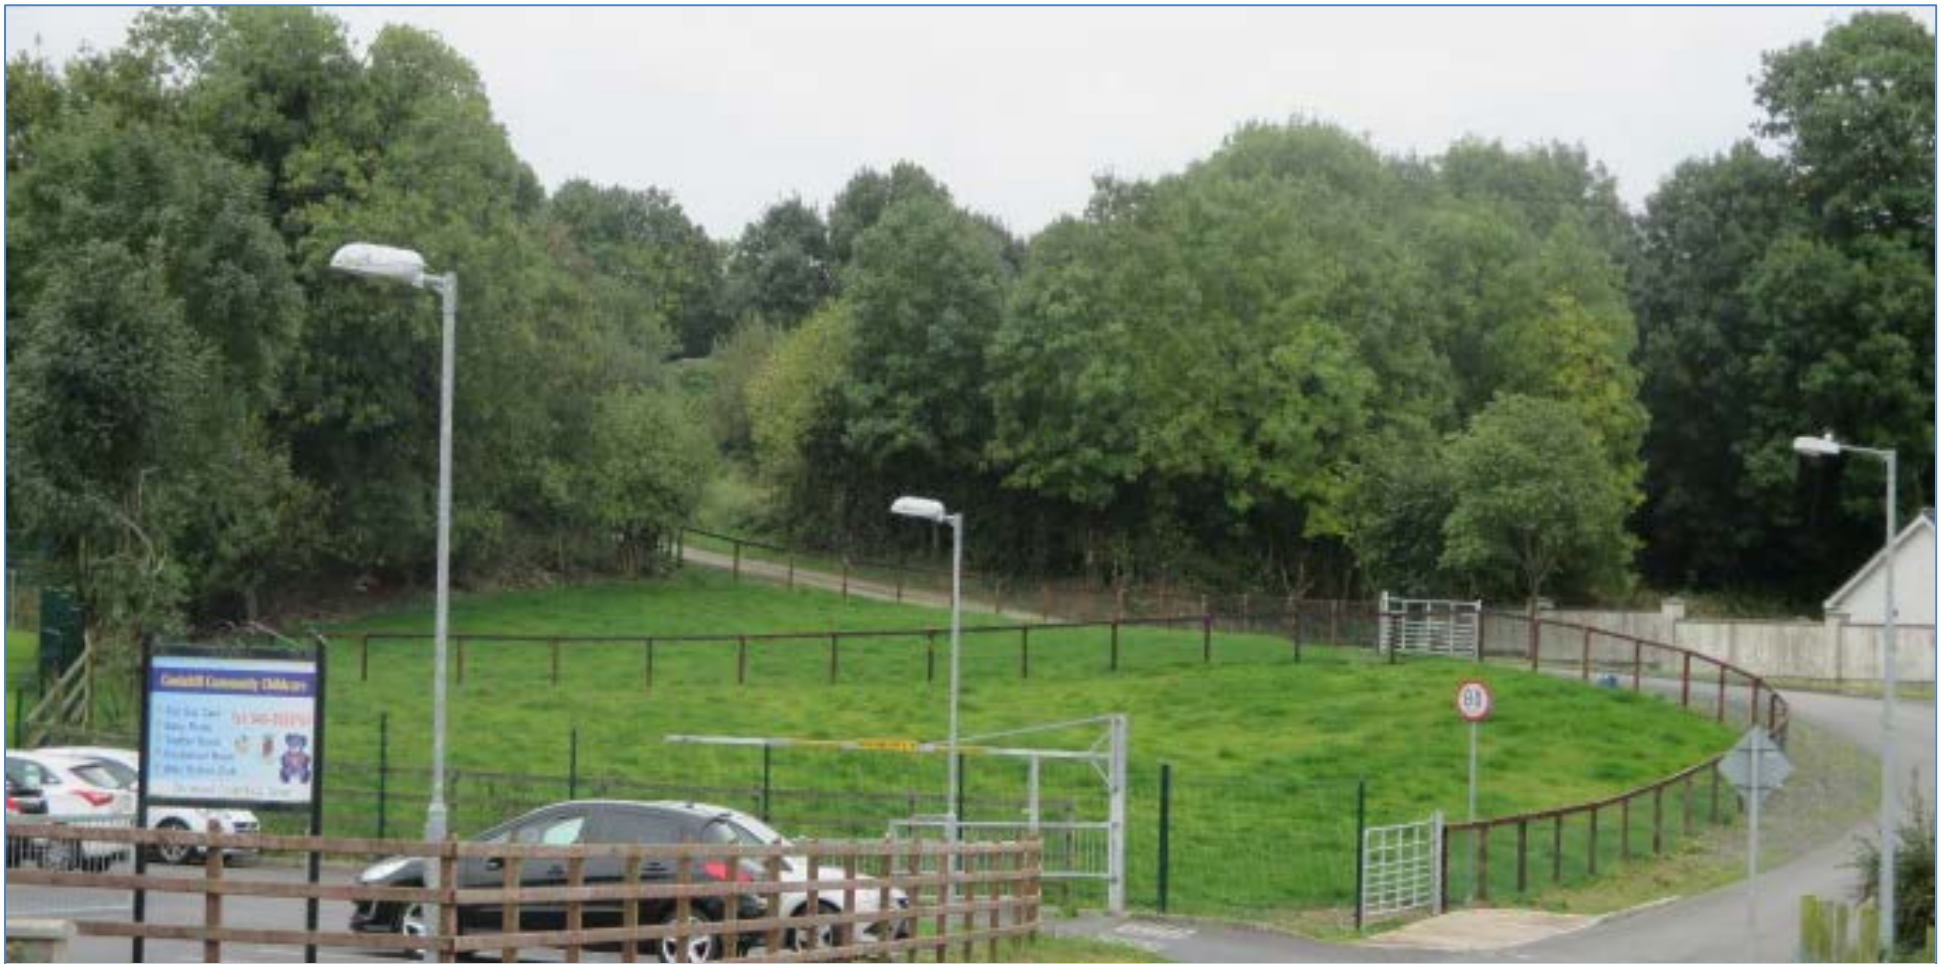
Figure 3: Current condition of the landfill site

Current condition and appearance of closed landfill:	The landfill site is now grassed and fenced off as shown in Figure 3. There is a small stream, referred to in the application as Pottleboy stream, flowing along the northern and western site boundary as shown in Figure 4.
Site investigations	The site investigations established the following facts: <ul style="list-style-type: none"> • the extent of the waste body is 1,700 m²; • waste was found in 19 of the 25 trial holes excavated as shown in Figure 6; • waste material was intermixed with clay; • the landfill is not lined; • the landfill gas was being generated; however, the recorded gas levels were low; and • in some areas of the site the bed rock was reached at a depth of 0.6m.
Monitoring and analysis of samples (water, gas, waste):	The following site investigations were carried out as part of Tier 2 and Tier 3 investigations: <ul style="list-style-type: none"> • topographical survey (carried out in October 2014); • ecological survey (carried out in November 2014); • trial hole survey, including waste classification (carried out in October 2014); • gas monitoring (was carried out on 15 occasions over a six week period from October 2014 to November 2014. Also, extended gas monitoring was carried out in November 2014); • soil sampling (carried out in October 2015); and • sampling of water quality in the stream (carried out in 2014).

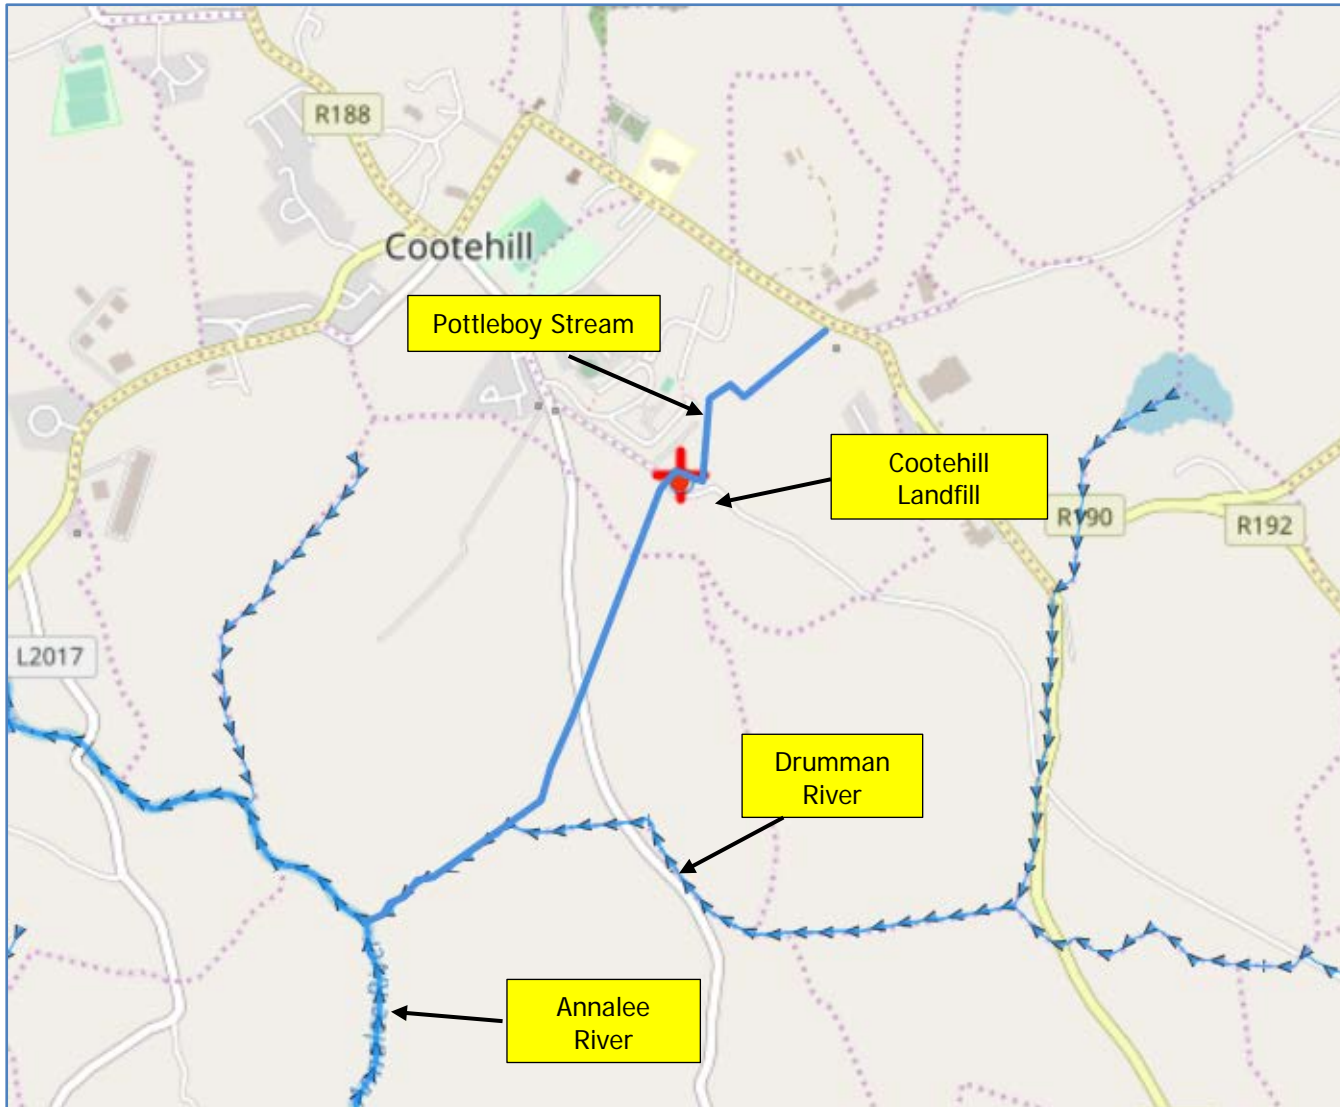
Figure 4: Local river network

Hydrology	The Pottleboy Stream flows in a south-western direction and discharges to the Drumman River (Waterbody code: IE_NW_36A020600) 0.9km downstream of the closed landfill. Drumman River discharges to Annalee River (Waterbody code: IE_NW_36A020600) 1.3km downstream of the closed landfill. The status of the Drumman River and Annalee River is good. Approximately 25km downstream of the landfill site the Annalee River forms a part of Lough Oughter and Associated Loughs SAC [Site Code: 000007]. A section of the stream that borders with the landfill site is piped as shown in Figure 5. Sampling of water quality in the stream was carried out at locations upstream and downstream of the landfill in October 2014 (see Figure 5 for sampling locations). The analysed parameters included pH, electrical conductivity, dissolved organic carbon, fluoride, chloride, sulphate, volatile organic compounds
