**Re: Kingscourt Landfill Reg. No. H0016-01
Appeal of Conditions of Proposed Decision**

KINGSCOURT HISTORICAL LANDFILL RESTORATION PROJECT

VALIDATION REPORT

CAPPING WORKS

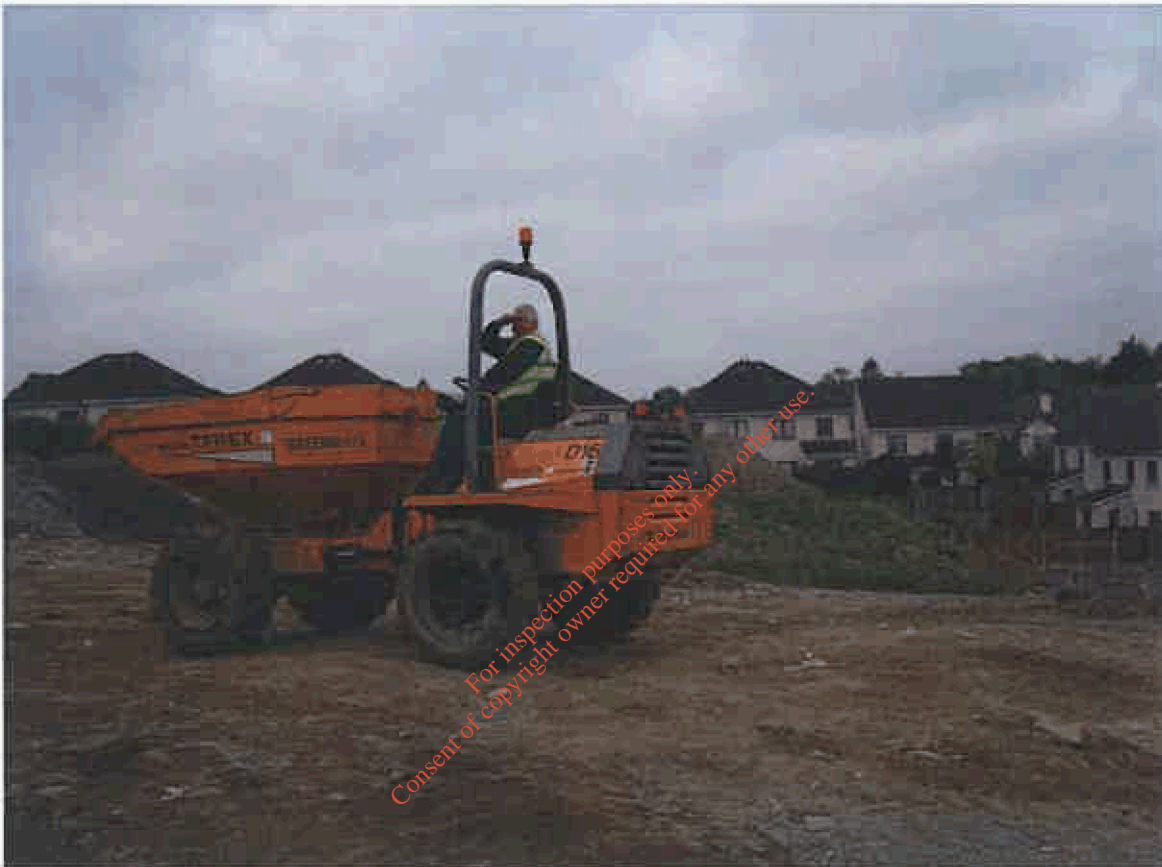
Photograph 1 showing site preparation works.

The initial preparation of the site comprised of securing the access points as a construction site. Safety fencing was erected where required and both on-site and off-site safety signage was erected. A full risk assessment was carried out by the contractor and a safety file prepared and retained on site. Part of the site is in use as a storage depot by Cavan County Council.

Further site clearance works included clearing bushes and shrubs from the site especially at the rear of the houses whose gardens adjoin the facility.

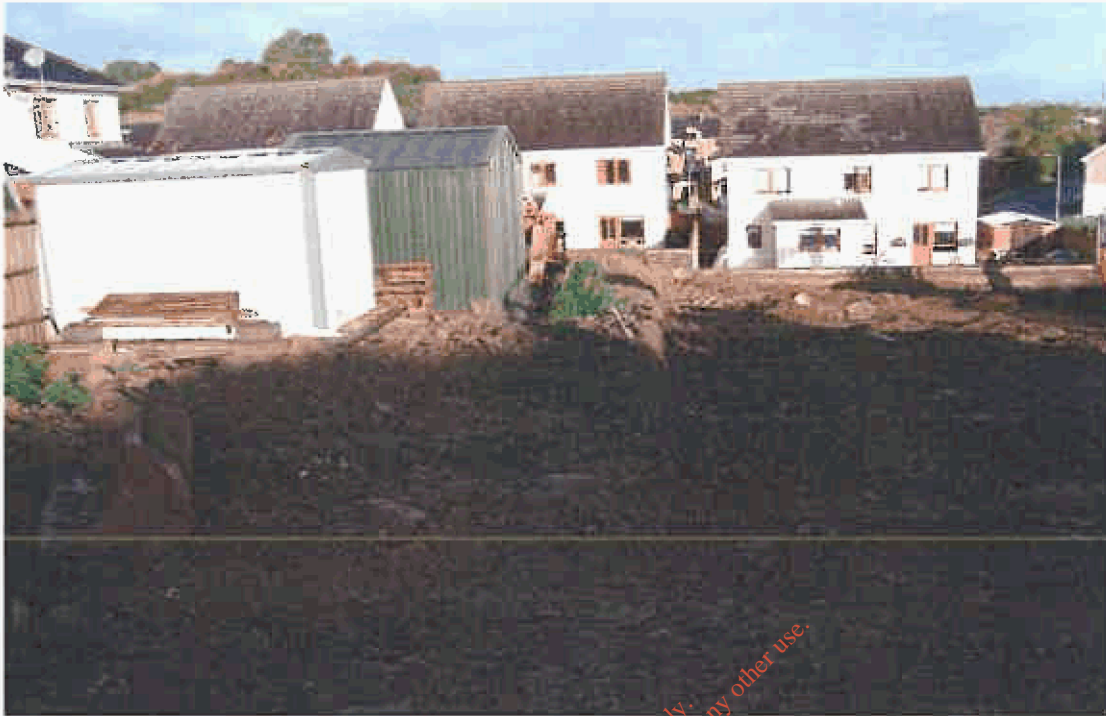
Photograph 2: Grading and profiling works.

Phase 1 works comprised the grading and profiling of the site to ensure suitability for lining works. As per the Tier 3 Traynor report it was decided that the option with the lowest impact would be to leave the waste in situ. Therefore the most significant aspect of this work was to ensure that the entire site was graded with a suitable slope and surface that permitted effective lining works. There were three stockpiles of soil and a stockpile of pea gravel on site and these were sampled and analysed for suitability to use for this purpose and for use as the final cap. The Waste Acceptance Criteria (WAC) testing of this soil confirmed that it was suitable for this purpose. There was an initial concern that the pea gravel showed a slightly elevated level for arsenic however on retest this proved not to be the case. Further pea gravel was imported from the same source when required for grading works and to protect the liner. No addition soils was imported on to the site. The locations

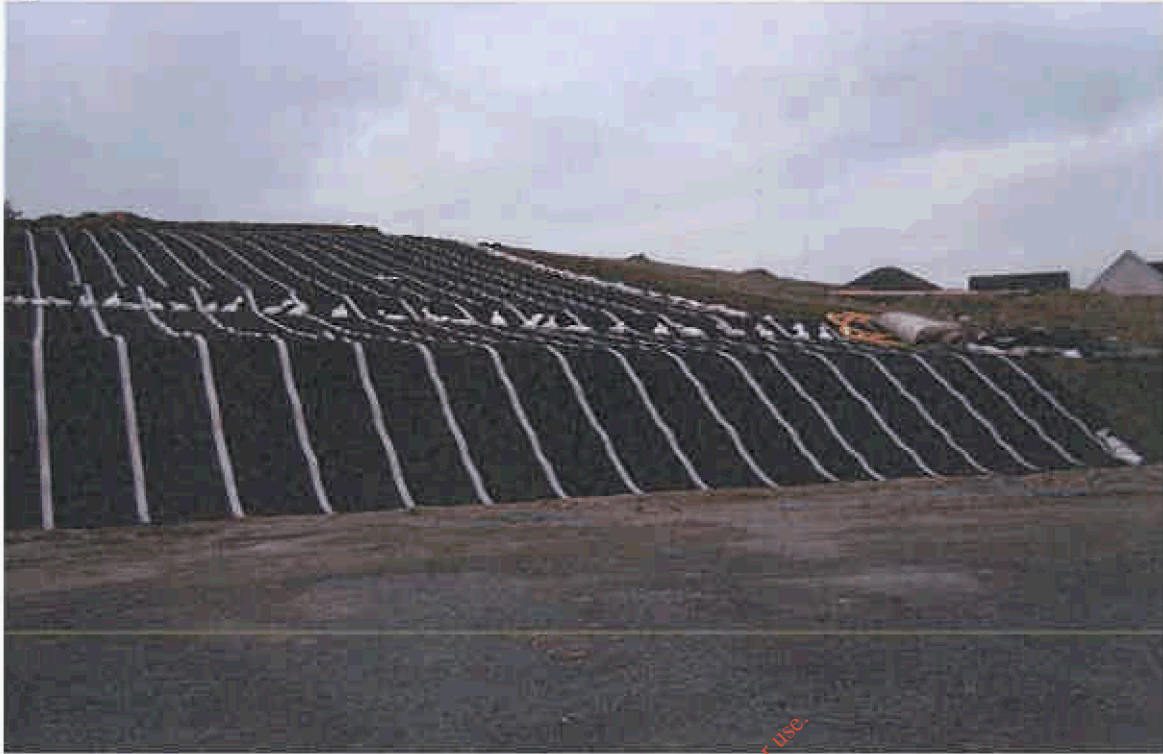
The lining comprises a protective layer of Terram, a geosynthetic protective layer which is placed to protect the liner from possible damage by stones etc. in the soil. This is followed by the LLDPE (Linear Low Density Polyethylene) liner, followed by another layer of Terram to protect the liner from stones etc. in the soil above. This will also act as a drainage layer. Finally the cap is finished off with a layer of soil approximately 700 mm deep. The LLDPE liner is welded in situ and all of the welds are tested for quality assurance and to demonstrate that they are leakproof. There is a 1 metre deep anchor trench around the entire perimeter of the landfill.

Photograph 5 showing the LLDPE liner being rolled out.

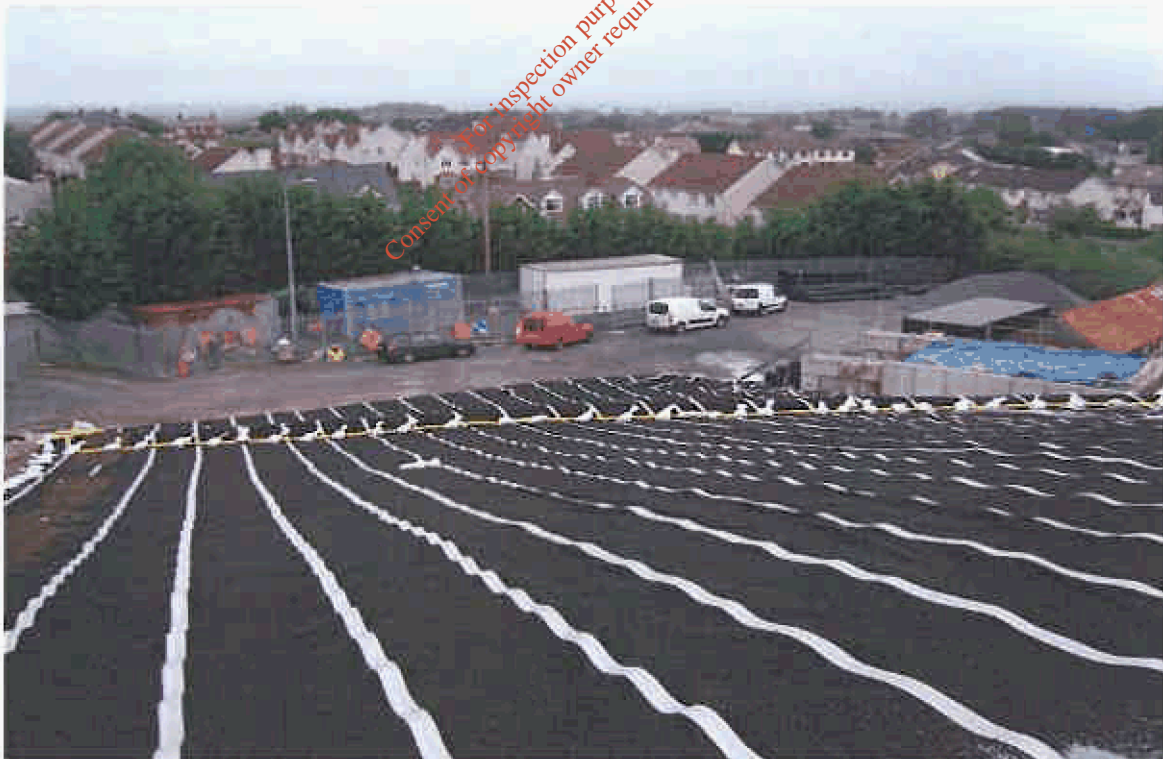
Photograph 6 showing LLDPE liner and surface water collection (yellow pipe).

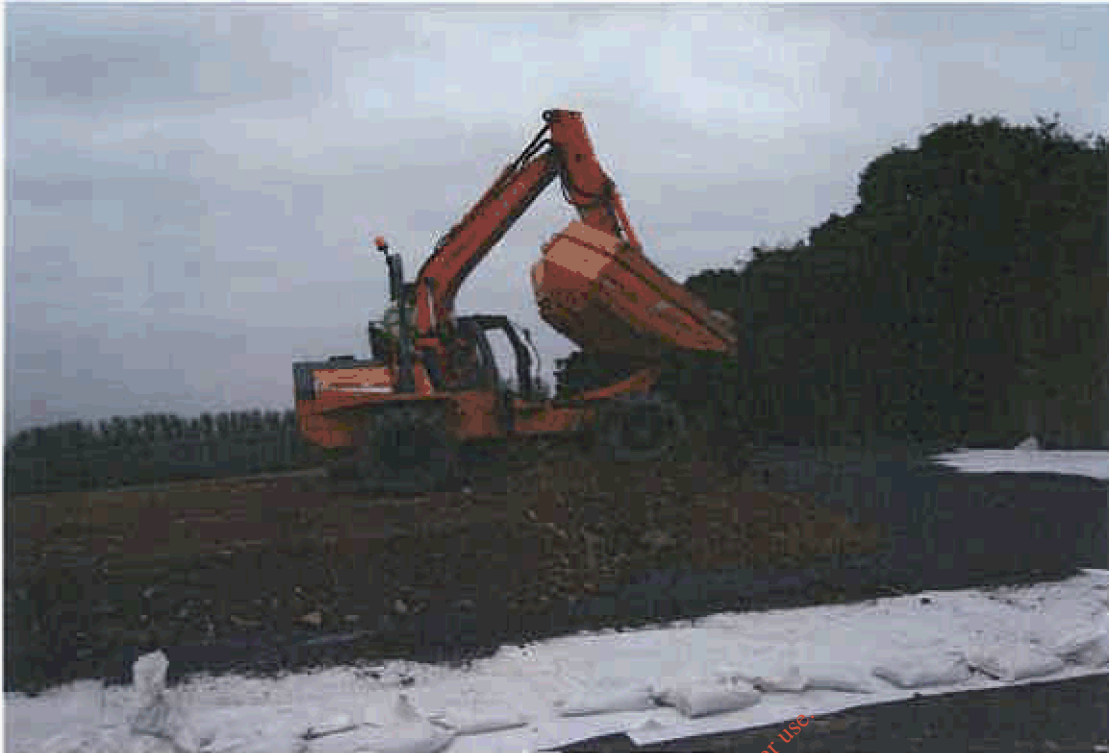
Photograph 7 showing Terram top layer in place covered by pea gravel in turn covered by the final soil cap.

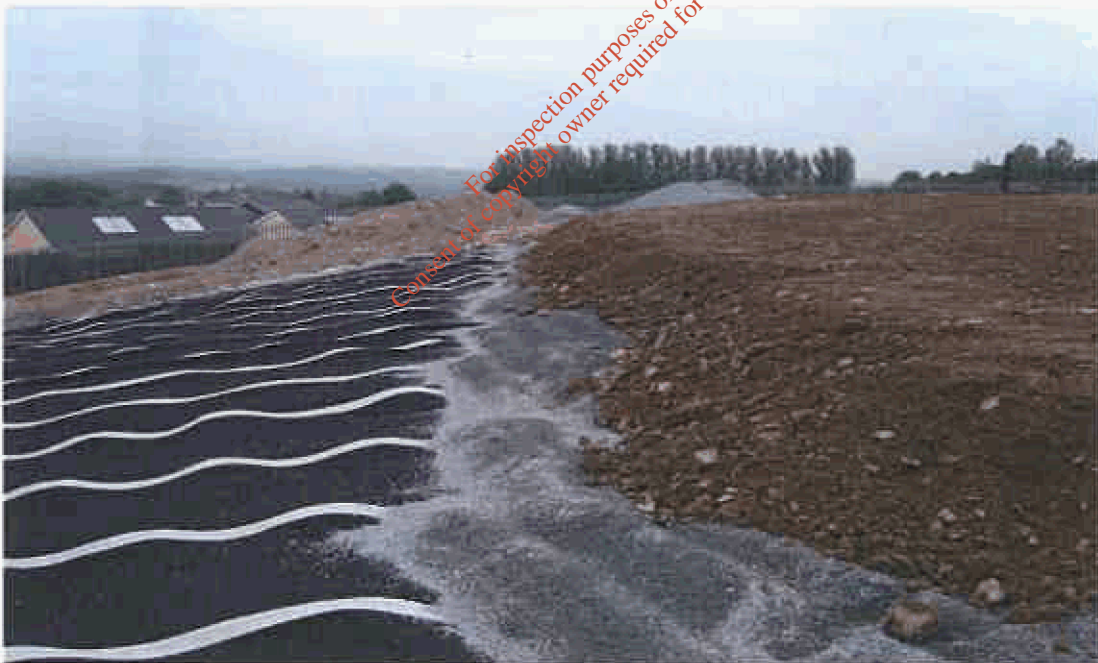
Photograph 8 showing placement of final layer of soil

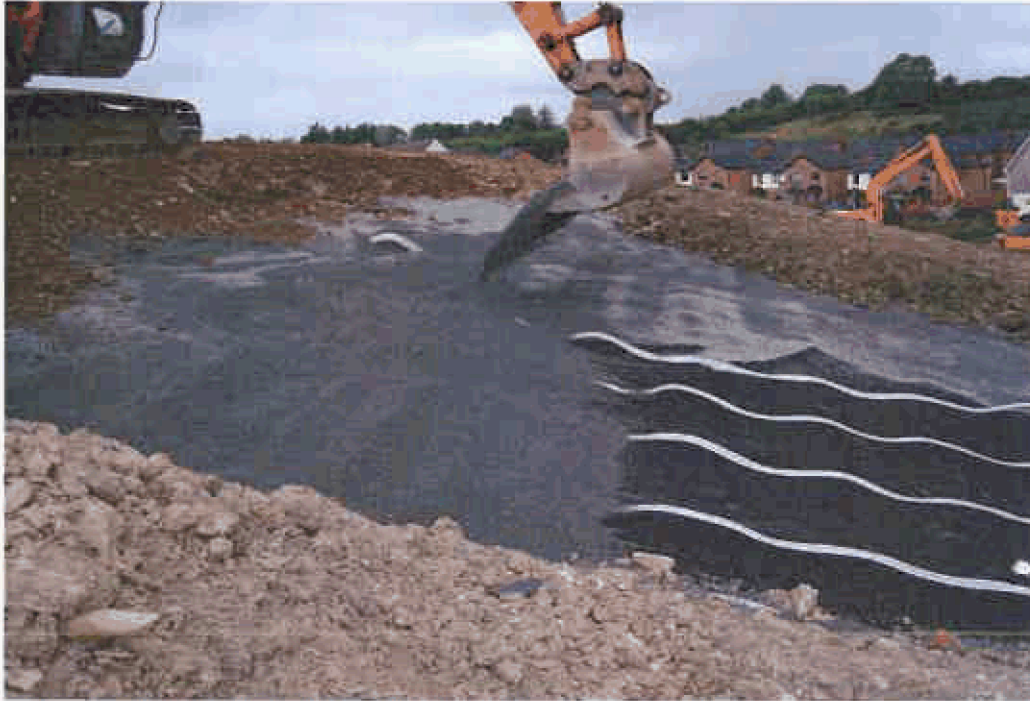
Photograph 9 showing capping layers.

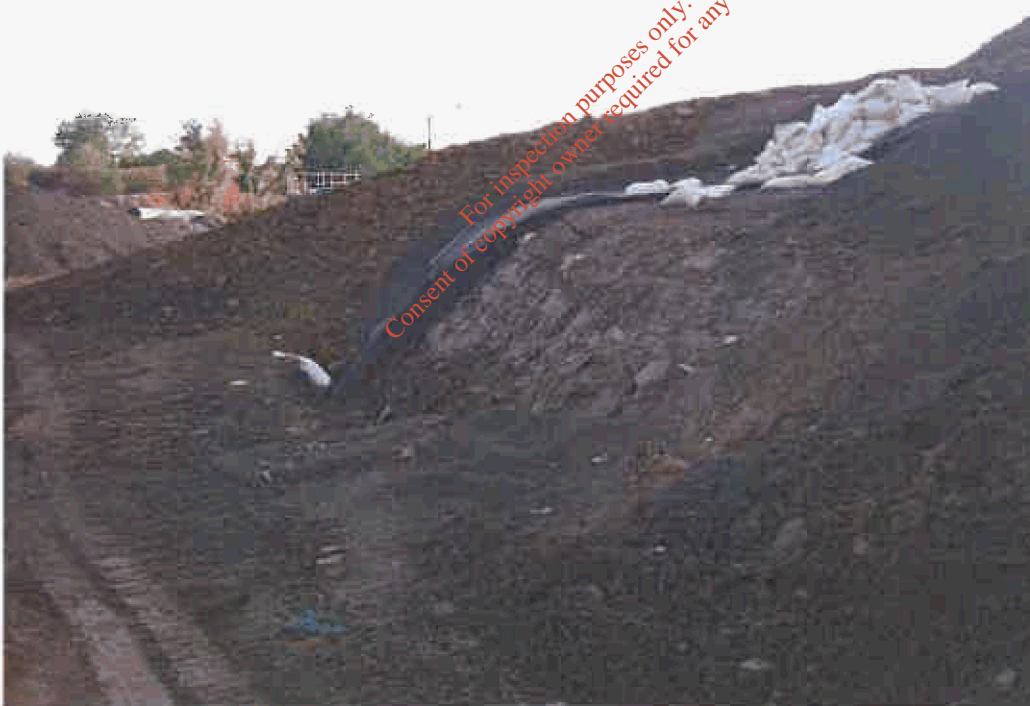
Photograph 10 showing anchor trench

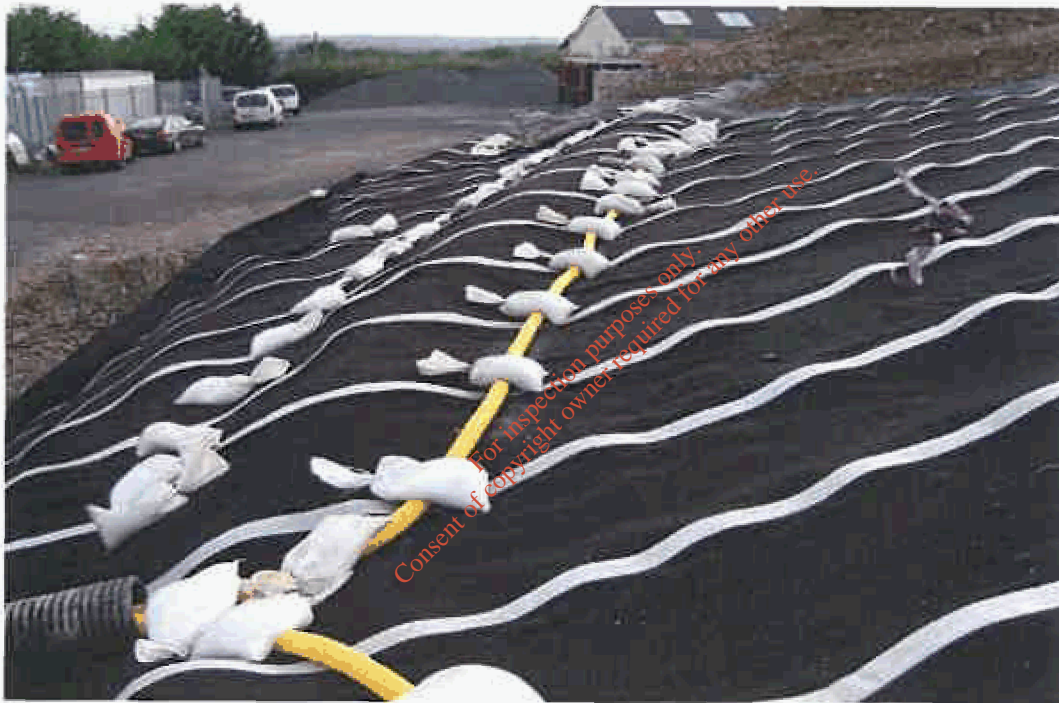
The Traynor report recommends that control of surface water be implemented to reduce the infiltration of surface water into the waste body and promote surface water runoff and drainage to the watercourse on the north-eastern aspect of the landfill. The gradient of the slope and the impermeability of the liner combined with the design of the drainage layer as described above will ensure that all surface water runoff is collected and directed to the existing watercourses adjacent to the site. The drainage layer is depicted in photographs 10 and 11 below and comprise the terram layer with slatted pipe placed at the bottom of the slope which directs the water into larger collection pipes for distribution to the local surface water systems.

Photograph 11 showing slatted pipe (yellow) for collection of surface water running into larger (black) pipe.

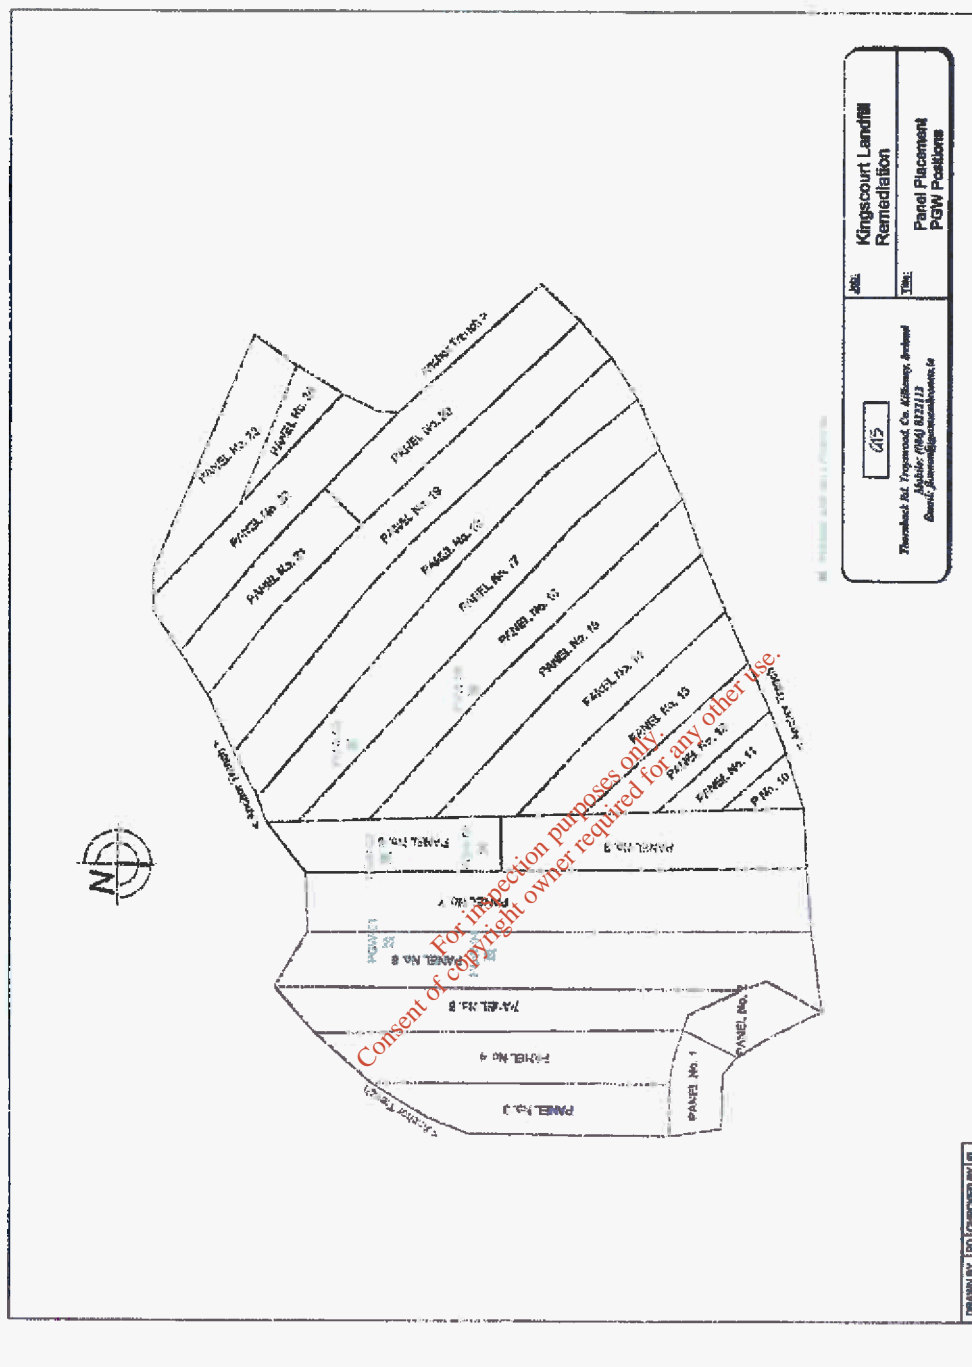
Figure 2 Location of passive gas wells

As recommended by the Traynor report 6 passive gas wells was installed. These were installed as per the attached locations map (green text) all located within the main body of the waste.

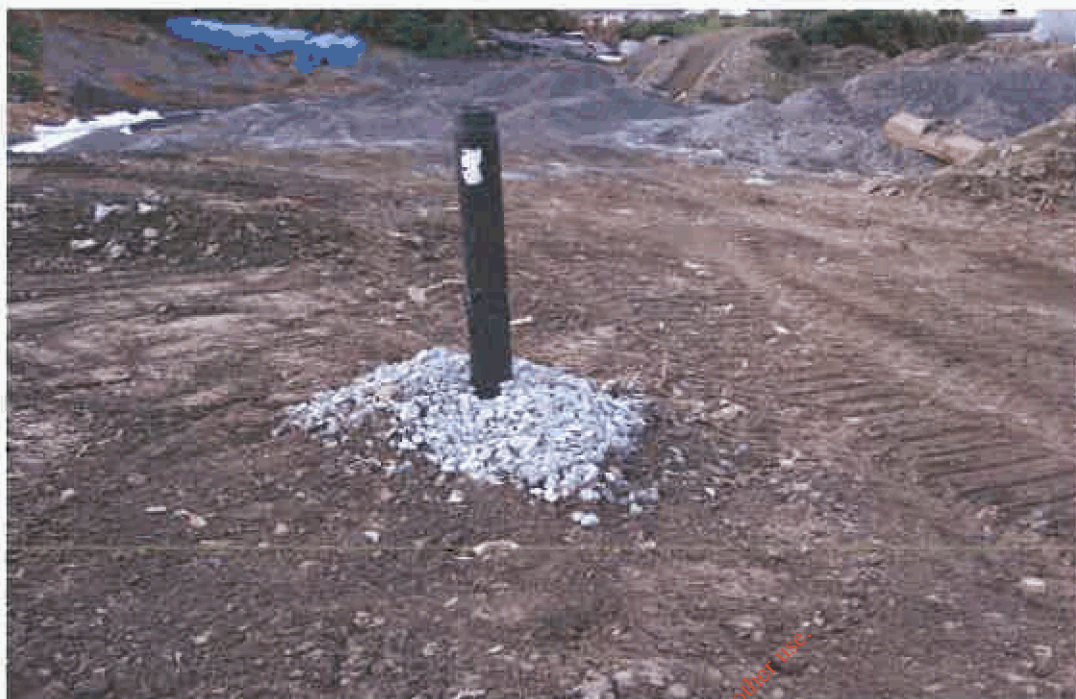
Photograph 13: Passive venting gas well

These wells consist of 160mm slotted pipe installed to a depth of 4 metres with the section of the pipe that is not slotted installed a minimum of 0.5 metres below the liner. The wells are backfilled

with stone 5mm or less to the full depth and with a diameter of 1 metre. See photograph 12. These wells extend to at least 1 metre above the surface.

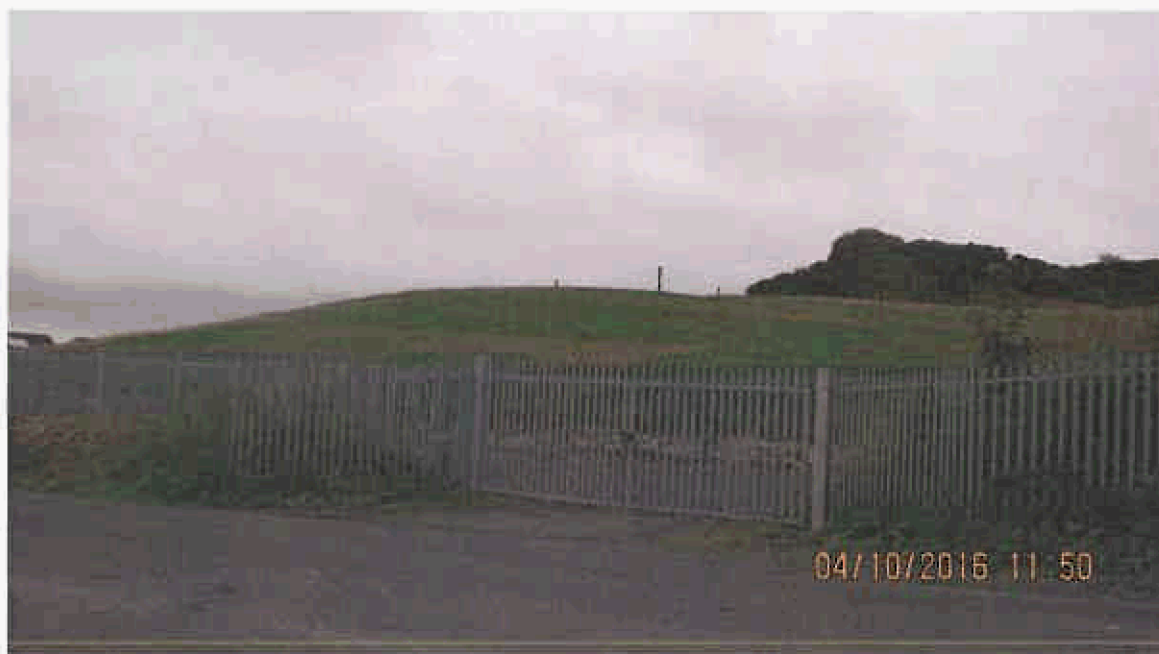
Photograph 15 Entrance to site showing remediation works and passive gas wells

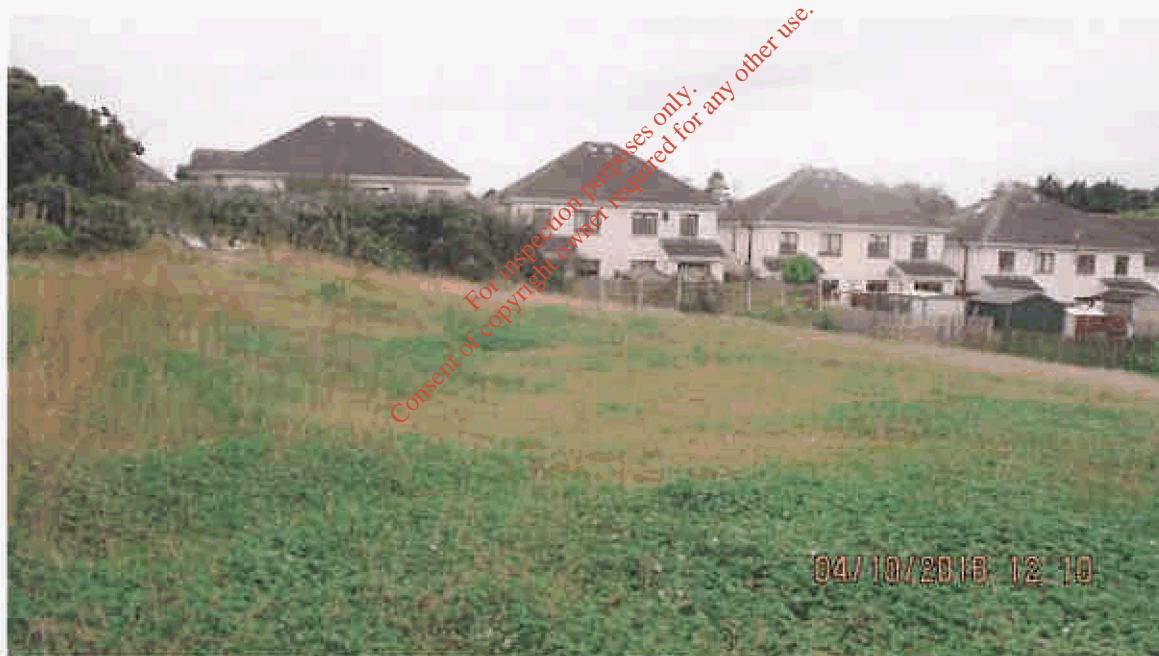
Photograph 16 showing remediated site at rear of dwelling houses. (cf photograph 3.)

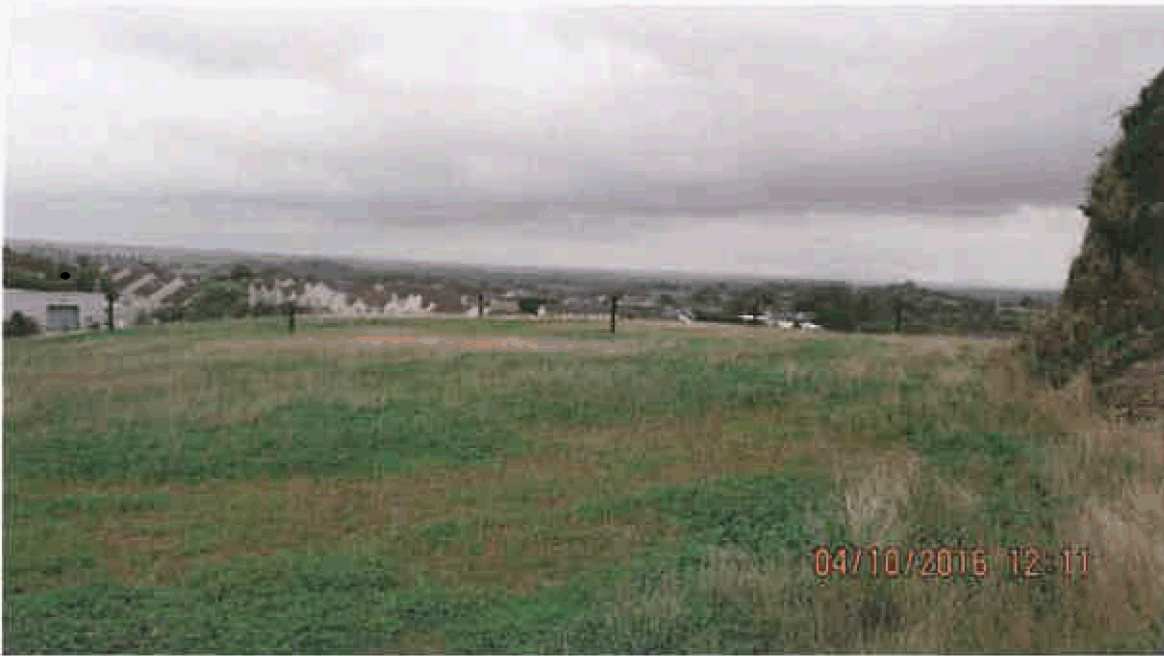
Photograph 17 showing overall remediated site.

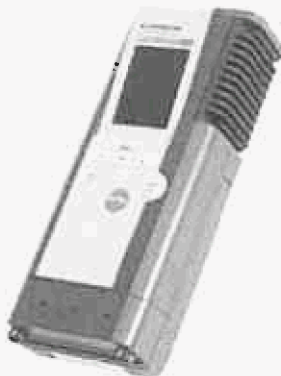
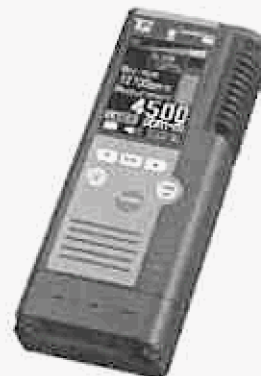
Laser Methane Mini

- Visual and audible alarms
- Lightweight and portable
- Bluetooth connection
- Data logging capabilities

Remote Methane Gas Detection

Laser Methane mini (LMm) is a compact handheld detector that can detect methane gas from a safe distance. Utilising laser technology, methane leaks can be quickly confirmed by pointing the laser beam towards the suspected leak, or along the survey line. This revolutionary technology removes the need to access elevated places, under floor or other hard to reach areas. It is also ideal for surveying large open spaces e.g. landfills or along pipelines.

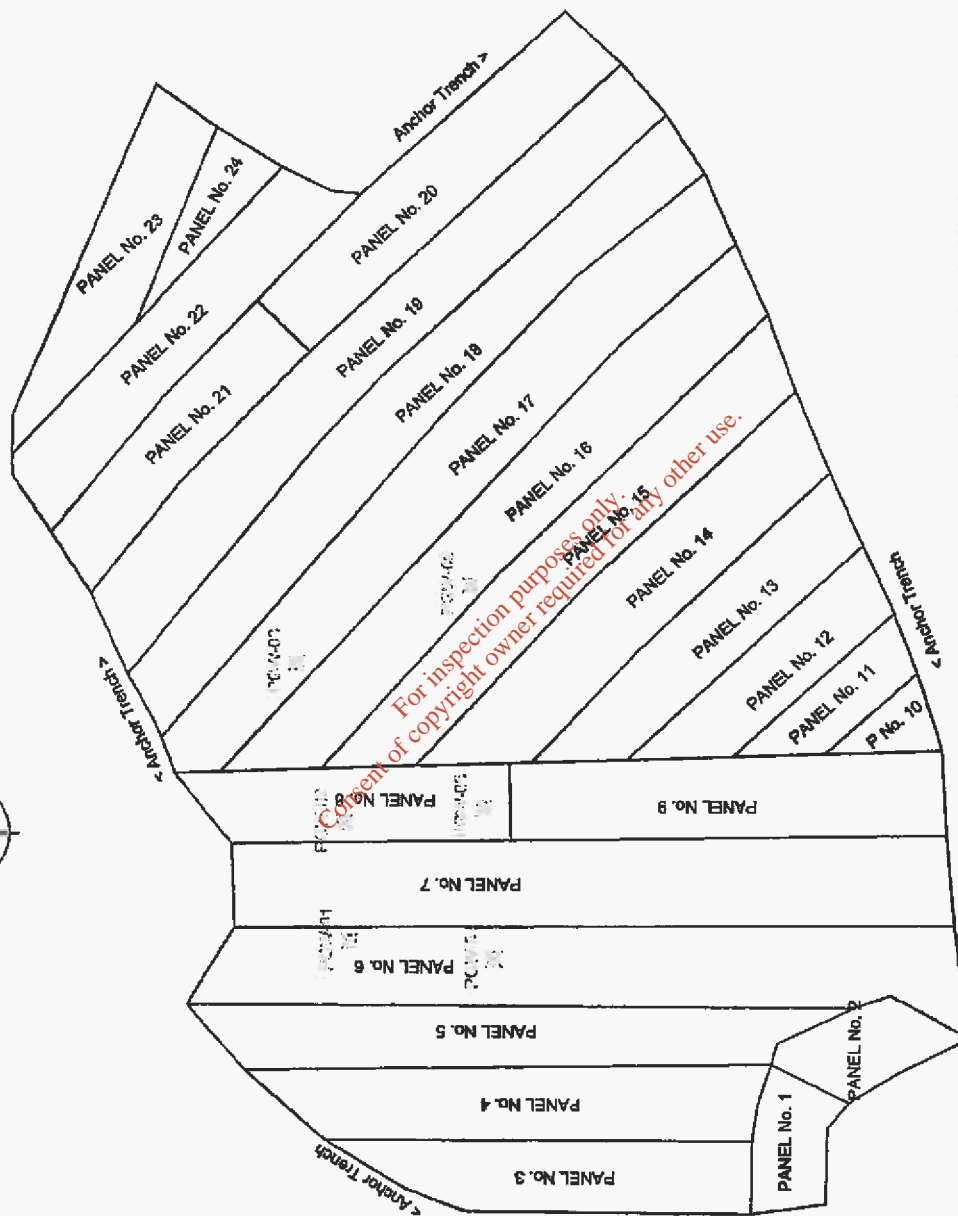
Plan: LLDPE Panel Placement

Kingscourt Landfill Remediation	
Job:	
Title:	
Panel Placement PGW Positions	
GIS	
Thornback Rd. Troyevood, Co. Kilkenny, Ireland Mobile: (086) 833113 Email: jennan@geosumbraste.ie

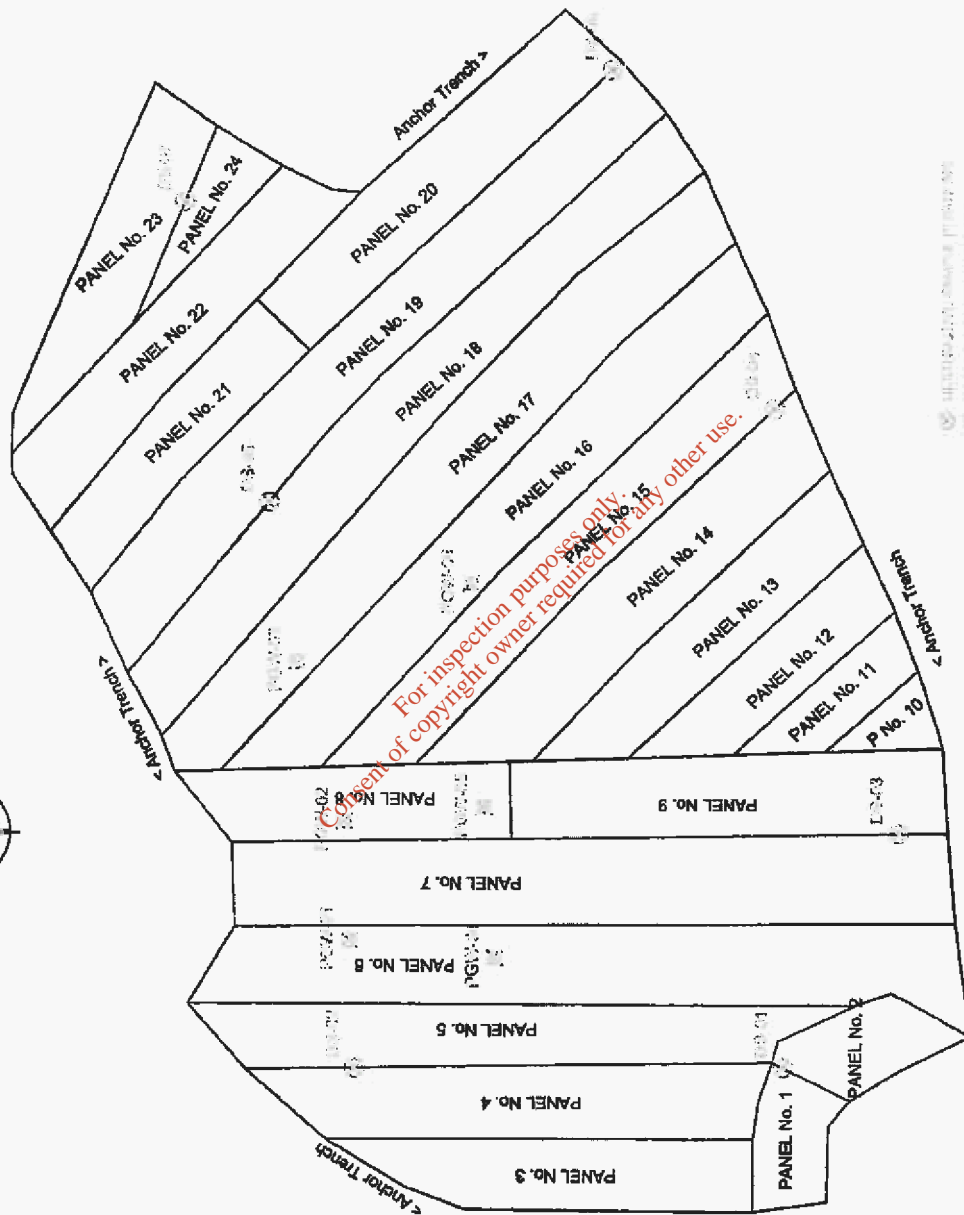
Plan: Destructive Sample Positions

Job:	Kingscourt Landfill Remediation
Title:	Panel Placement DS & PGW Positions
<div>GIS</div> <p>Thorntree Rd. Troywood, Co. Kilkenny, Ireland Mobile: (085) 8331113 Email: geomatic@kingscourt.ie</p>

Sample	Panel # / Panel #	Date Removed	Insp. ID				Lab Test Results Pass/Fail	Remarks
				Peel A (ppi)	Peel B (ppi)	Shear (ppi)		
DS 2	P4/P5	20/08/15	FL	72	66	80	Pass	Good air channel
Describe Sample Location Panel 4 – Panel 5 (see attached drawing)				73	70	82	Pass	Good air channel
				70	64	82	Pass	Good air channel
				74	64	81	Pass	Good air channel
				69	64	80	Pass	Good air channel

Sample	Panel # / Panel #	Date Removed	Insp. ID	Peel A (ppi)	Peel B (ppi)	Shear (ppi)	Lab Test Results Pass/Fail	Remarks
DS 5	P18/P19	08/10/15	FL	71	76	93	Pass	Good air channel
Describe Sample Location Panel 18 – Panel 19 (see attached drawing)				71	75	87	Pass	Good air channel
				71	78	89	Pass	Good air channel
				71	77	84	Pass	Good air channel
				71	76	83	Pass	Good air channel
DS 6	P19/P20	08/10/15	FL	60	65	78	Pass	Good air channel
Describe Sample Location Panel 19 – Panel 20 (see attached drawing)				62	65	80	Pass	Good air channel
				62	64	84	Pass	Good air channel
				62	64	83	Pass	Good air channel
				61	63	85	Pass	Good air channel

Sample	Panel # / Panel #	Date Removed	Insp. ID				Lab Test Results Pass/Fail	Remarks
				Peel A (ppi)	Peel B (ppi)	Shear (ppi)		
DS 7	P23/P24	09/10/15	FL	67	65	77	Pass	Good air channel
Describe Sample Location Panel 23 – Panel 24 (see attached drawing)				68	69	77	Pass	Good air channel
				69	64	78	Pass	Good air channel
				69	67	80	Pass	Good air channel
				69	67	80	Pass	Good air channel
