TIER 1 ENVIRONMENTAL RISK ASSESSMENT

HISTORIC LANDFILL AT KILLYCARD LANDFILL CO. MONAGHAN

APRIL 2020

Client: Monaghan County Council

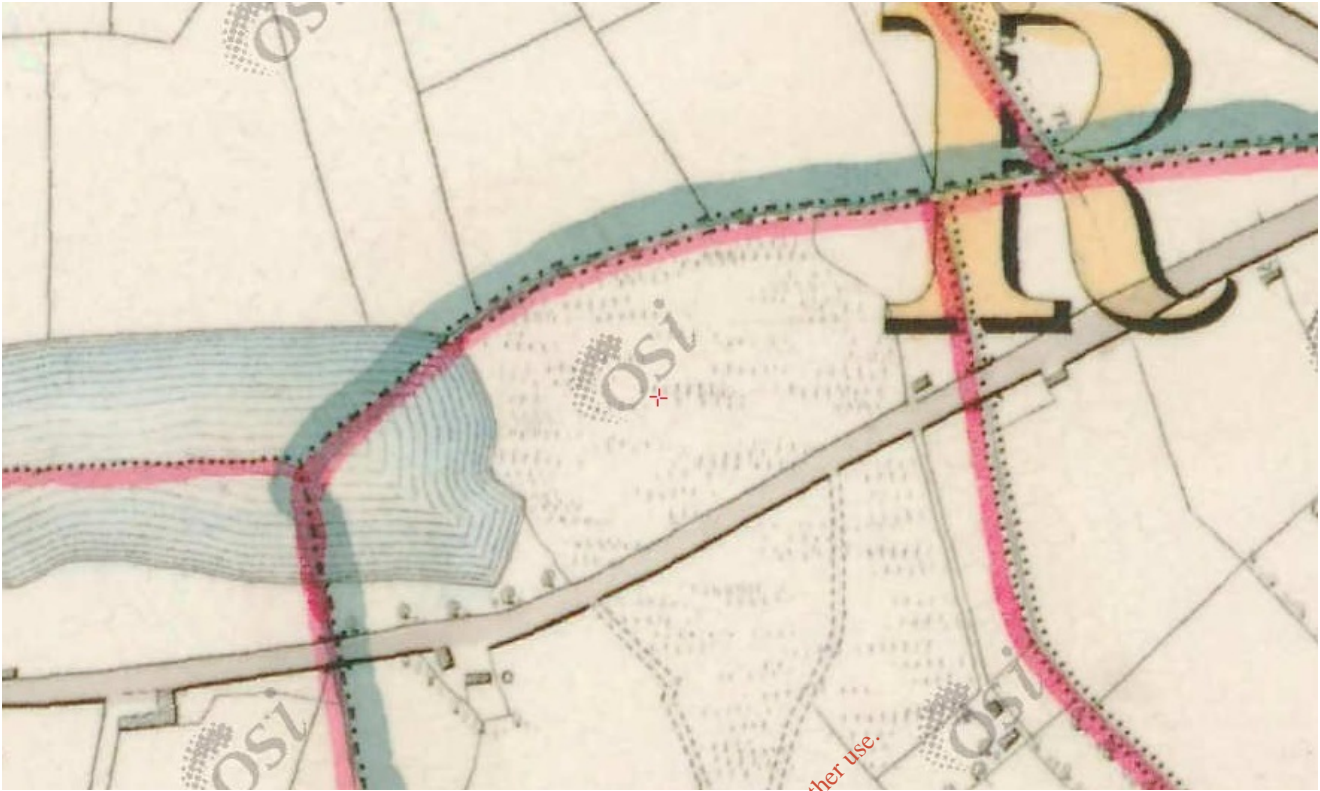
Figure 2.3.1: OSI Site Historic Map

OSI Historic Map (1888-1913 and 1837-1842) identifies that the land within the site boundary and the surrounding area was previously 'Bog or uncultivated land'. The historic map of the site is shown in Figure 2.4 below.
