Figure Title	Ecology: Protected Sites	
Figure No.	2.7	
Project	ERA of Historic Landfill at Killycard, Co. Monaghan	
Client	Monaghan County Council	
Scale	1:120,000	Page Size A3
Revision	A	Date 17/10/2018

Figure Title	Site Investigation Location Plan		
Figure No.	3.1		
Project	ERA of Historic Landfill at Killicard, Co. Monaghan		
Client	Monaghan County Council		
Scale	1:1,500	Page Size	A3
Revision	A	Date	09/11/2018

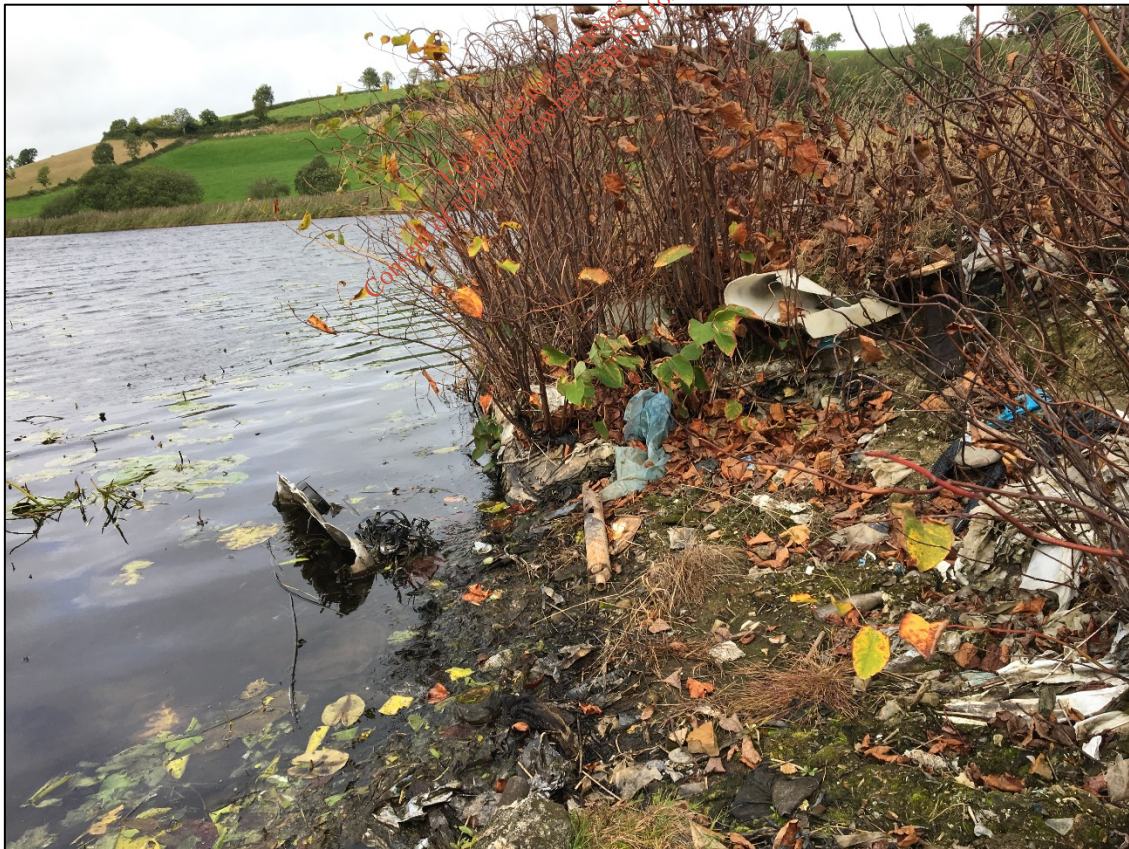
Plate 2-1: Japanese Knotweed and exposed waste material

During the site walkover, Japanese Knotweed was identified along the western banks of the site and evidence of eradication was identified, see Plate 2-1. The lake is eroding the banks of the site exposing the interred waste.

During the site walkover, Japanese Knotweed was identified along the western banks of the site. Evidence of eradication efforts by means of spraying was confirmed as discussed previously in Section 2.2.8. The lake also appears to be eroding the banks of the landfill and exposing the interred waste in this area.

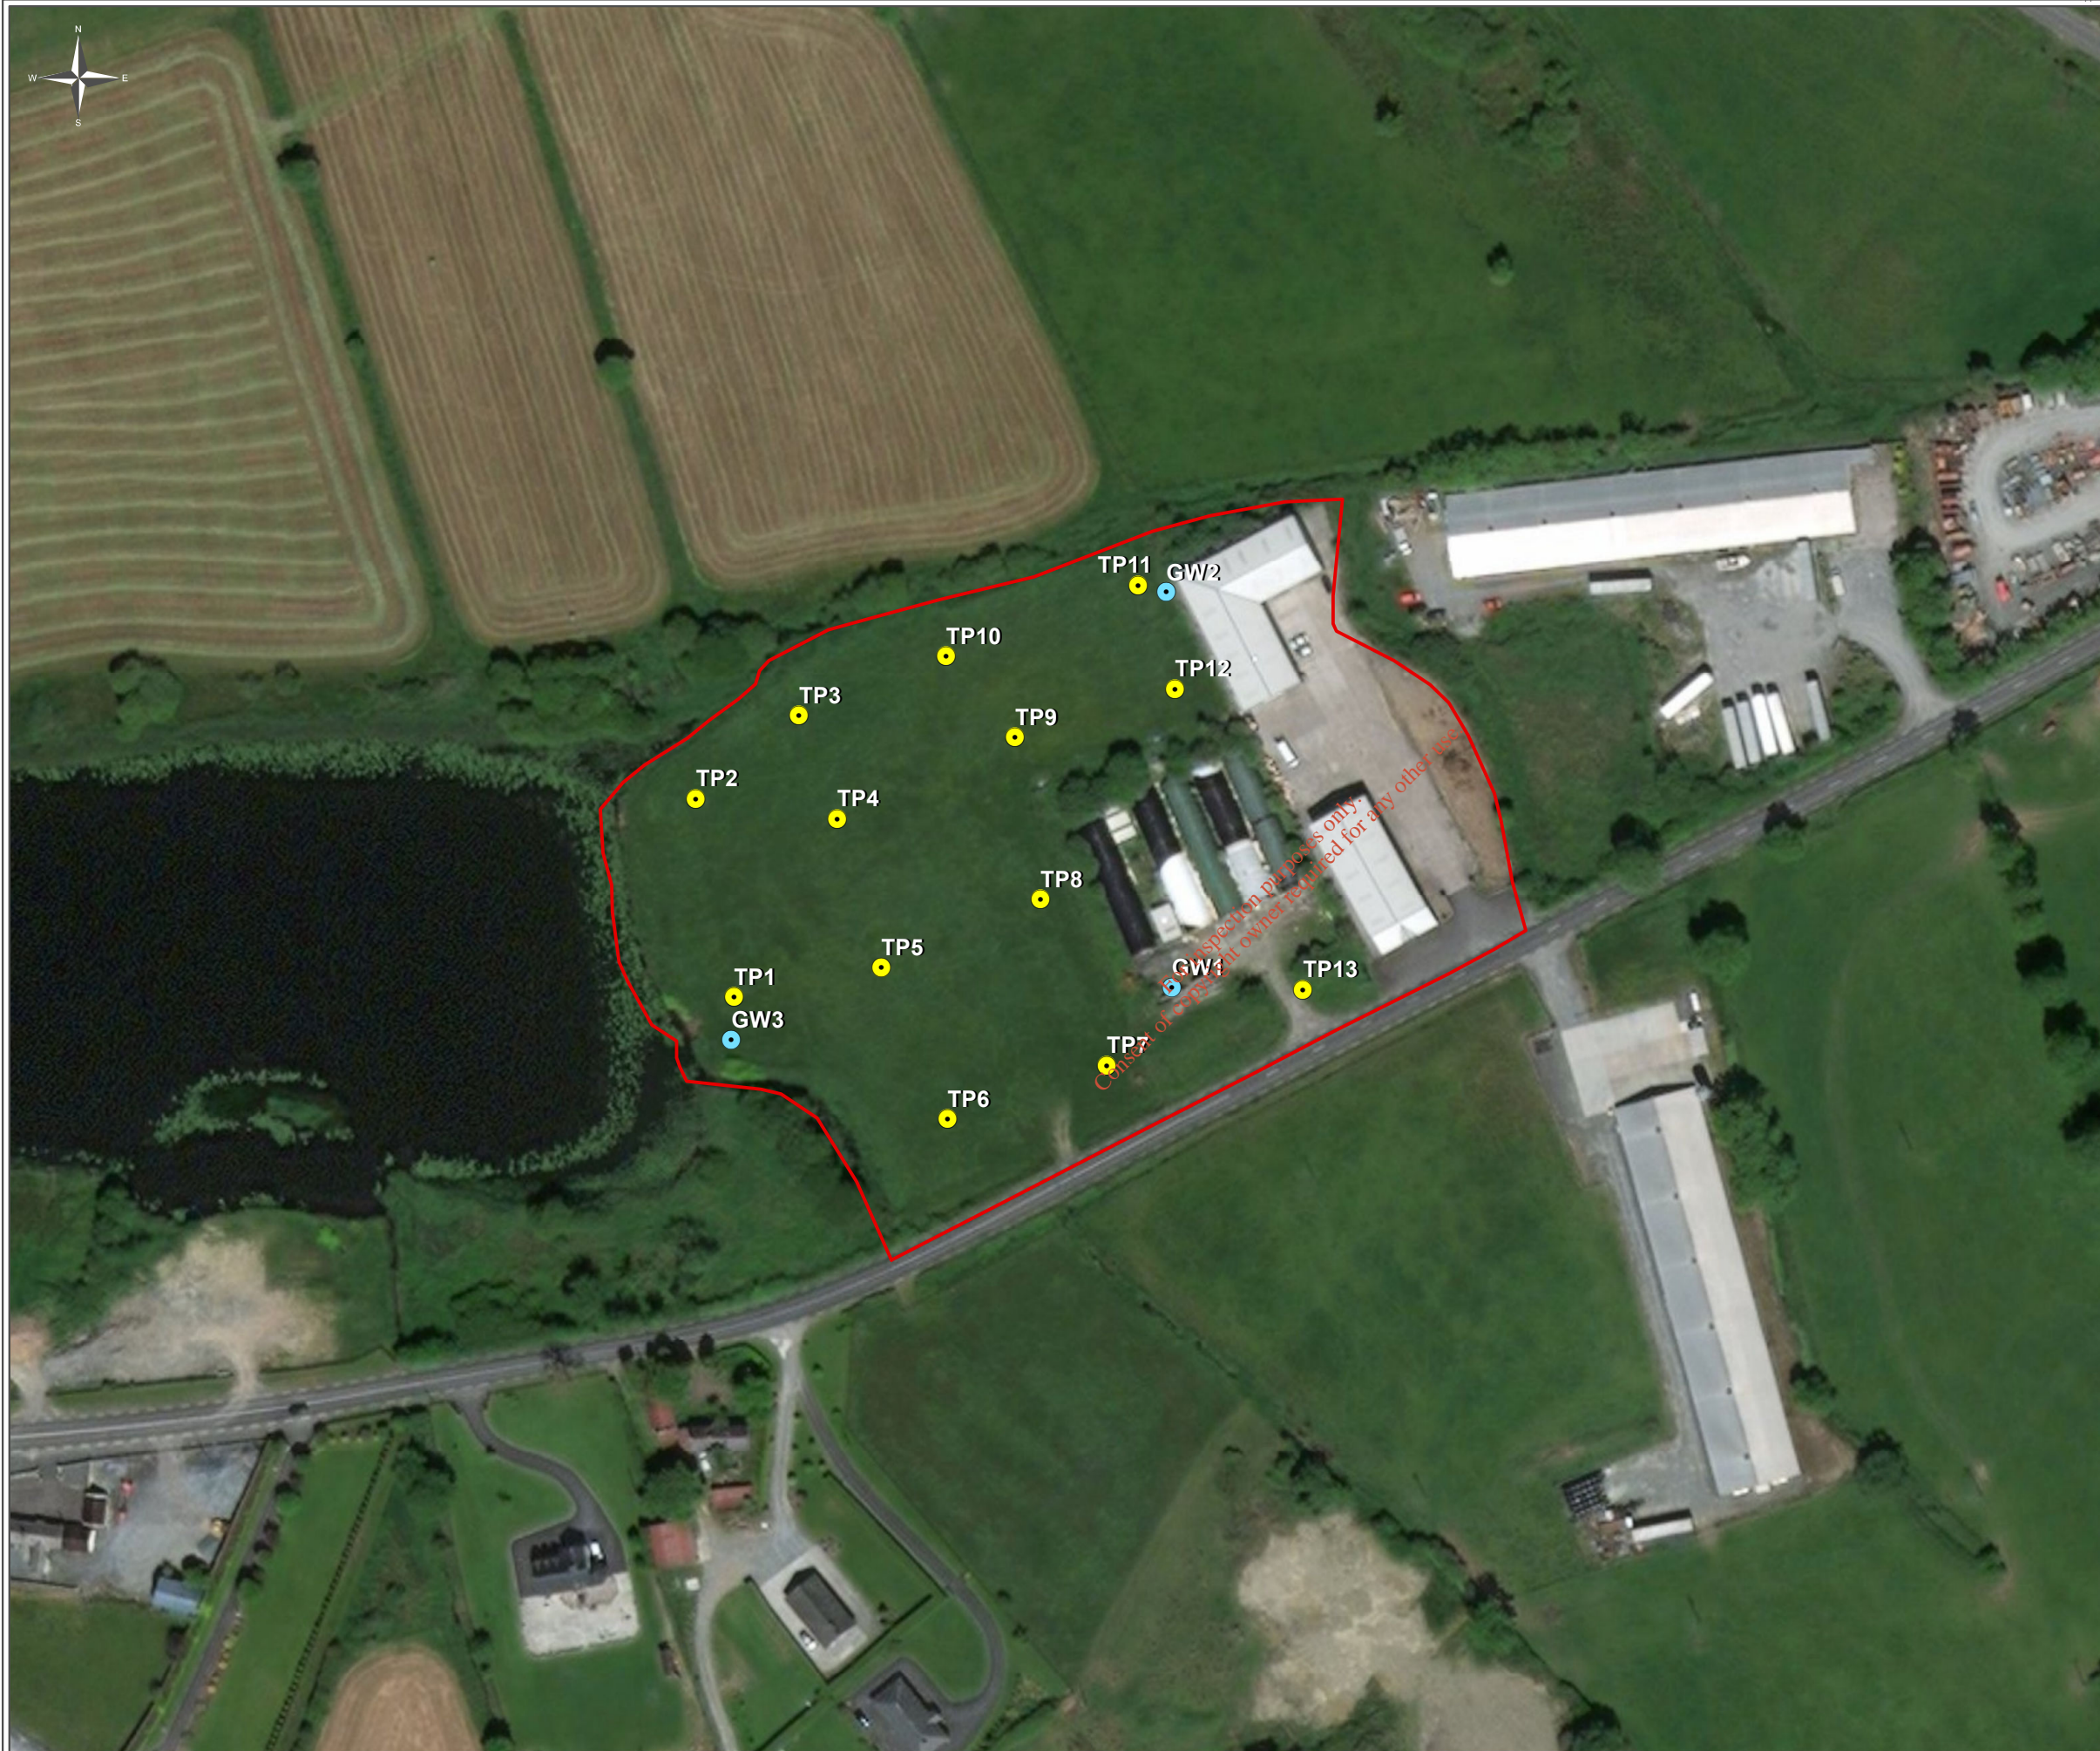
The locations of the intrusive works at the site are presented in Figure 3.1.

- Legend**
- Groundwater Well Locations
 - Trial Pit Locations
 - Site Boundary

A Causeway Geotech (CGL) Engineering Geologist supervised the advancement of 13 No. trial pits, shown in Figure 3.1, on the 20th September and 21st September 2018.

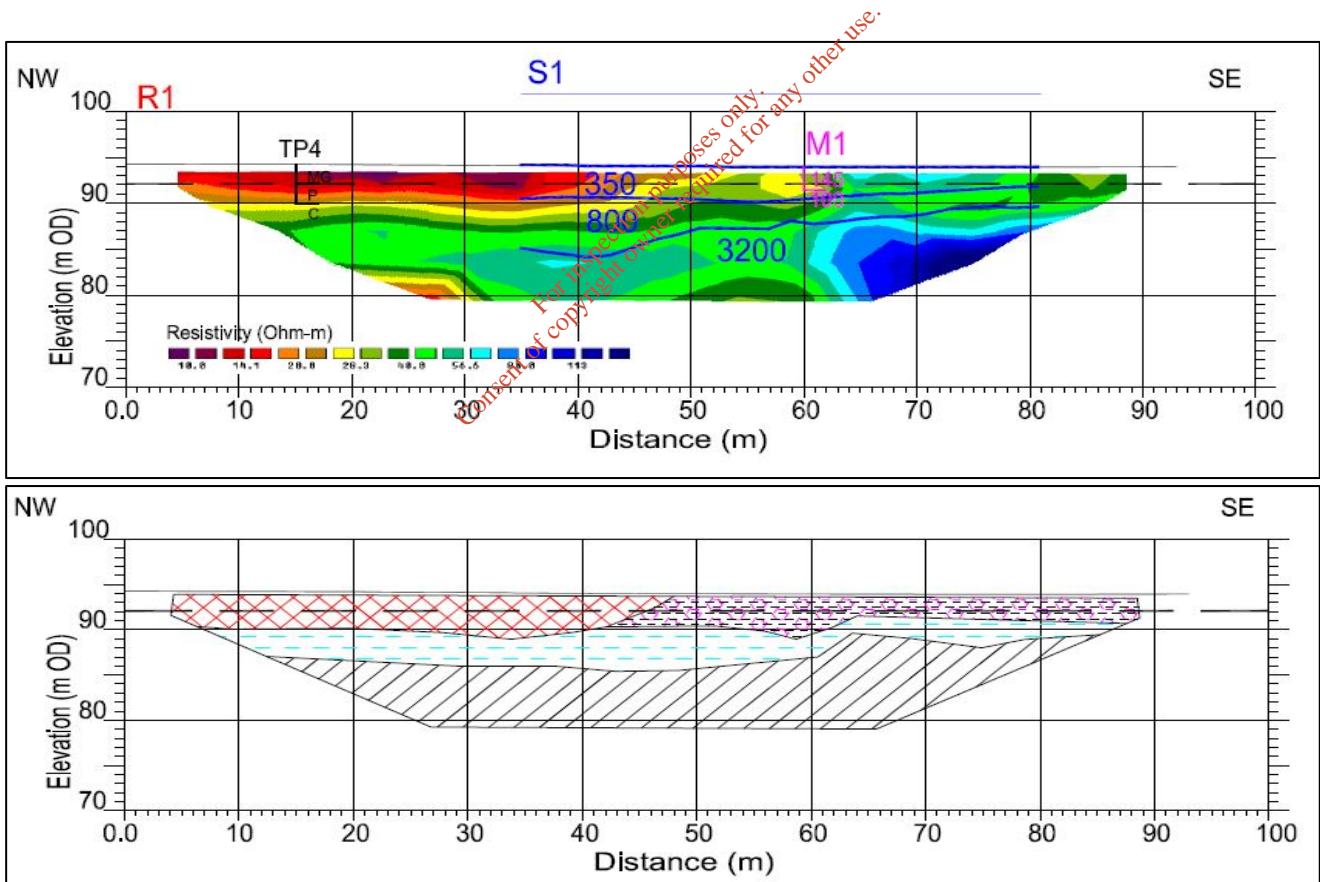
Figure 3-3: ERT Profile R1 Interpreted Cross Section

Apex recorded 5 no. ERT profiles data along three designated profiles. ERT profiles are named R1 through R5. The location of these profiles is given in Drawing No. AGL18164_01 and interpreted cross sections were compiled for the profiles on Drawing No. AGL18164_R1-R5.
