**FIGURE 5.1 KILLYCARD HISTORIC LANDFILL
CONCEPTUAL SITE MODEL**

TIER 1 ENVIRONMENTAL RISK ASSESSMENT

HISTORIC LANDFILL AT KILLYCARD LANDFILL CO. MONAGHAN

HISTORIC LANDFILL AT KILLYCARD LANDFILL, CO. MONAGHAN

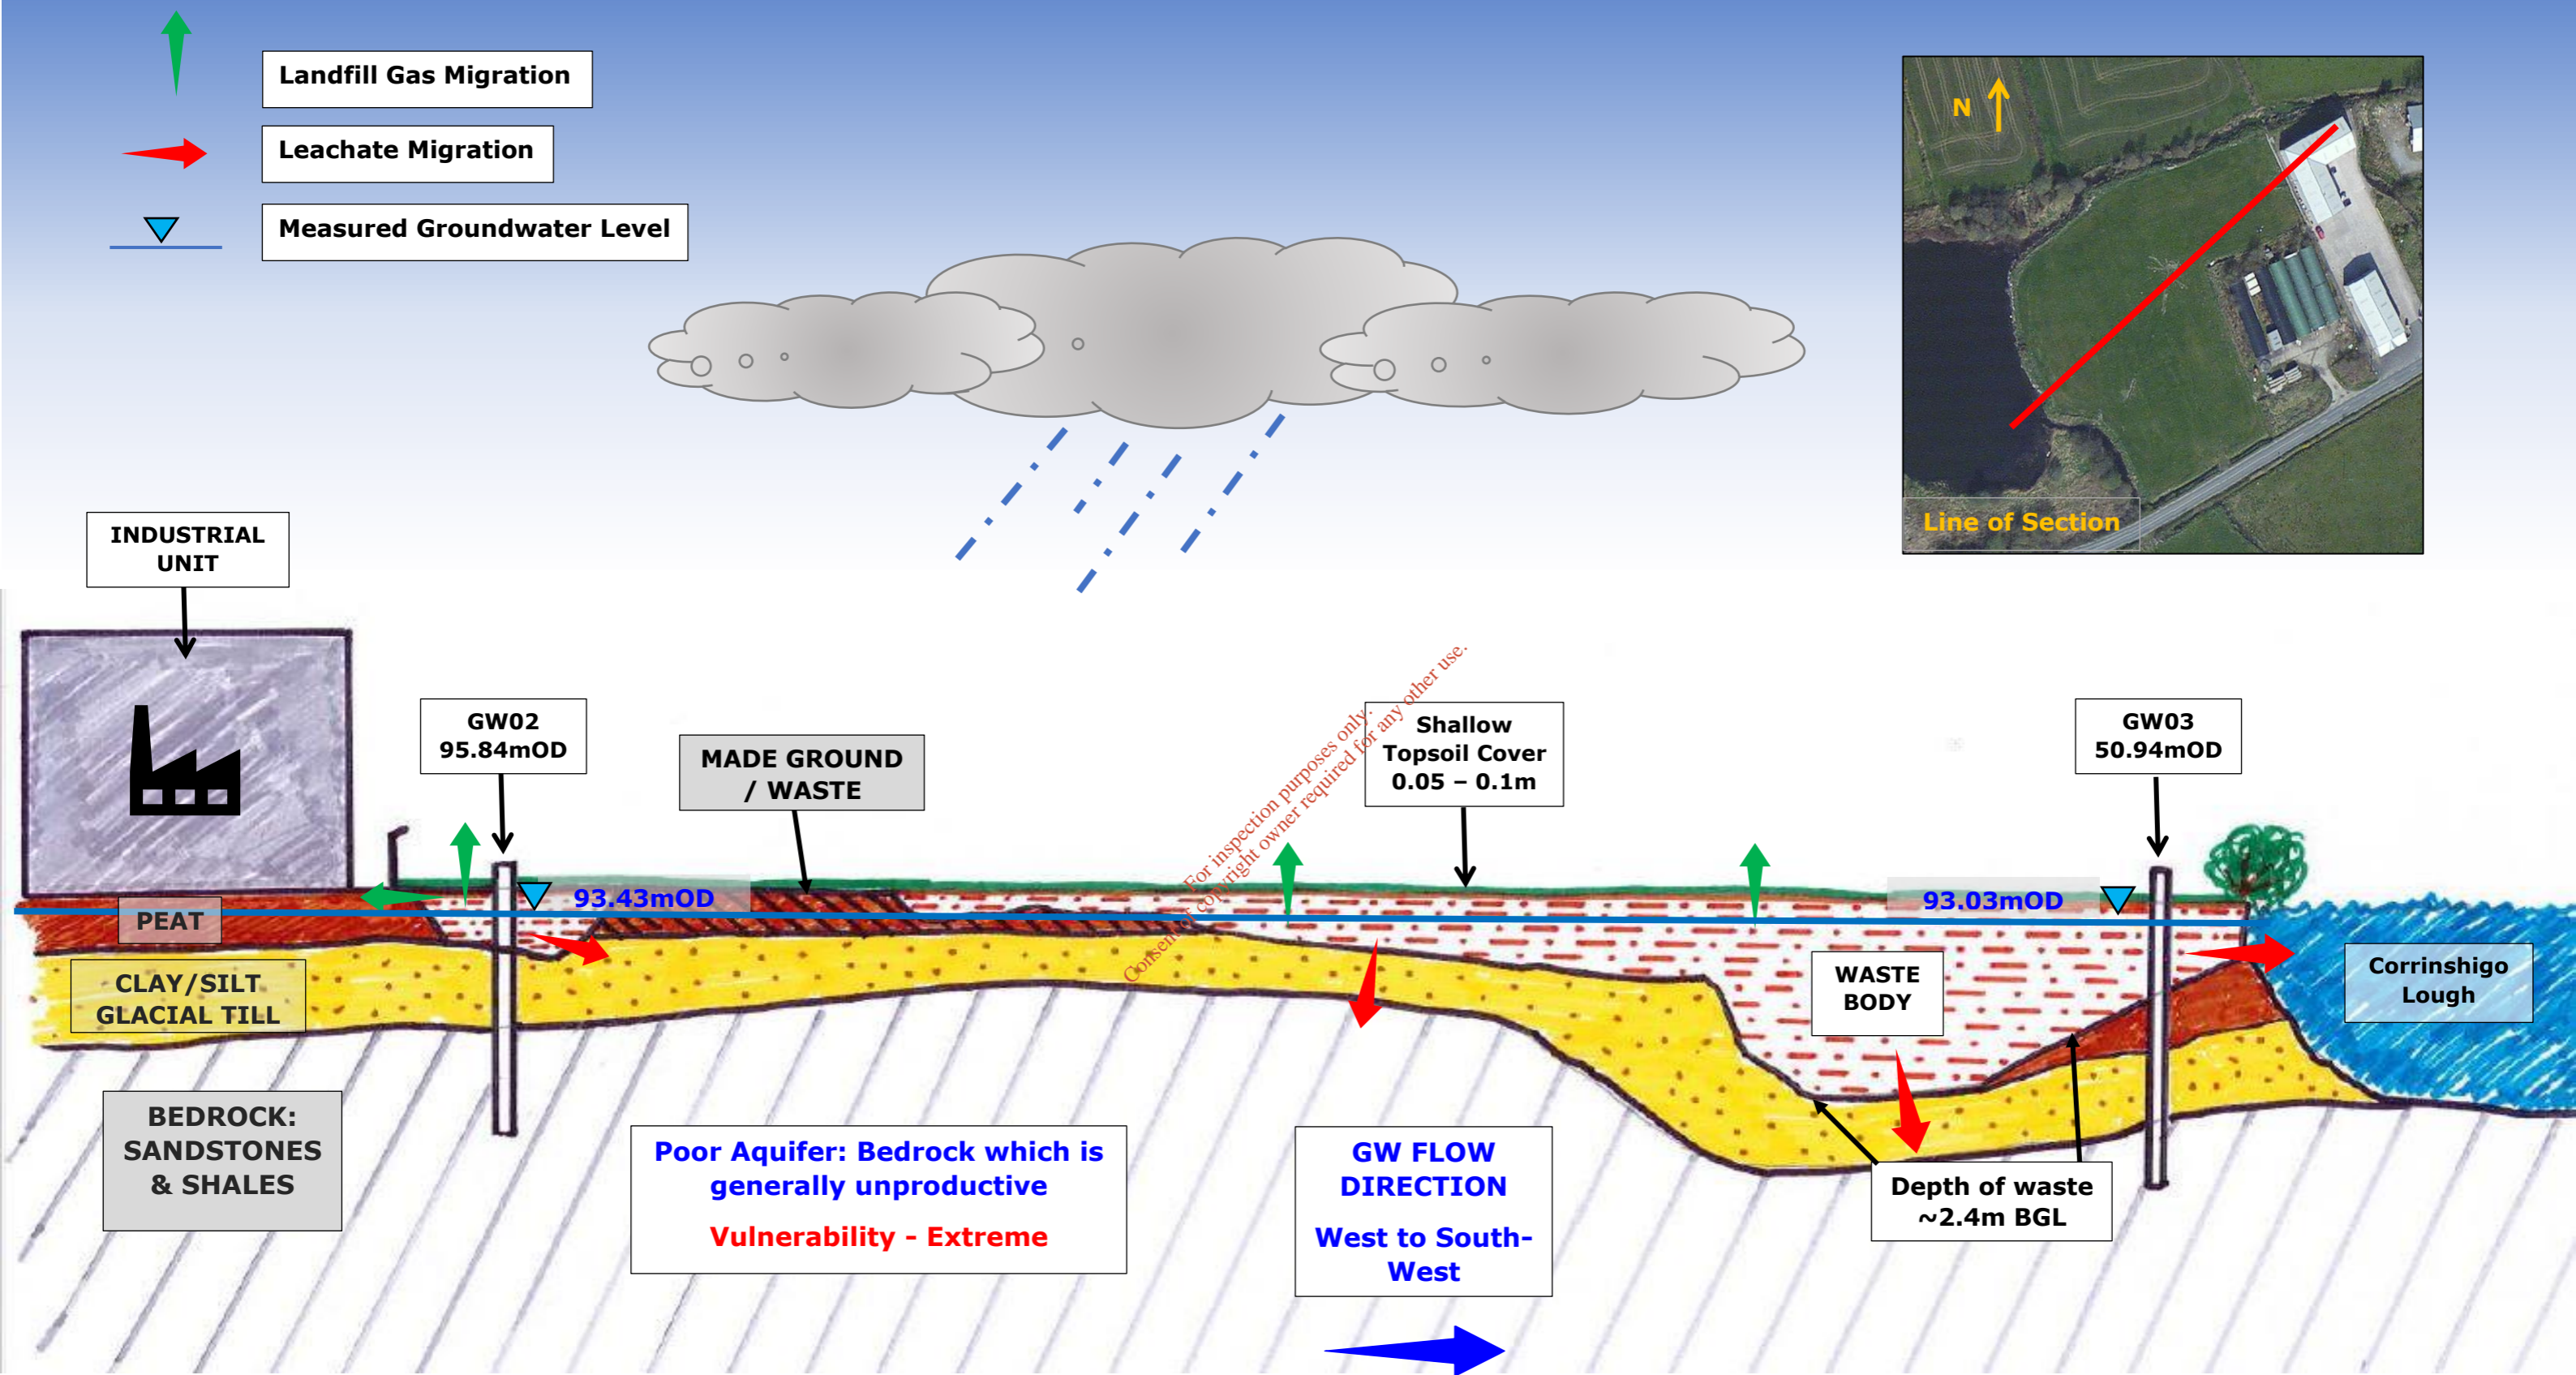
CROSS SECTION NORTH-EAST / SOUTH-WEST

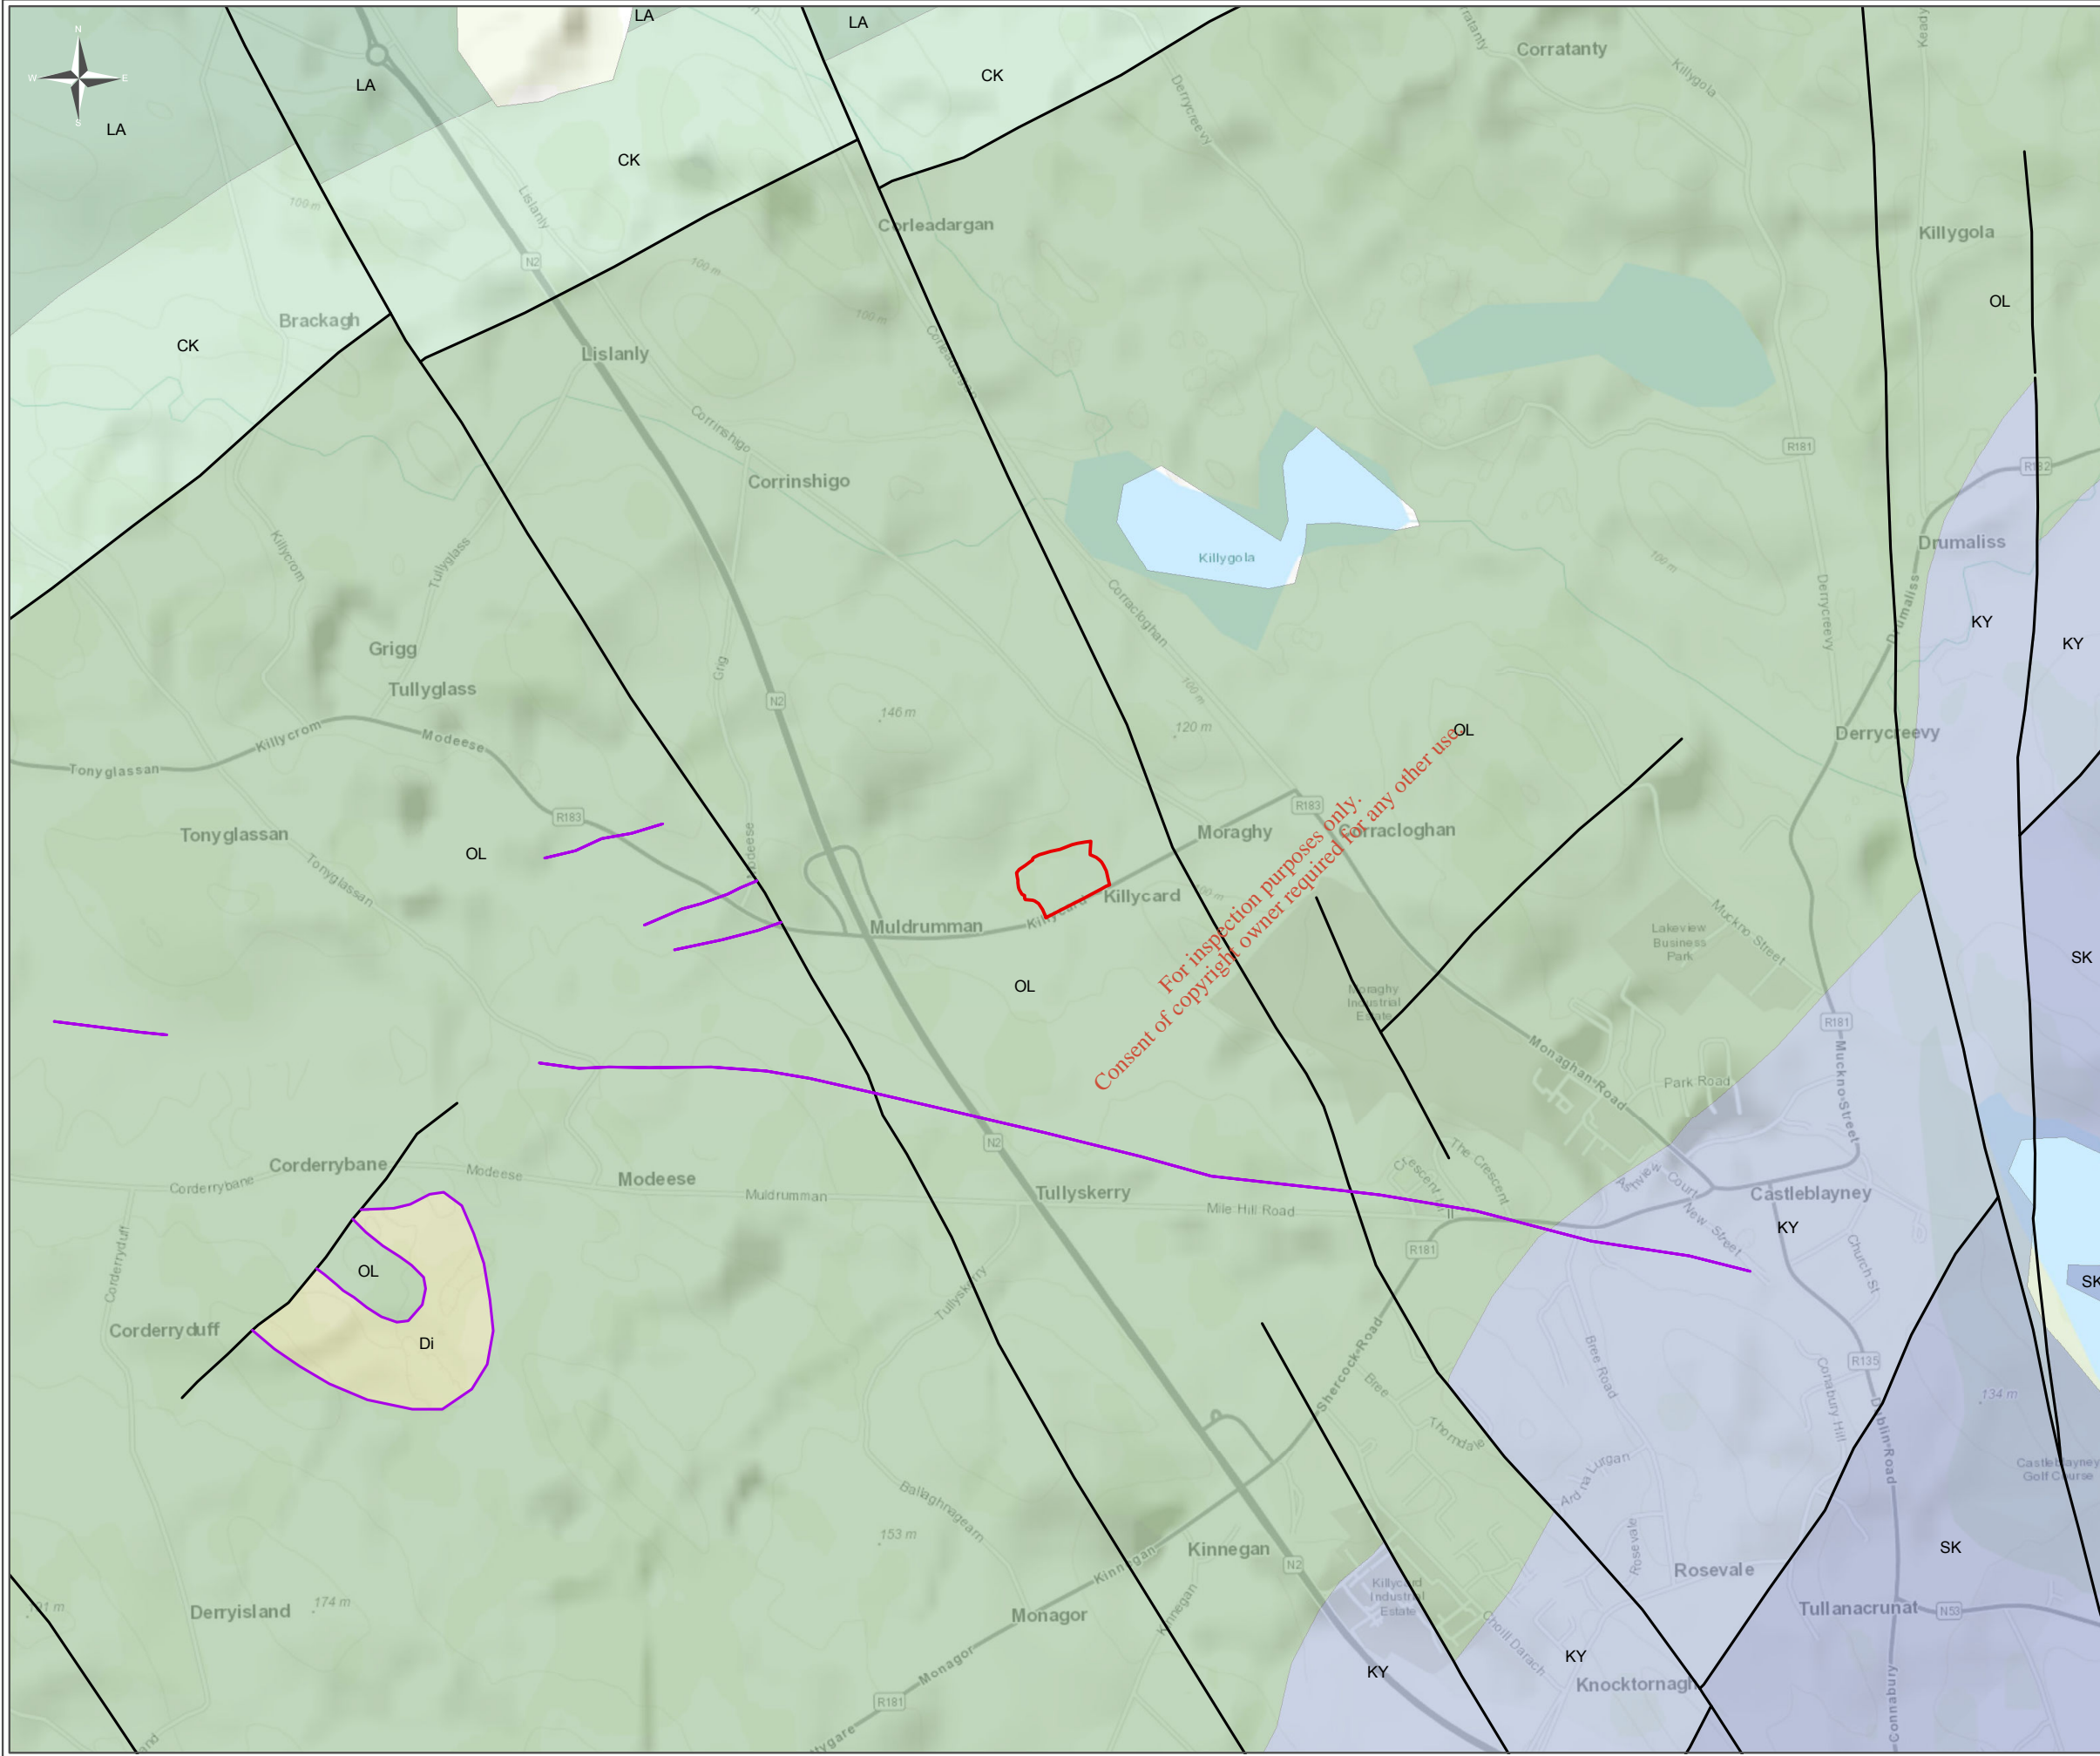
Figure No. 2.2

The GSI bedrock geology map shows a fault travelling north-south across the eastern area of the site.

Figure Title
Bedrock Geology
Killycard

According to the GSI the site and surrounding area is underlain by the Silurian Oghill formation (OL) which is generally made up of

'grey to grey-green massive sandstone (greywacke), microconglomerate and amalgamated beds with subordinate thin to thick-bedded greywacke and locally, at least partly, in faulted dark grey or black pyritic, occasionally graptolitic shale-mudstone'.

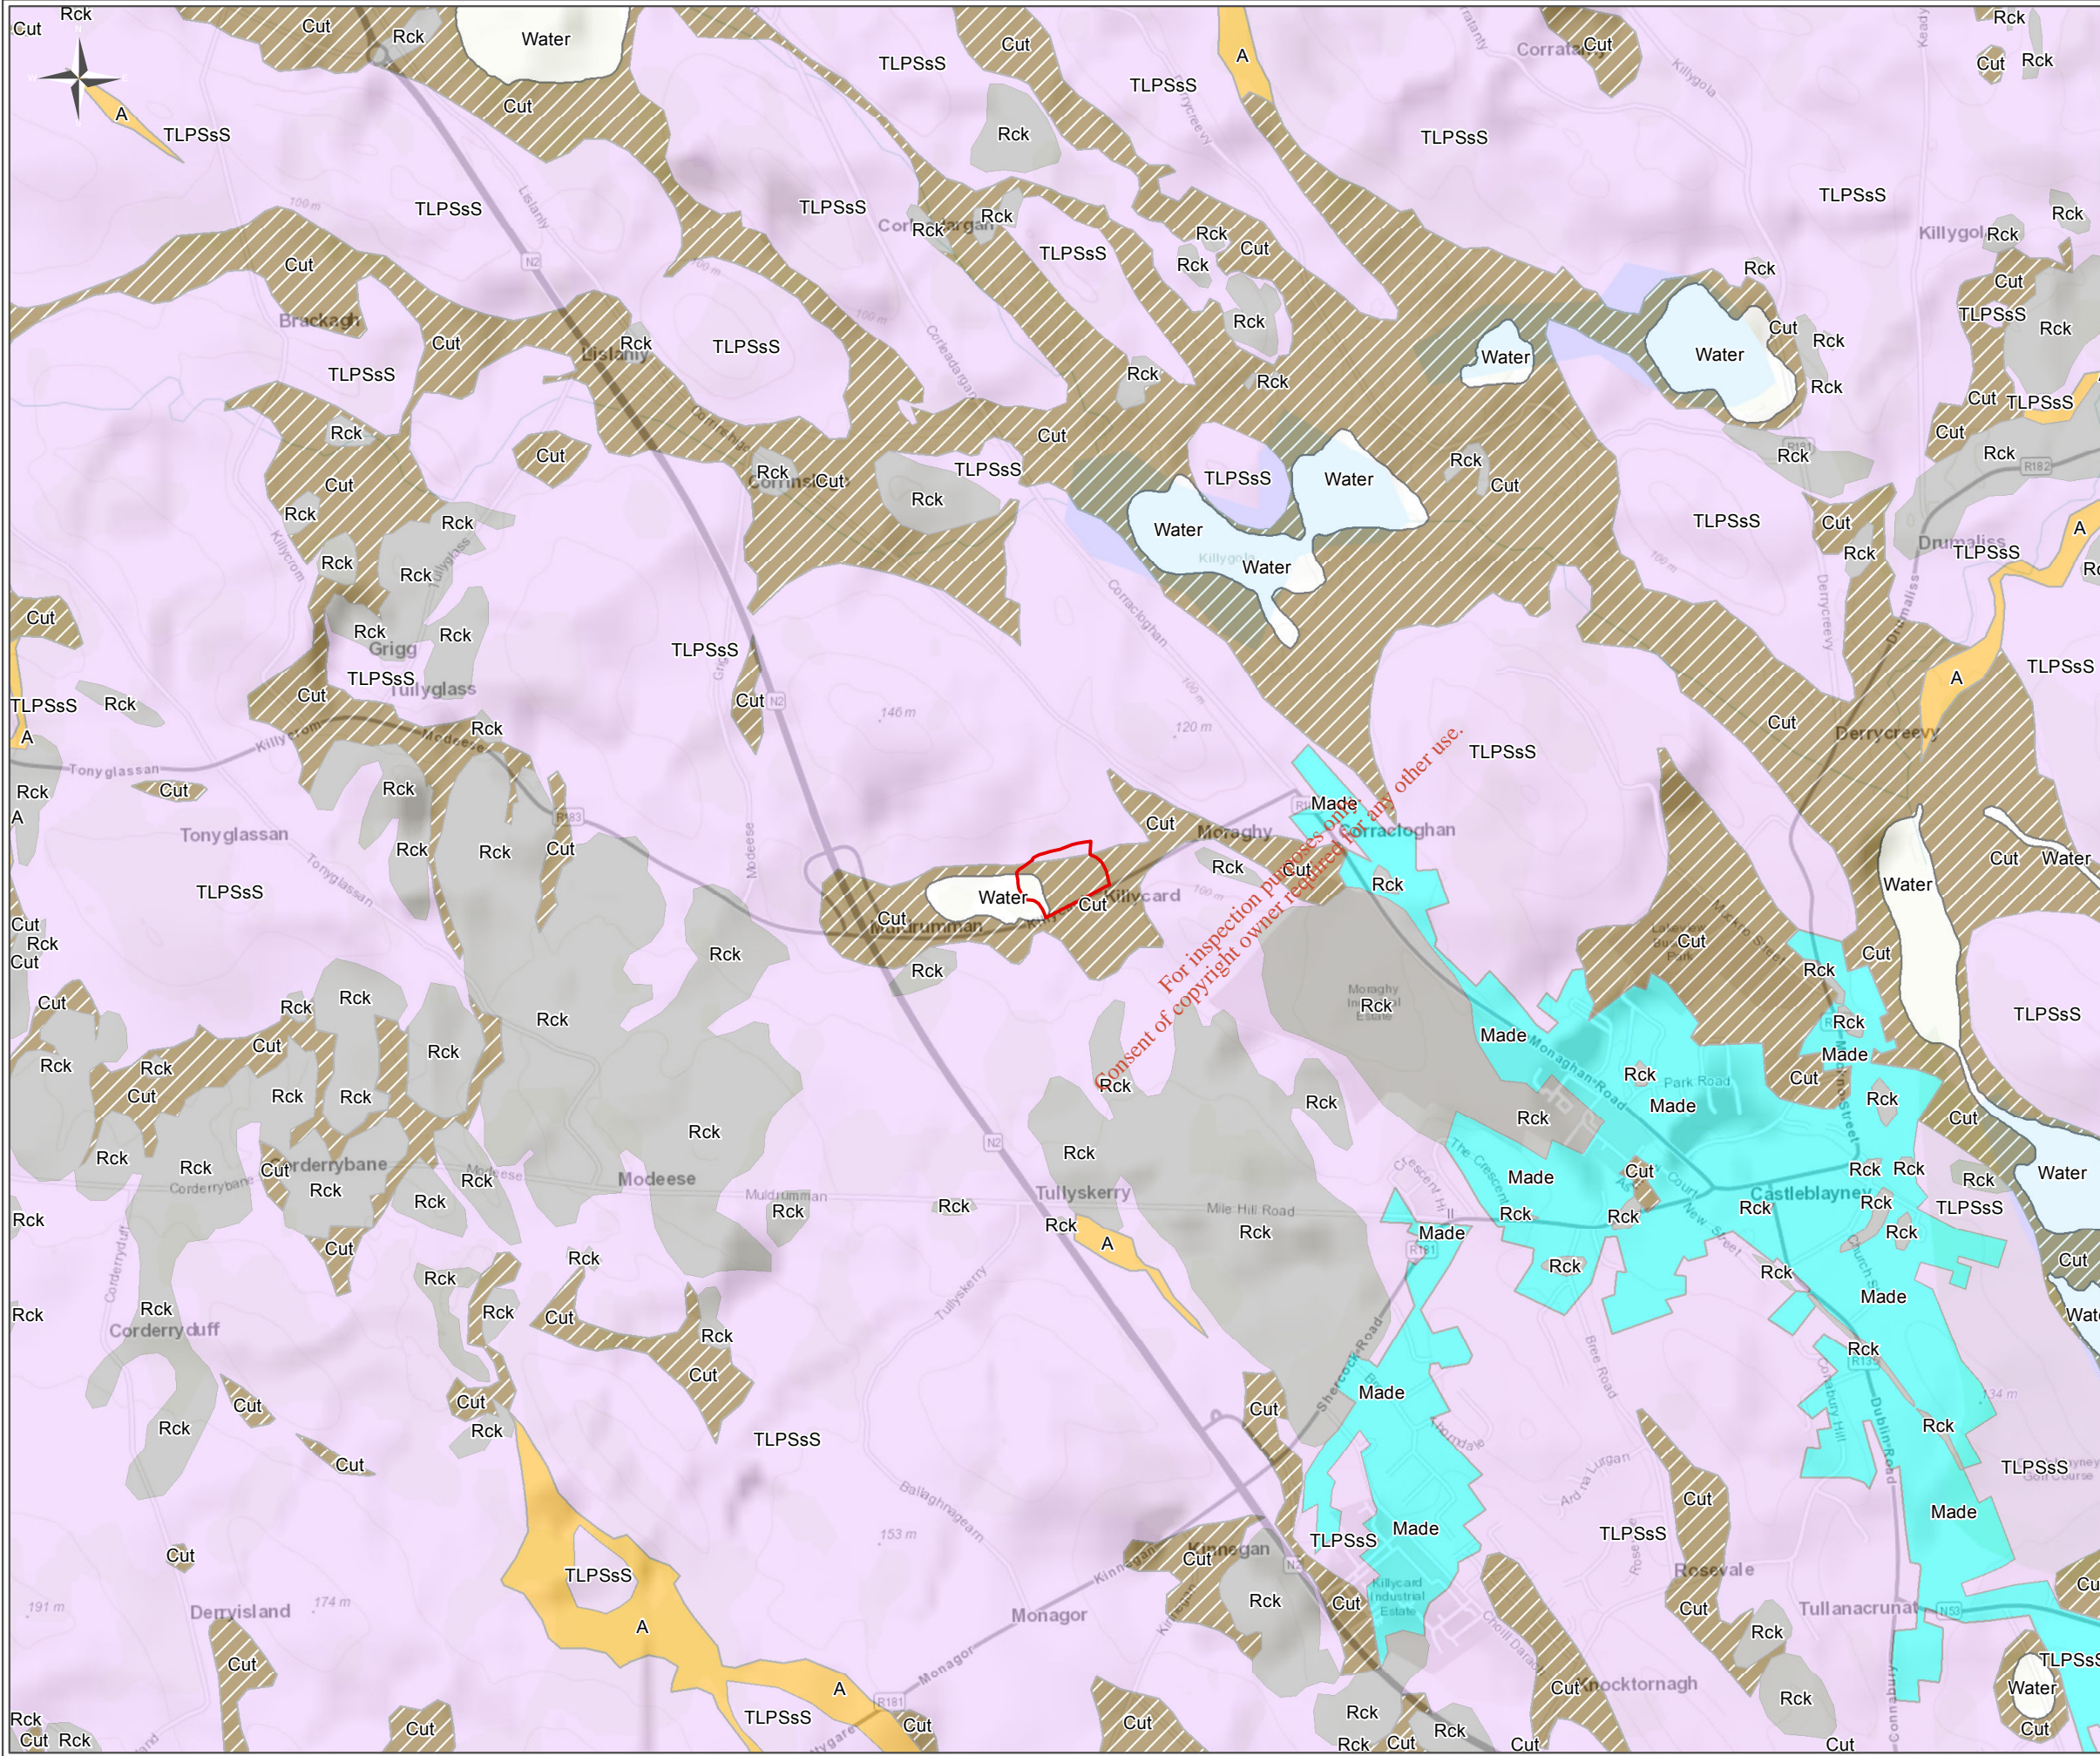
Figure Title	Quaternary Geology Killycard
Figure No.	2.3
Project	Tier 1 Assessment of Historical Landfills in Monaghan
Client	Monaghan County Council
Scale	1:15,000
Page Size	A3
Revision	A
Date	15/06/2018

The landfill site is underlain by cut over raised peat overlying a poorly productive bedrock aquifer. The subsoils are typically of cutover/cutaway peat. According to the GSI, the glacial overburden is mapped as 'Cut over raised peat', as shown in Figure 2.3.

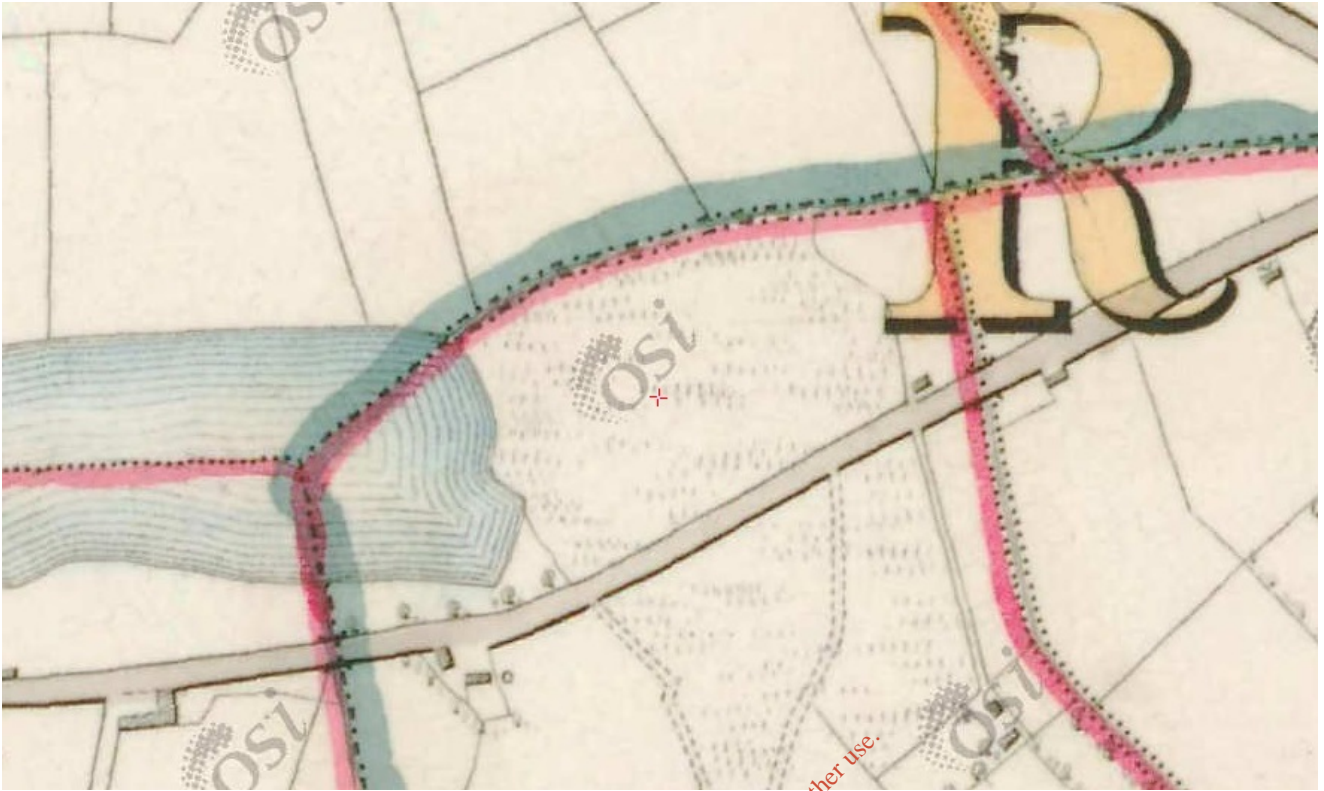
Figure 2.3.1: OSI Site Historic Map

OSI Historic Map (1888-1913 and 1837-1842) identifies that the land within the site boundary and the surrounding area was previously 'Bog or uncultivated land'. The historic map of the site is shown in Figure 2.4 below.

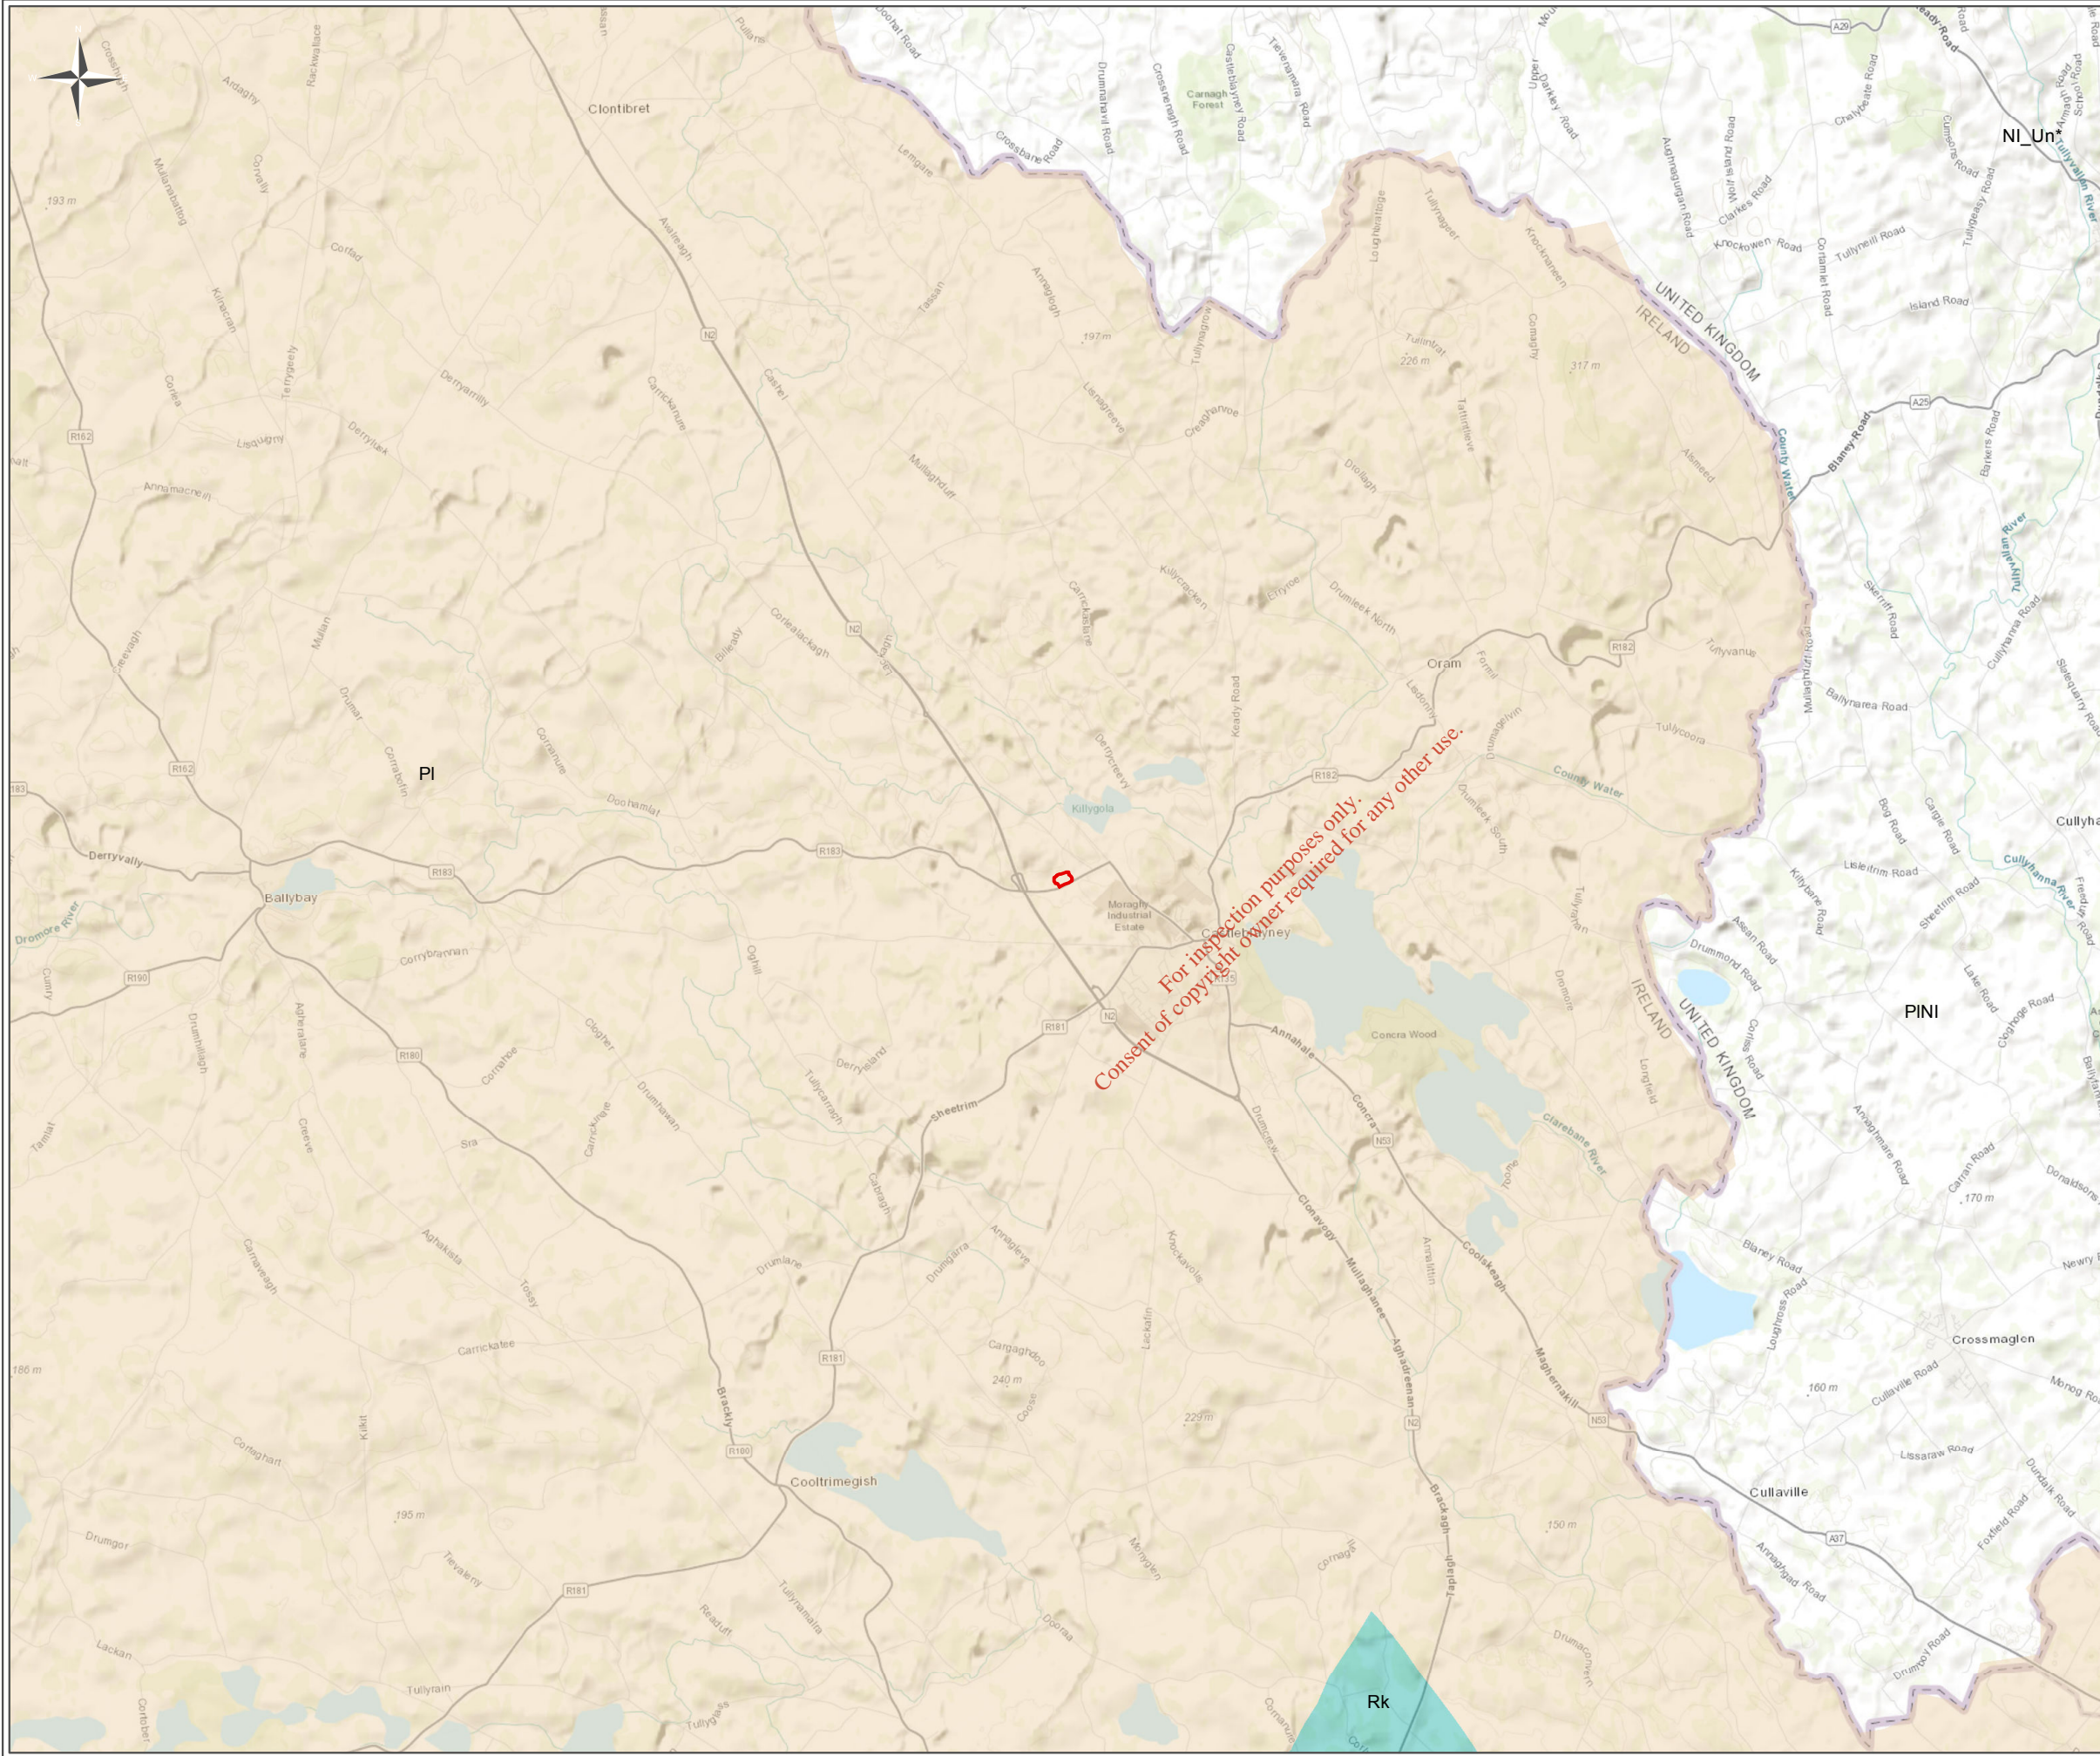
Figure Title	Aquifer Classification Killycard
Figure No.	2.4
Project	Tier 1 Assessment of Historical Landfills in Monaghan
Client	Monaghan County Council
Scale	1:75,000
Page Size	A3
Revision	A
Date	15/06/2018

- Site Boundary
- PI: Poor Aquifer Bedrock Generally Unproductive Except Locally
- Rk: Regionally Important Aquifer - Karstified

The Oghill formation is classified as a Poor Aquifer (PI) that is generally unproductive except in local zones. The aquifer vulnerability of the site is Extreme.

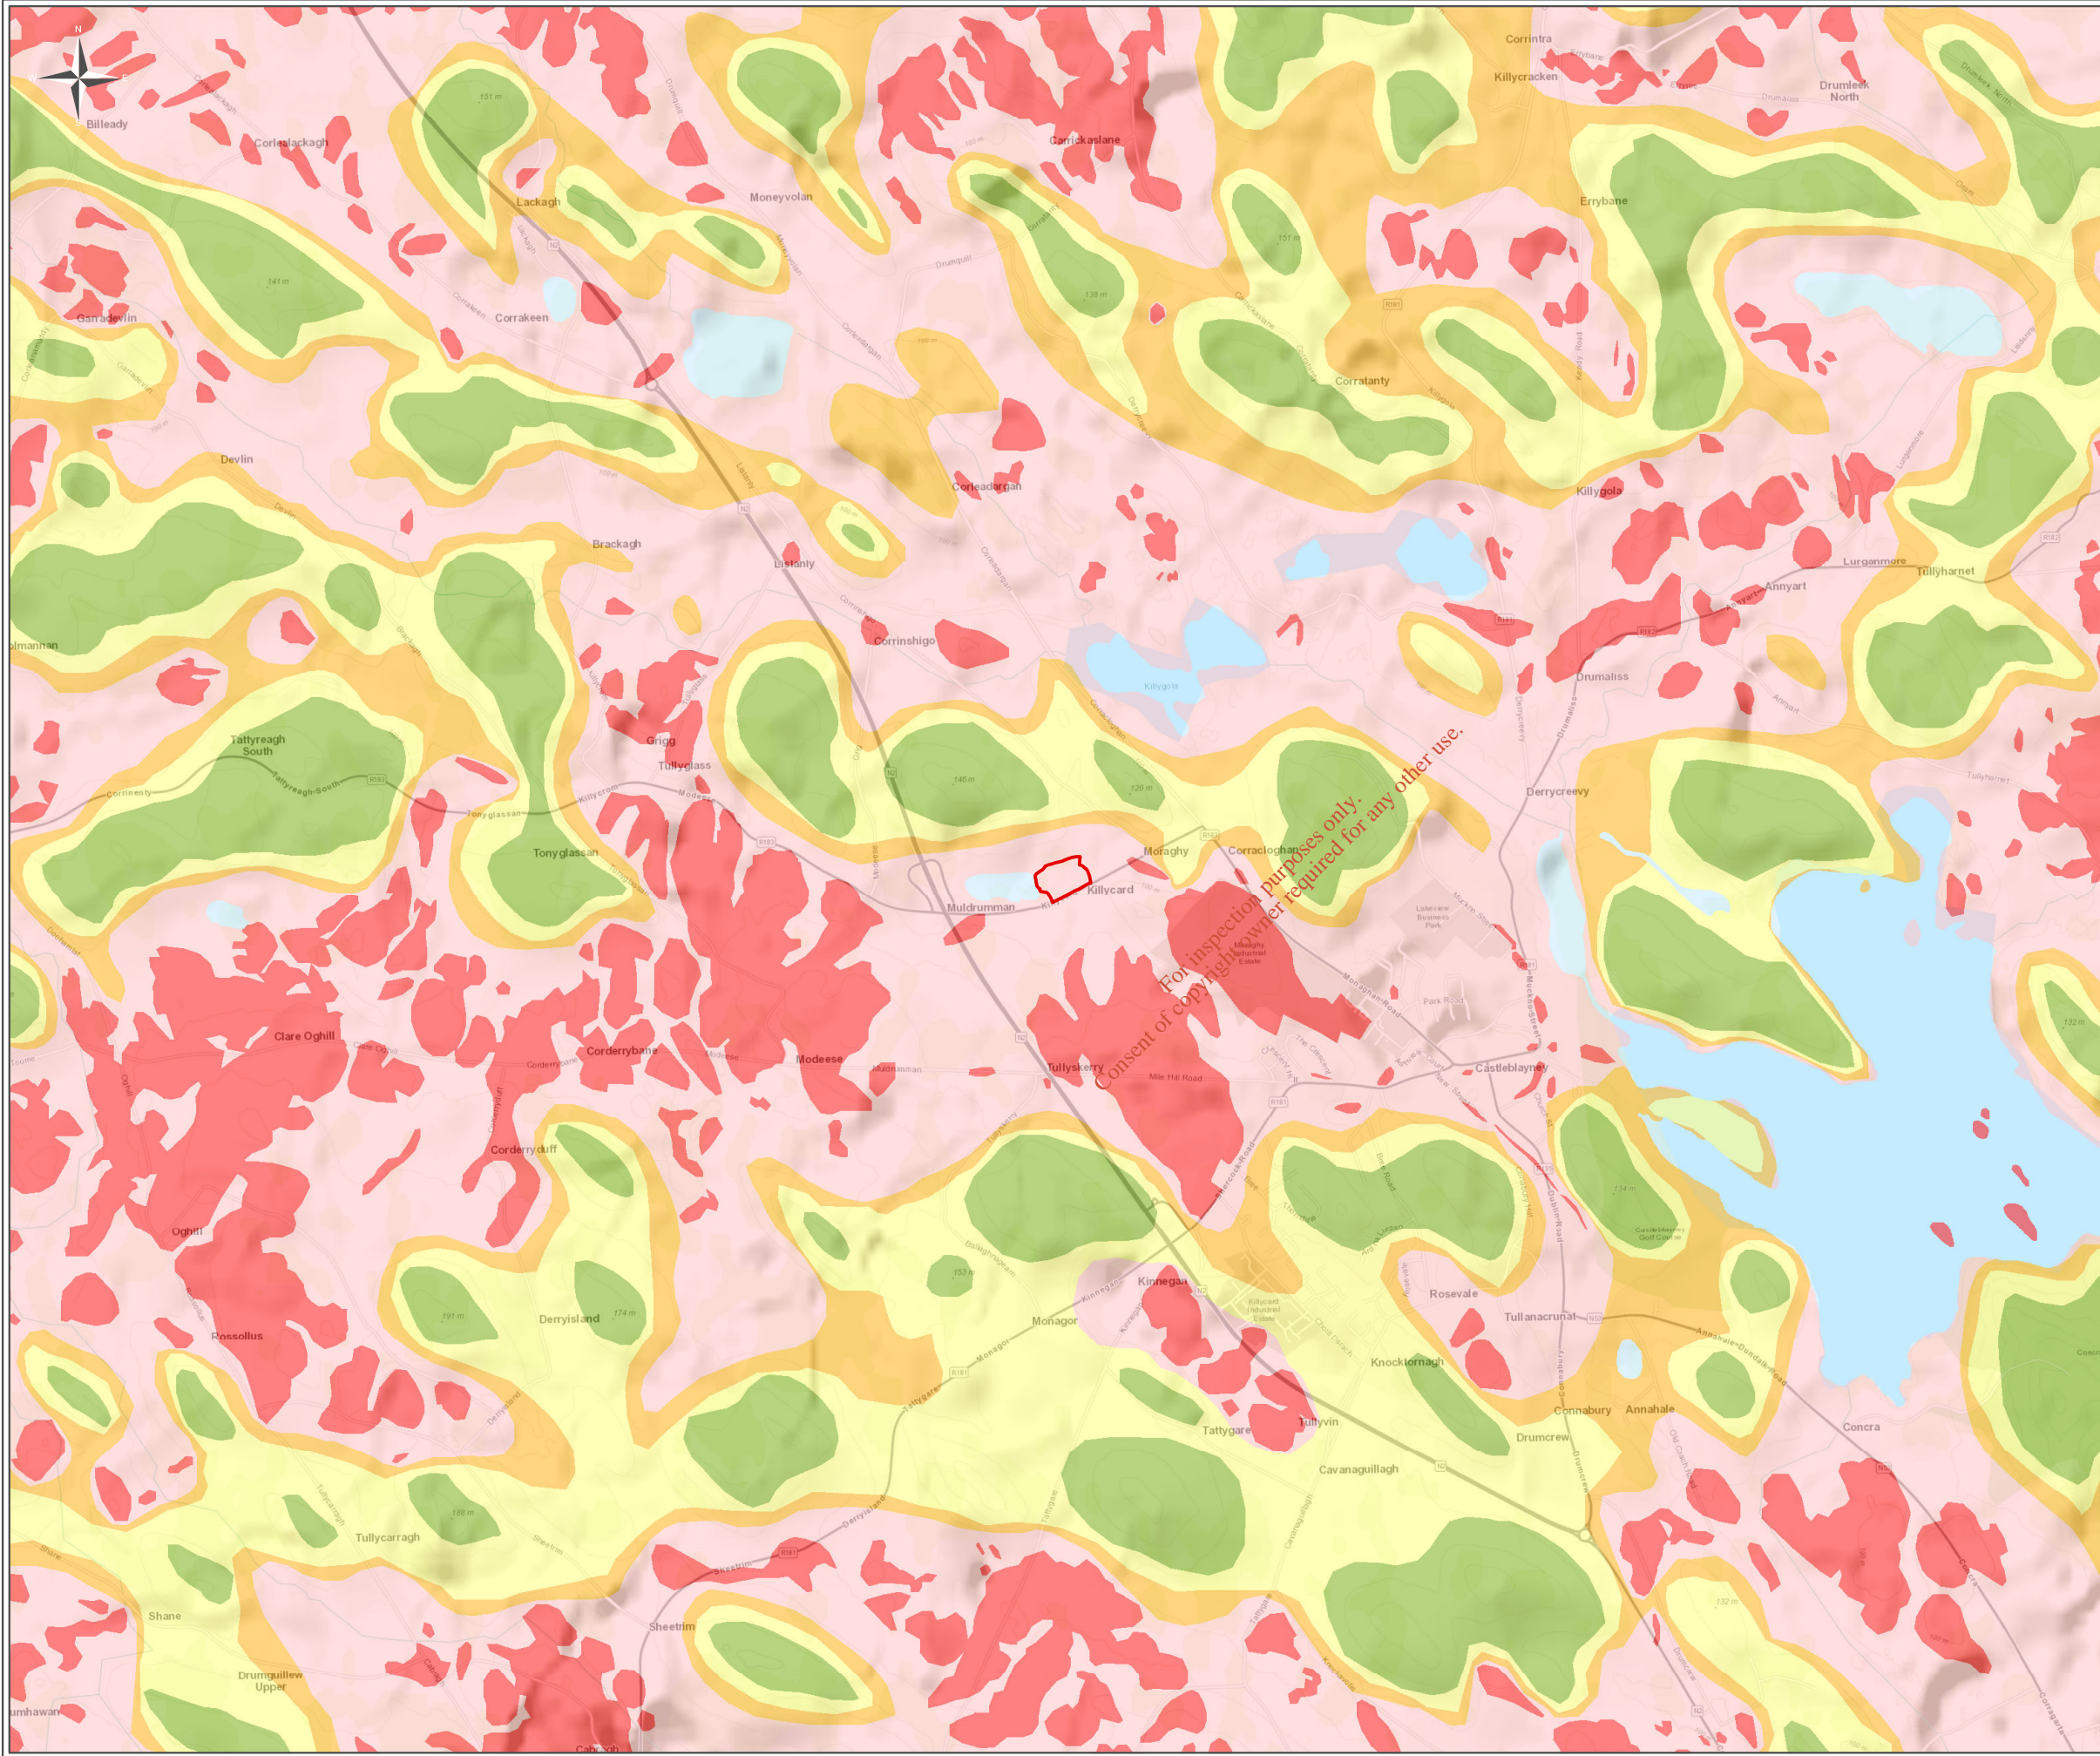
Figure Title	Groundwater Vulnerability Killicard	
Figure No.	2.5	
Project	Tier 1 Assessment of Historical Landfills in Monaghan	
Client	Monaghan County Council	
Scale	1:25,000	Page Size A3
Revision	A	Date 15/06/2018

- Site Boundary
- Groundwater Vulnerability**
- E - Extreme
- H - High
- M - Moderate
- L - Low
- Water
- X (Rock Near Surface or Karst)
