Subject: H0394-01 COA Application FI - Castlerea Historic Landfill.
Attachments: H0394-01 FI Reply.pdf; Entec Risk Assessment for Castlrea Landfill Site.pdf;
H0394-01 LFG Addendum.pdf

**Re: Further Information Application for Certificate of Authorisation
Castlerea Historic Landfill, Co. Roscommon – Site Code S22-02423**

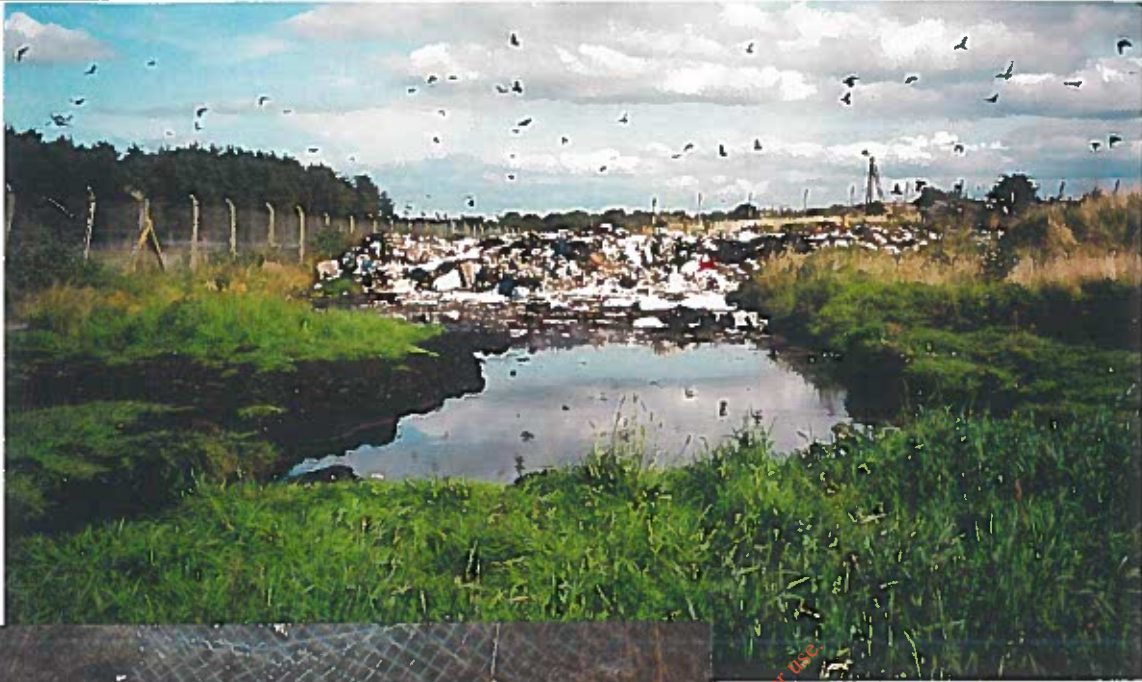
Plate 3.1: Castlereas Landfill
Ponded leachate at foot
of waste area

Further leachate had accumulated in a series of interconnected ponds along the western edge of the waste deposited in area A2 (Plate 3.1). These ponds received leachate directly from the base of the waste and discharge into the perimeter drainage ditch running along the western site boundary (Plate 3.2), close to monitoring point CSW2, as well as infiltrating directly into the surrounding peat. The impact of this leachate on surface water quality is discussed in Section 4.

The most effective leachate control measure will be to reduce infiltration to the waste and thereby reduce the quantity of leachate generated. This effect can be maximised by construction of low permeability cap over the landfill waste. The present programme of capping is likely to reduce infiltration to around 200 m/year. Further improvement of leachate quality can be achieved by providing limited storage in the lateral drainage and small stepped weirs at their outfalls.
