**TULLYVOGHEEN HISTORIC LANDFILL  
TULLYVOGHEEN,  
CLIFDEN, CO. GALWAY**

**VOLUME II. SECTION D - PART A  
*TIER 2 SITE INVESTIGATION & TIER 3 GQRA  
ASSESSMENT OF TULLYVOGHEEN LANDFILL  
REPORT***

**TIER 2 SITE INVESTIGATION &  
TIER 3 GENERIC QUANTITATIVE RISK ASSESSMENT  
OF  
FORMER TULLYVOGHEEN LANDFILL**

9<sup>TH</sup> July 2014

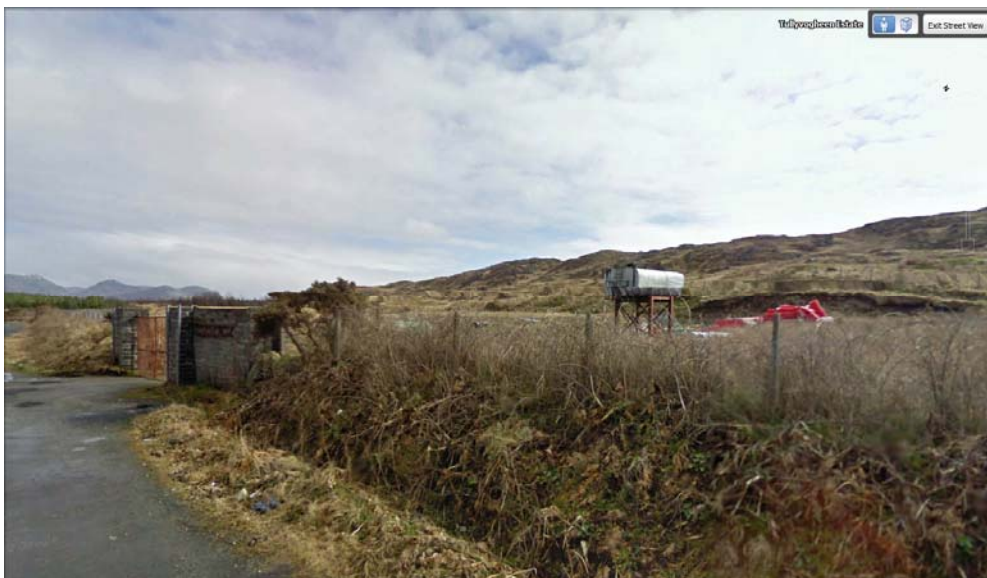
According to Galway C.C., the former municipal landfill at Tullyvogheen, Clifden, County Galway, was in operation between the years of 1984 and 1999. During this period it is estimated by Galway County Council that approximately 23,000 tonnes of mixed waste including domestic, commercial and construction & demolition (i.e. C & D) waste per annum was deposited annually (see Plate 2 below). The site area is 1.27 hectares (ha) and the total waste body is estimated at 114,000m<sup>3</sup> or 205,000 tonnes.

**Plate 2. View of former Tullyvogheen Landfill from west of site entrance facing southeast**

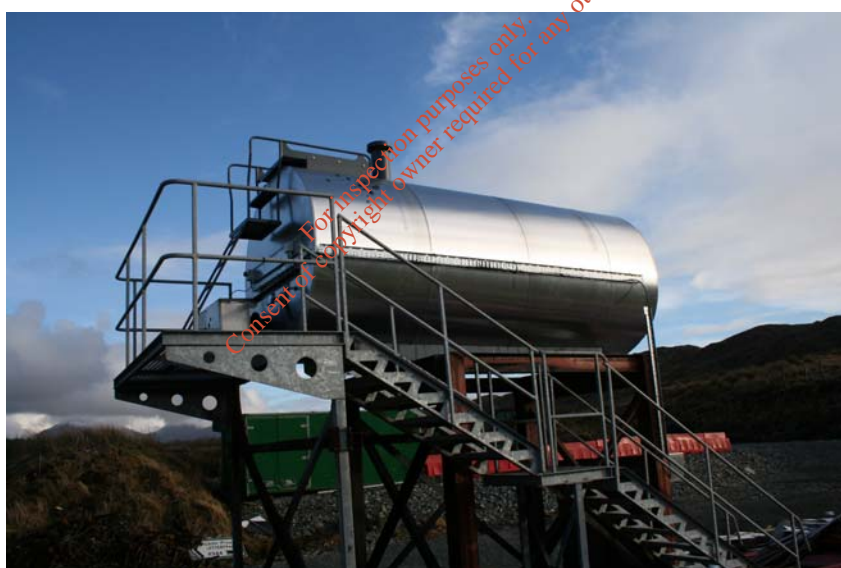
The site is currently used as a road depot by Galway County Council roads department with a 10,000l aboveground storage tank (AST) used for the storage of road bitumen (see Figure 4). It is understood that the bitumen, prior to use and transfer into the road maintenance vehicle, is heated by an in-built heater powered by gas provided by an on-site LPG tank (see Plate 3 following).

**Plate 3. View of 10,000l aboveground storage tank used for the storage of road bitumen**

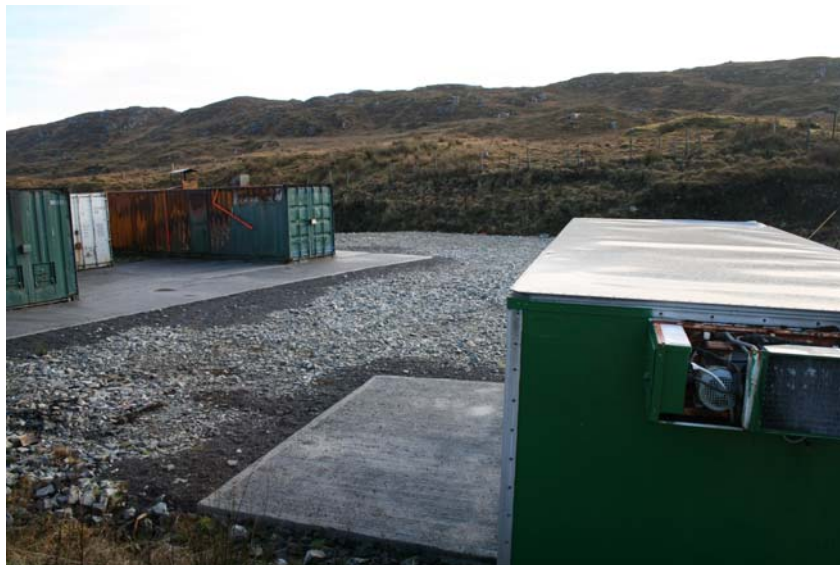
The site is also used by Galway Fire Brigade for fire drills. A hardcore-covered area to the southeast of the entrance has been dedicated for this purpose. This area is bordered by 1.5 metre high earthen berms to the north and east which separate it from the landfill (see Figures 4 and 5). Two 40-foot and a 20-foot truck container are used in the 'Fire Drill Area' for the ongoing training of Galway Fire Brigade staff (see Plate 3). Another 20-foot container located in the north-western corner of the Fire Drill Area is used for the storage of fire-fighting equipment.

Plate 4. View of Galway Fire Brigade 'Fire Dill Area' to east of road depot area facing south

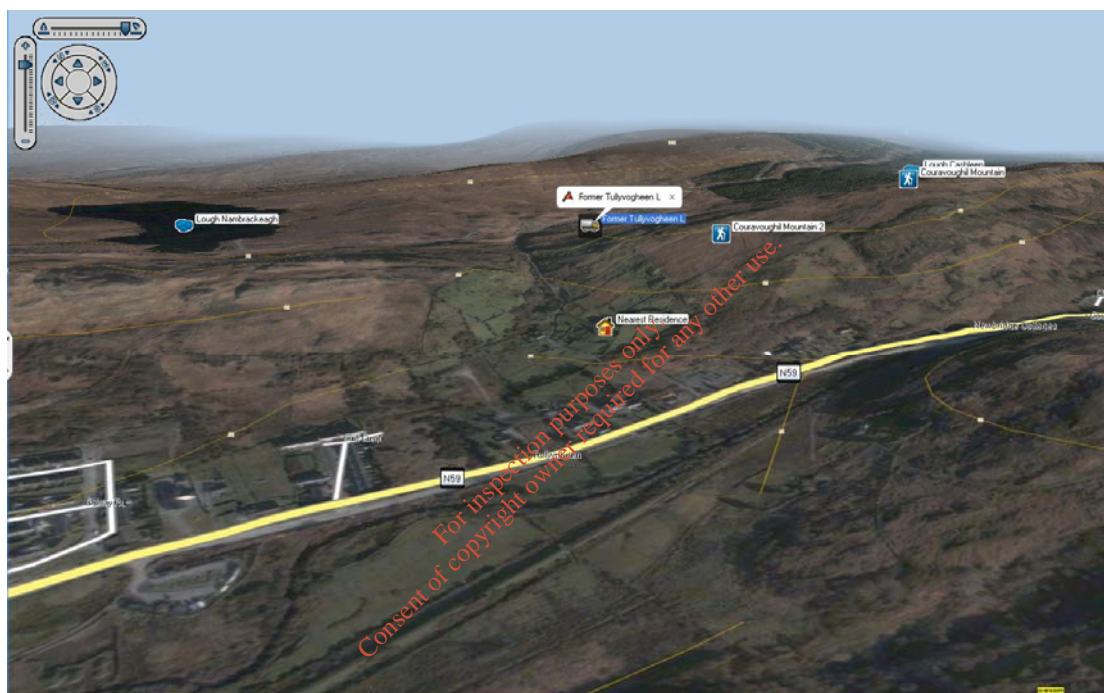
**Plate 5. View of country road facing northeast showing nearest residence in foreground, Couravoghil Mountain to south of former landfill with Lough Nambrackeagh to northwest of site**

As stated in the introduction, the site is located in a remote area. The site is approximately 2 km east of the town centre of Clifden. The site is located on a narrow country road that leads uphill approximately 660m from the Clifden to Galway Secondary Road (the N59) (see Figures 1 and 2). At a distance of approximately 600m from the N59 the country road turns eastwards (see Plate 5 below).

Where the site is located, this country road has been constructed at the edge of a valley between a small mountain, Couravoghil Mountain to the south and a number of hills to the north. The valley is orientated in an approximate west to east direction. The landfill to the south of the country road consists of a substantial infill operation where the valley was raised approximately 3.5m on the eastern side of the site and approximately 7-8m on the western side of the site.

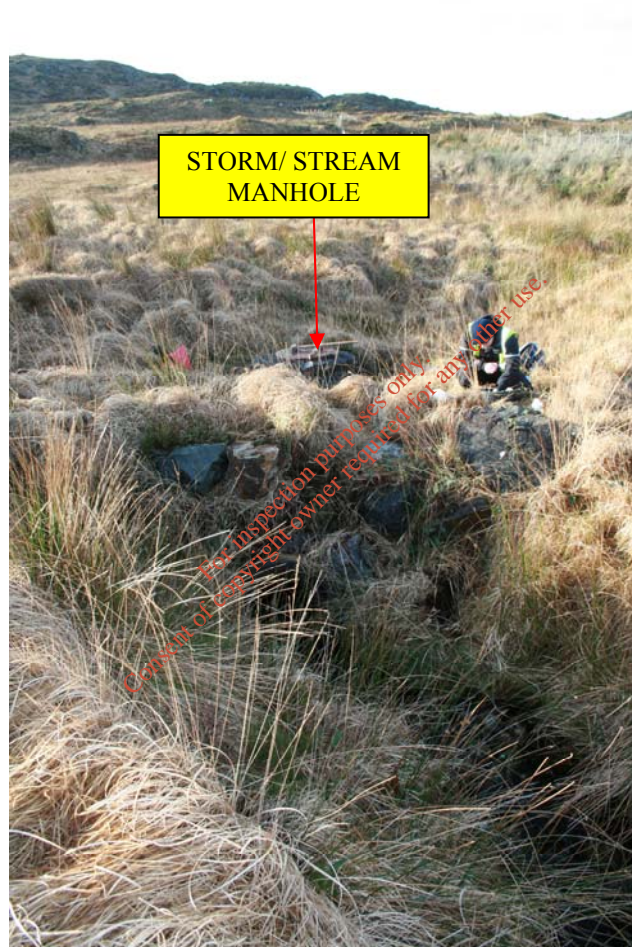
It is understood that a number of years after the infilling of waste at Tullyvogheen Landfill commenced, the stream which runs through the site was culverted. The stream is culverted 27m from the eastern boundary of the site (see Figure 10).

**Plate 6. To east of site at country road facing southwards showing stream/storm access manhole and landfill to west (i.e. left)**

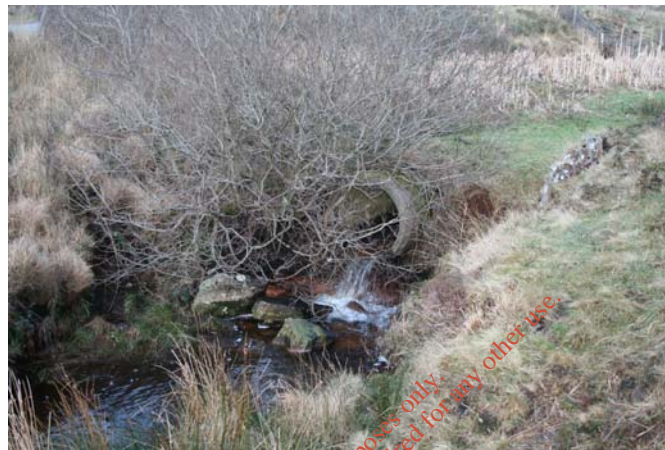
In addition to receiving a 475mm ID concrete pipe from the stream to the west, it also received a 475mm ID concrete pipe from a culverted stream to the north of the site, a 300mm ID concrete pipe from a stream/land drain to the south and a 150mm ID concrete pipe from a land drain located just to the east of the landfill. A 900mm ID concrete pipe exits this manhole in a westerly direction. This pipe or appears to run the full length of the landfill (i.e. 260m) and exits to the west of the landfill (see Plate 7 following).

Another land drain was observed on the south-western boundary of the site (see Figure 4). This also serves to remove ponded water from this area which results from run-off from Couravoughil Mountain to the south of the site. This land drain appears to discharge into the stream at a point immediately adjacent and to the south of the culvert discharge point (see Plate 7 below).

**Plate 7. To west of site facing northeast showing culvert discharge point to west of landfill.**

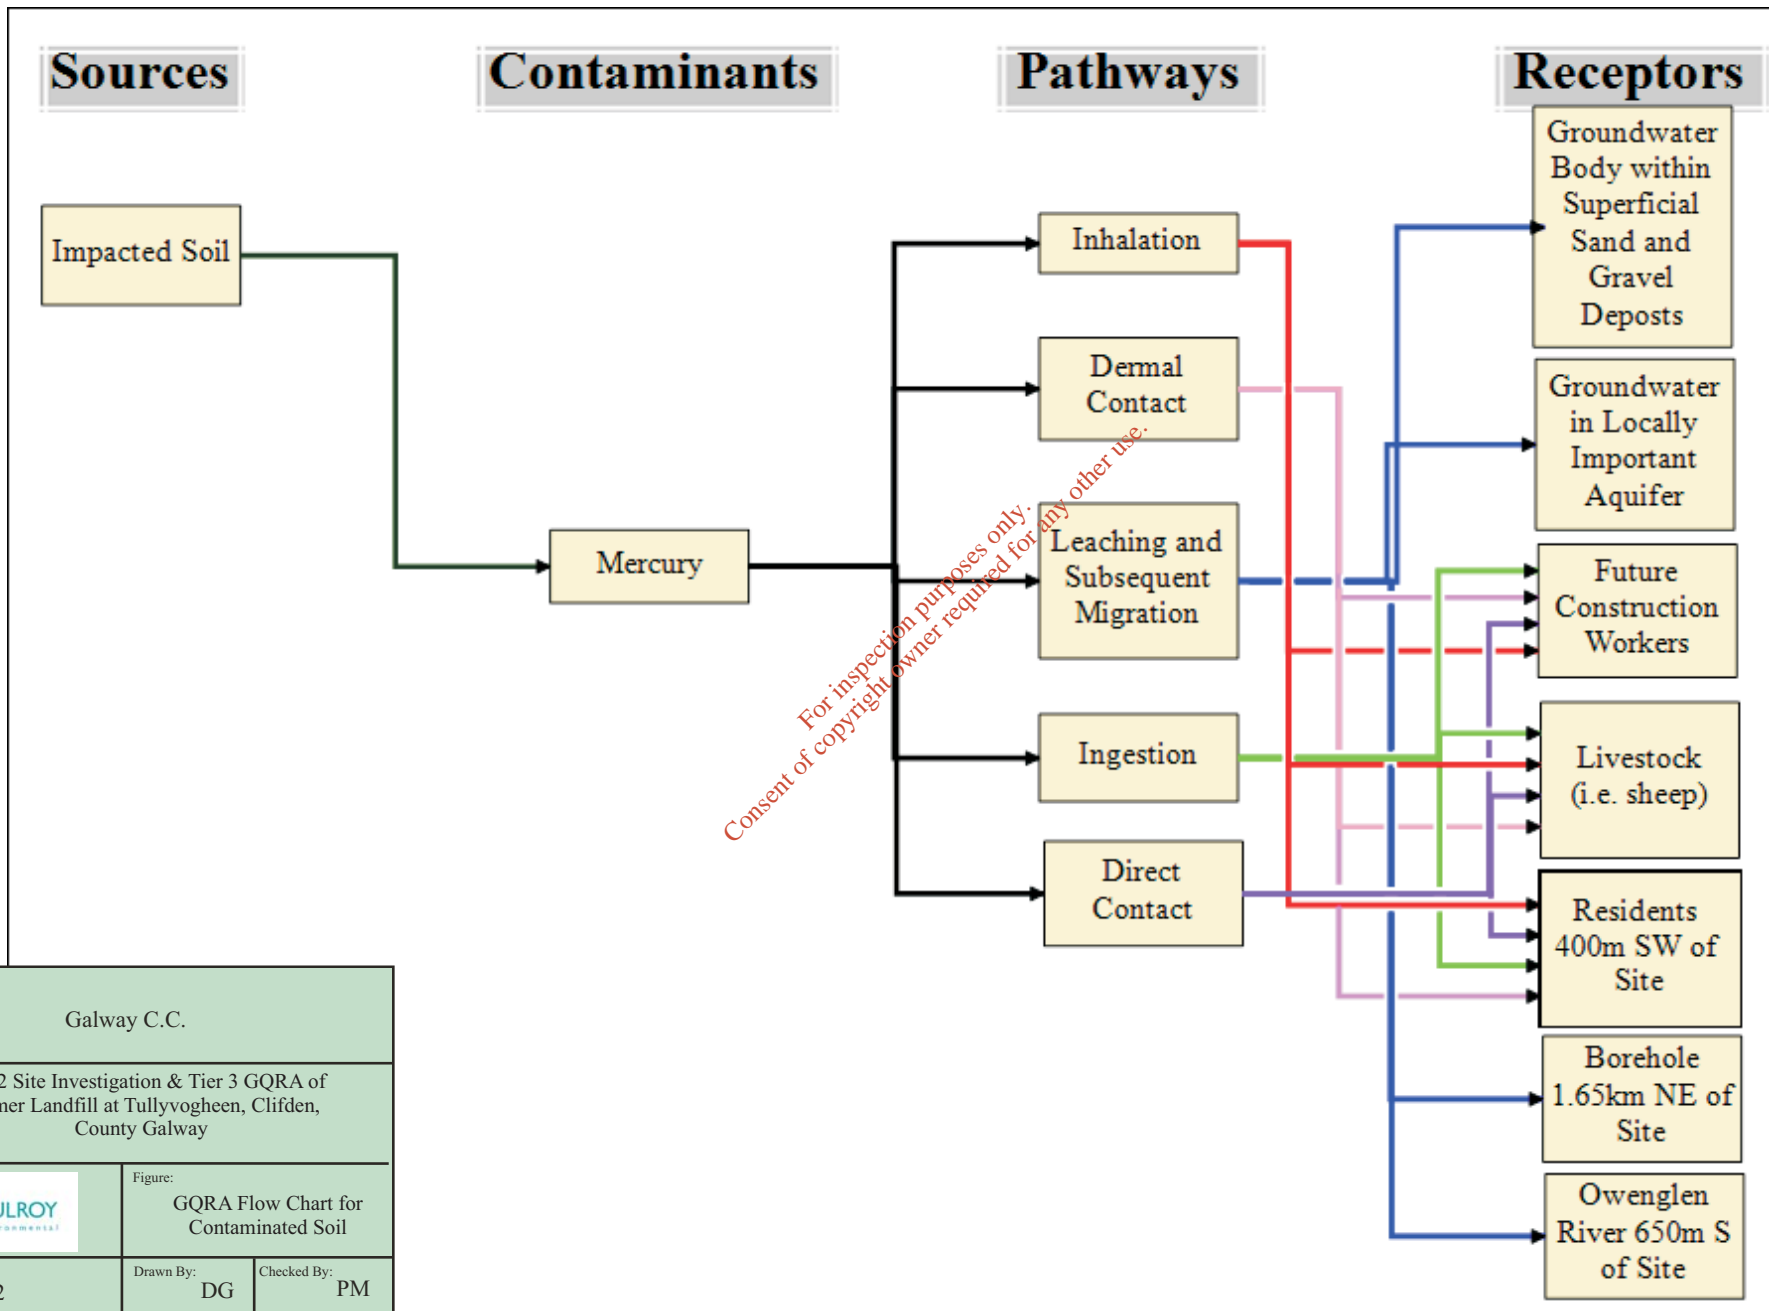
Chart 2. GQRA Flow Chart for Contaminated Soil (i.e Mercury)

A process flow chart, Chart 2 showing the Source-Contaminant-Pathway-Receptor rationale has been prepared to explain the above table.

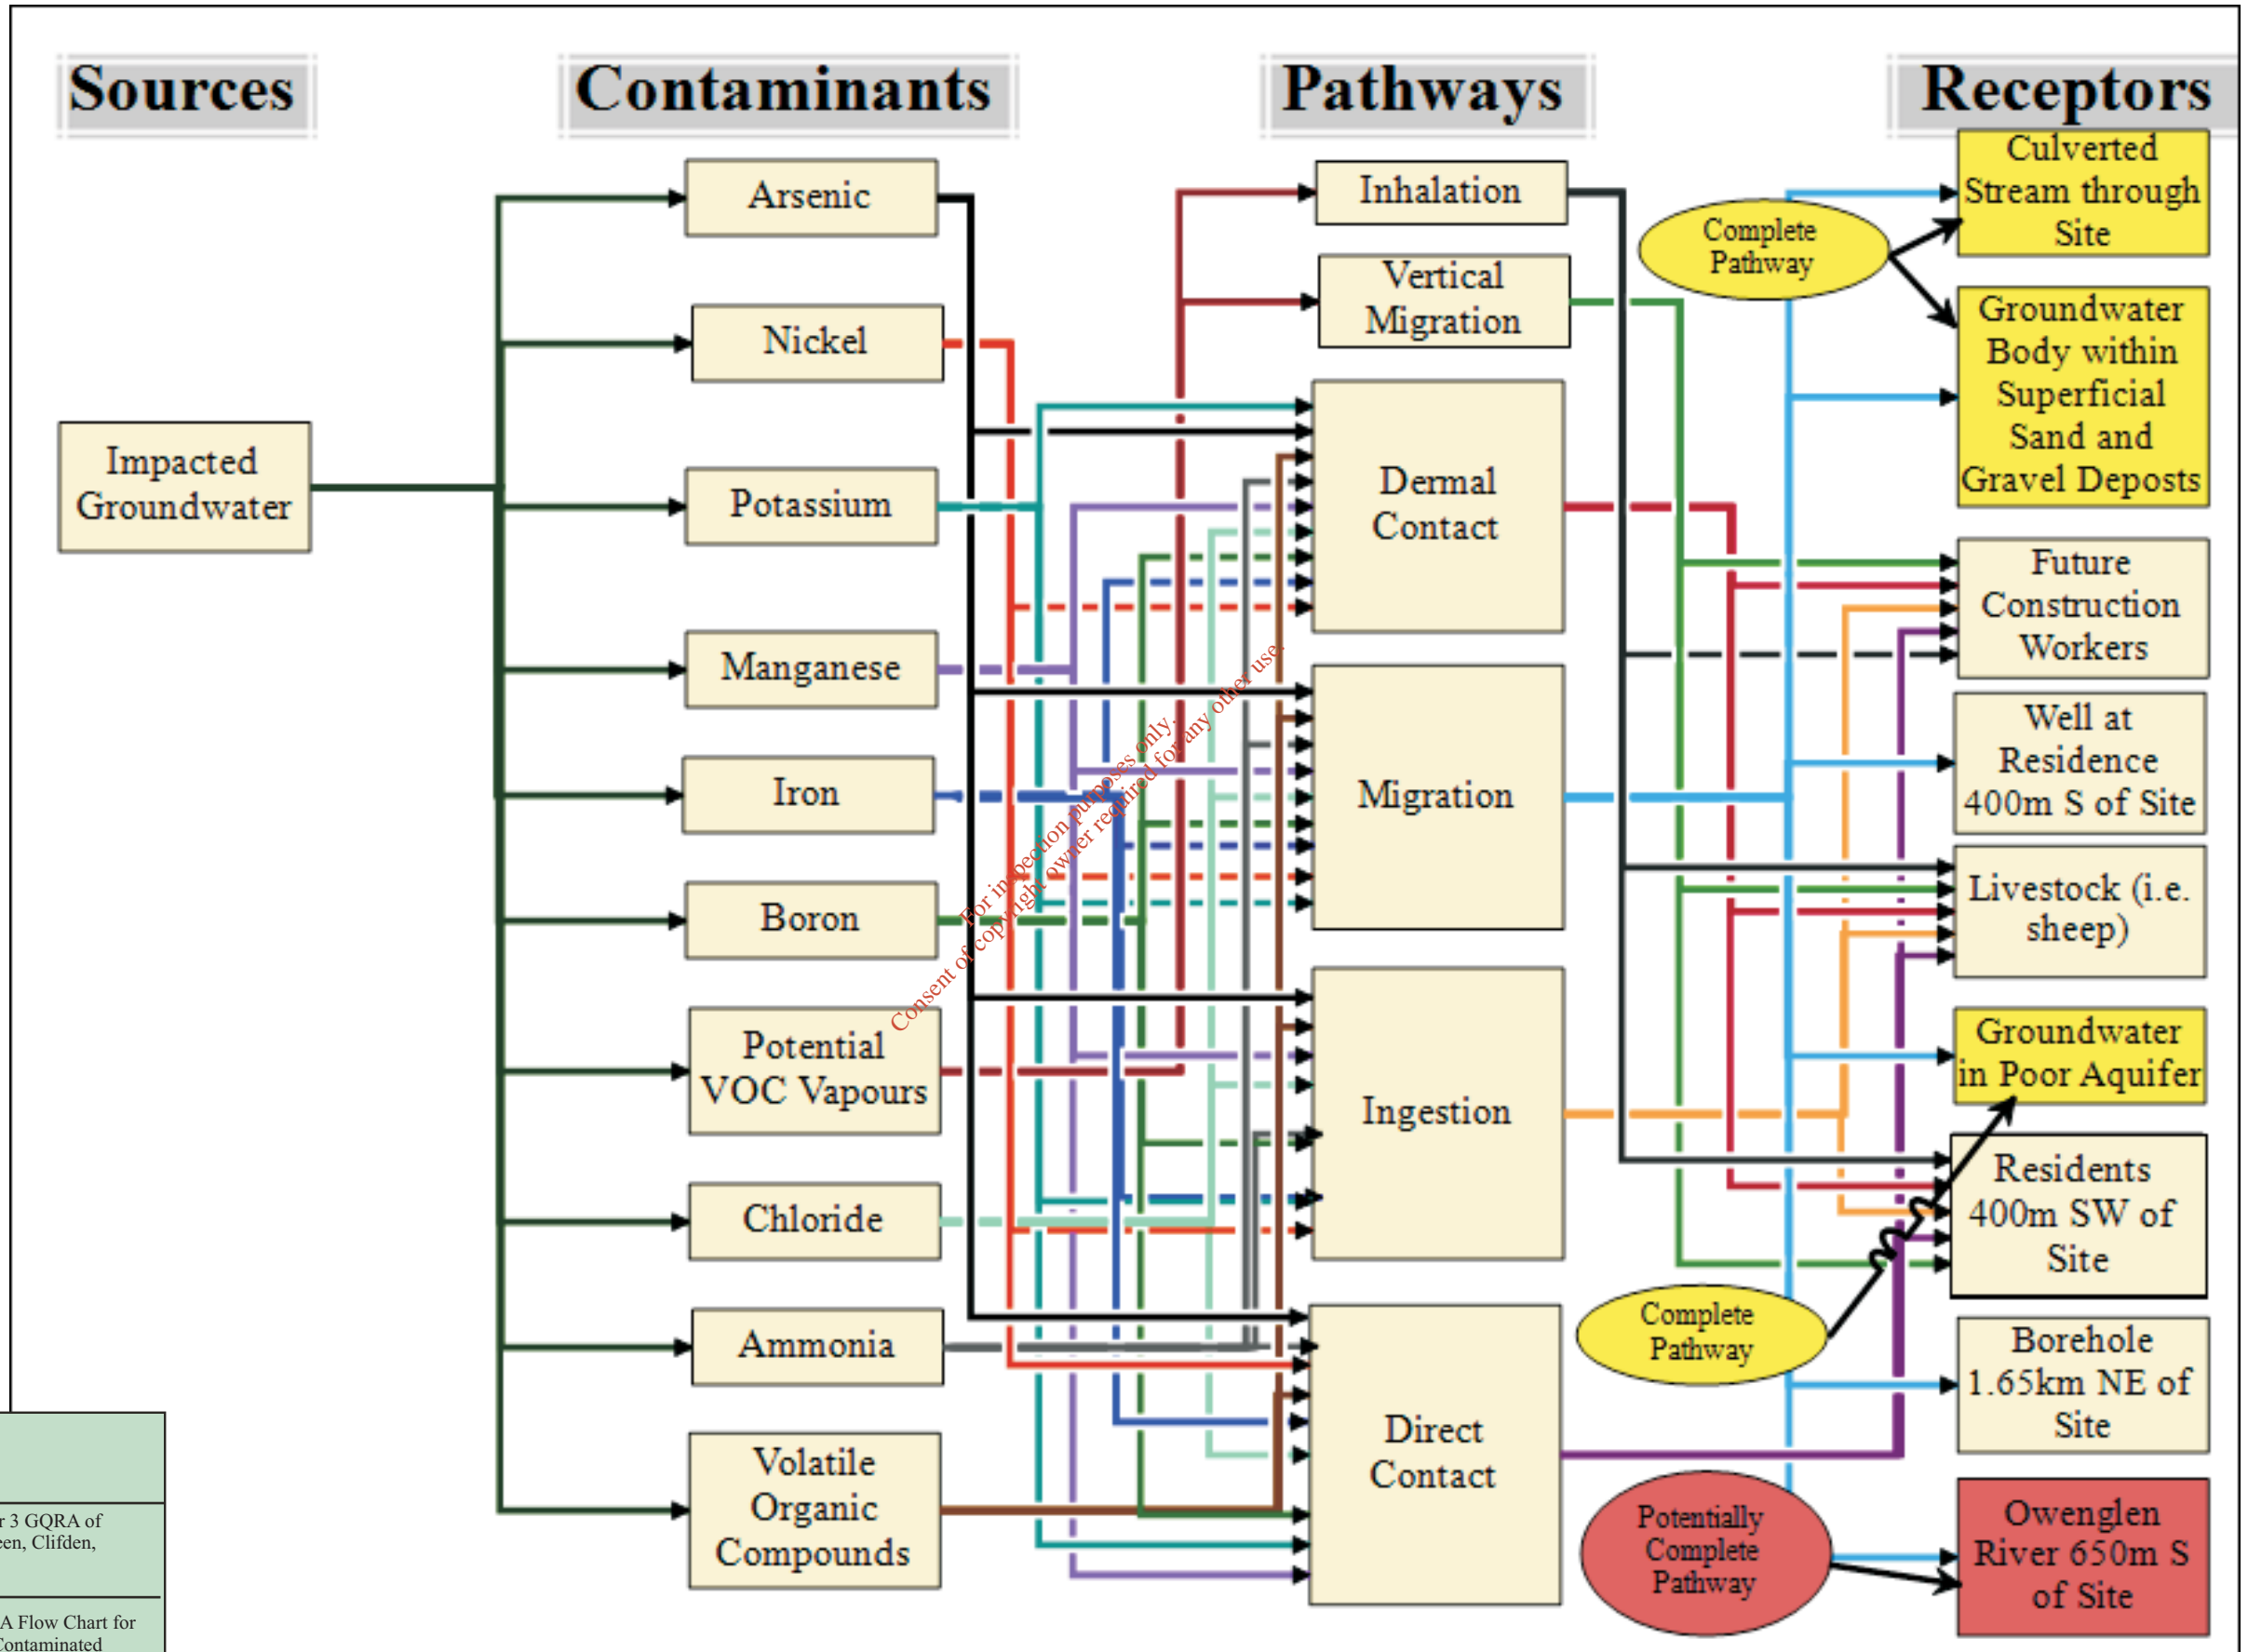
Chart 3. GQRA Flow Chart for Contaminated Groundwater

There are no other viable receptors such as water abstraction boreholes identified in the immediate vicinity of the site and more importantly downgradient of the site.
