**TULLYVOGHEEN HISTORIC LANDFILL  
TULLYVOGHEEN,  
CLIFDEN, CO. GALWAY**

**APPLICATION TO EPA  
FOR  
CERTIFICATE OF AUTHORISATION**

**FURTHER INFORMATION –  
HYDROLOGY/TIER 3 GQRA REPORT  
VOLUME I. REPORT**

**21<sup>st</sup> November 2019**

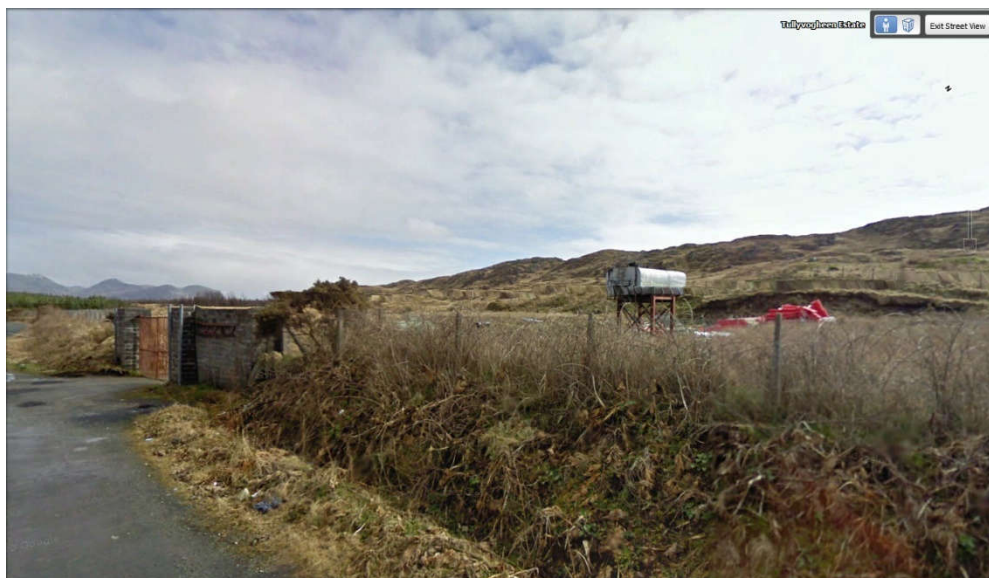
According to Galway C.C., the former municipal landfill at Tullyvogheen, Clifden, County Galway, was in operation between the years of 1984 and 1999. During this period it is estimated by Galway County Council that approximately 23,000 tonnes of mixed waste including domestic, commercial and construction & demolition (i.e. C & D) waste per annum was deposited annually (see Plate 3 following). The site area is 1.27 hectares (ha) and the total waste body is estimated at 114,000m<sup>3</sup> or 205,000 tonnes.

**Plate 3. View of former Tullyvogheen Landfill from west of site entrance facing southeast**

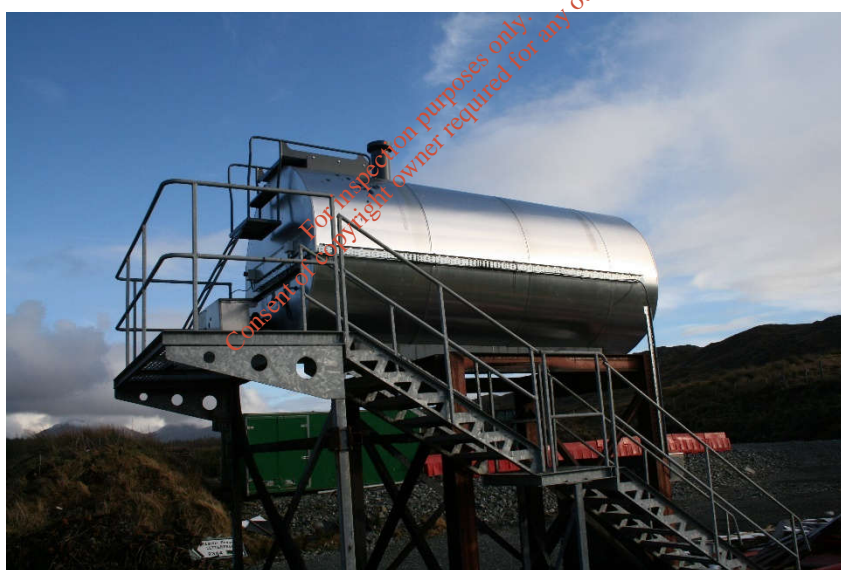
The site is currently used as a road depot by Galway County Council roads department with a 10,000l aboveground storage tank (AST) used for the storage of road bitumen (see Figures 4 & 5). It is understood that the bitumen, prior to use and transfer into the road maintenance vehicle, is heated by an in-built heater powered by gas provided by an on-site LPG tank (see Plate 4 below).

**Plate 4. View of 10,000l aboveground storage tank used for the storage of road bitumen**

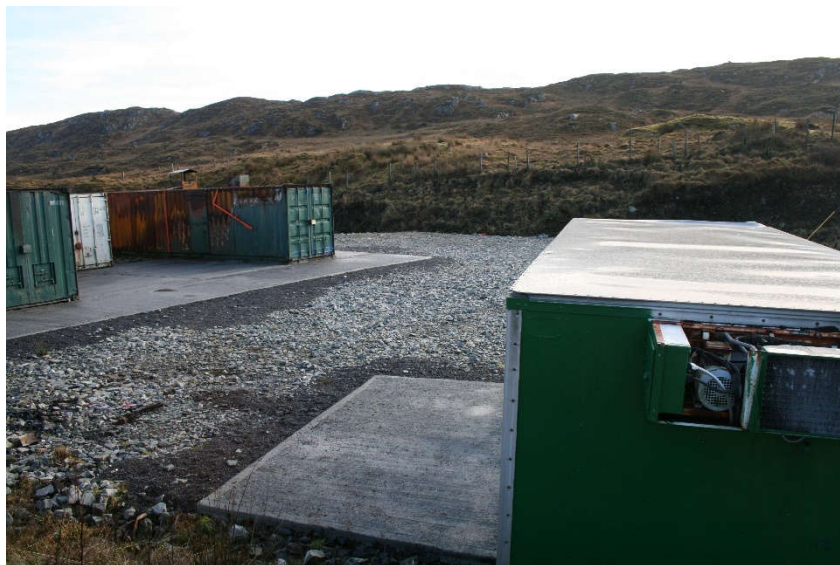
The site was formerly used by Galway Fire Brigade for fire drills. A hardcore-covered area to the southeast of the entrance was dedicated for this purpose. This area is bordered by 1.5 metre high earthen berms to the north and east which separate it from the landfill (see Figures 4 and 5). Two 40-foot and a 20-foot truck container were used in the 'Fire Drill Area' for the ongoing training of Galway Fire Brigade staff (see Plate 5). Another 20-foot container located in the north-western corner of the Fire Drill Area was used for the storage of fire-fighting equipment.

**Plate 5. View of former Galway Fire Brigade 'Fire Dill Area' to east of road depot area facing south**

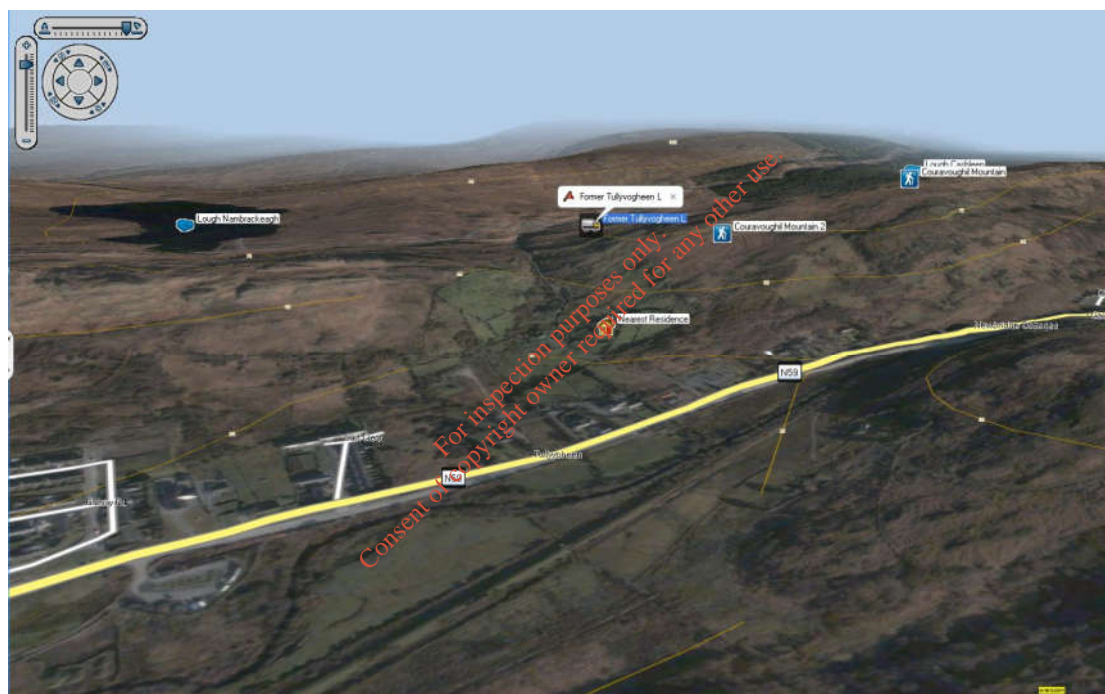
**Plate 6. 3D View of country road facing northeast showing nearest residence in foreground, Couravoughil Mountain to south of former landfill with Lough Nambrackeagh to northwest of site**

As stated in the introduction, the site is located in a remote area. The site is approximately 2 km east of the town centre of Clifden. The site is located on a narrow country road that leads uphill approximately 660m from the Clifden to Galway Secondary Road (the N59) (see Figures 1, 2 and 3). At a distance of approximately 600m from the N59 the country road turns eastwards (see Plate 6 below).

Where the site is located, this country road has been constructed at the edge of a valley between a small mountain, Couravoughil Mountain to the south and a number of hills to the north. The valley is orientated in an approximate west to east direction. The landfill to the south of the country road consists of a substantial infill operation where the valley was raised approximately 3.5m on the eastern side of the site and approximately 7-8m on the western side of the site.

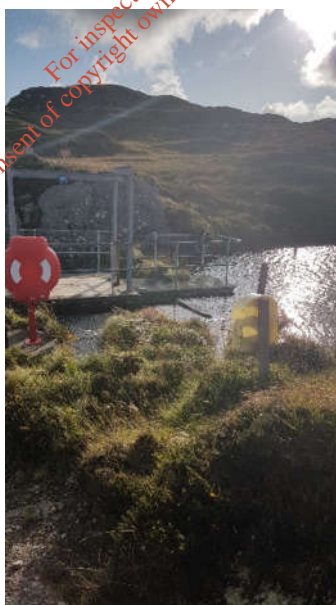
**Plate 7. Water extraction/pumping plant located on the southern end of Lough Nambrackeagh**

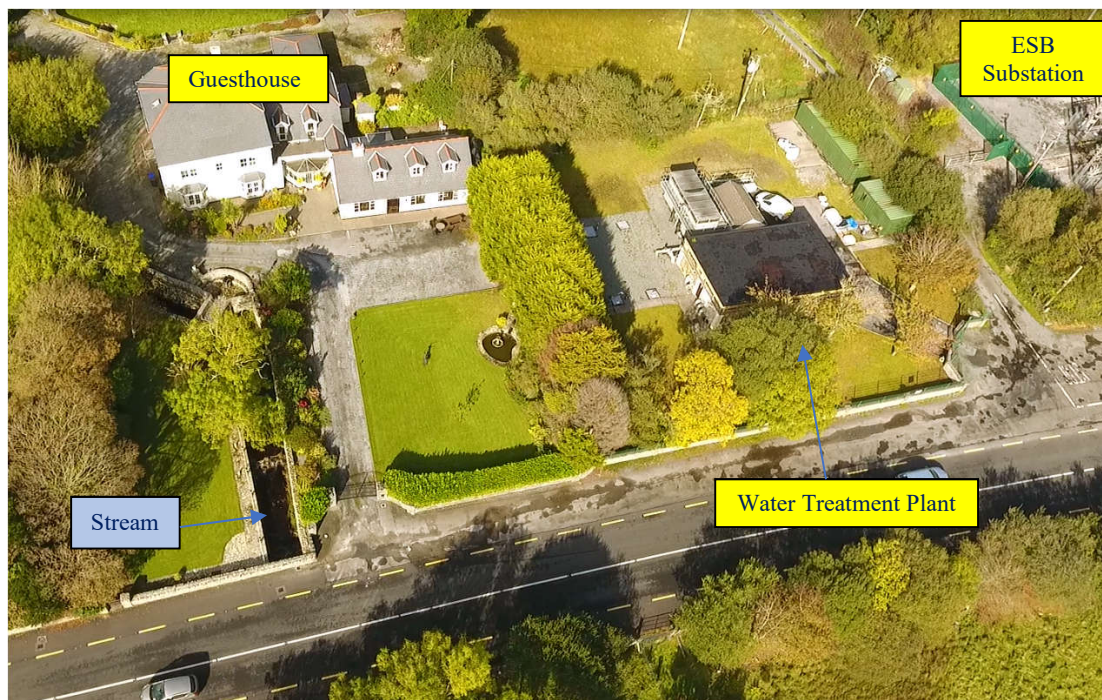
**Plate 8. Galway County Council/Irish Water - Water Treatment plant located at corner of country road and national road N59 (note guesthouse to west of plant and ESB substation to east of site)**

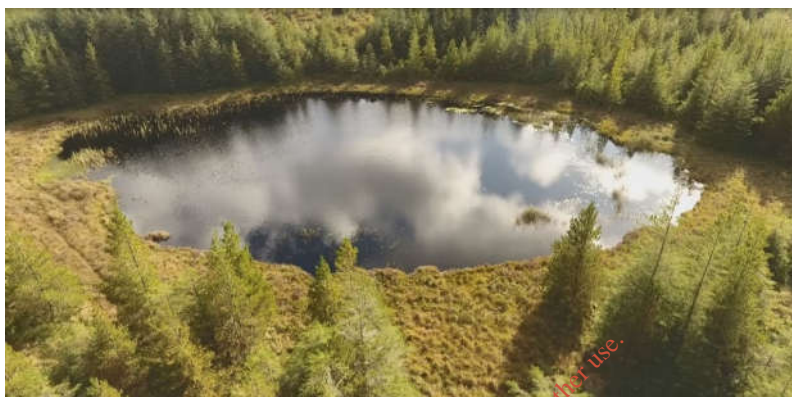
The valley contains a meandering stream flowing in an approximate east to west direction which rises from Lough Cashleen which is located approximately 690m to the east of the site in a Coillte Coniferous Forest Plantation (see Figures 13 and Plate 9 below). It is understood that a number of years after the infilling of waste at Tullyvogheen Landfill commenced, the stream which runs through the site was culverted (see Figures 4-5). The stream is culverted 27m from the eastern boundary of the site.

**Plate 9. UAV aerial photograph of Lough Cashleen taken at 40m elevation from the northern side facing in a southerly direction (note the stream exits the Lough on its western side i.e. to the left of the photo).**

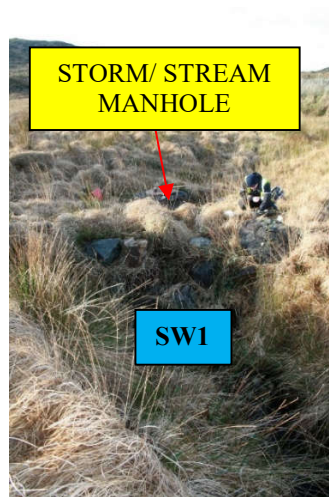
A 900mm ID concrete pipe exits this manhole in a westerly direction. This pipe appears to run the full length of the landfill (i.e. 260m) and exits to the west of the landfill (see Plates 10, 11 & 12 following and Figures 13 and 14).

**Plate 12. To east of site facing westwards towards landfill showing stream feeding into storm access manhole and surface water monitoring location SW1 manhole**

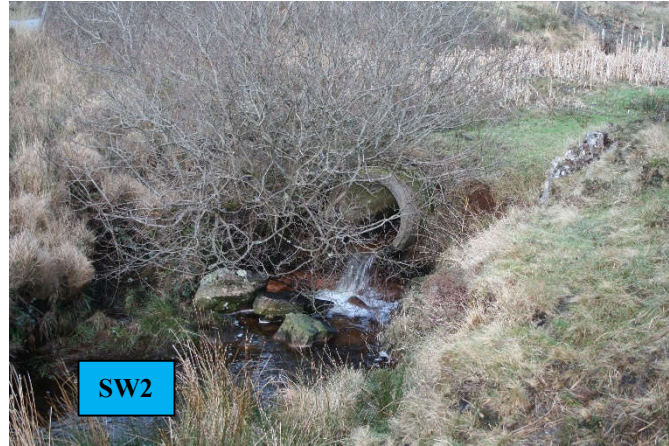
This stream, which runs in an east to west direction through the valley, is culverted through the landfill before continuing in a south-westerly direction alongside the country road for a distance, then heading south-westwards (see Figures 15). The 2<sup>nd</sup> surface water sample SW2 was taken at this unnamed 1<sup>st</sup> order stream (see Surface Water Monitoring Logs in Appendix 3). In addition, the 1<sup>st</sup> invertebrate kick sample was taken at this location (see Plates 13 and 14 below and following, and Figures 14 & 15).

**Plate 14. To west of site facing northeast showing culvert discharge point to west of landfill (note iron deposit)**

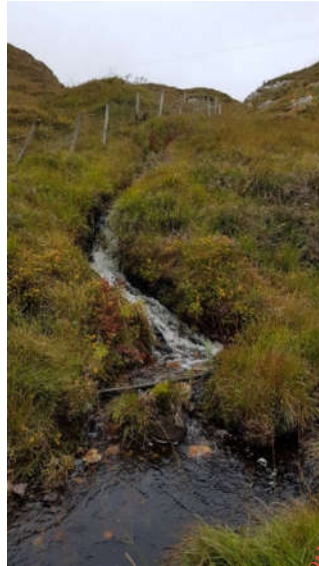
The 3<sup>rd</sup> surface water sample, SW3 was taken downgradient of the confluence with the Lough Nambrackeagh stream, on this unnamed 2<sup>nd</sup> order stream (see Surface Water Monitoring Logs in Appendix 3). In addition, the 2<sup>nd</sup> invertebrate kick sample was taken at this location (see Figure 15 and Plates 16 & 17 following).

Plate 16. Digital photograph taken at point where stream from Lough Nambrackeagh joins subject stream (i.e. upgradient of SW3)

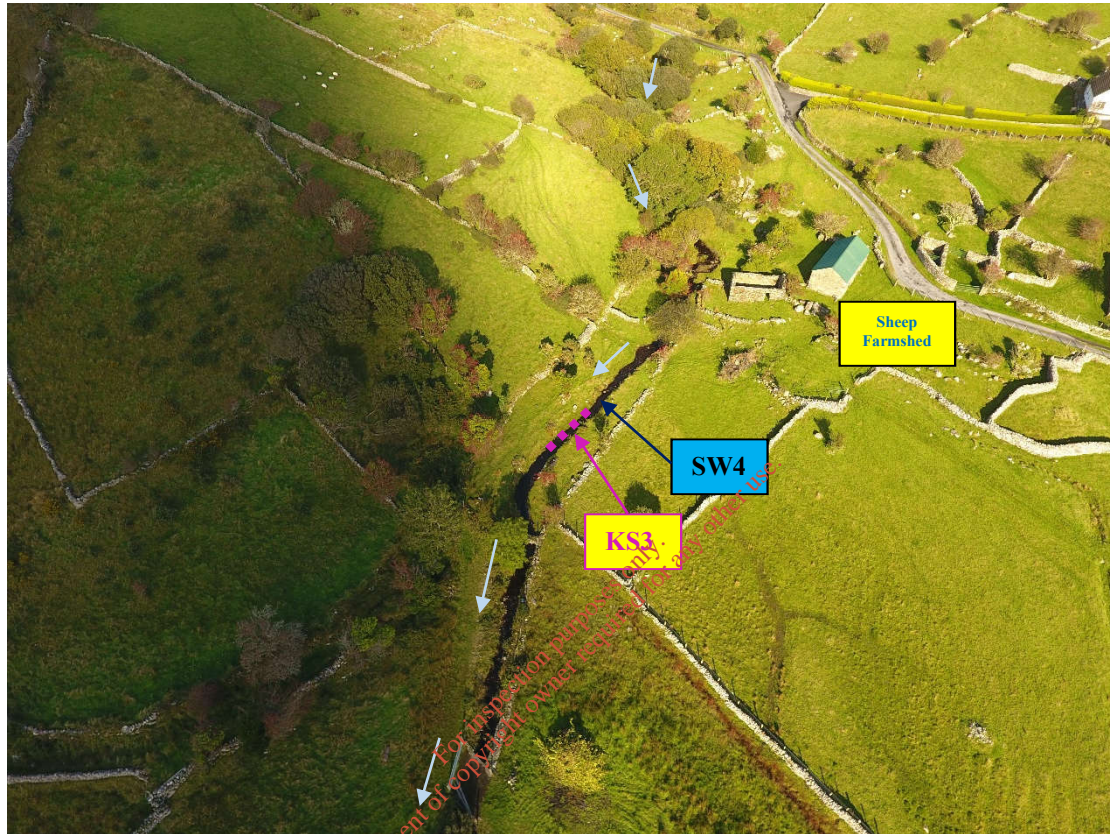
The 4<sup>th</sup> surface water sample, SW4 was taken at a location approximately 460m to the southwest of the landfill where the stream, which is a 2<sup>nd</sup> order unnamed stream, passes through a sheep farm which is downgradient of the site (see Surface Water Monitoring Logs in Appendix 3). In addition, the 3<sup>rd</sup> invertebrate kick sample, KS3 was taken at this location (see Plates 18, 19, 20 and 21 following and Figures 16 & 17).

Plate 18. UAV aerial photograph taken at 40m elevation approximately 460m to the southwest of landfill at the western boundary of the sheep farm (i.e. note location of SW4 and KS3).

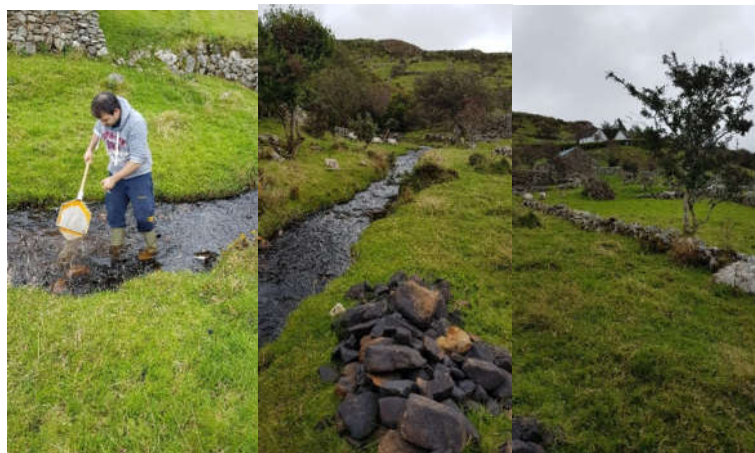
Plate 19. Photographs of SW4 surface water sampling area/KS3 invertebrate sampling area showing kick sampling in progress, sheep grazing and adjacent sheep farmshed.

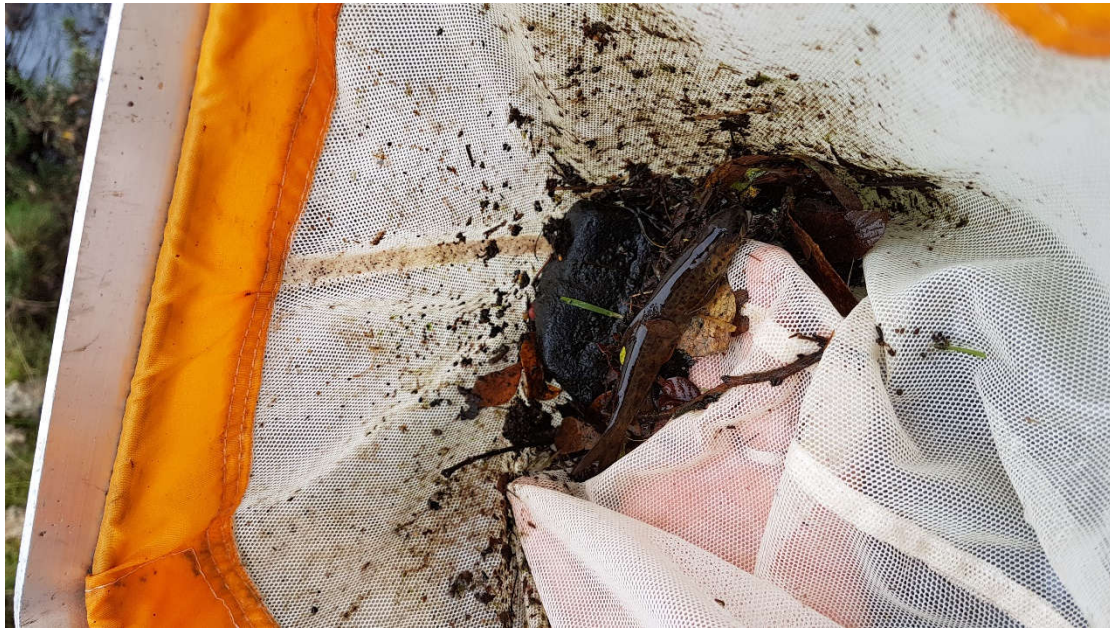
**Plate 20. Photograph of the kick sample net taken from KS3 showing a trout parr**

One site KS3, was assigned a Q4, largely due to the presence of Group A taxa and good representation of Group B taxa, with a high overall % EPT (i.e. *Ephemeroptera*, *Plecoptera*, *Trichoptera*). It should be noted that during sampling a trout parr was recorded within the sample (see previous plate, Plate xx). The slight to moderate silt plume observed, the low filamentous algae cover and DO concentration of 95% recorded at the site supports the Q4 classification (see Figure 16 and previous Section 4.4.11 for detailed description of location).

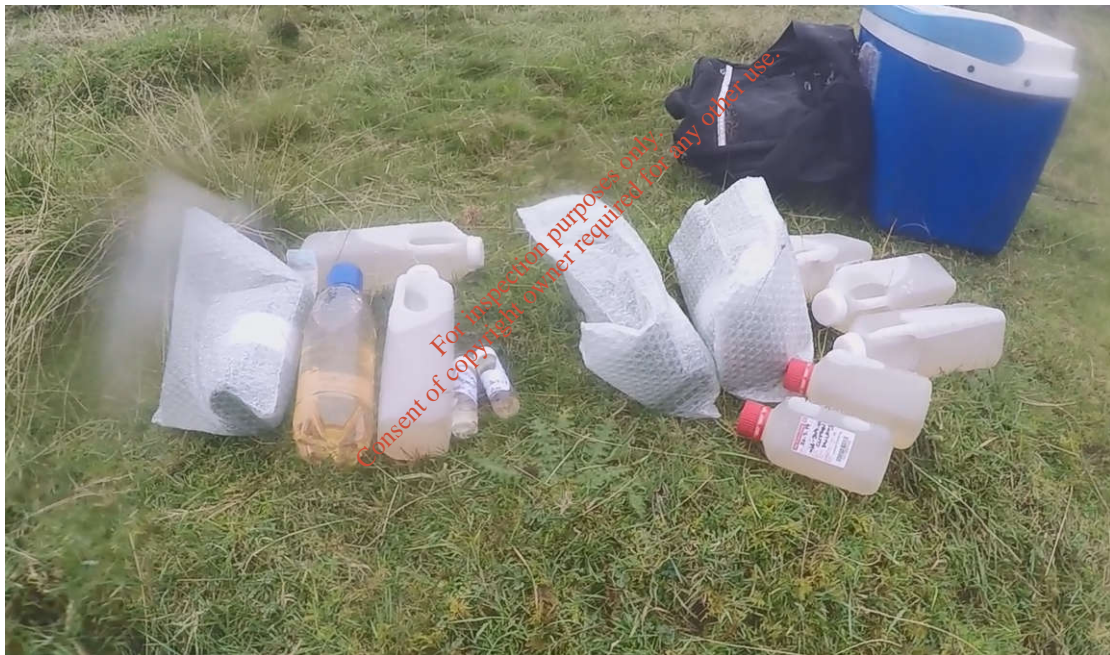
**Plate 21. Photograph of surface water sample taken at SW4 showing peat tannins**

Despite the discoloration (i.e. brown taint) caused by peat tannins within the surface water samples, the results obtained for Total Suspended Solids for all 7 surface water samples were low at <5mg/l (see Table 4-Part A and surface water monitoring field logs in Appendix 3).

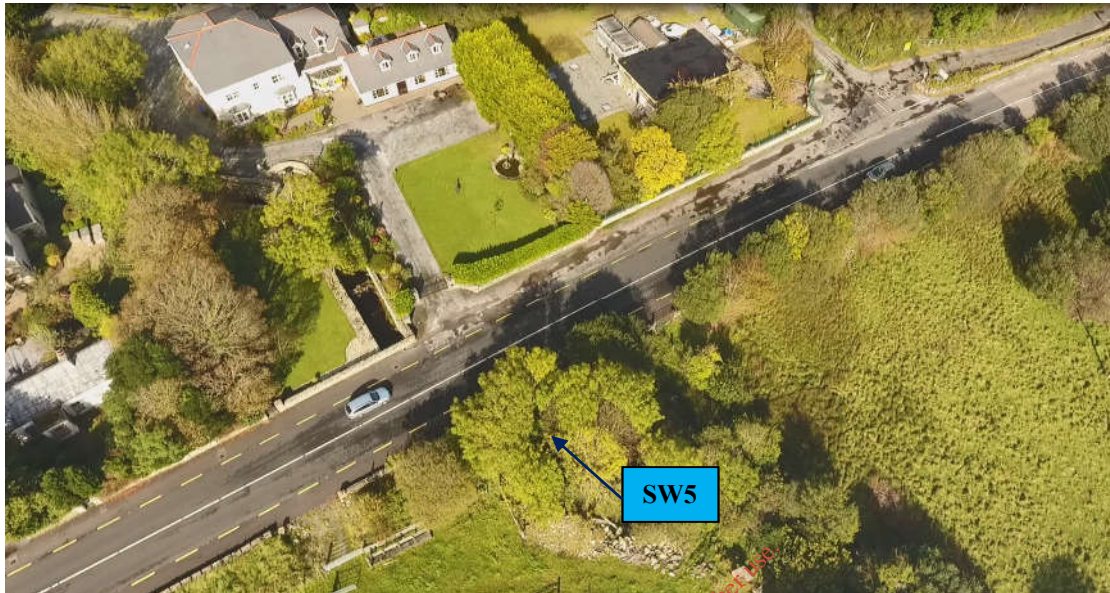
The 5<sup>th</sup> surface water sample, SW5 was taken at a location approximately 700m to the southwest of the landfill where the stream, which is a 3<sup>rd</sup> order unnamed stream, passes under the national road N59 (see Figures 17 & 18 and following Plates 22 & 23) (see Surface Water Monitoring Logs in Appendix 3). No invertebrate sample was taken in this area.

Plate 22. Photographs of SW5 surface water sampling area (note guest house to north of location with stream dividing property from residence to the west. Also note water treatment plant to northeast of location)

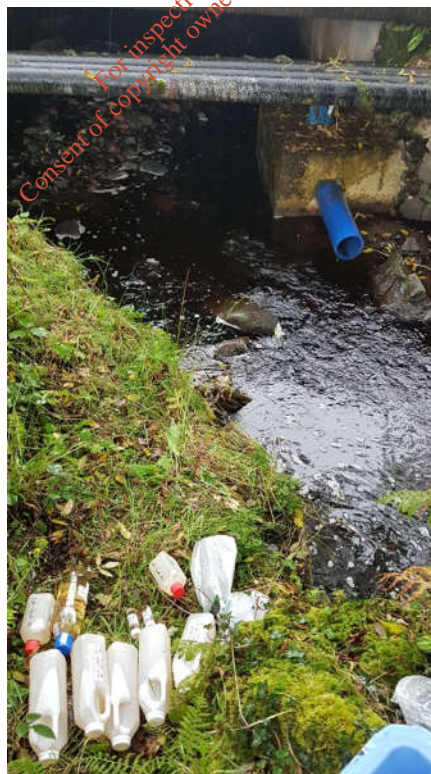
Plate 23. Photographs of SW5 surface water sampling area (note discharge pipe equipped with valve and services running in line with road)

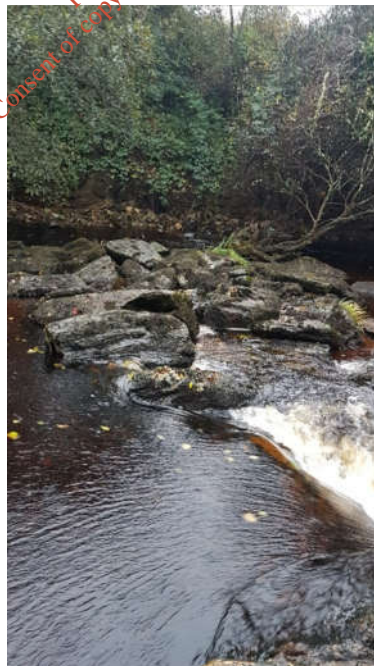
The 6<sup>th</sup> surface water sample, SW6 was taken on the Owenglen River, which is classed as a 4<sup>th</sup> order stream, at a location approximately 30m upgradient and to the east of the confluence of the stream with the Owenglen River. The 4<sup>th</sup> invertebrate kick sample location was taken in the same area (see Figure 18 and following Plates 24 & 25).

Plate 25. Photographs of SW6 surface water sampling area (note rock weir downgradient of sampling area)

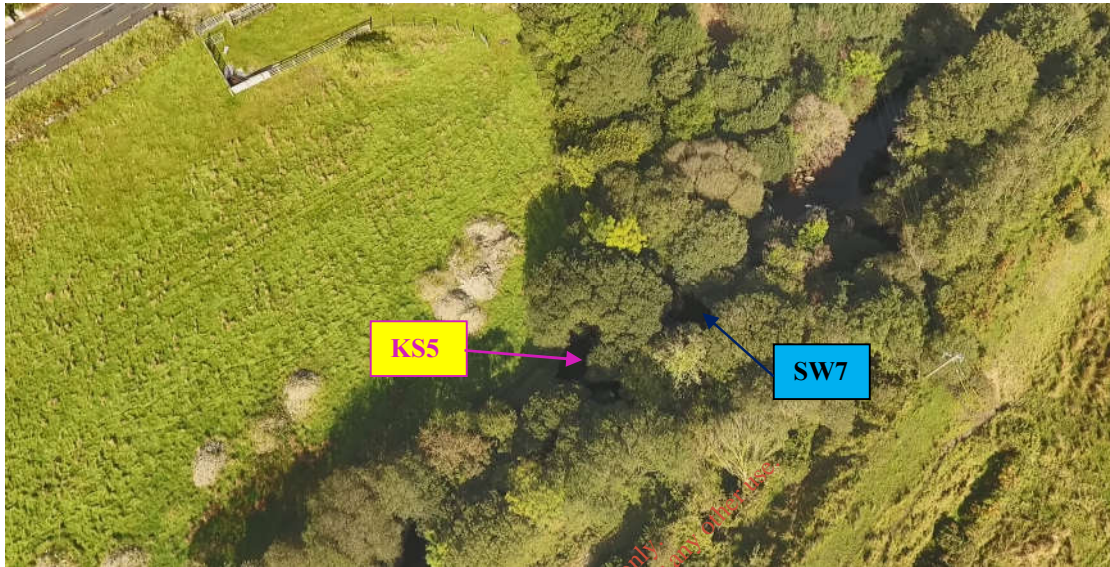
The 7<sup>th</sup> surface water sample, SW7 was taken on the Owenglen River, which is classed as a 4<sup>th</sup> order stream, at a location approximately 20m downgradient and to the west of the confluence of the stream with the Owenglen River. The 5<sup>th</sup> invertebrate kick sample location was taken in the same area (see Figures 18 and following Plate 26).

Plate 26. UAV aerial photograph taken at 40m elevation directly over the Owenglen River facing northwards (note locations of surface water monitoring point and invertebrate kick sampling location)

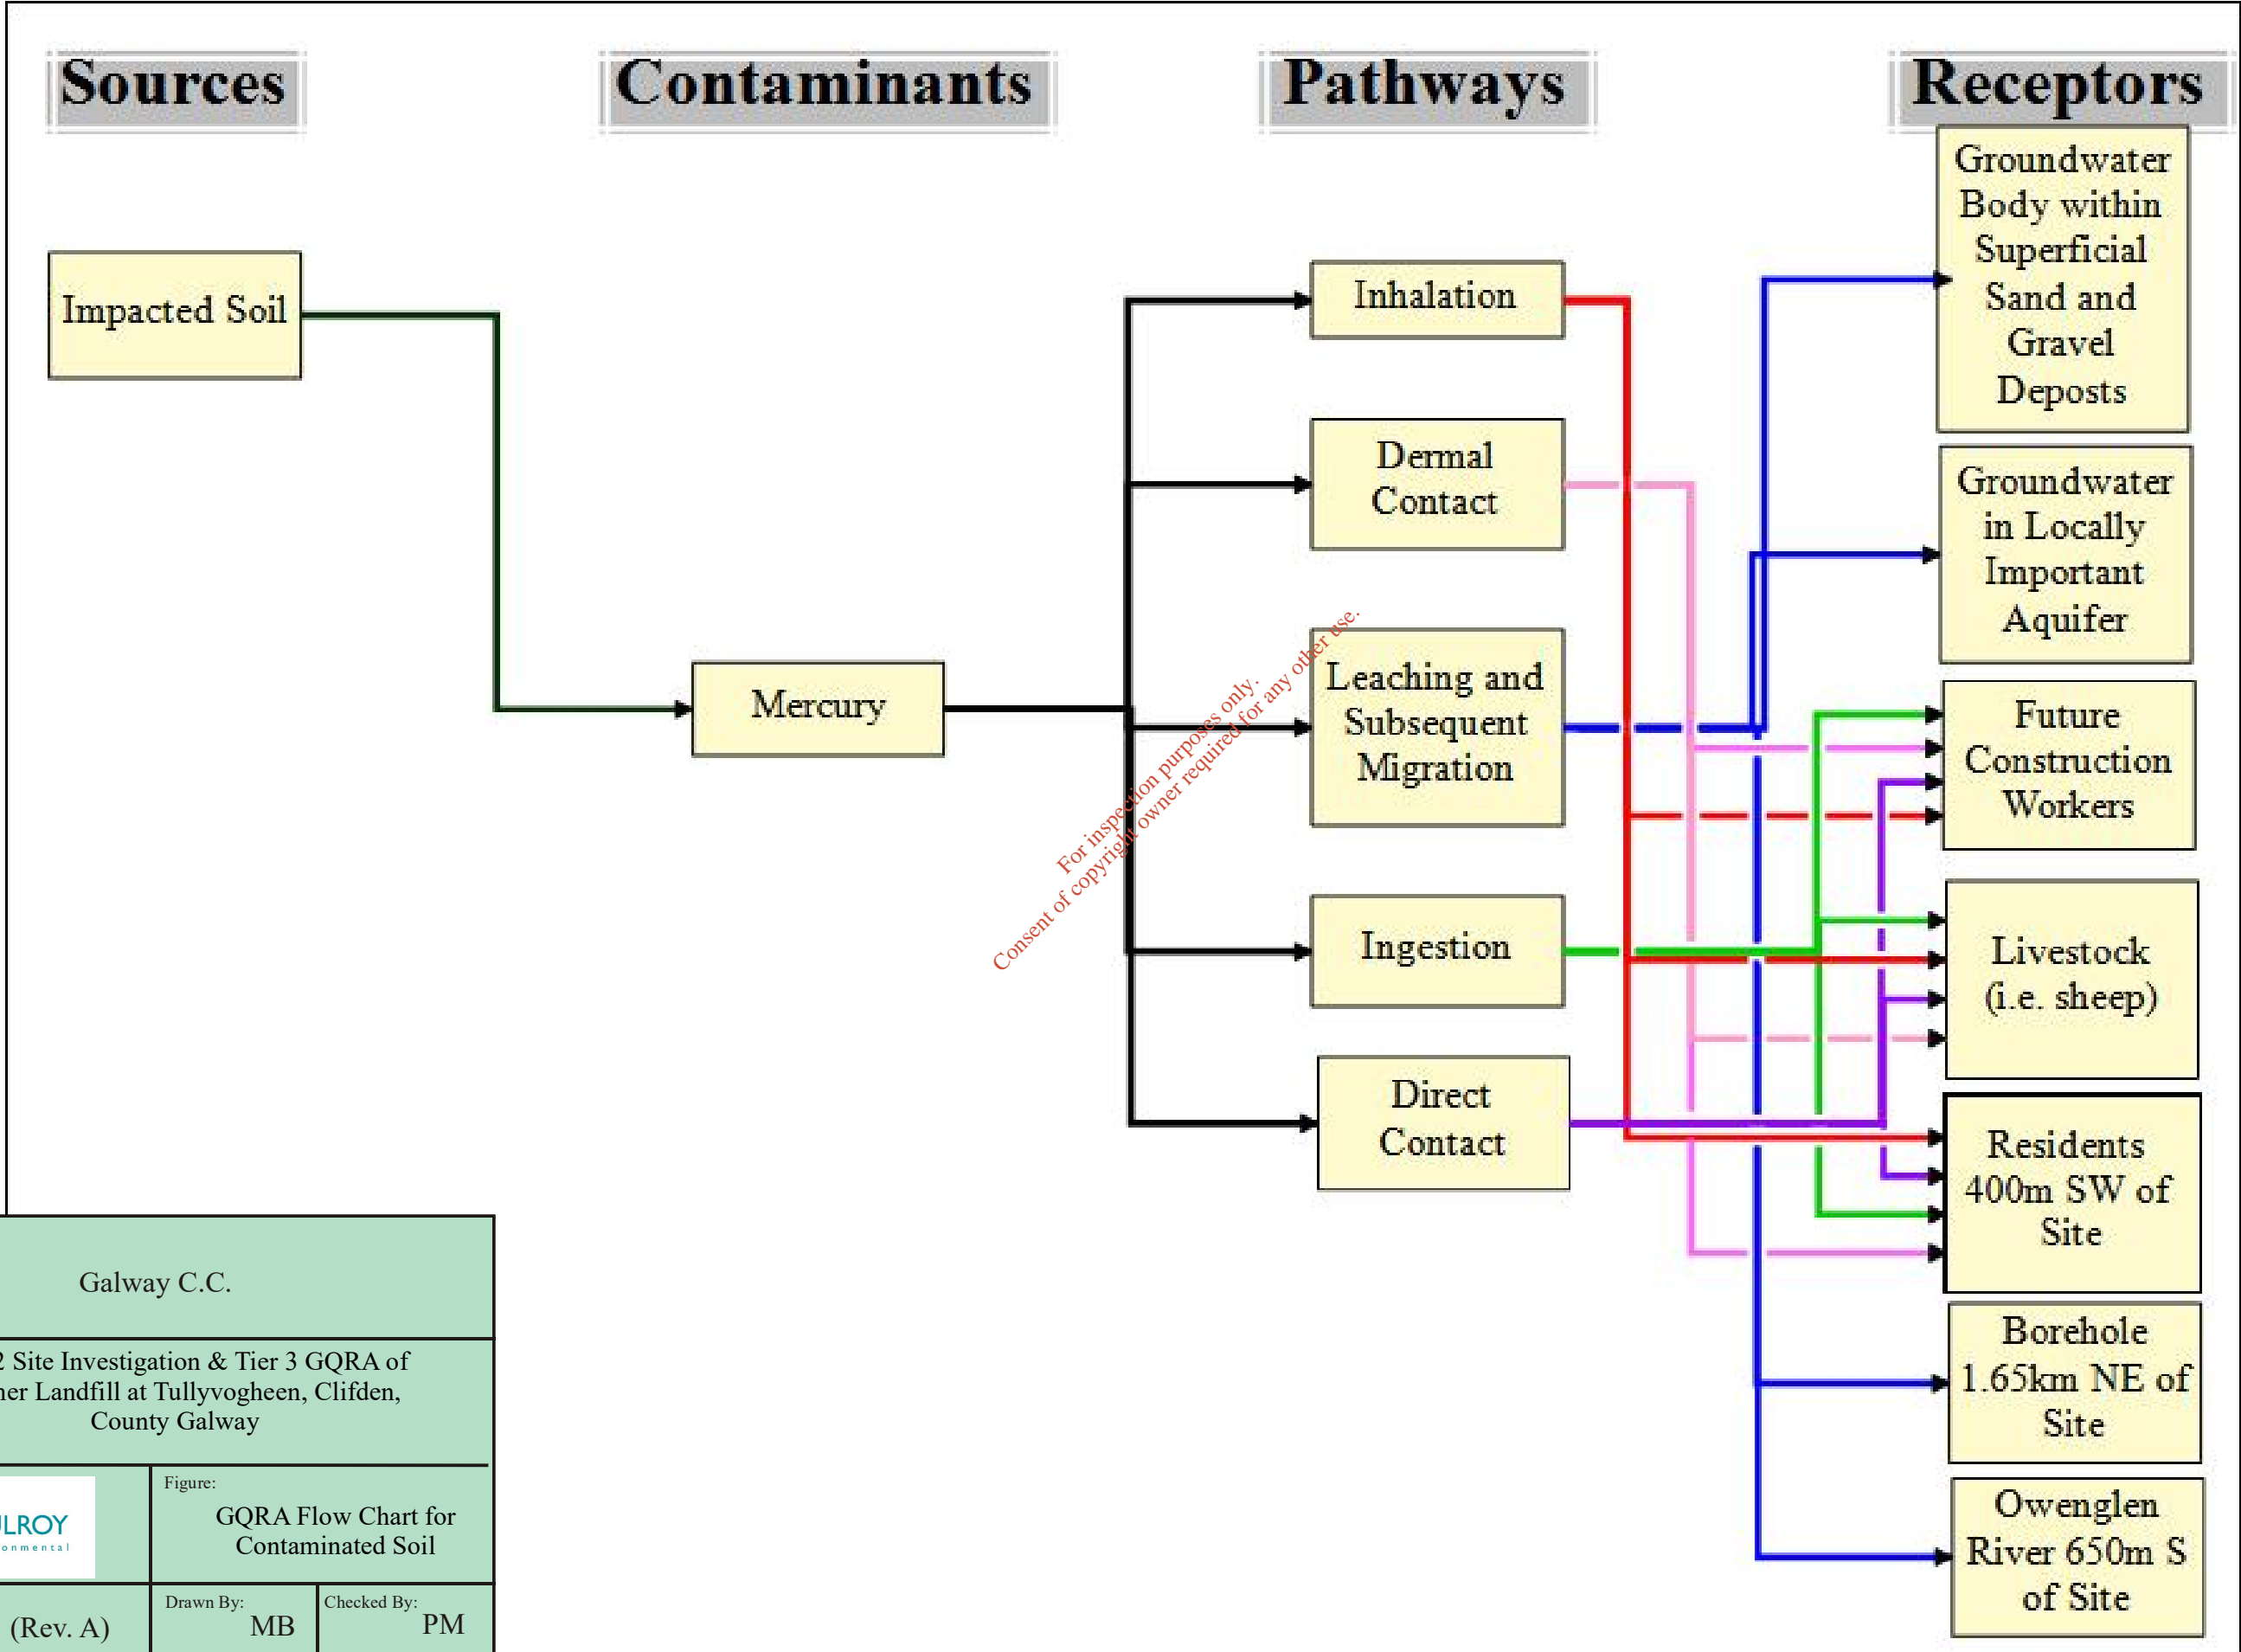
Chart 1. GQRA Flow Chart for Contaminated Soil (i.e Mercury)

Client: Galway C.C.		
Project: Tier 2 Site Investigation & Tier 3 GQRA of Former Landfill at Tullyvogheen, Clifden, County Galway		
	Figure: GQRA Flow Chart for Contaminated Soil	
Chart No.: 1 (Rev. A)	Drawn By: MB	Checked By: PM
Scale: NA	Date: 20 <sup>th</sup> November, 2019
