BARNAGEERAGH UNREGULATED WASTE DISPOSAL SITE

TIER 1 ENVIRONMENTAL RISK ASSESSMENT

MDR1552Rp0001
Barnageeragh
Tier 1 Environmental Risk
Assessment
F01
13 August 2019

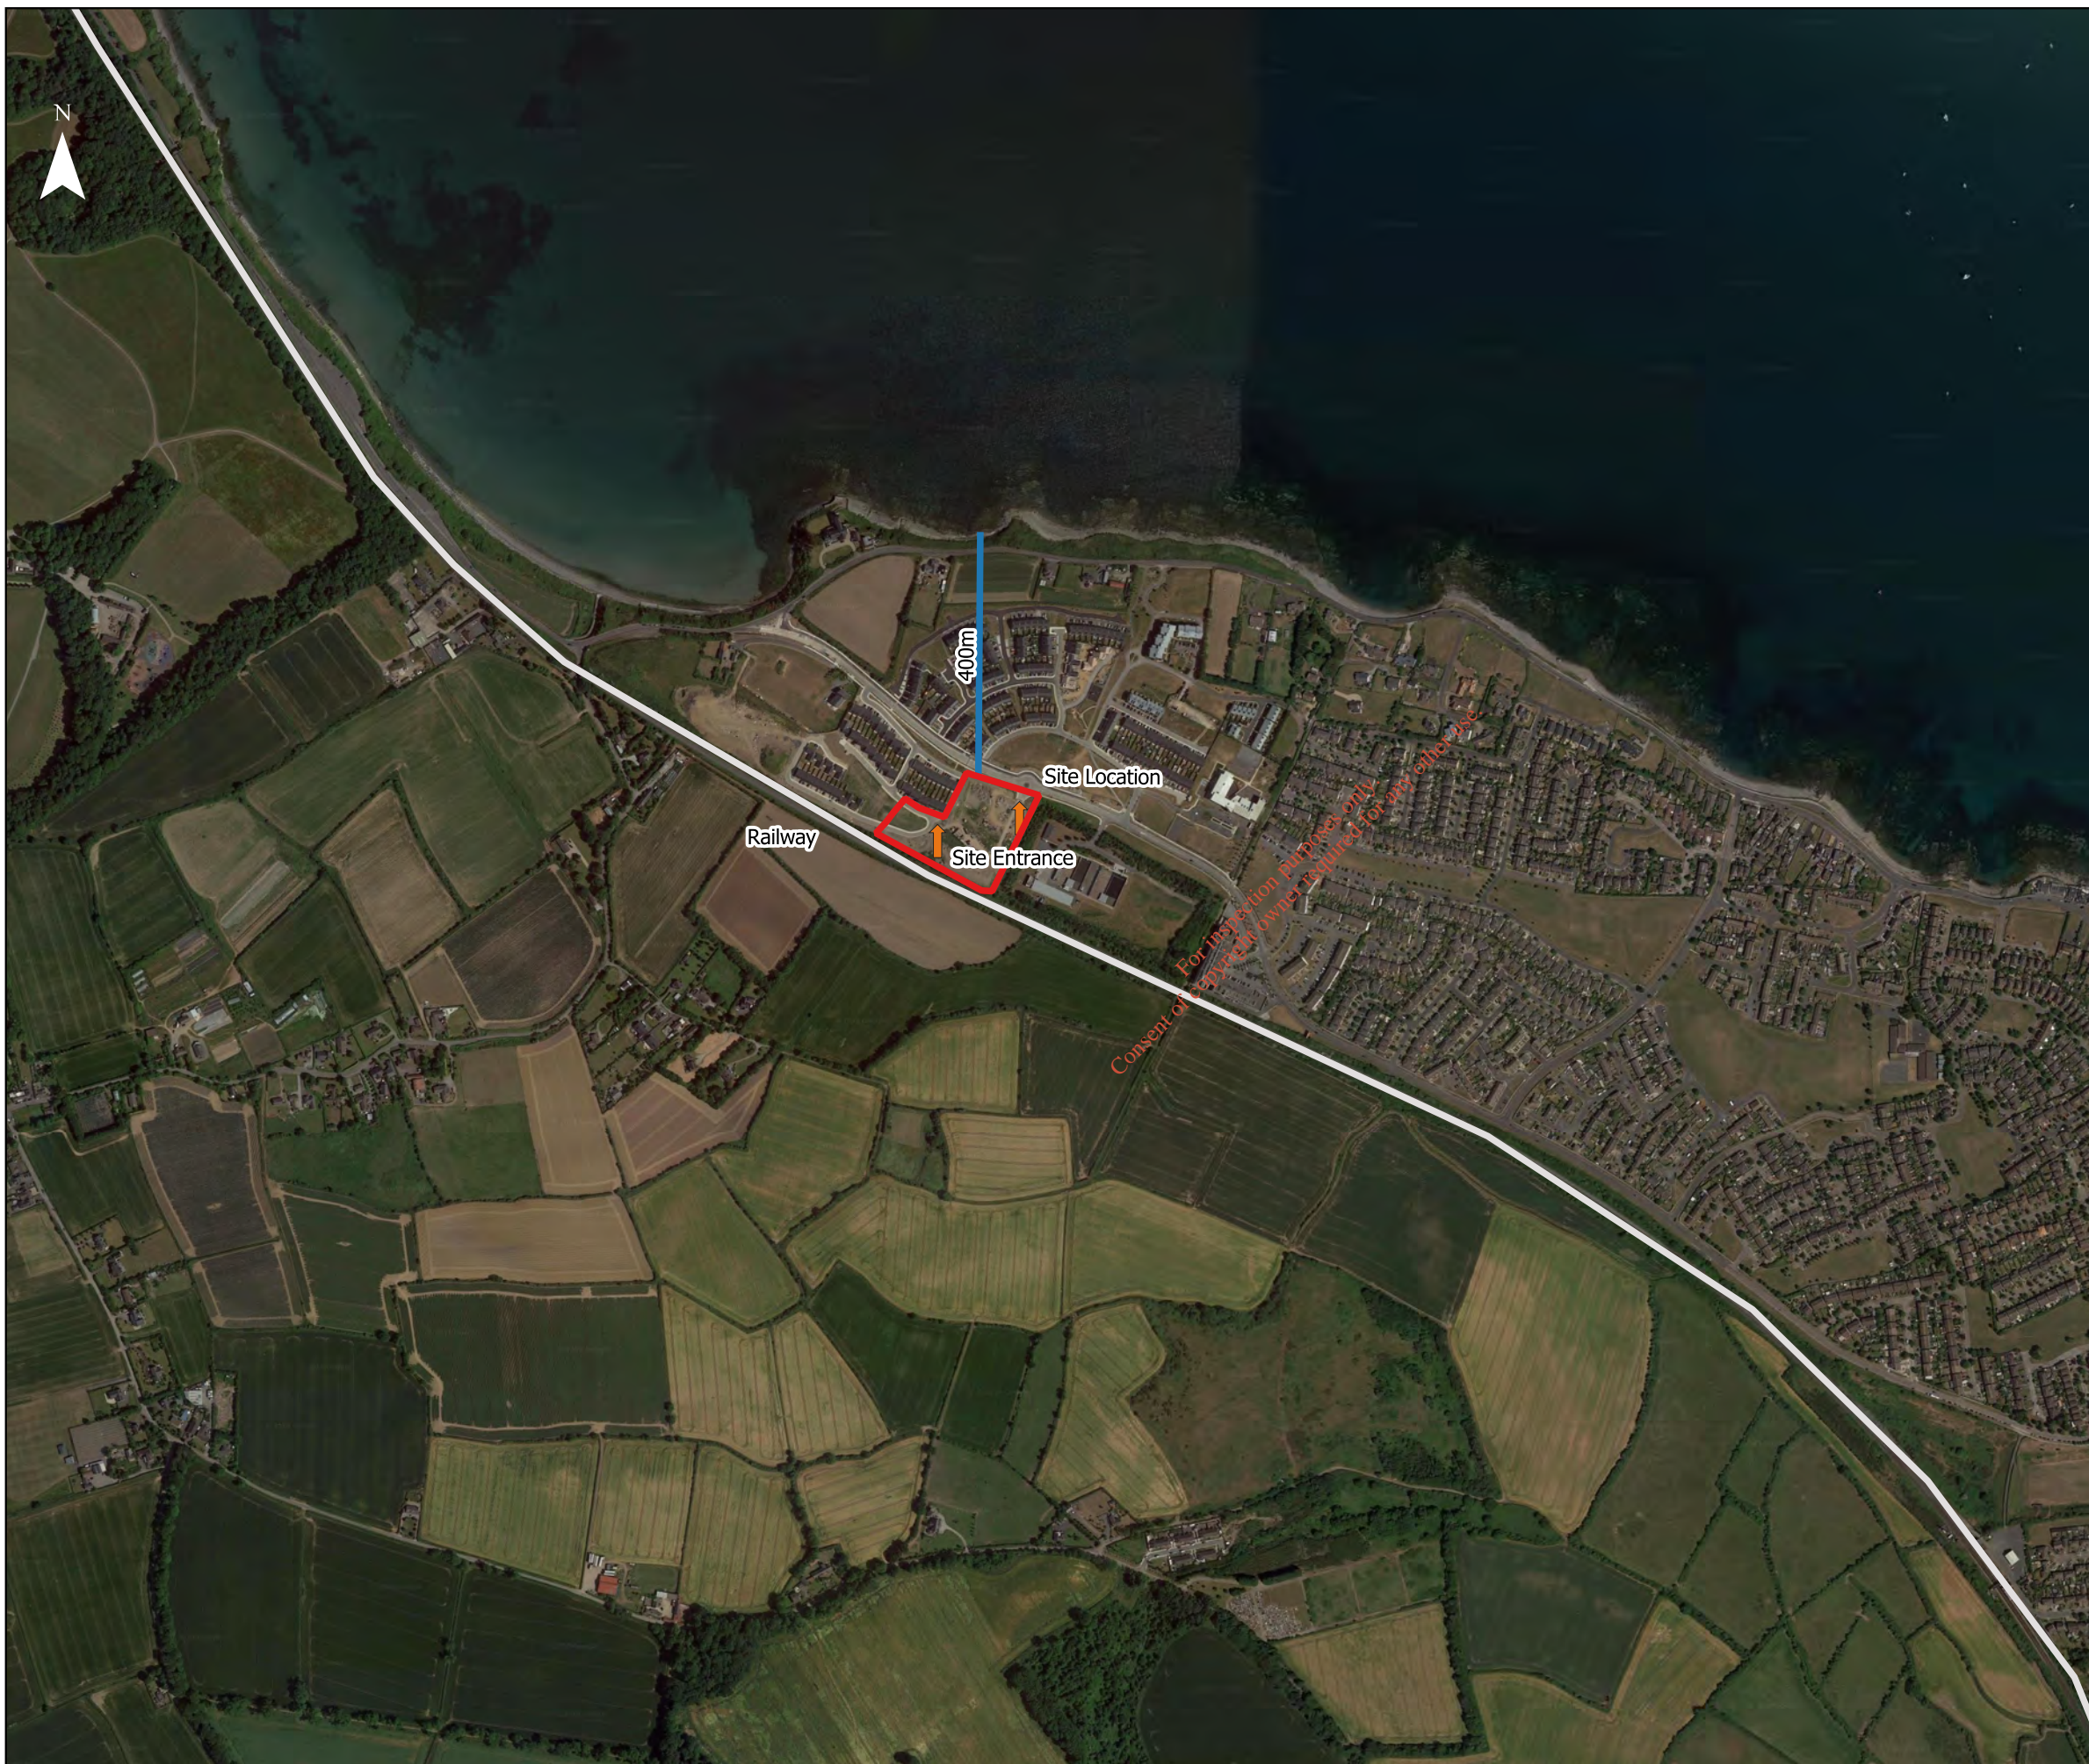
Drawn by: Scott Graydon	Project No: MDR1552
Checked by: PC	File Ref.:
Approved by: GMcE	MDR1552QGIS0001F01
Scale: 1:15,000@A3	Figure 1.1
Date: 13/08/2019

Map showing a larger area surrounding the site. Identifying site entrance points, railway and distance to Irish Sea.

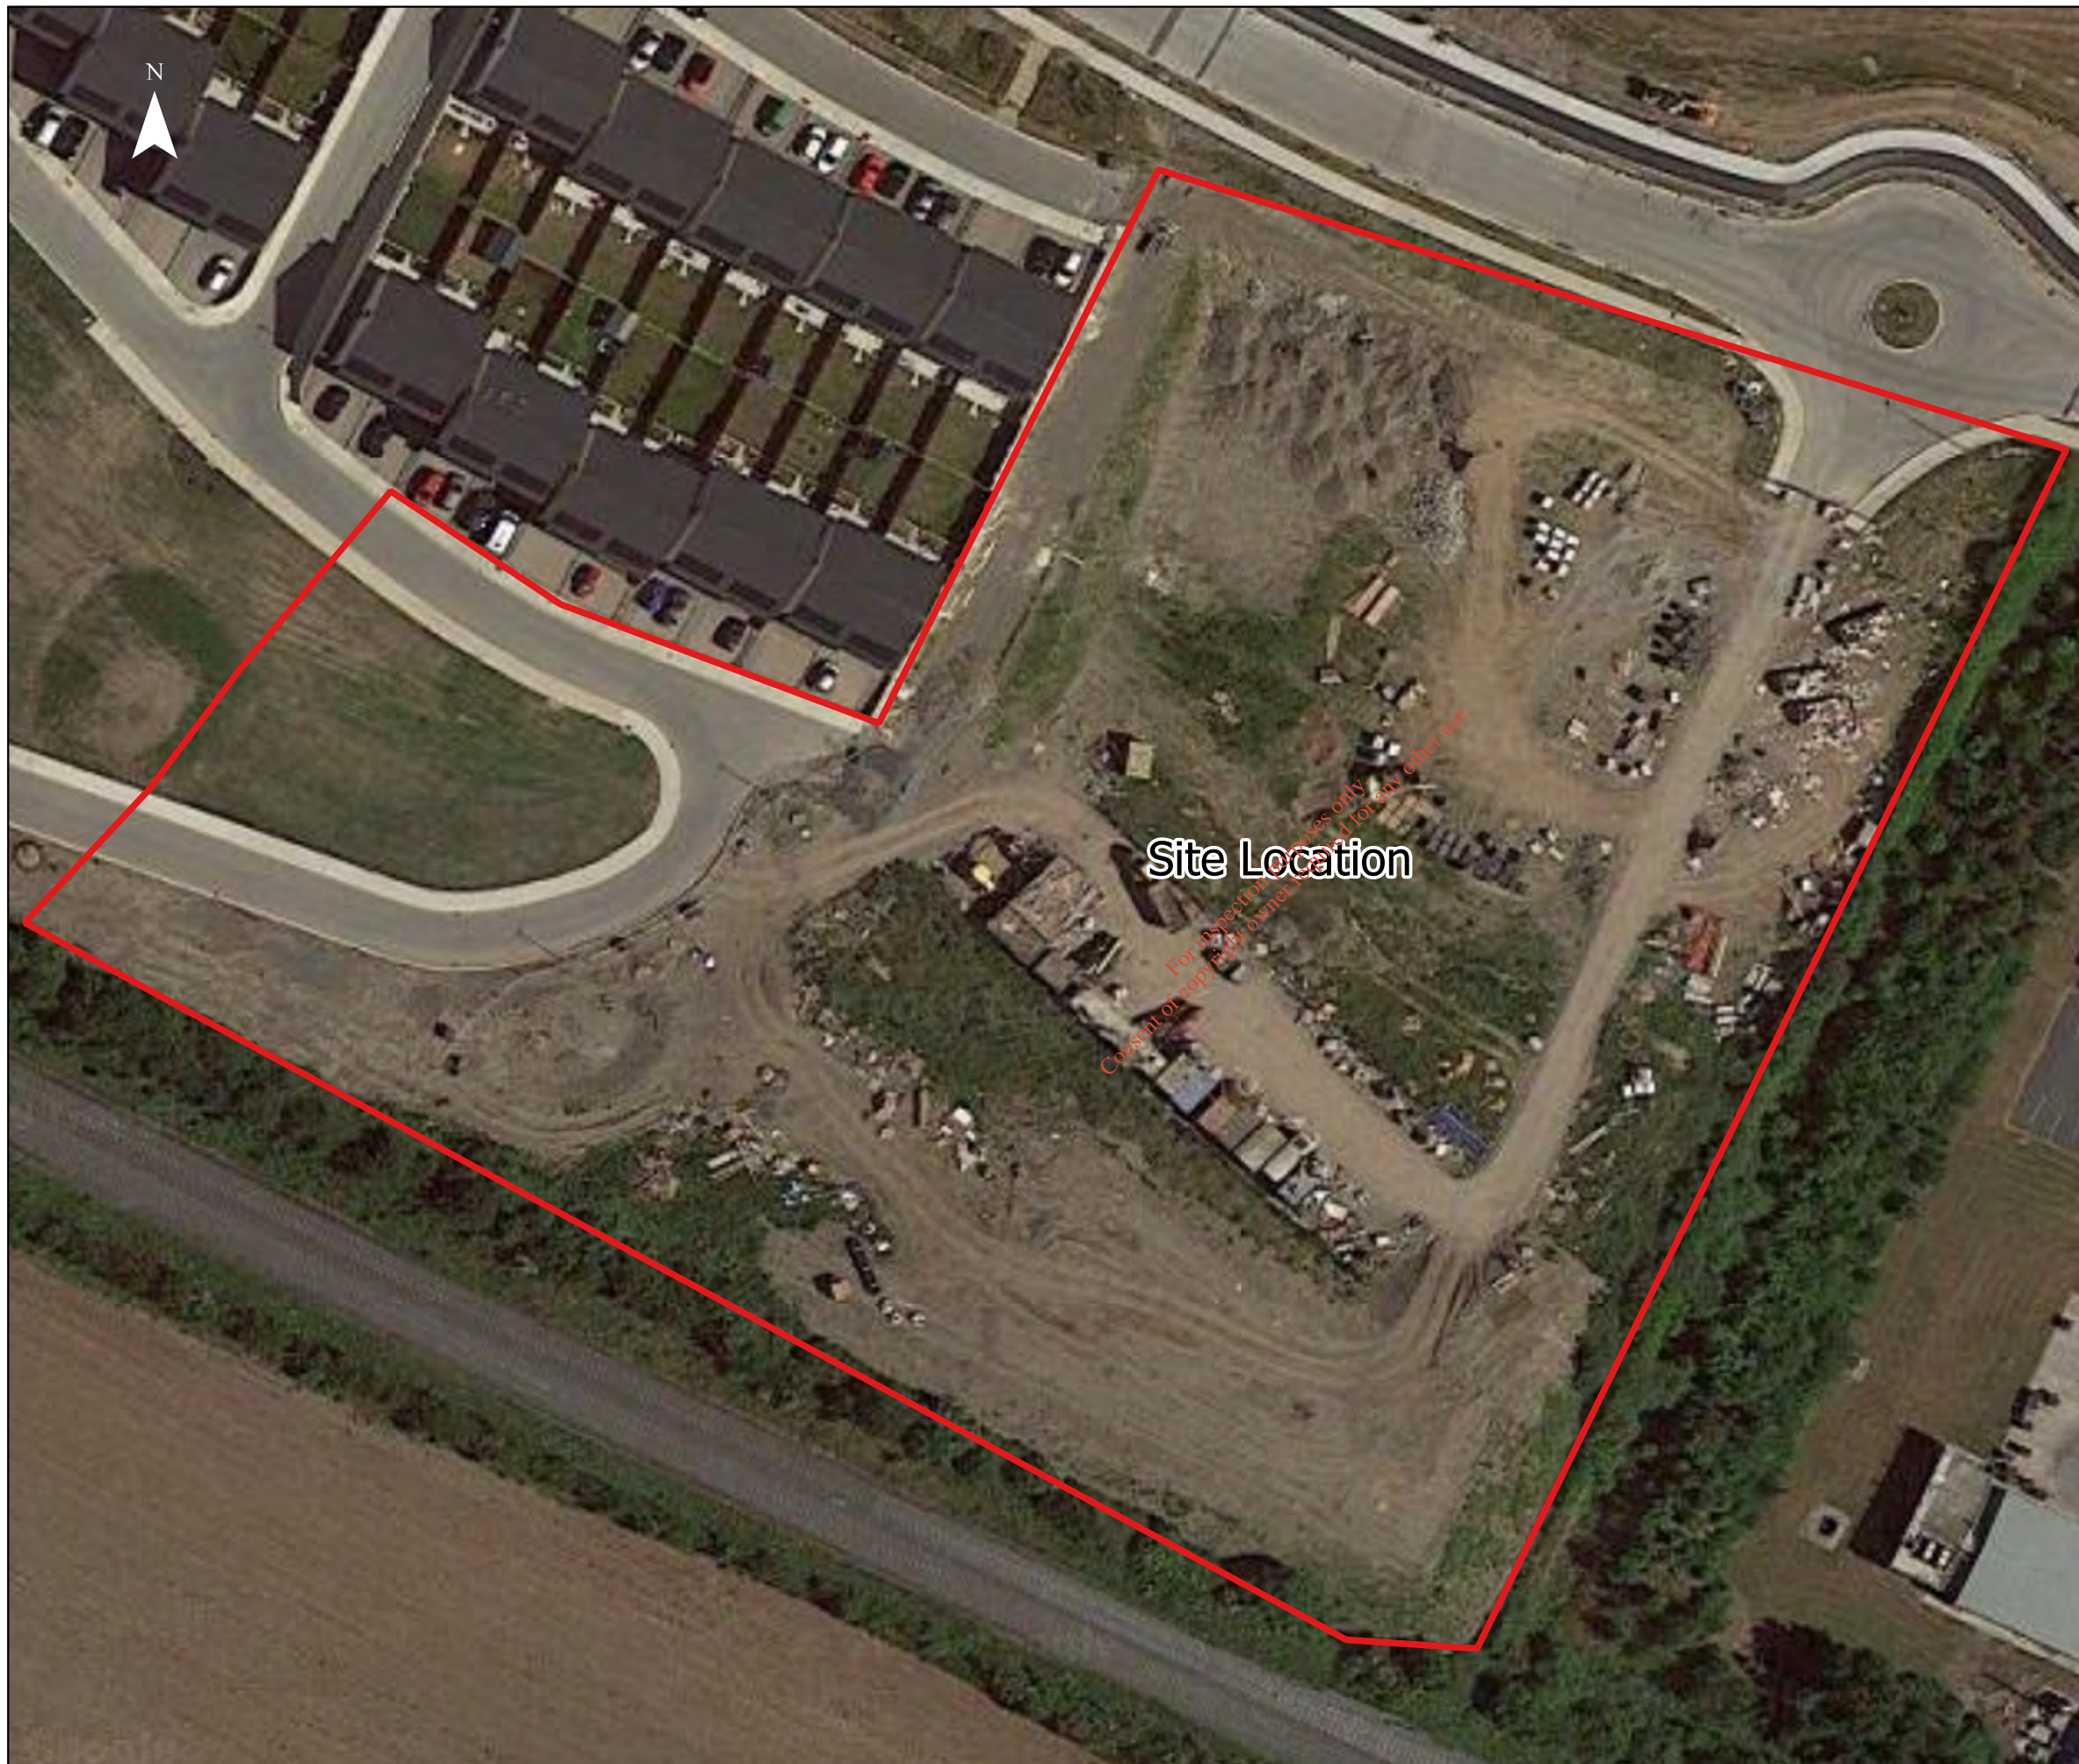
Drawn by: Scott Graydon	Project No: MDR1552
Checked by: PC	File Ref.:
Approved by: GMcE	MDR1552QGIS0001F01
Scale: 1:1,200@A3	Figure 2.1
Date: 13/08/2019

Map showing the location boundary for the Barnageeragh Landfill Site.

The site is located in the Barnageeragh Cove area to the north of the town of Skerries, Co. Dublin (Figure 2.1). The site is bounded to the north by Barnageeragh Road and access to the site is via the Hamilton Hill housing estate to the east or via a gate at the roundabout opposite Fulmar housing estate. New residential housing has been constructed to the north and west of the site as Hamilton Hill. To the east is the Irish Water WWTP separated from site by a dense treeline and boundary fence. To the south of the site is the Belfast to Dublin rail line and beyond are agricultural fields. The Irish Sea is approximately 400m north of the site.

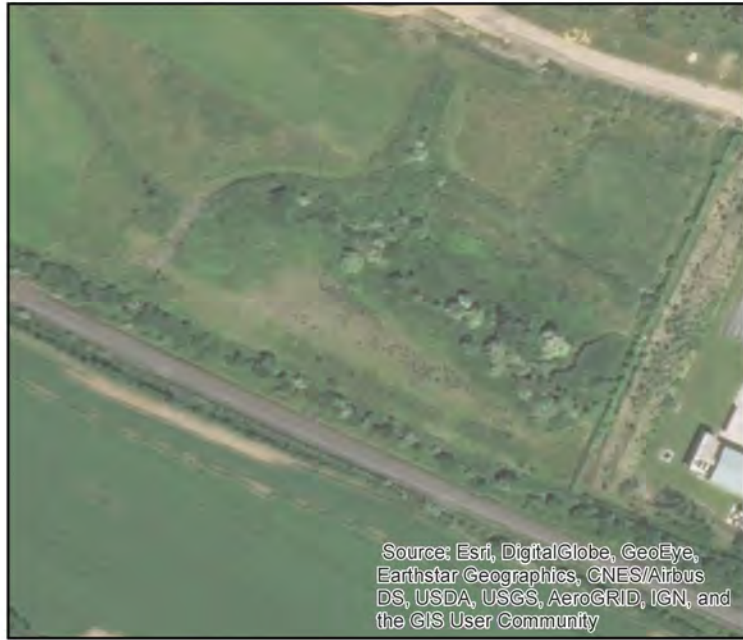
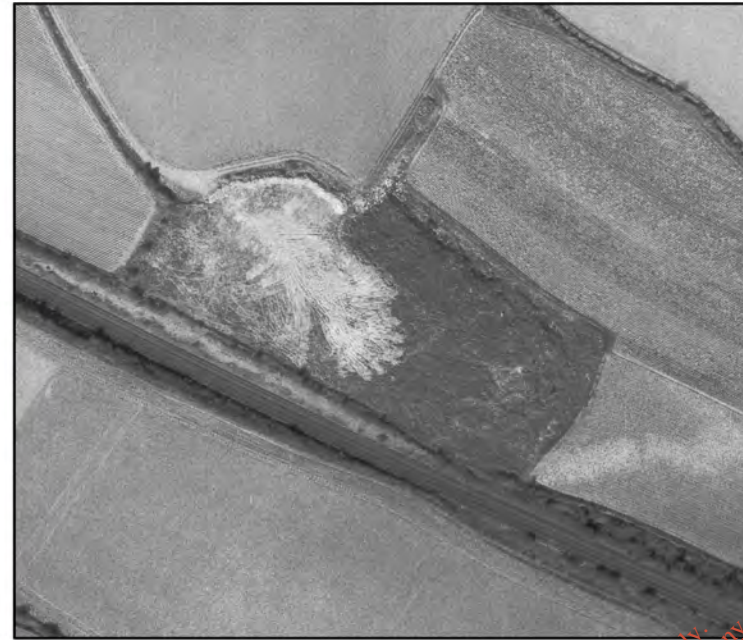
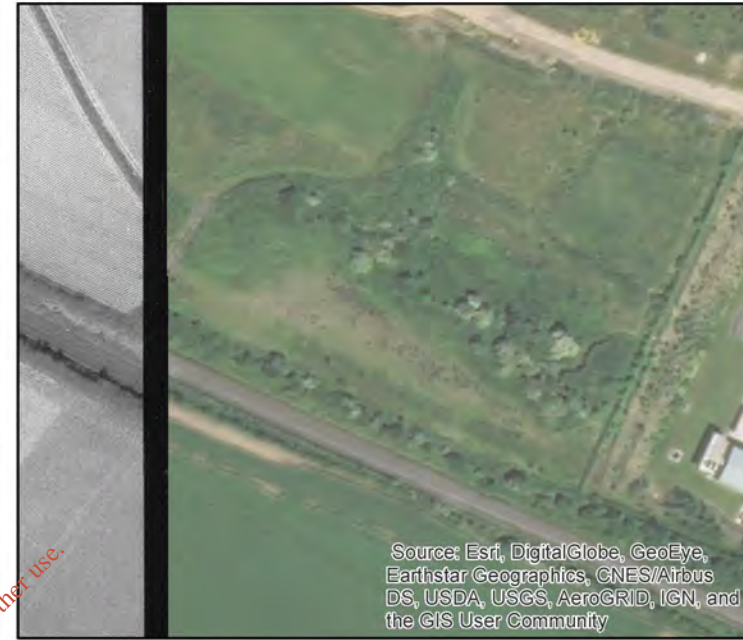
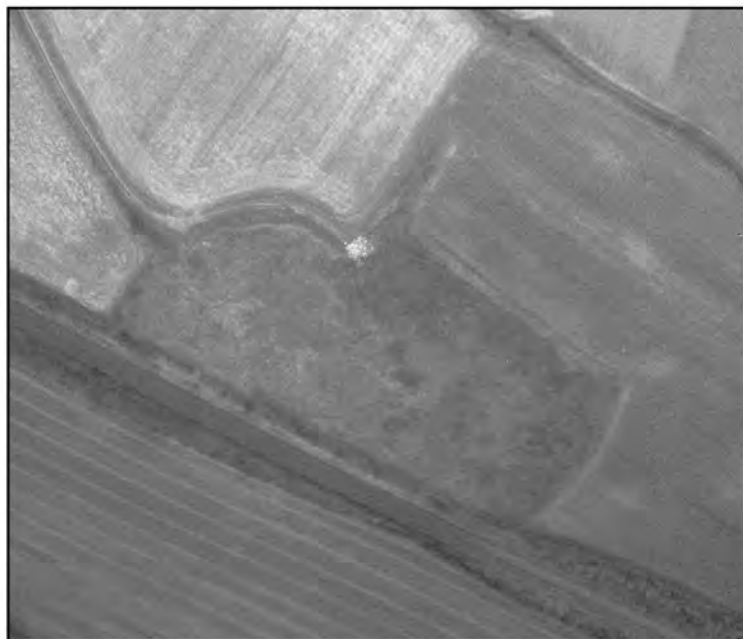
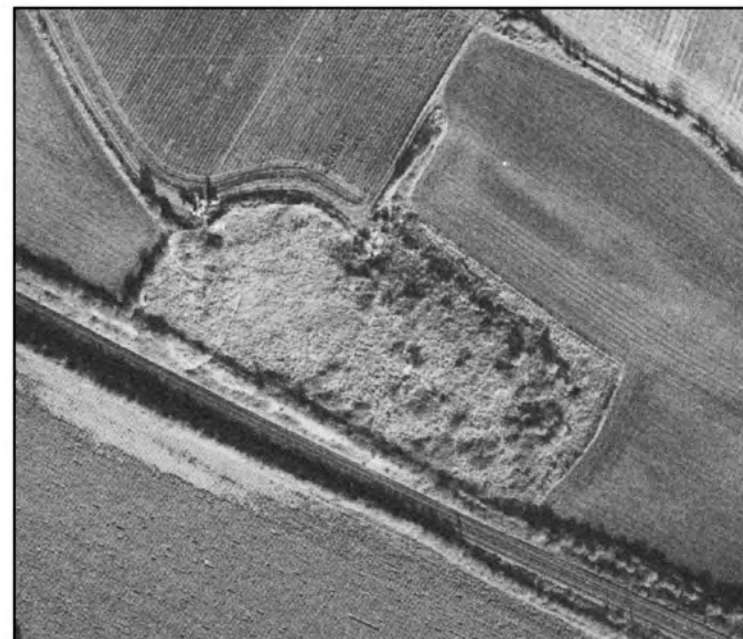
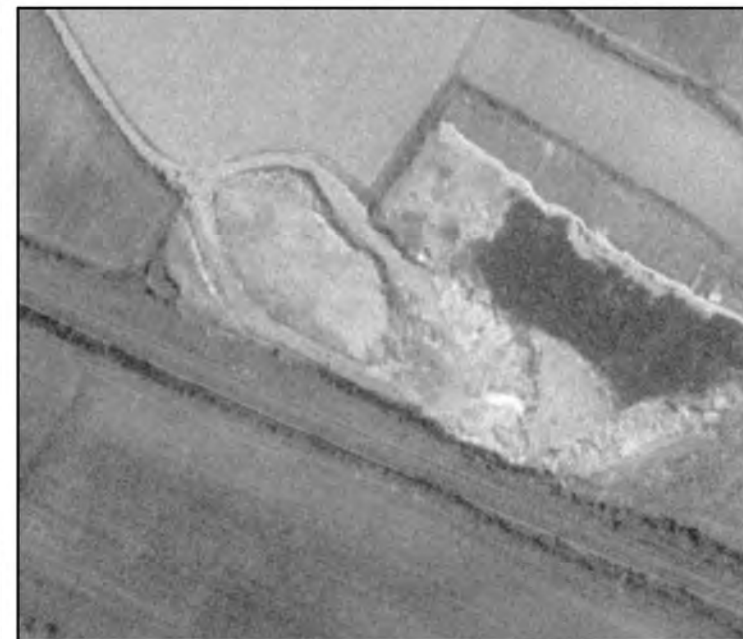
Drawn by: Scott Graydon	Project No: MDR1552
Checked by: PC	File Ref.:
Approved by: GMcE	MDR1552QGIS0001F01
Scale: NA	Figure 2.2
Date: 13/08/2019

6 No. historical aerial views showing the site location identifying the landfill area.

The following is a brief description of the history of the site and surrounding area. **Figure 2.2** shows selected historical aerial views of the site and the full maps described below can be accessed through the [GeoHive](#) website (June 2019).

- Historic map 6 inch colour (1837 – 1842):
 - Map shows Dublin to Drogheda (as it was at that point) railway in progress.
 - The site in question was agricultural land at this point in time.

- Historic map 25 inch (1888 – 1913):
 - Map shows the completed railway line, now named Great Northern Railway (Ireland).
- Aerial map 1995 (black and white):

- Farm houses and buildings appear near the coast to the north and west of the site.
 - Outward expansion of the town of Skerries.
 - An access road has been constructed west to east approaching the subject site, with a turning area constructed at the end of the road.

- The site appears to be no longer being used for agricultural purposes with some of the ground appearing to be overgrown. There is some evidence of human disturbance of the ground in the area immediately south of the eastern extent of the access road.

- Aerial map 2000 (colour):
 - Site identified as an irregular mound (suggesting waste activity), with access road directly to the site from the west.
 - Expansion of residential housing estates associated with Skerries toward the subject site. These are connected by a link road from the R127 Dublin Road.

- Aerial map 2005:
 - The access road was extended to the north of site to the field boundary and subsequently runs due east-southeast towards the town of Skerries.

- Expansion of residential housing estates associated with Skerries toward the subject site. These are connected by a link road from the R127 Dublin Road.

- Aerial map 2005 – 2012:
 - Identifies an expansion of the vegetation to the north and north east of the site.
 - Removal of vegetation along the southern part of the site.

- Wastewater treatment facility constructed to the east of the subject site. The road from the wastewater treatment plant runs east, south of Skerries, where it joins the previously constructed road associated with the residential housing estates and eventually re-joins the R127 Dublin Road.

- Signs of further residential housing development to the north and north-east.

- Current/premium aerial maps:
 - The Barnageeragh Road has been constructed west to east across the northern boundary of the subject site connecting the R127 Balbriggan Road with the wastewater treatment plant. This road now links all the way to the R127 Dublin Road to the east of Skerries.
 - Shows the near completion of the residential housing estates to the north of the subject site with construction commencing on the Hamilton Hill estate.
 - Landscape of waste site has changed with vegetation now removed.
 - Site used as a compound during construction of new houses with storage facilities and vehicle movements evident from tracks.
 - Building materials and excavated material deposited in the south east of the site.
 - Deposited building materials observed around the site including to the immediate north, between waste area and new road.

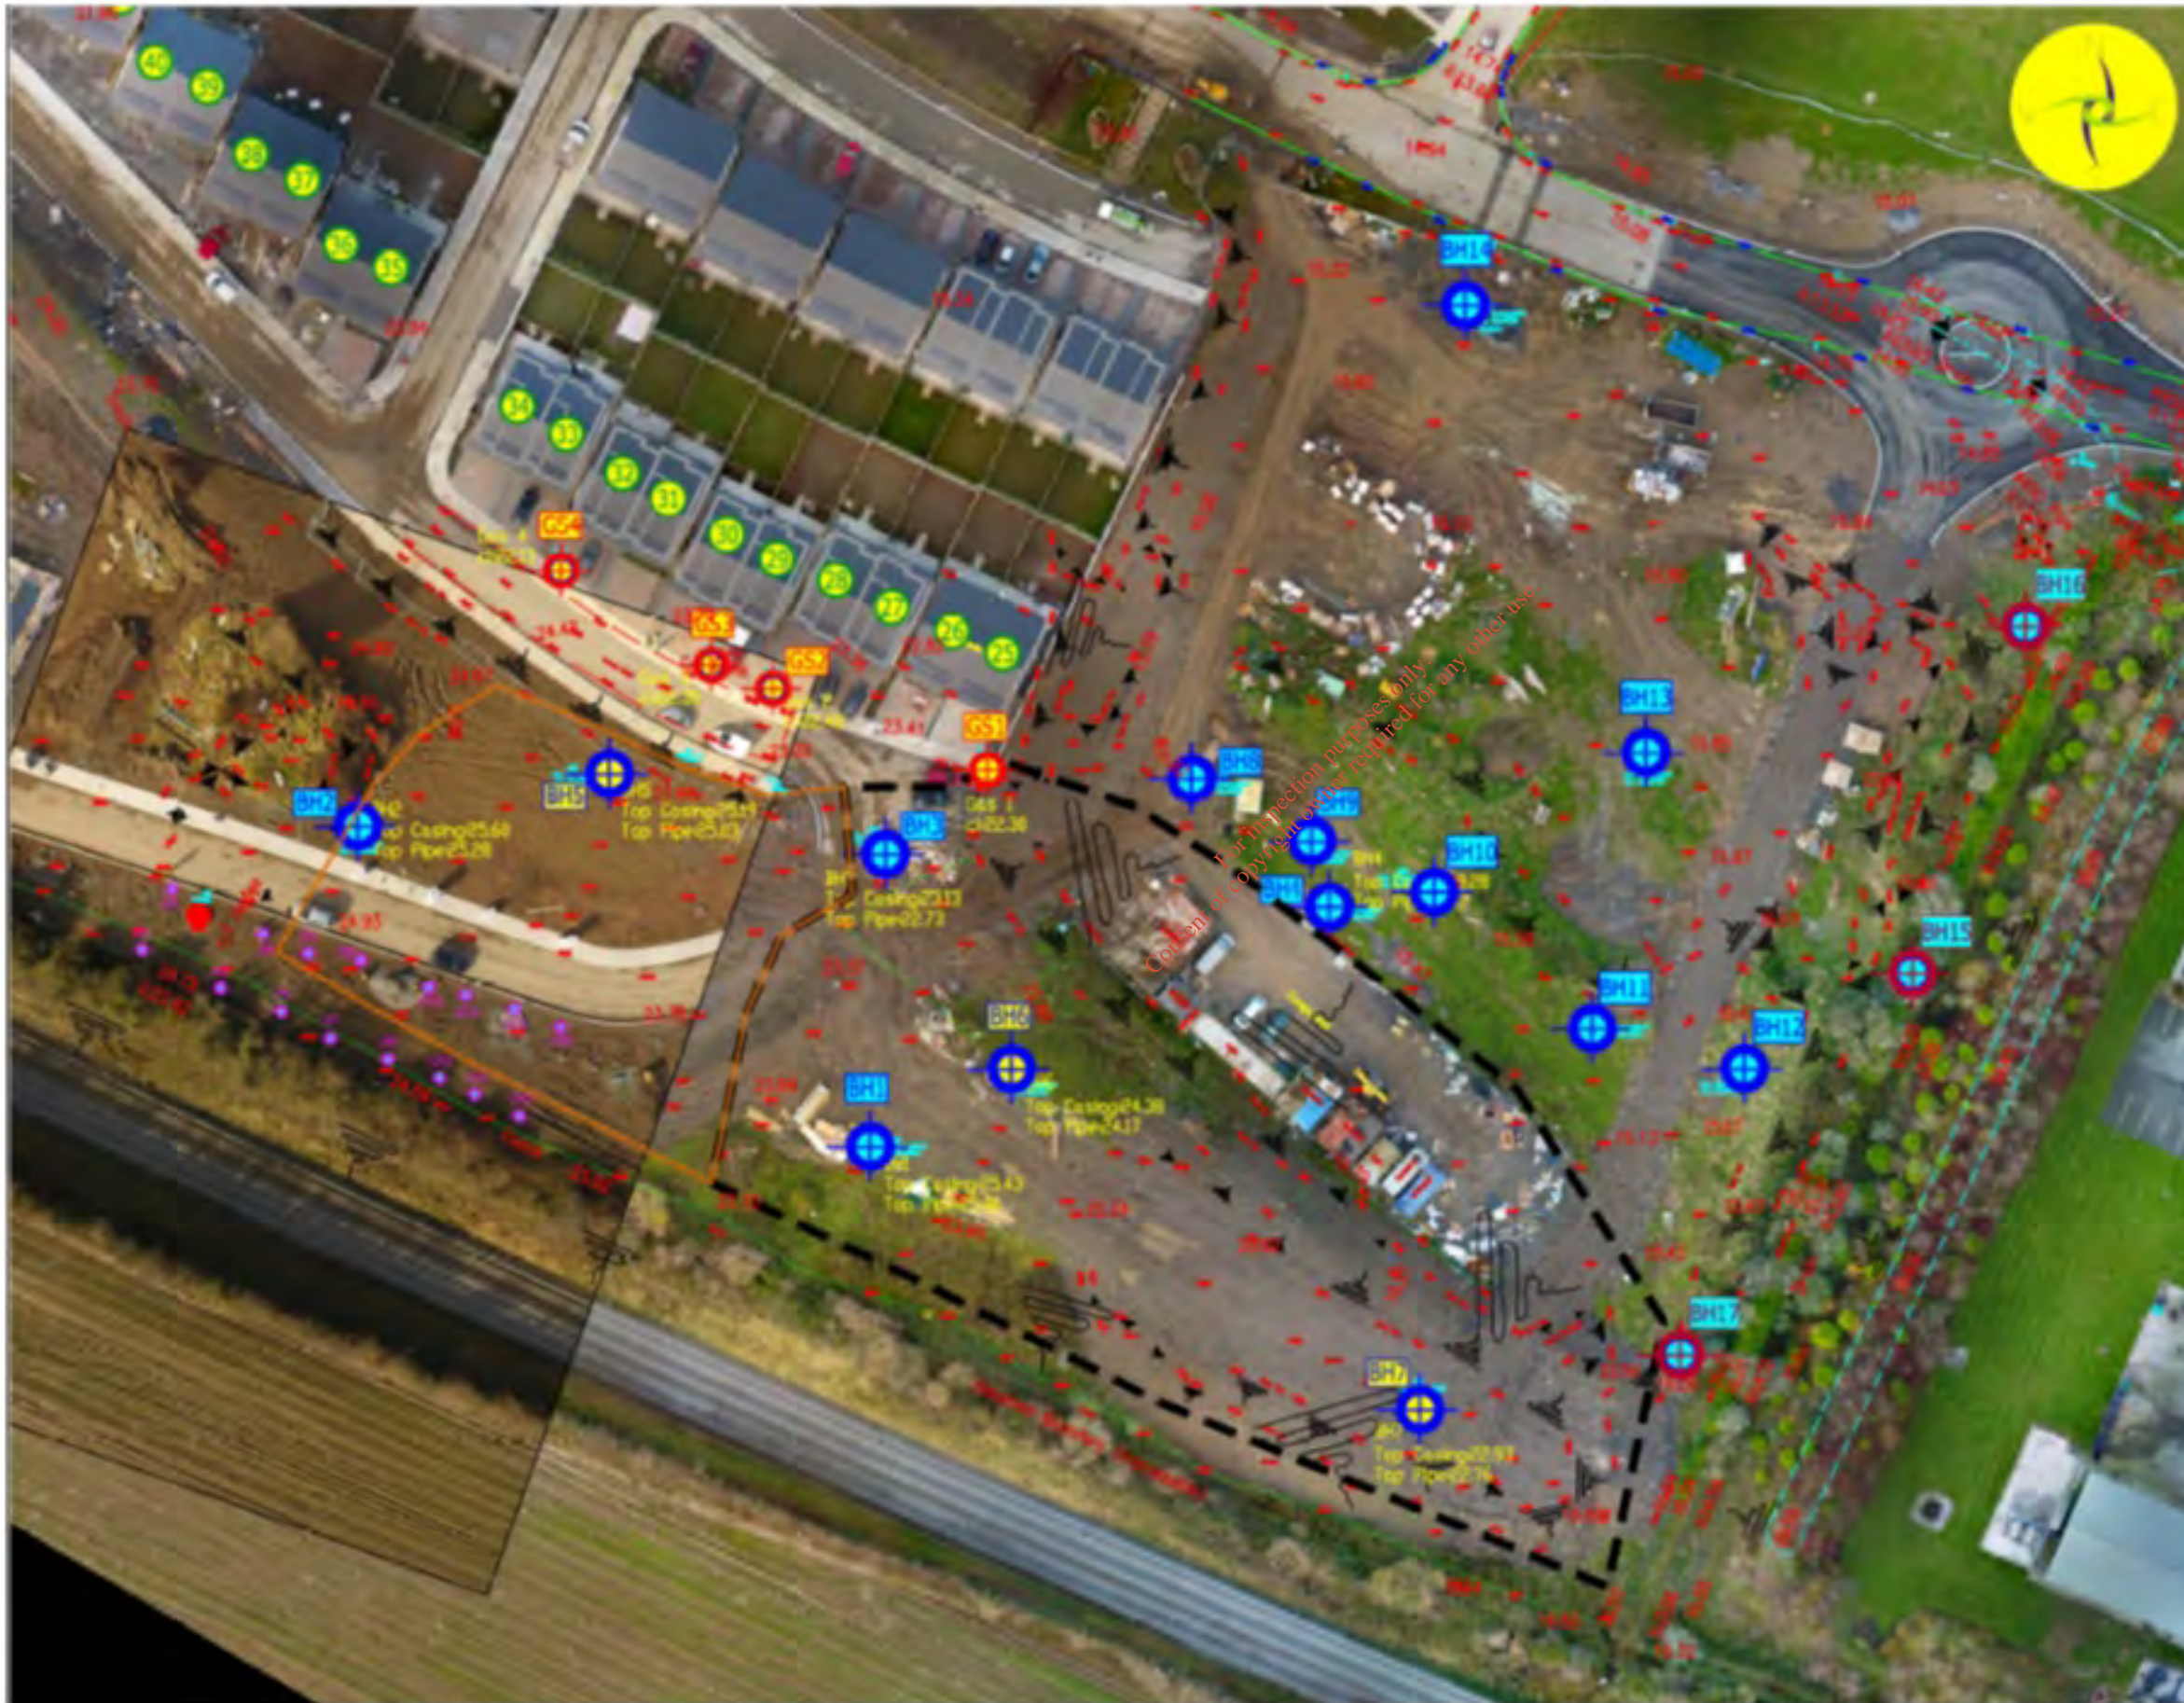
Title: **Monitoring BH Location Map**

Map showing the location of monitoring BH's for the Barnageeragh Landfill Site, and the landfill outline identified by the dashed black line.

50 rounds of landfill gas monitoring have been carried out and the potential risk from landfill gas has been assessed as very low risk in pathway boreholes. Elevated levels of methane have been detected at a number of wells, in particular BH4 and BH17. As a consequence, five passive gas venting wells have been installed at the site in May 2018 by Winsac.

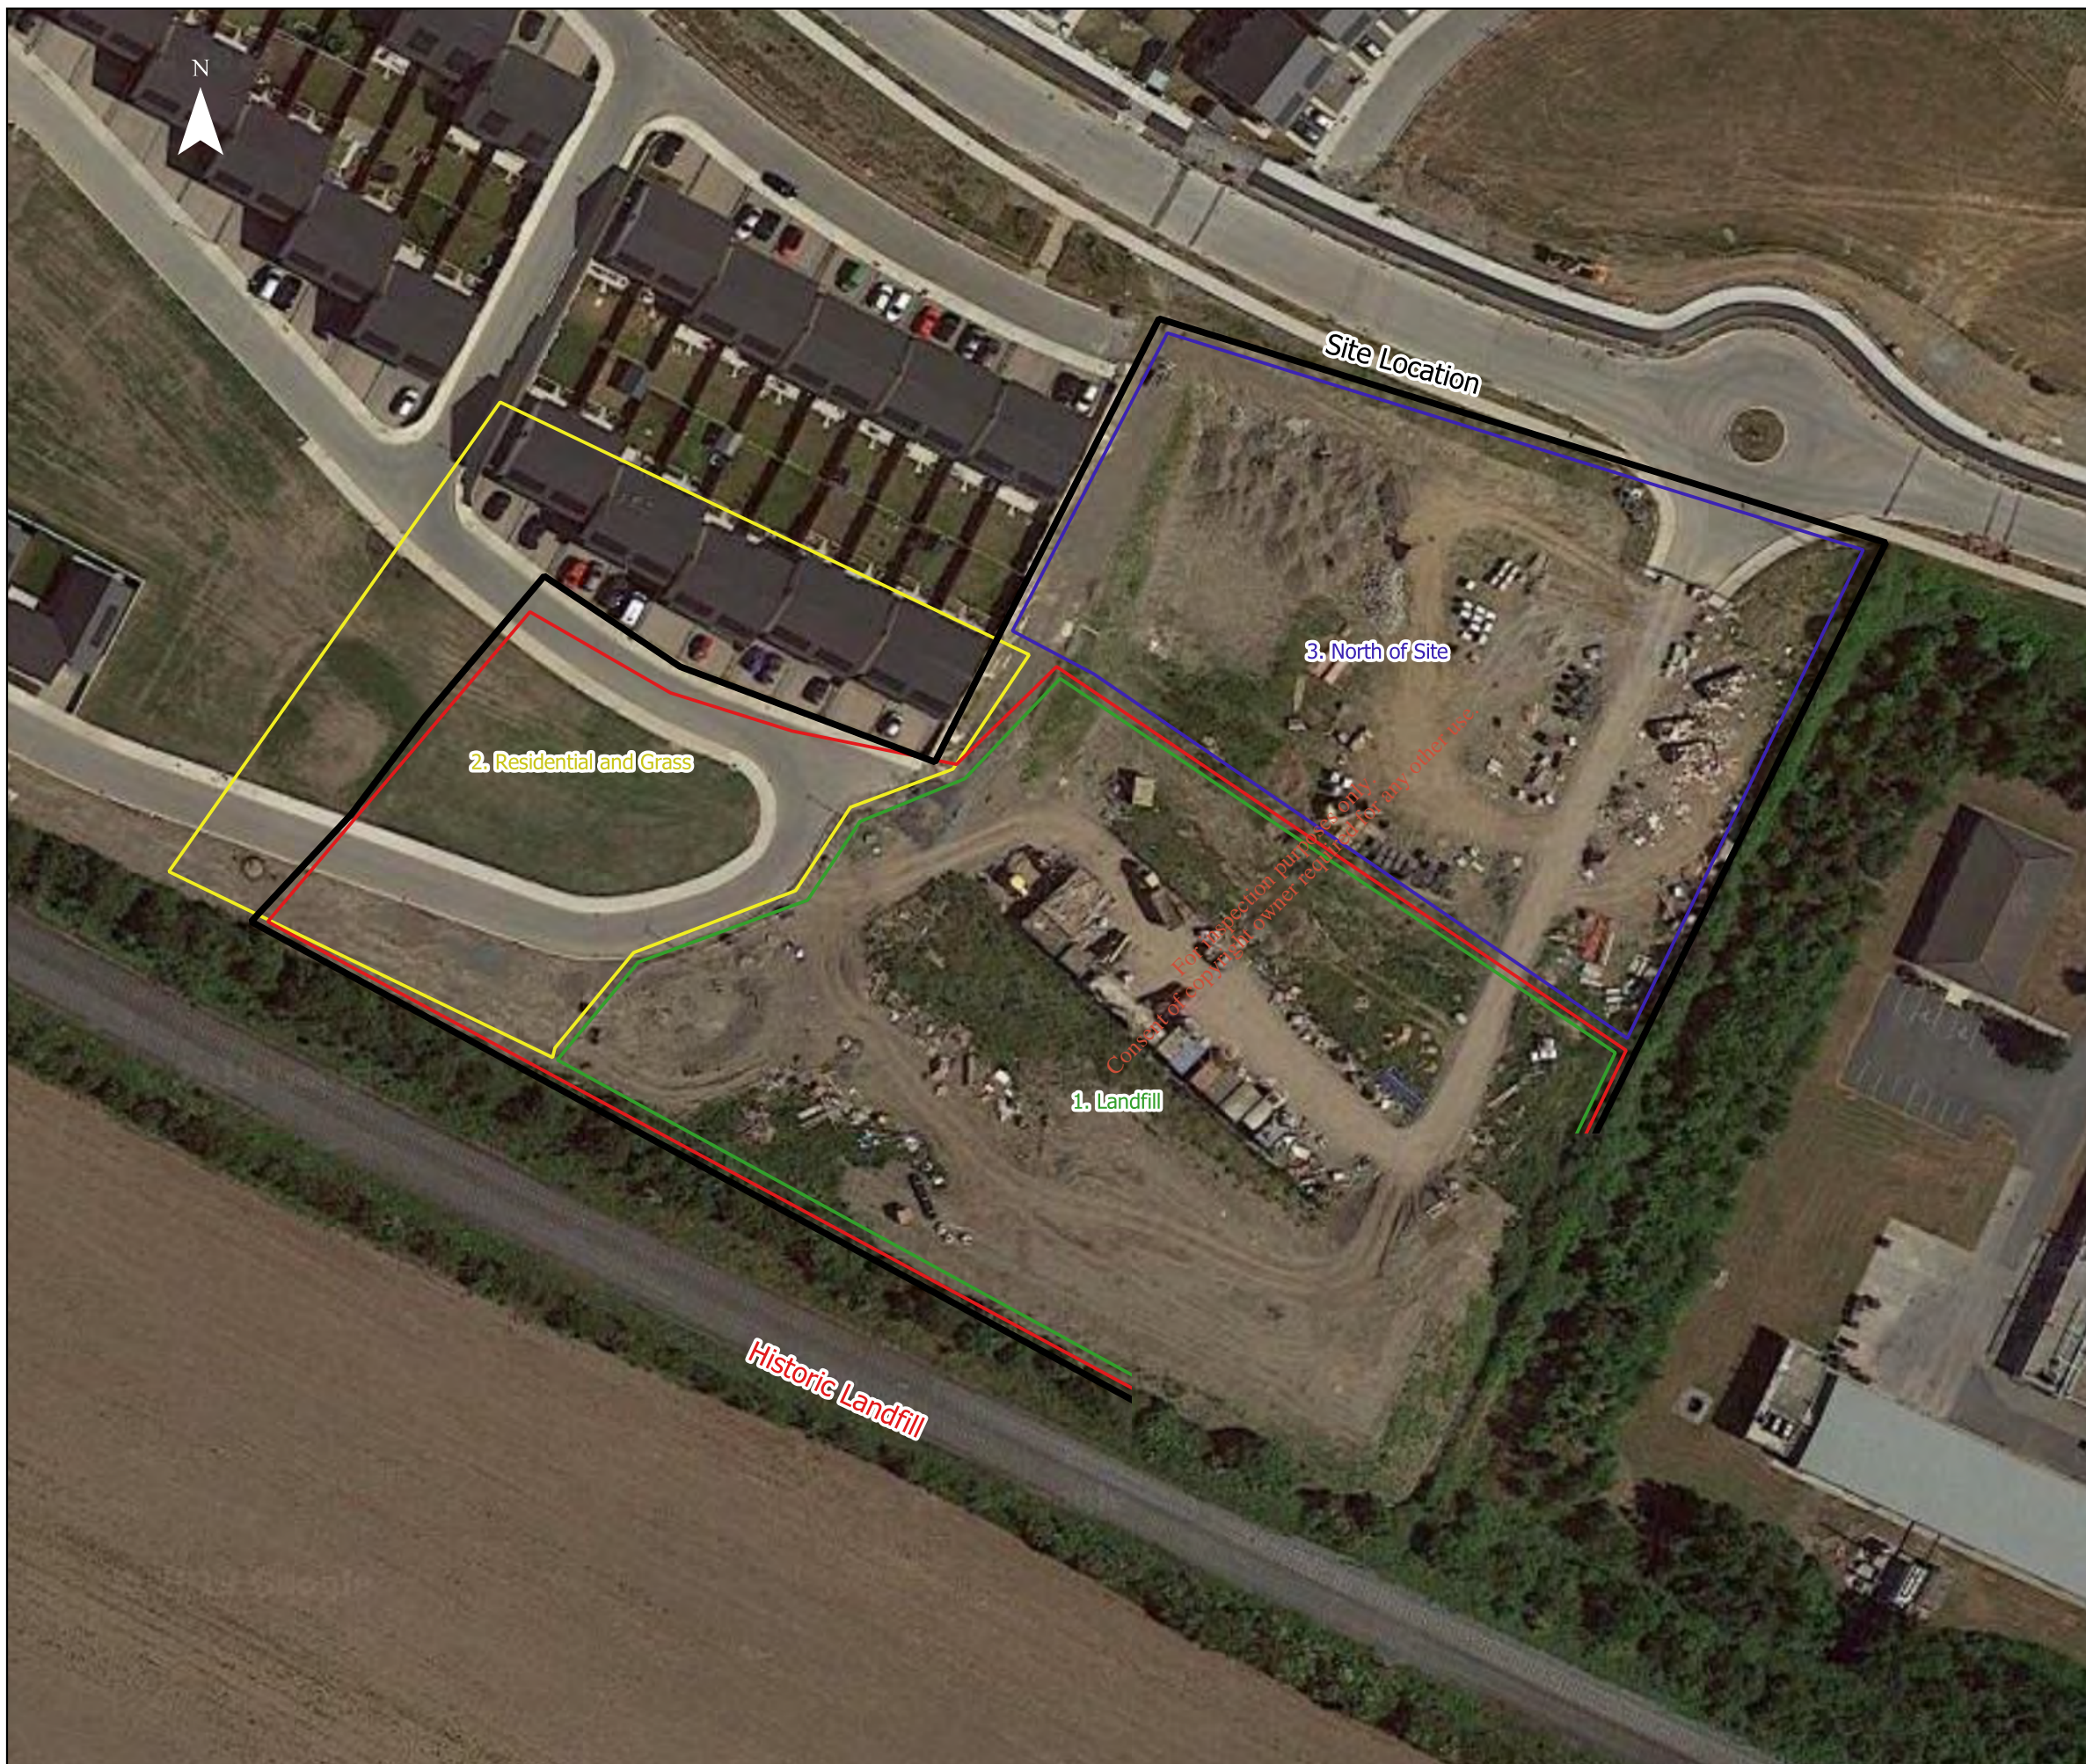
Issue Details	
Drawn by: Scott Graydon	Project No: MDR1552
Checked by: PC	File Ref.:
Approved by: GMcE	MDR1552QGIS0001F01
Scale: 1:1,500@A3	Figure 3.1
Date: 13/08/2019

Legend	
	Site Location
	Historic Landfill Area
	1. Landfill
	2. Residential and Grass
	3. North of Site
	County Boundary
	Sea Background

Map is to identify the different areas within the site.

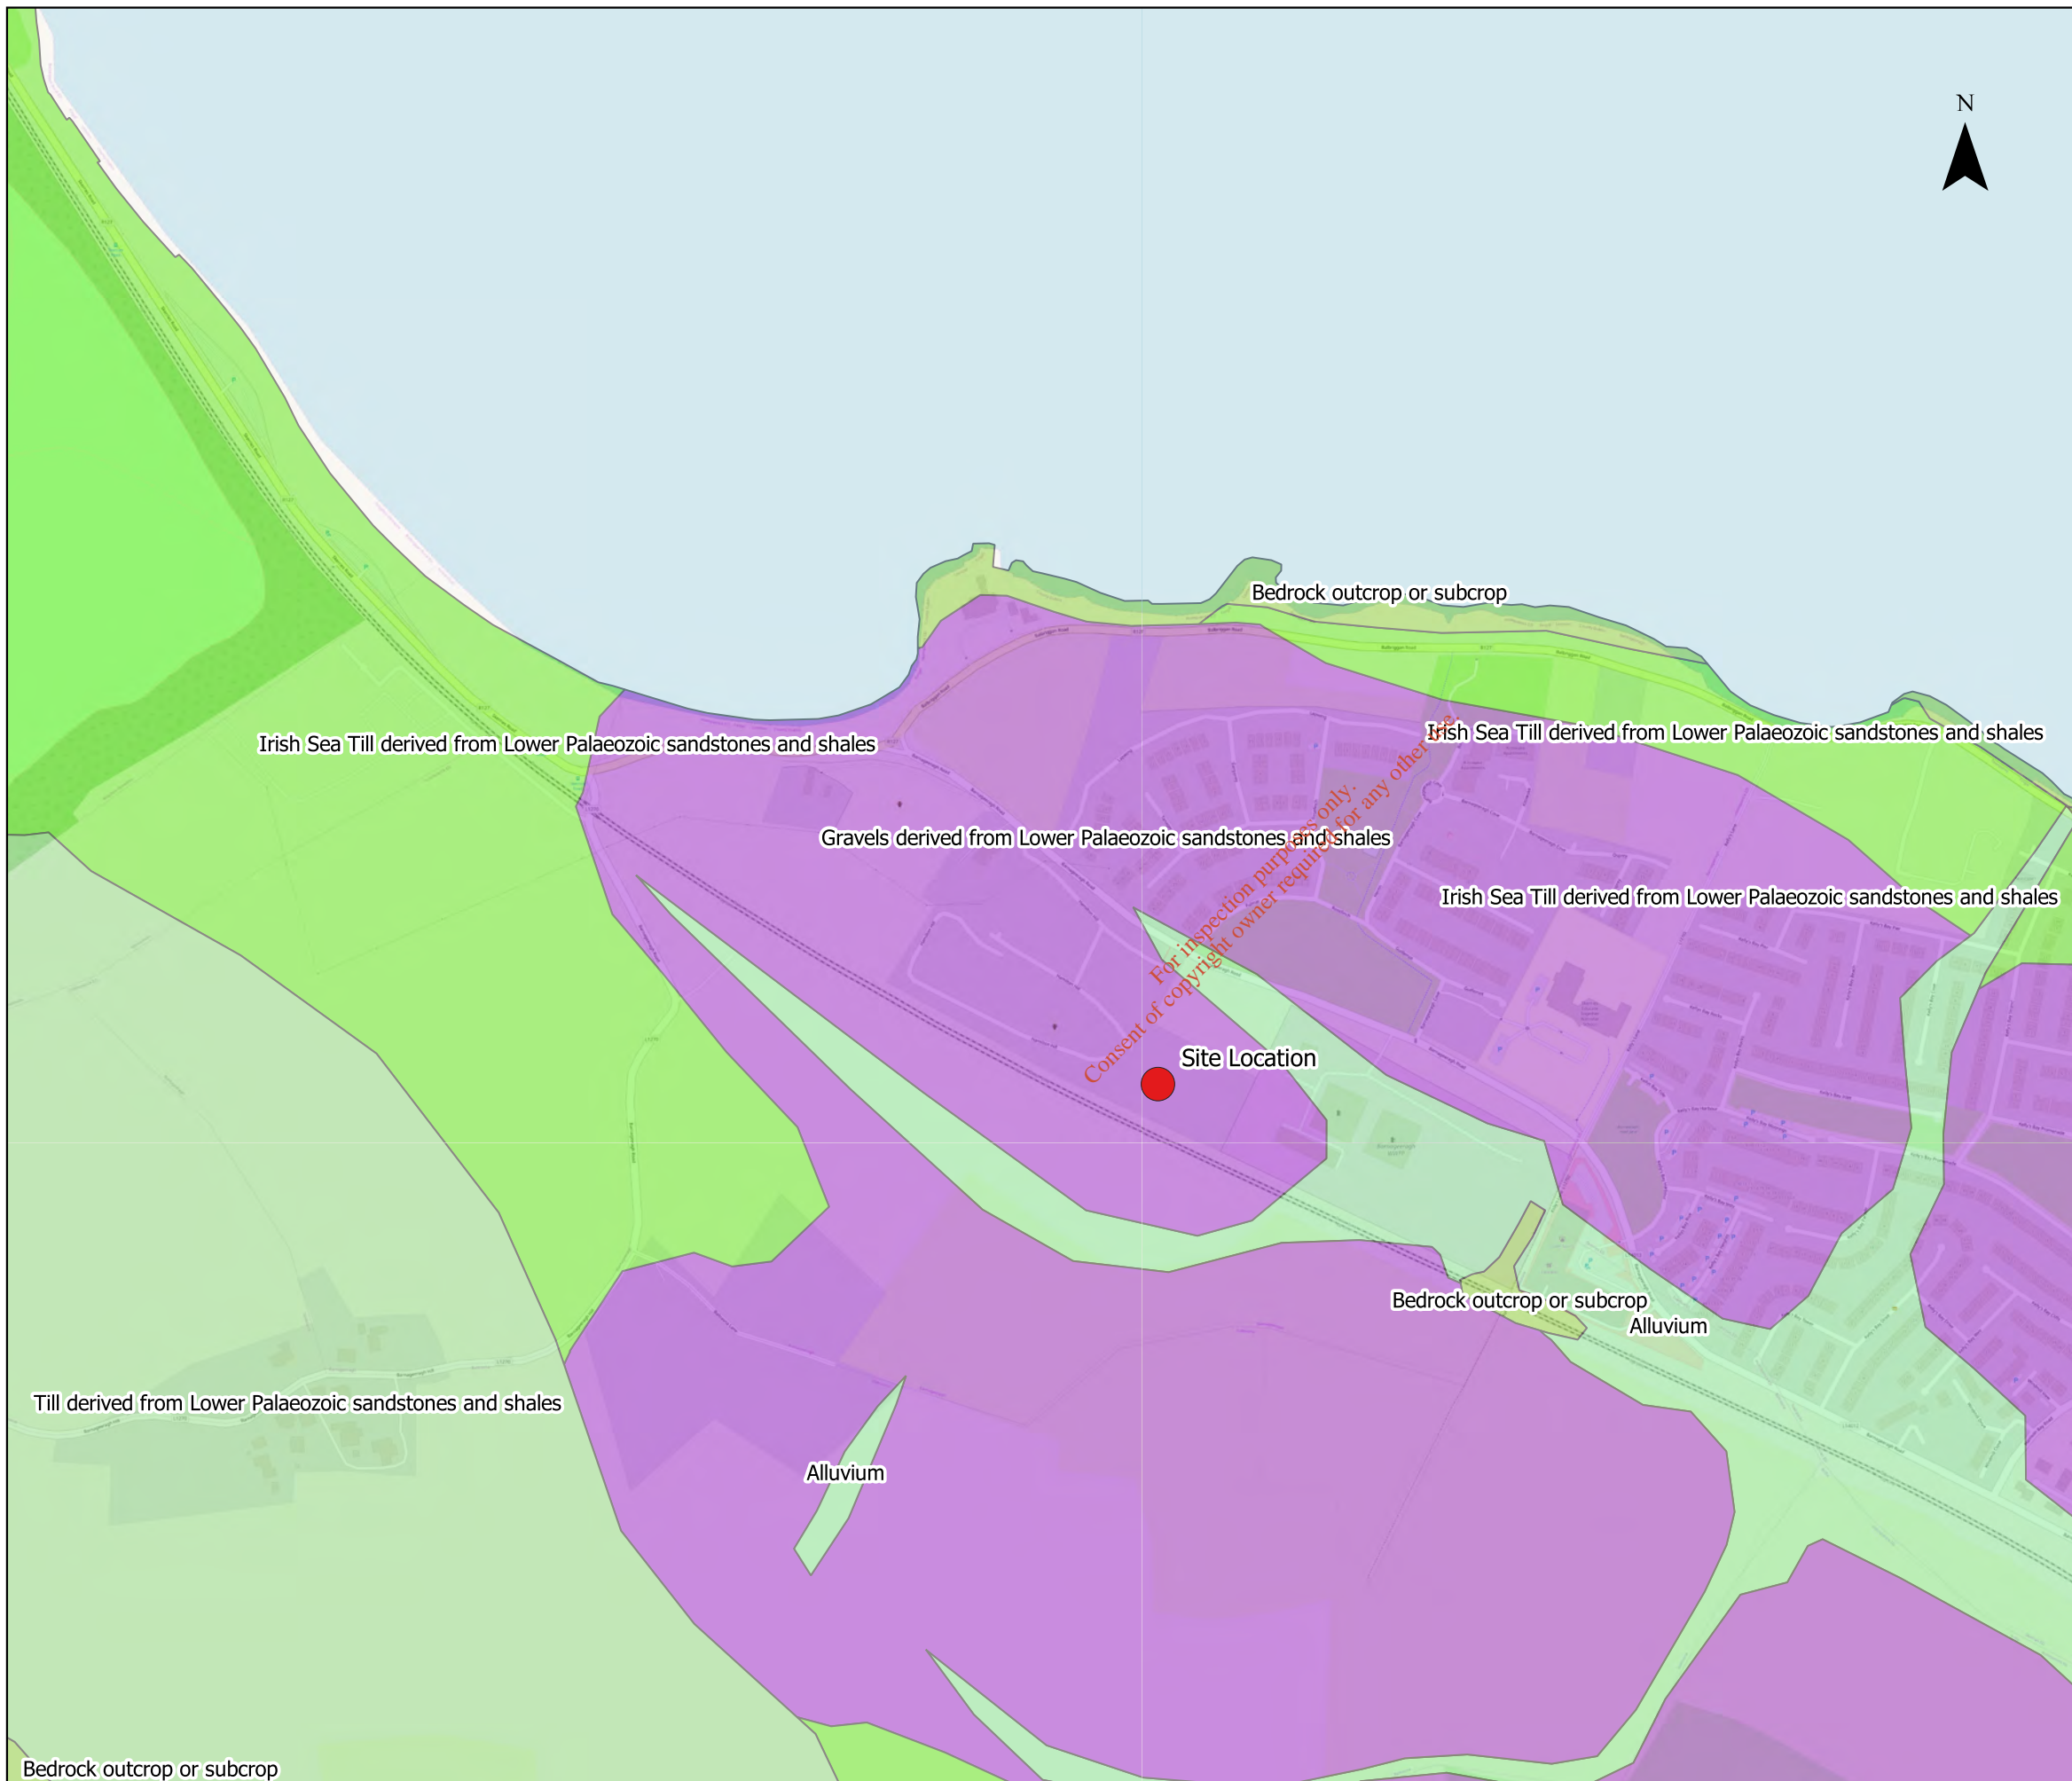
Drawn by: Scott Graydon	Project No: MDR1552
Checked by: PC	File Ref.:
Approved by: GMcE	MDR1552QGIS0001F01
Scale: 1:10,000@A3	Figure 3.2
Date: 13/08/2019

- Location
- QUATERNARY SEDIMENT**
- Alluvium
- Bedrock outcrop or subcrop
- Gravels
- Irish Sea Till
- Till
