BARNAGEERAGH UNREGULATED WASTE DISPOSAL SITE

TIER 1 ENVIRONMENTAL RISK ASSESSMENT

MDR1552Rp0001
Barnageeragh
Tier 1 Environmental Risk
Assessment
F01
13 August 2019

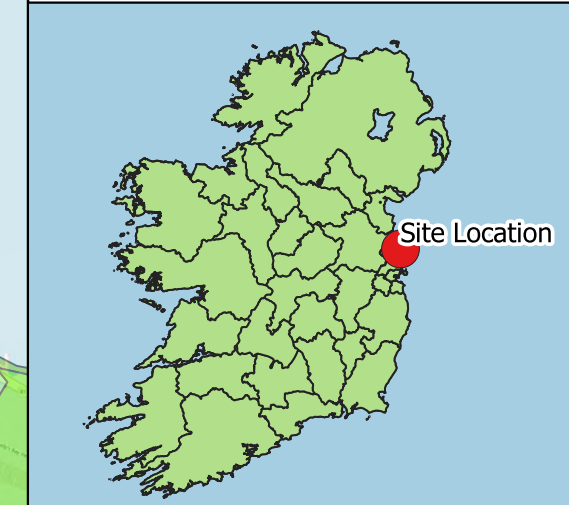
Title:	Sub Soil Geology
Project:	Barnageeragh Landfill
Client:	Fingal County Council
RPS	West Pier Business Campus, Dun Laoghaire, Co. Dublin, Ireland
Tel: +353 (0)1 4882900 Fax: +353 (0)1 2835676 Email: ireland@rpsgroup.com Web Page: rpsgroup.com/ireland

- Location
- QUATERNARY SEDIMENT**
- Alluvium
- Bedrock outcrop or subcrop
- Gravels
- Irish Sea Till
- Till

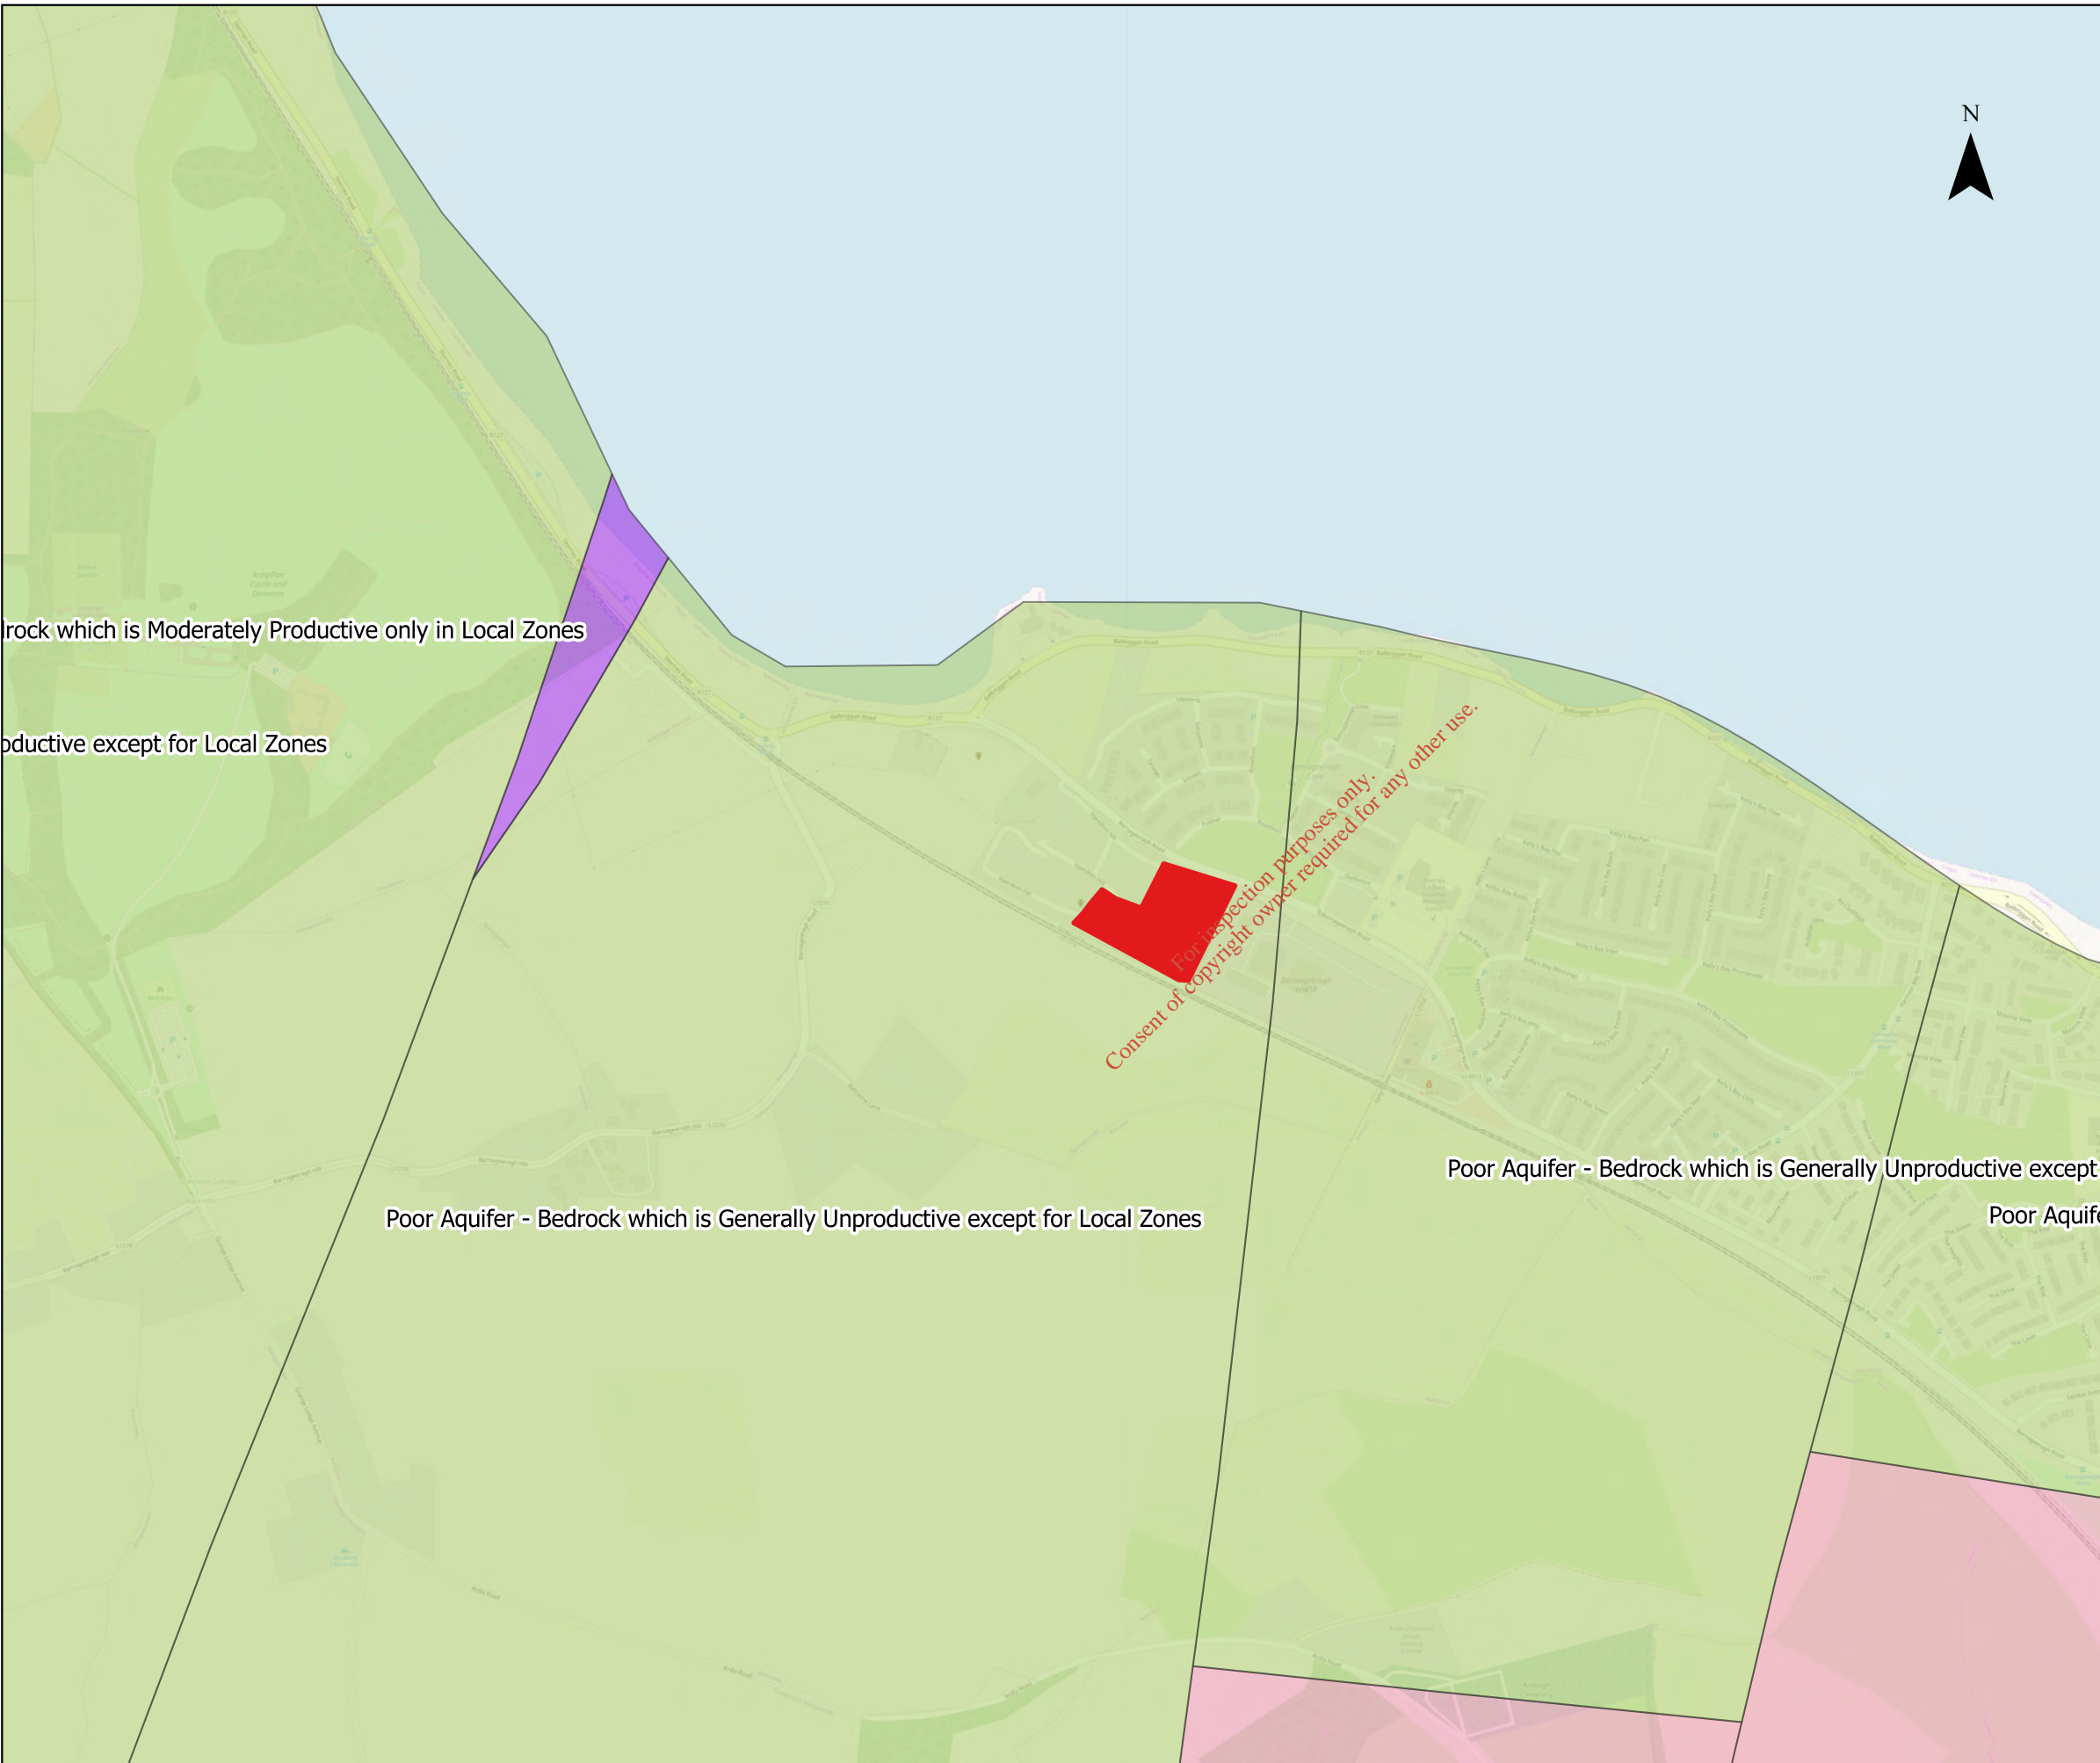
Title: **Hydrogeological Map**

- Site Location
- AquiferBed**
- Locally Important Aquifer - Bed
- Locally Important Aquifer - Kars
- Poor Aquifer - Bedrock which is

Close to the site between approximately 0.8km and 1km to the WNW and SSW respectively there is a locally important aquifer classified as a karstified aquifer, which has zones of erosion, often in limestone rock, that has produced fissures, sinkholes and underground streams allowing for flow of groundwater.

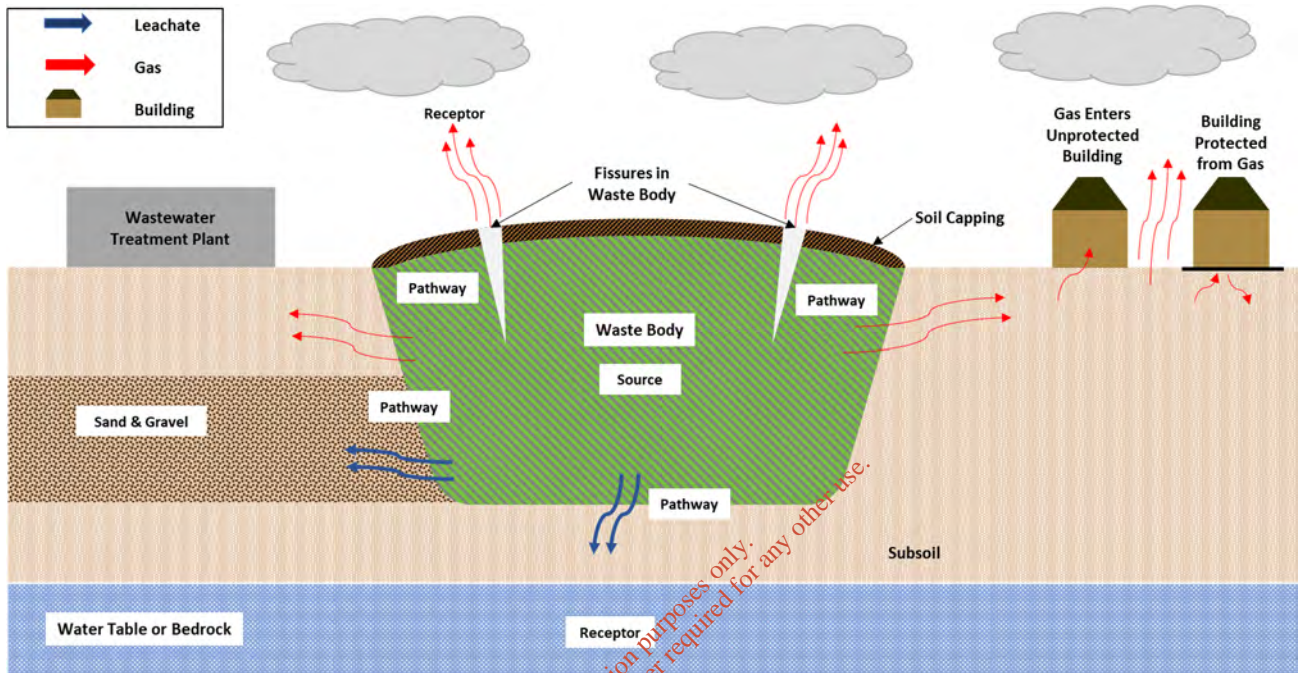
Figure 4.1 Initial CSM for Barnageeragh Landfill

The initial conceptual site model (CSM) was developed on the basis of the information collected as summarised in **Section 3** and is illustrated in **Figure 4.1**. The CSM indicates that there is the potential for landfill gas to be the main concern with regard to the proximity to receptors (the houses) with some likelihood of leachate also posing a risk to receptors if there is a pathway to groundwater or surface waters.
