BARNAGEERAGH LANDFILL

Tier 2 and Tier 3 Environmental Risk Assessment

EPA Site Registration Number: S22-0265

MGE0755RP0001
Barnageeragh Landfill Tier 2
and Tier 3 Environmental
Risk Assessment
F01
21 July 2020

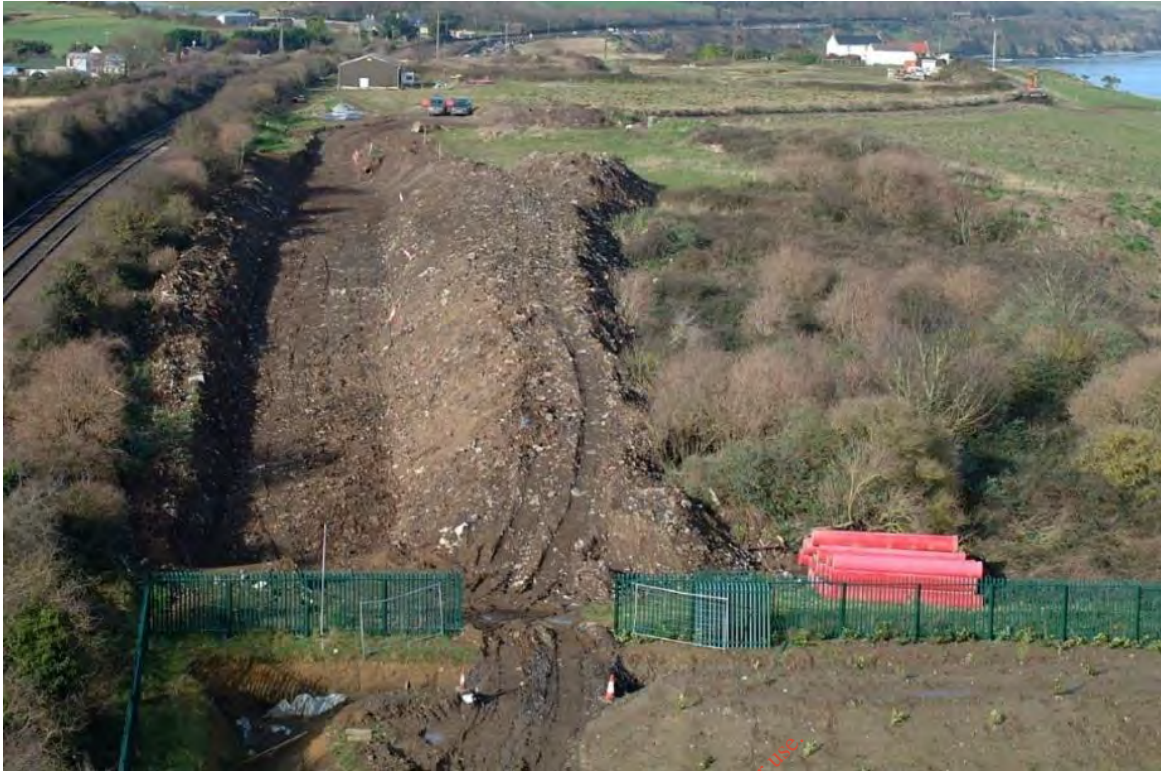
Figure 2.1 Barnageeragh Landfill During Construction of Wastewater Rising Main (view to the west, 2006).

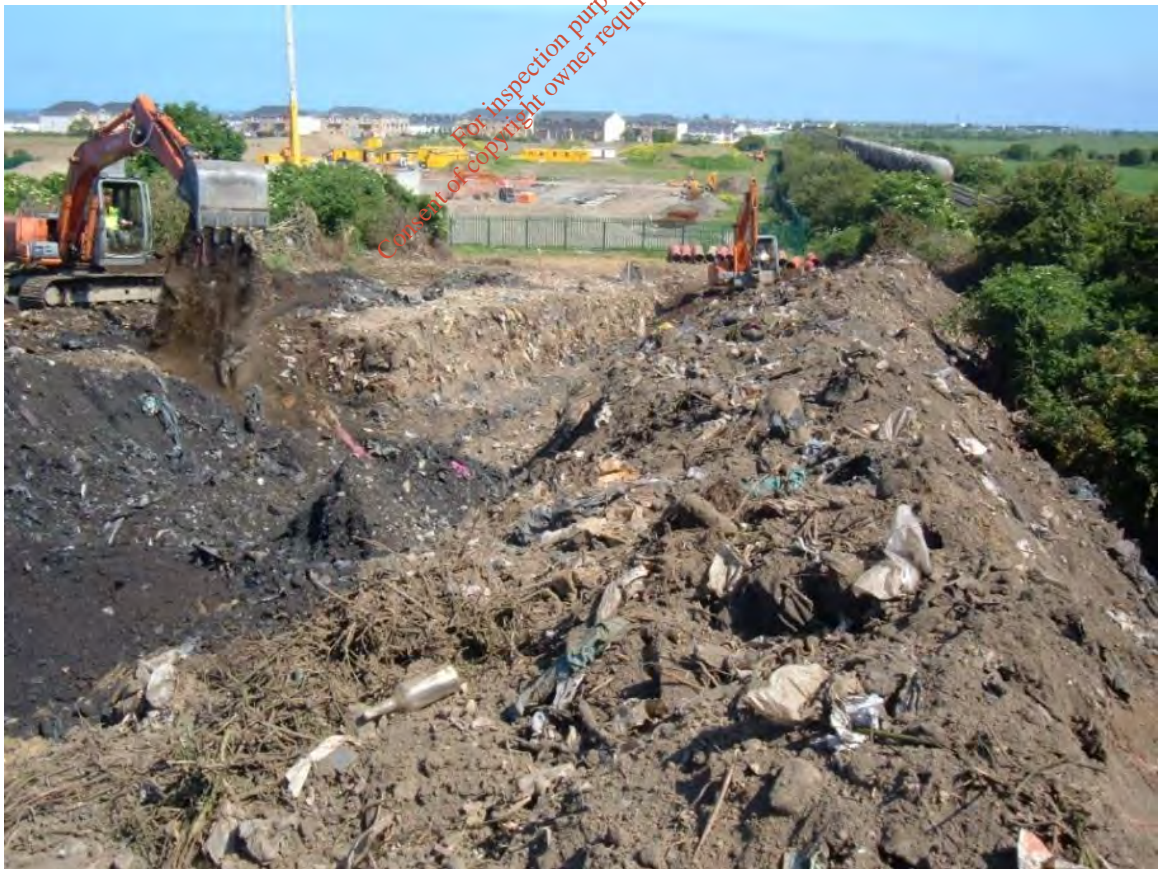
Figure 2.2 Barnageeragh Landfill During Construction of Wastewater Rising Main (view to the east, 2005).

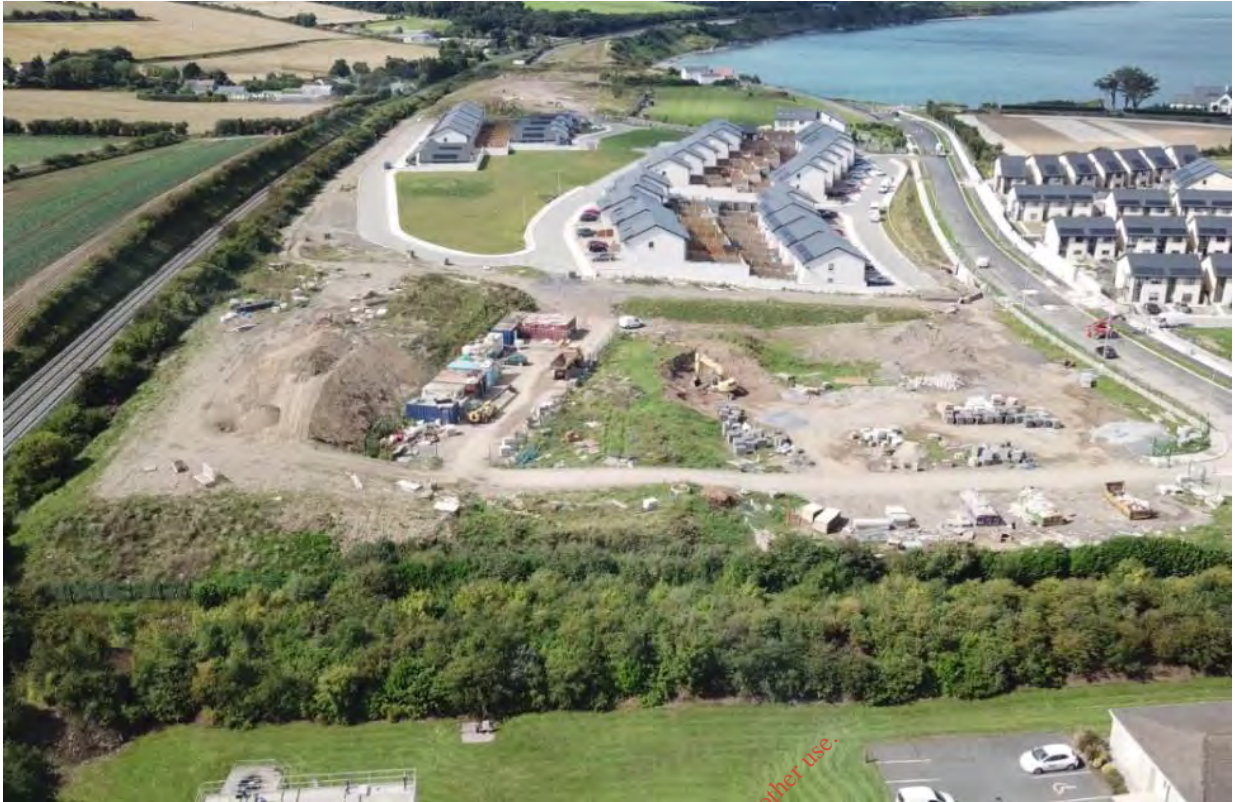
Figure 2.3 Barnageeragh Landfill Site (looking west) during the construction of the Hamilton Hill housing development

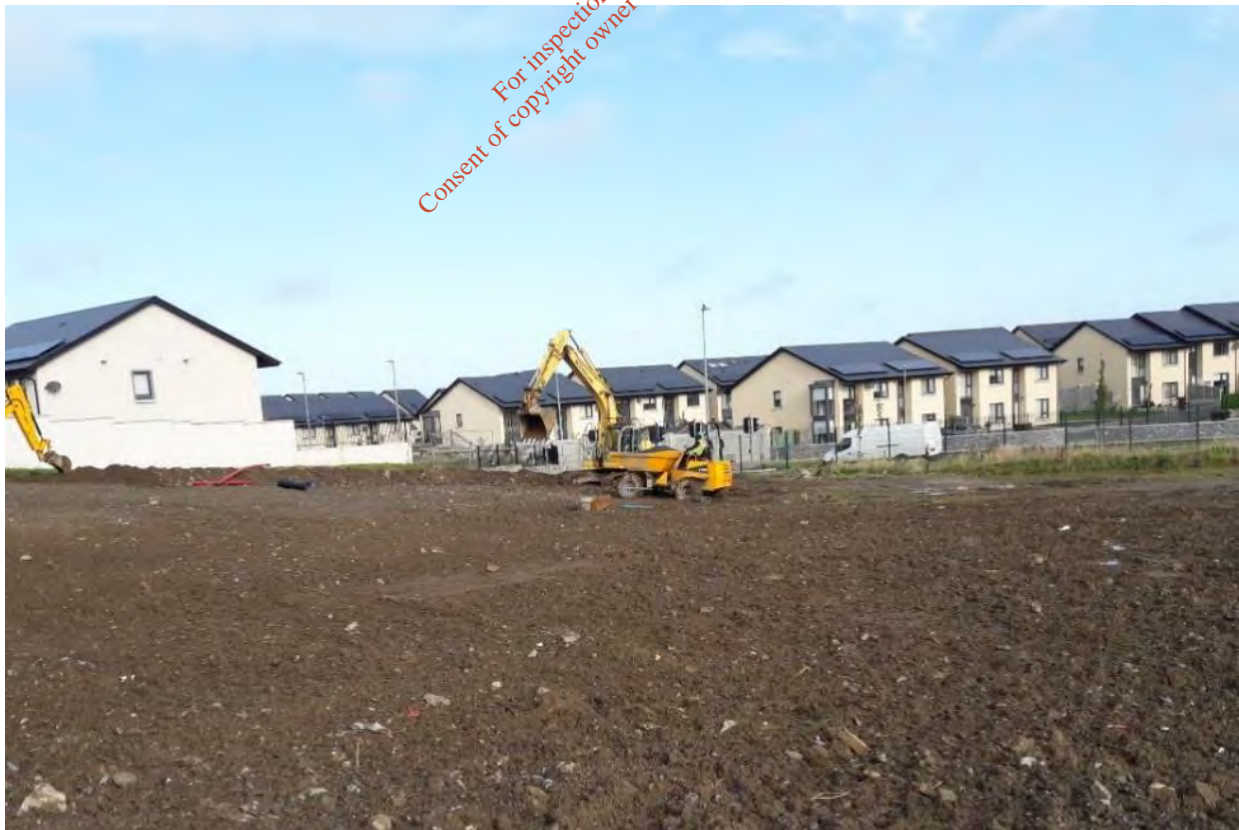
Figure 2.4 Regrading and Soil Spreading at Barnageeragh Landfill, October 2019

In October 2019, the waste body and the land to the north of the waste body was regraded and soiled by the developer (**Figure 2.4**) to provide a clean soil surface. The regraded site provides a gentle slope falling from south to north.

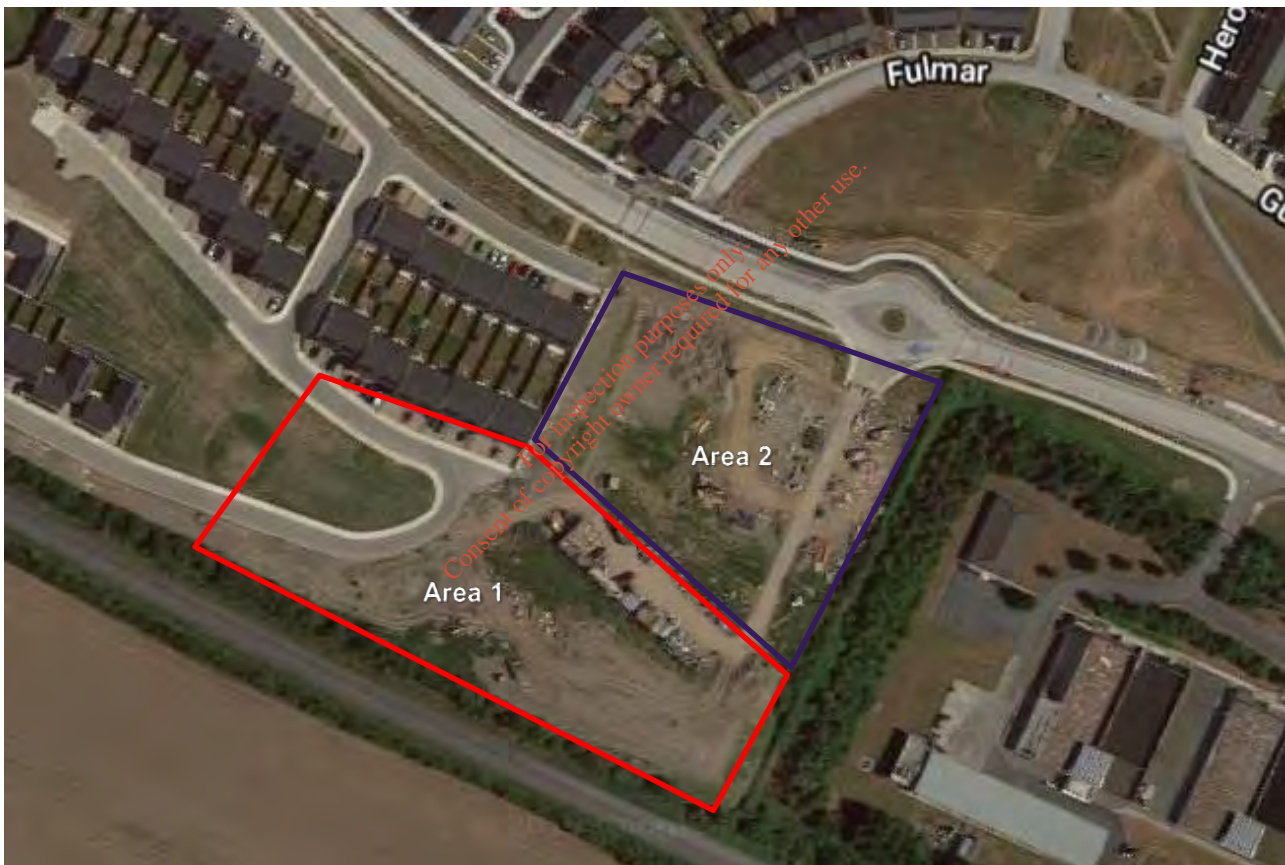
Figure 5.1 Areas identified as containing waste materials

- Area 1 – The main landfill waste body. This area is located to the south and southeast of the Hamilton Hill development.
- Area 2 – Made-ground. This area is located directly east of the Hamilton Hill development and north of the Area 1.

Figure 5.1 below presents an image from the DQRA showing the different areas. These areas have been delineated based on the information collected during the Tier 2 site investigations, including from trial pit and borehole logs.

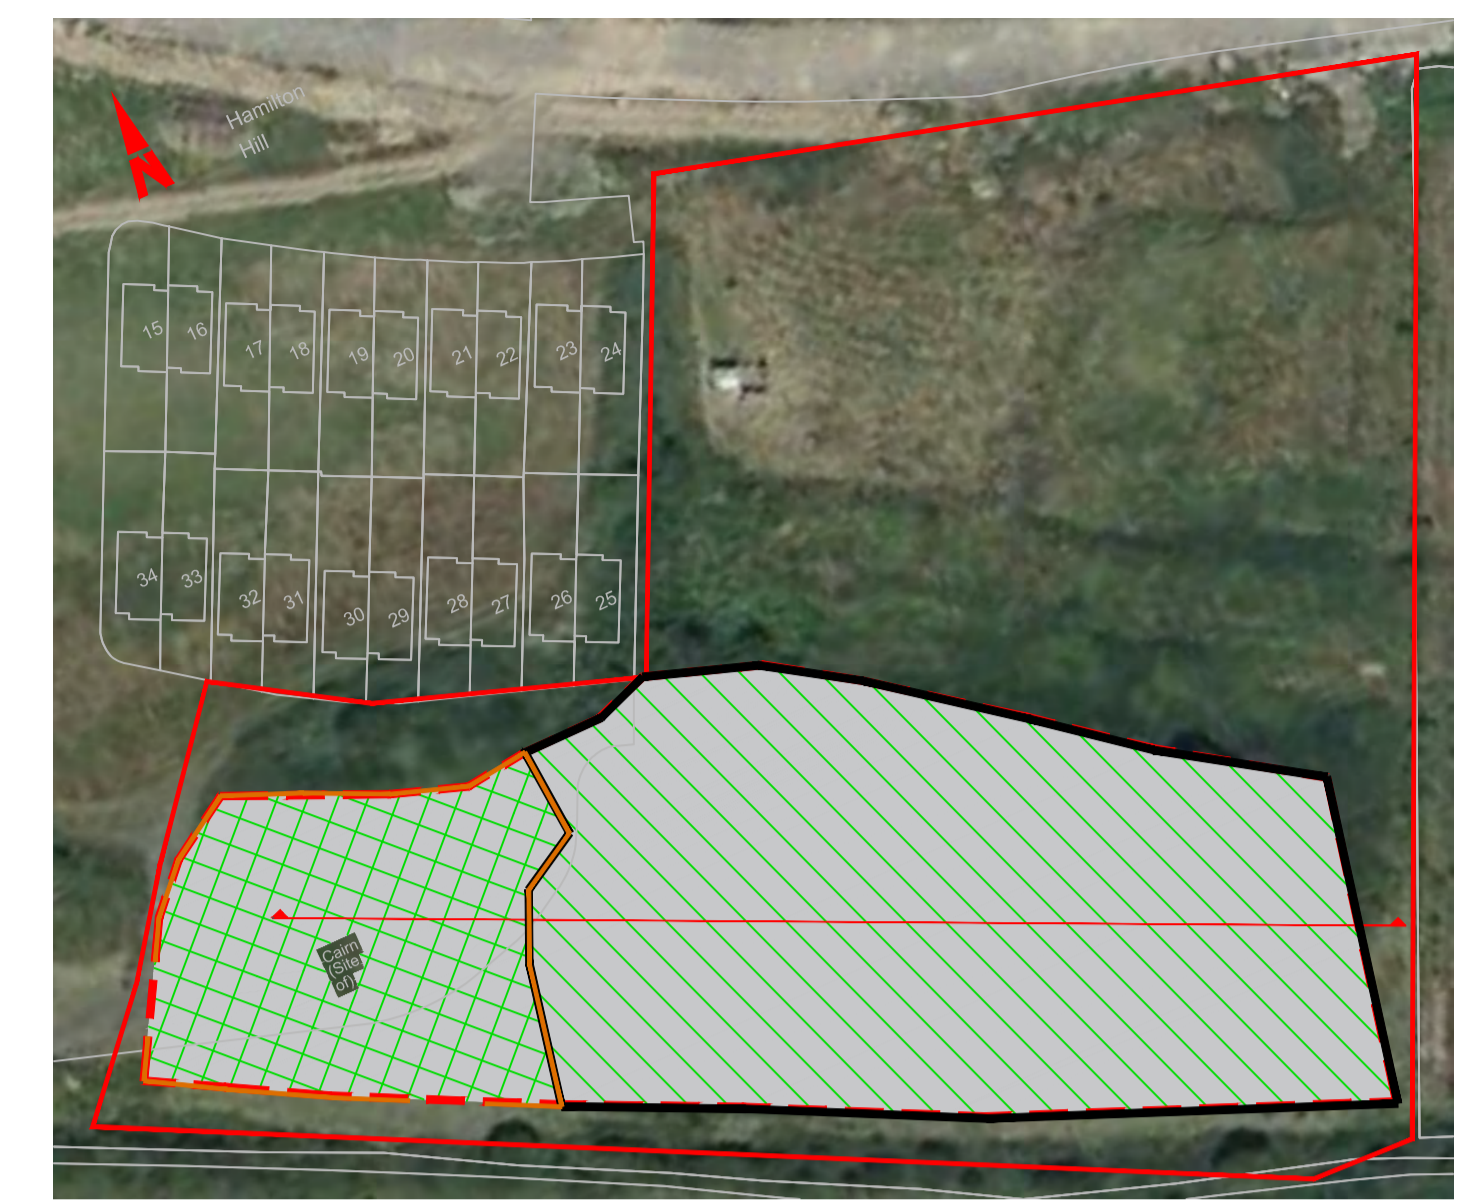
Model File Identifier
MGE0755-RPS-00-XX-DR-C-DG0005

Site Plan (Scale 1:1000)

Conceptual Site Model without Mitigation Measures (Not to scale)

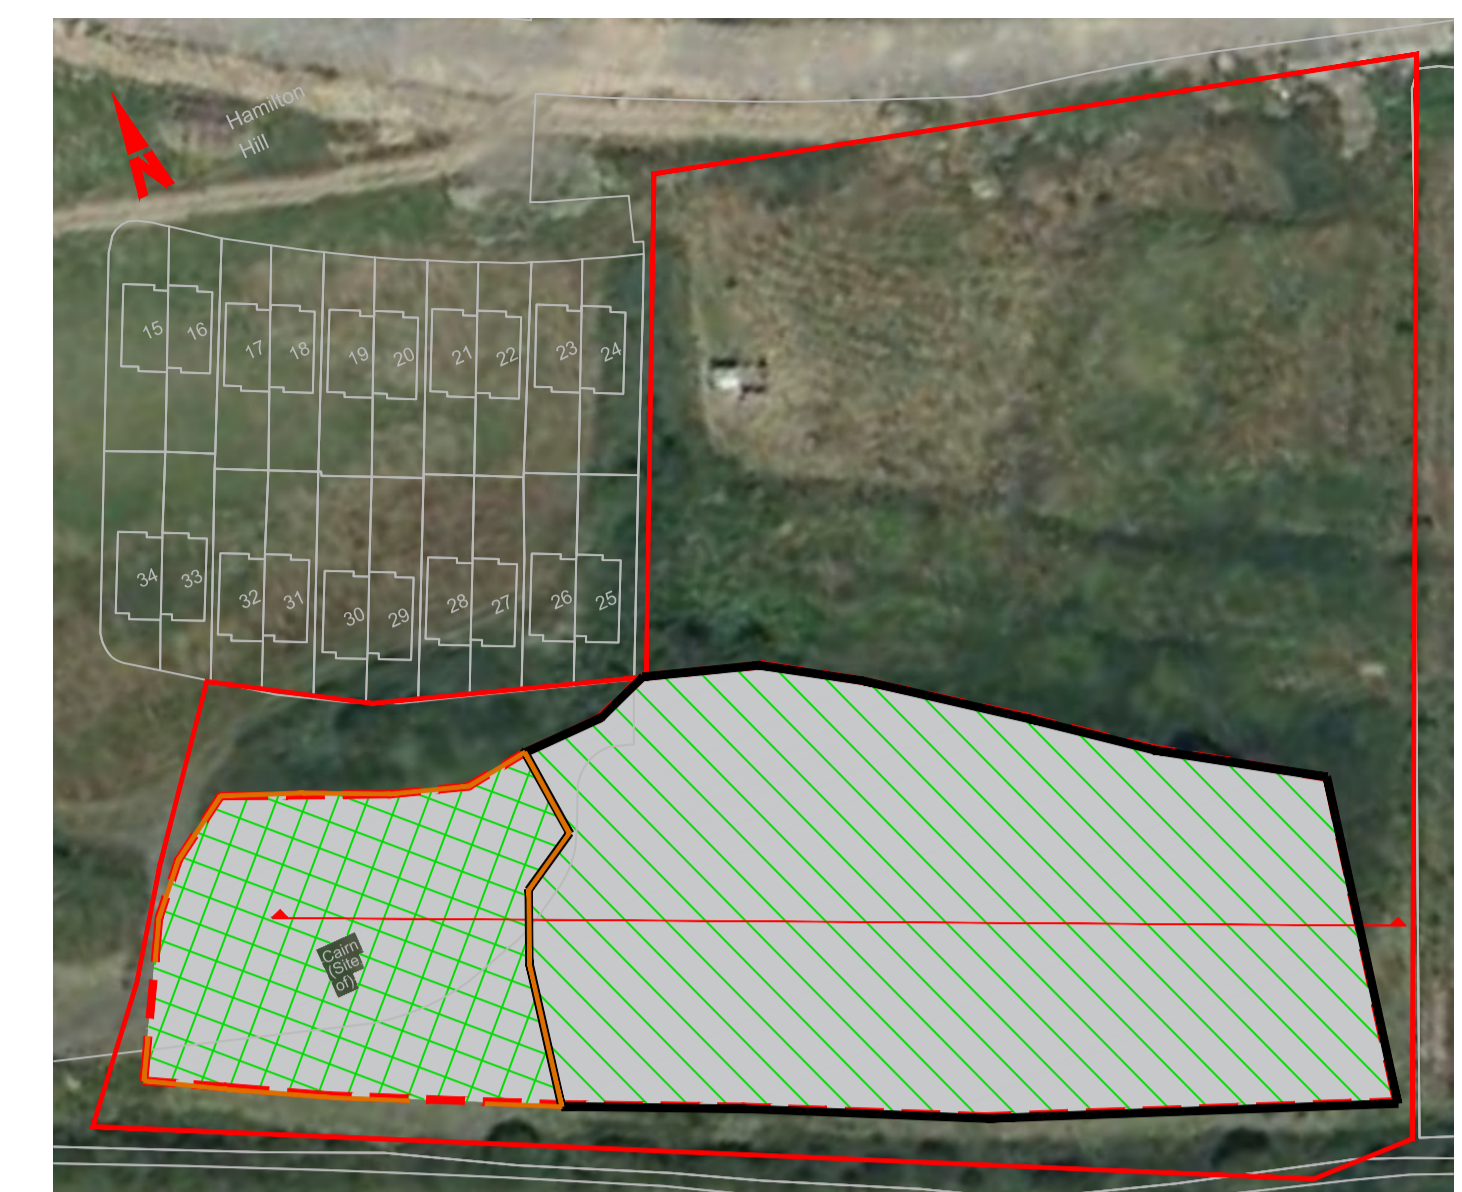
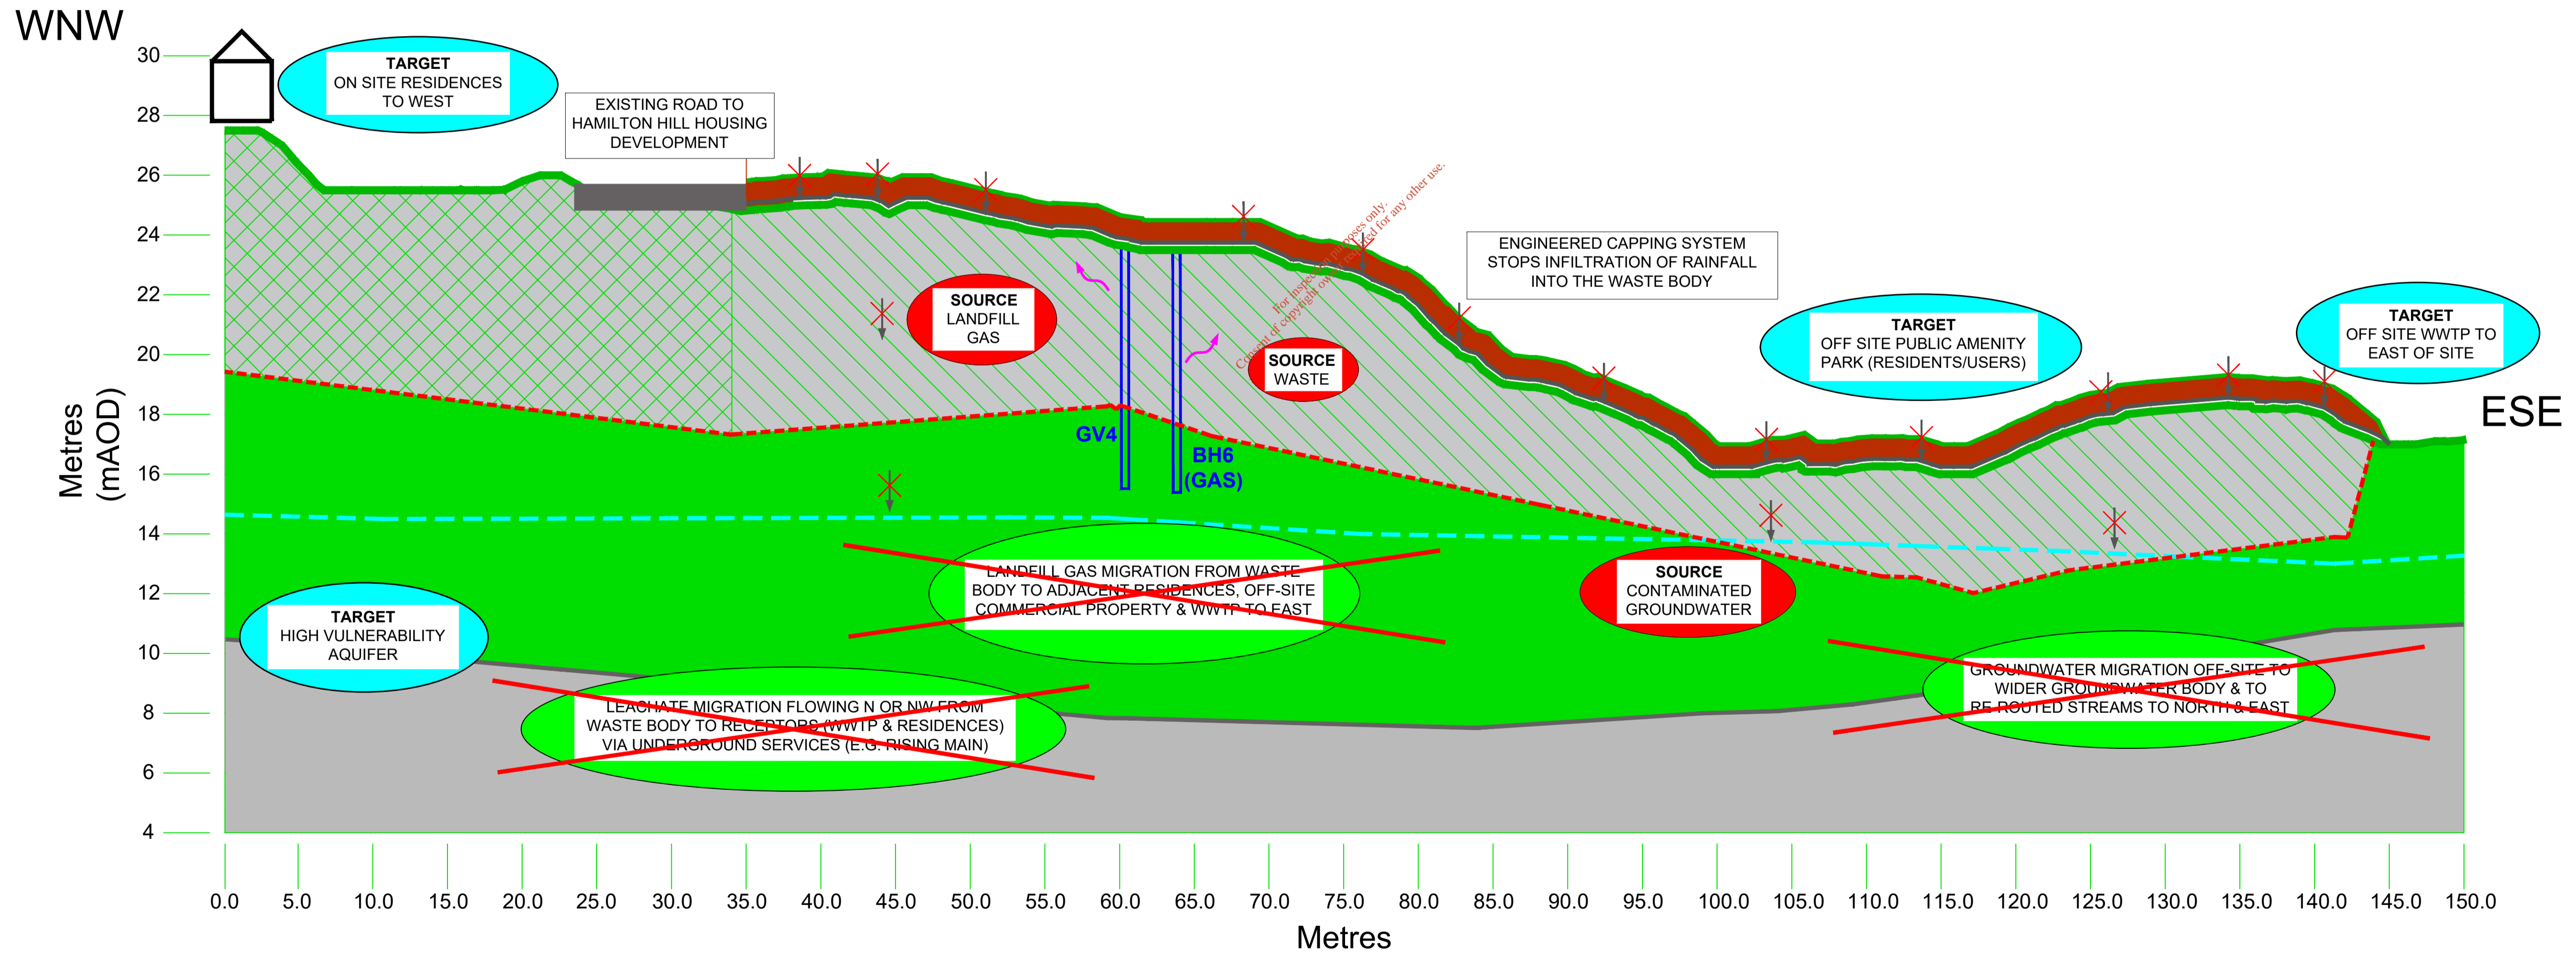
Model File Identifier
MGE0755-RPS-00-XX-DR-C-DG0005

Site Plan (Scale 1:1000)

Conceptual Site Model with Mitigation Measures (Not to scale)

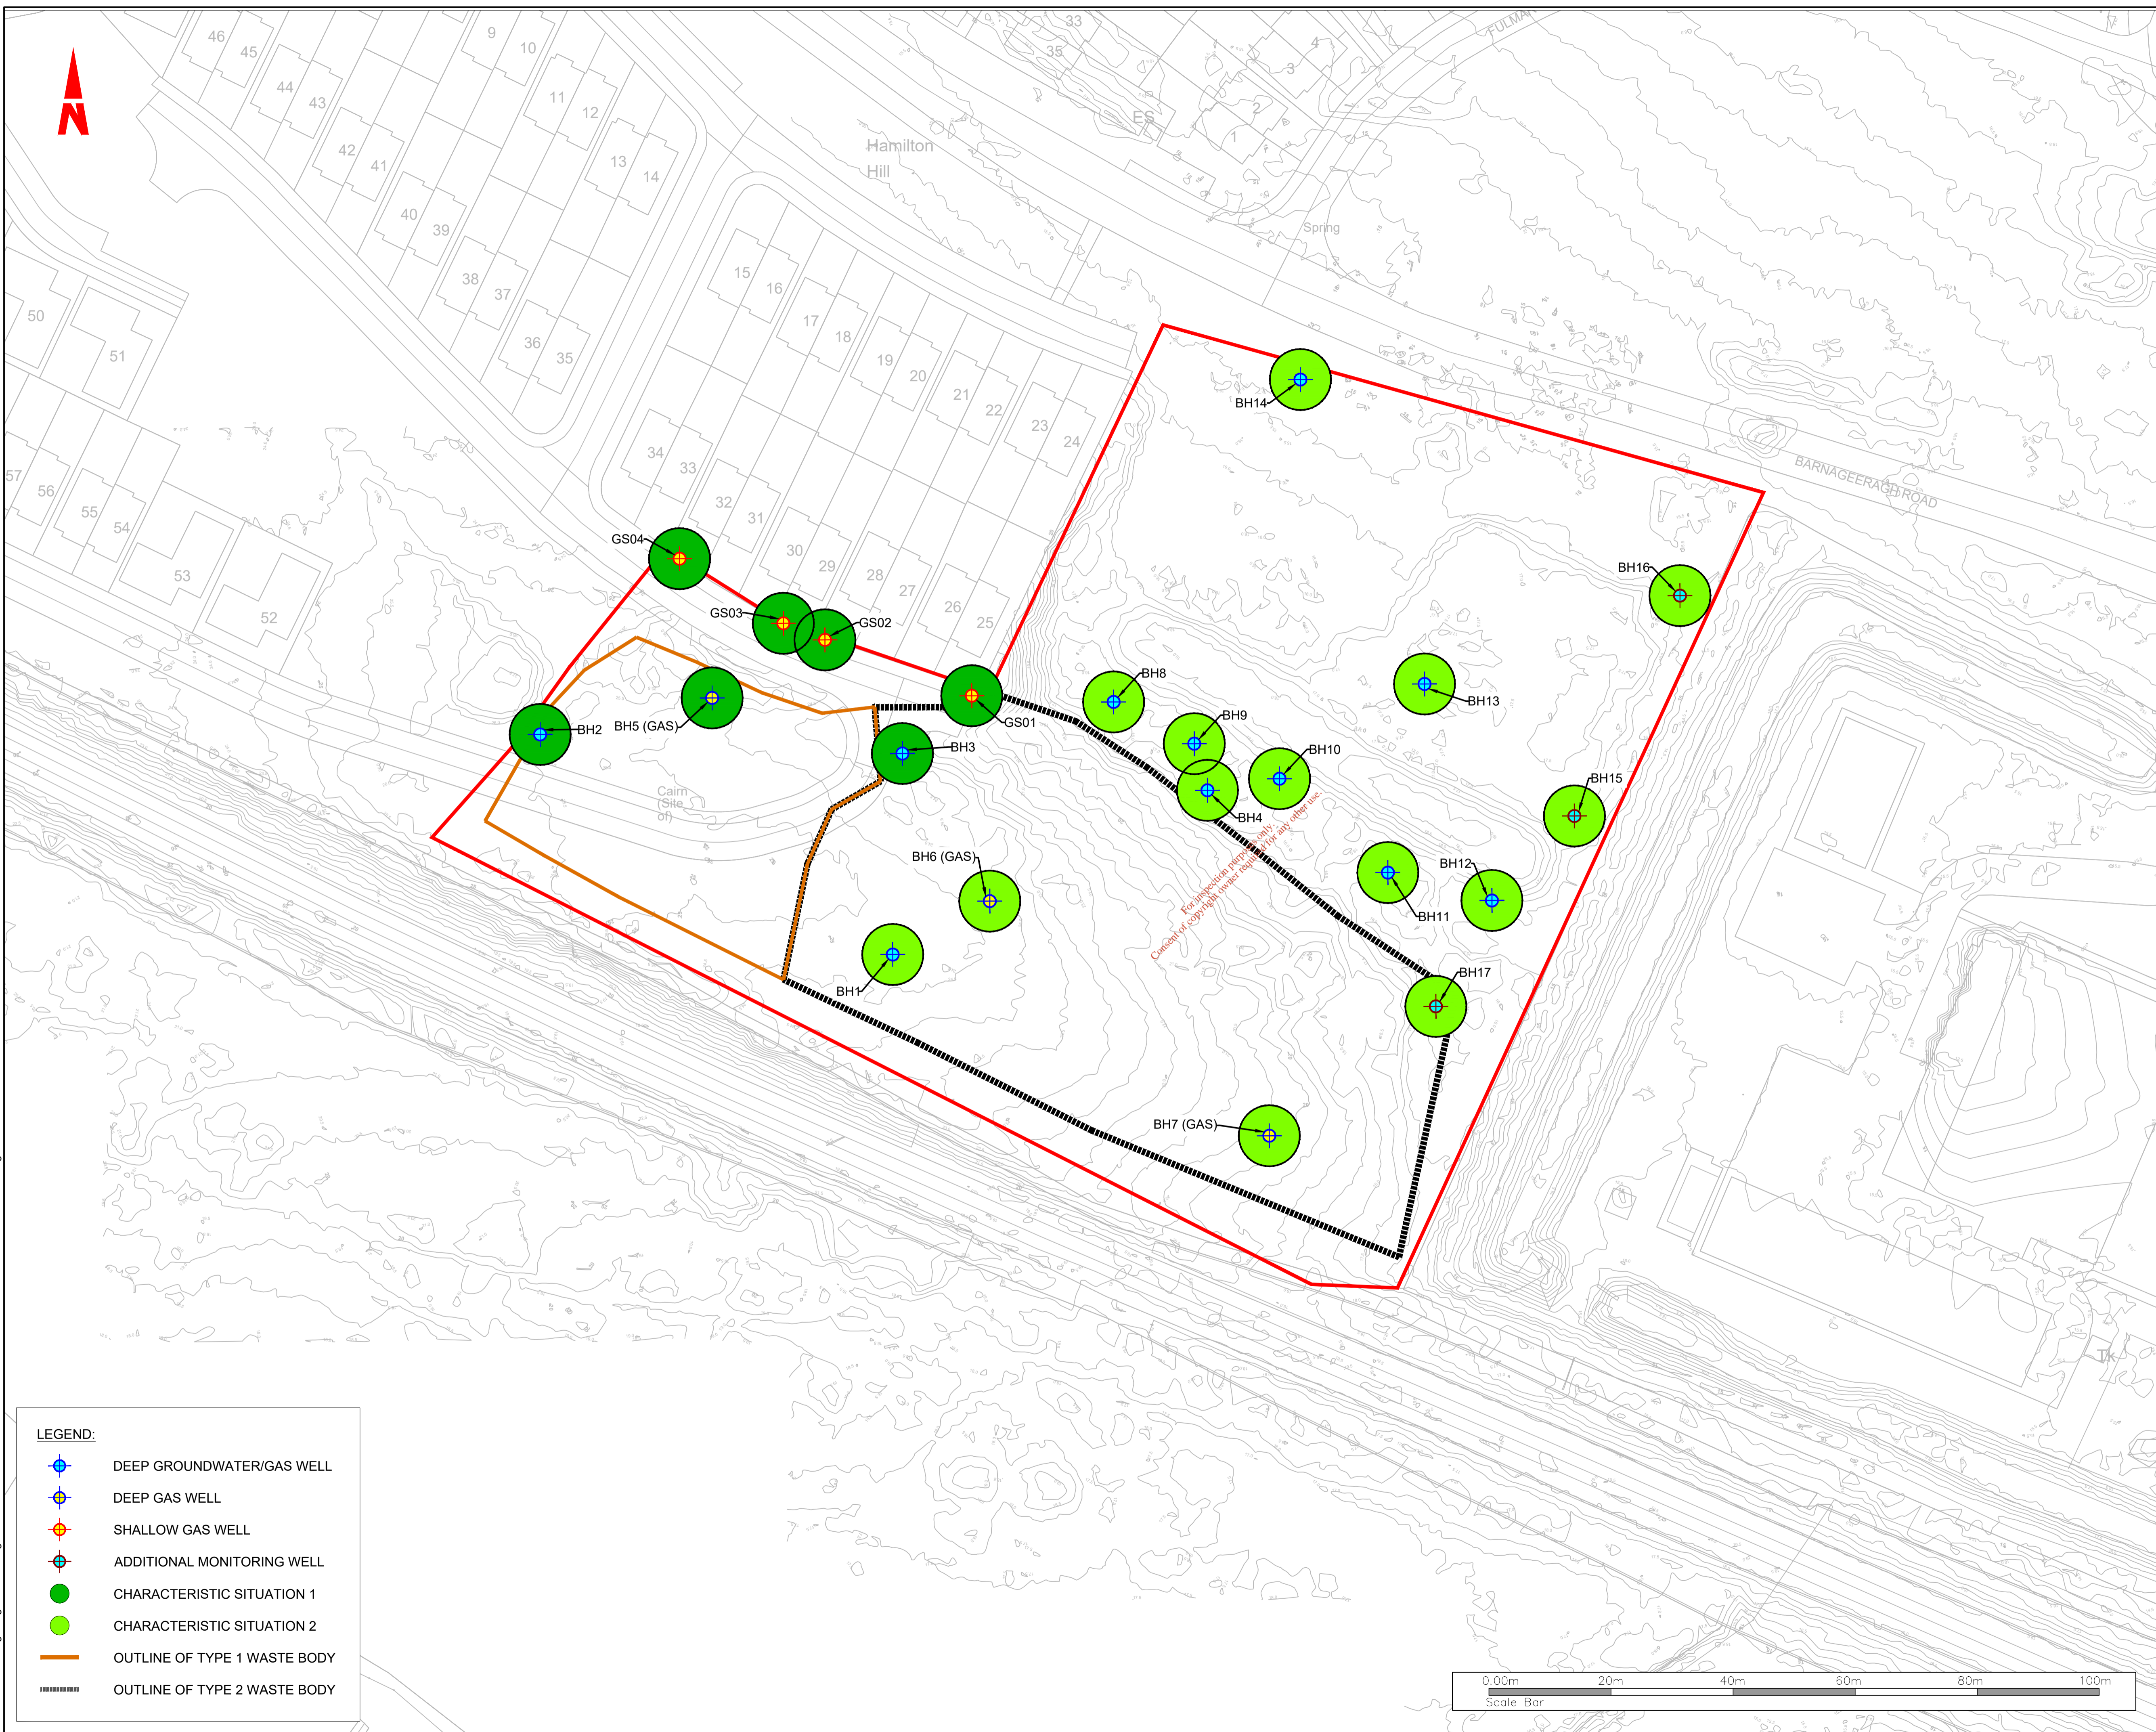
R:\MGE0755 Barnageeragh\6.0 Drawings\DM\GME0755-RPS-01-XX-DR-C-DG0002- Borehole and Trial Pit Locations.dwg

- DEEP GROUNDWATER/GAS WELL
- DEEP GAS WELL
- SHALLOW GAS WELL
- ADDITIONAL MONITORING WELL
- CHARACTERISTIC SITUATION 1
- CHARACTERISTIC SITUATION 2
- OUTLINE OF TYPE 1 WASTE BODY
- OUTLINE OF TYPE 2 WASTE BODY

Hazardous waste was found in 10 out of the 41 soil samples taken from trial pits excavated during the Tier 2 Site Investigation of Barnageeragh, as summarised in **Table 6.2**. All samples were classified as 17 05 03* - soil and stones containing hazardous substances. The affected trial pits where hazardous waste was found are TP4, TP5, TP8, TP10, TP11, TP14, TP15, TP20, TP22 and TP23. For the locations of these trial pits refer to drawing number MGE0755-RPS-01-XX-DR-C-DG0002-03 in **Appendix A**.

Five of the hazardous waste samples are located in the area to the west of the waste body that is located underneath the green and road area to the south of the Hamilton Hill houses nearest the waste body. The green area and the pavement provide an effective barrier to dermal contact and rainfall infiltration.

Four of the remaining five sample are clustered around the centre and deepest part of the waste body. The remaining hazardous waste sample was taken closer to the eastern edge of the waste body.

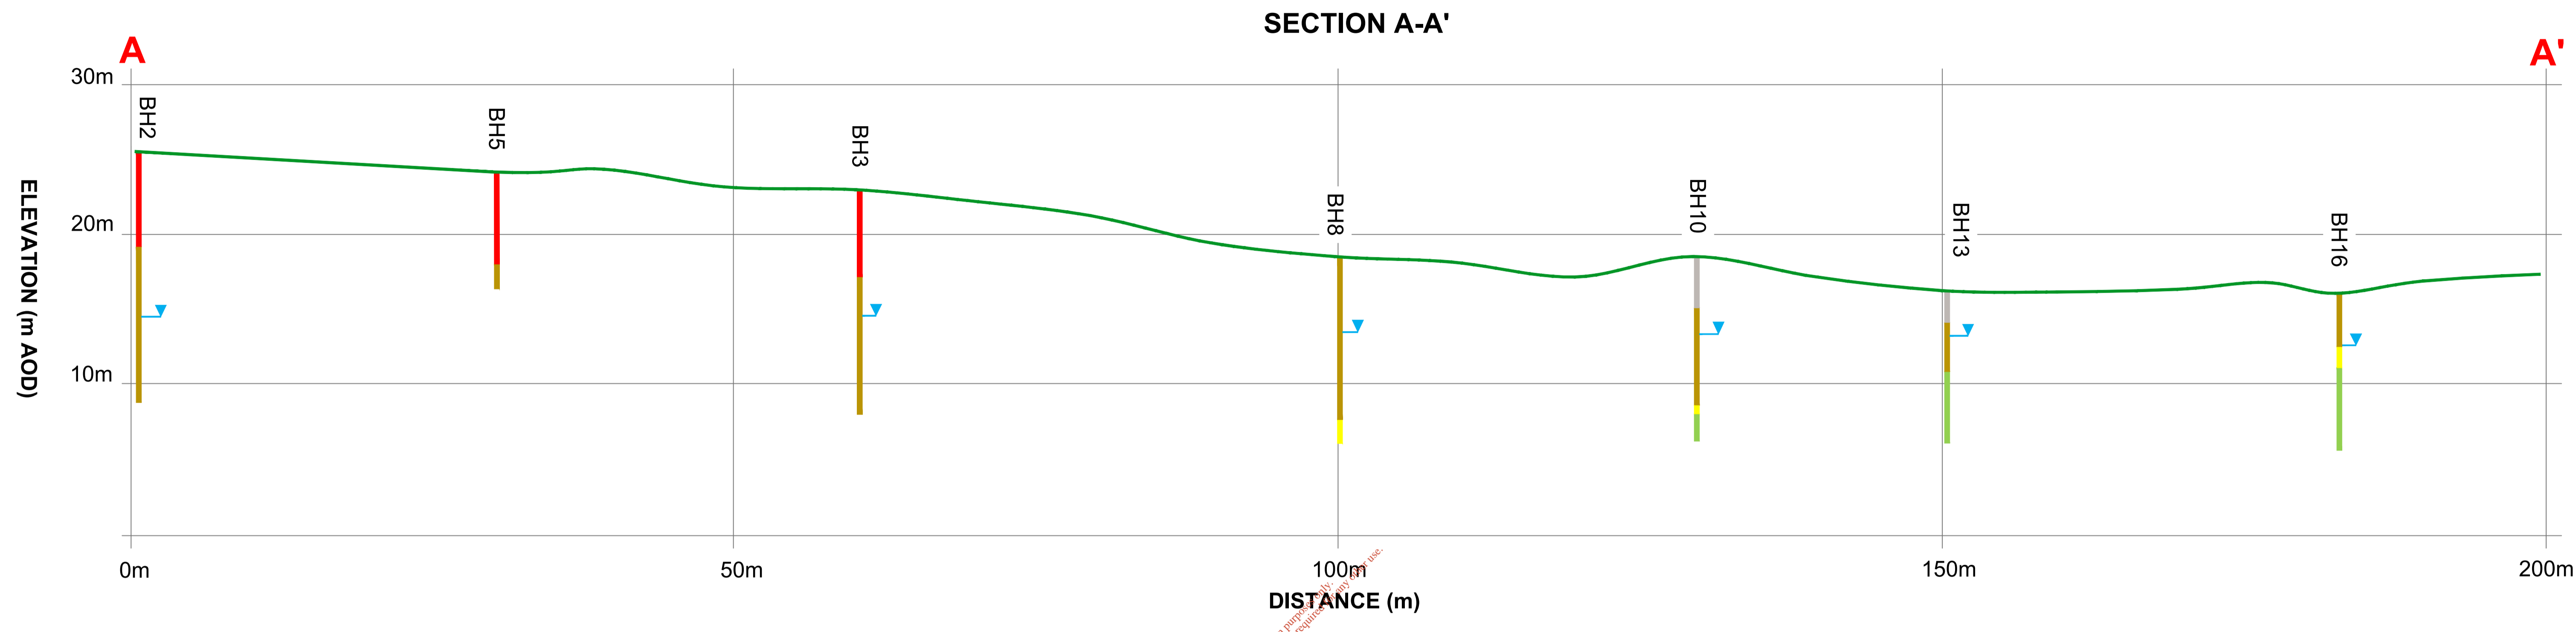
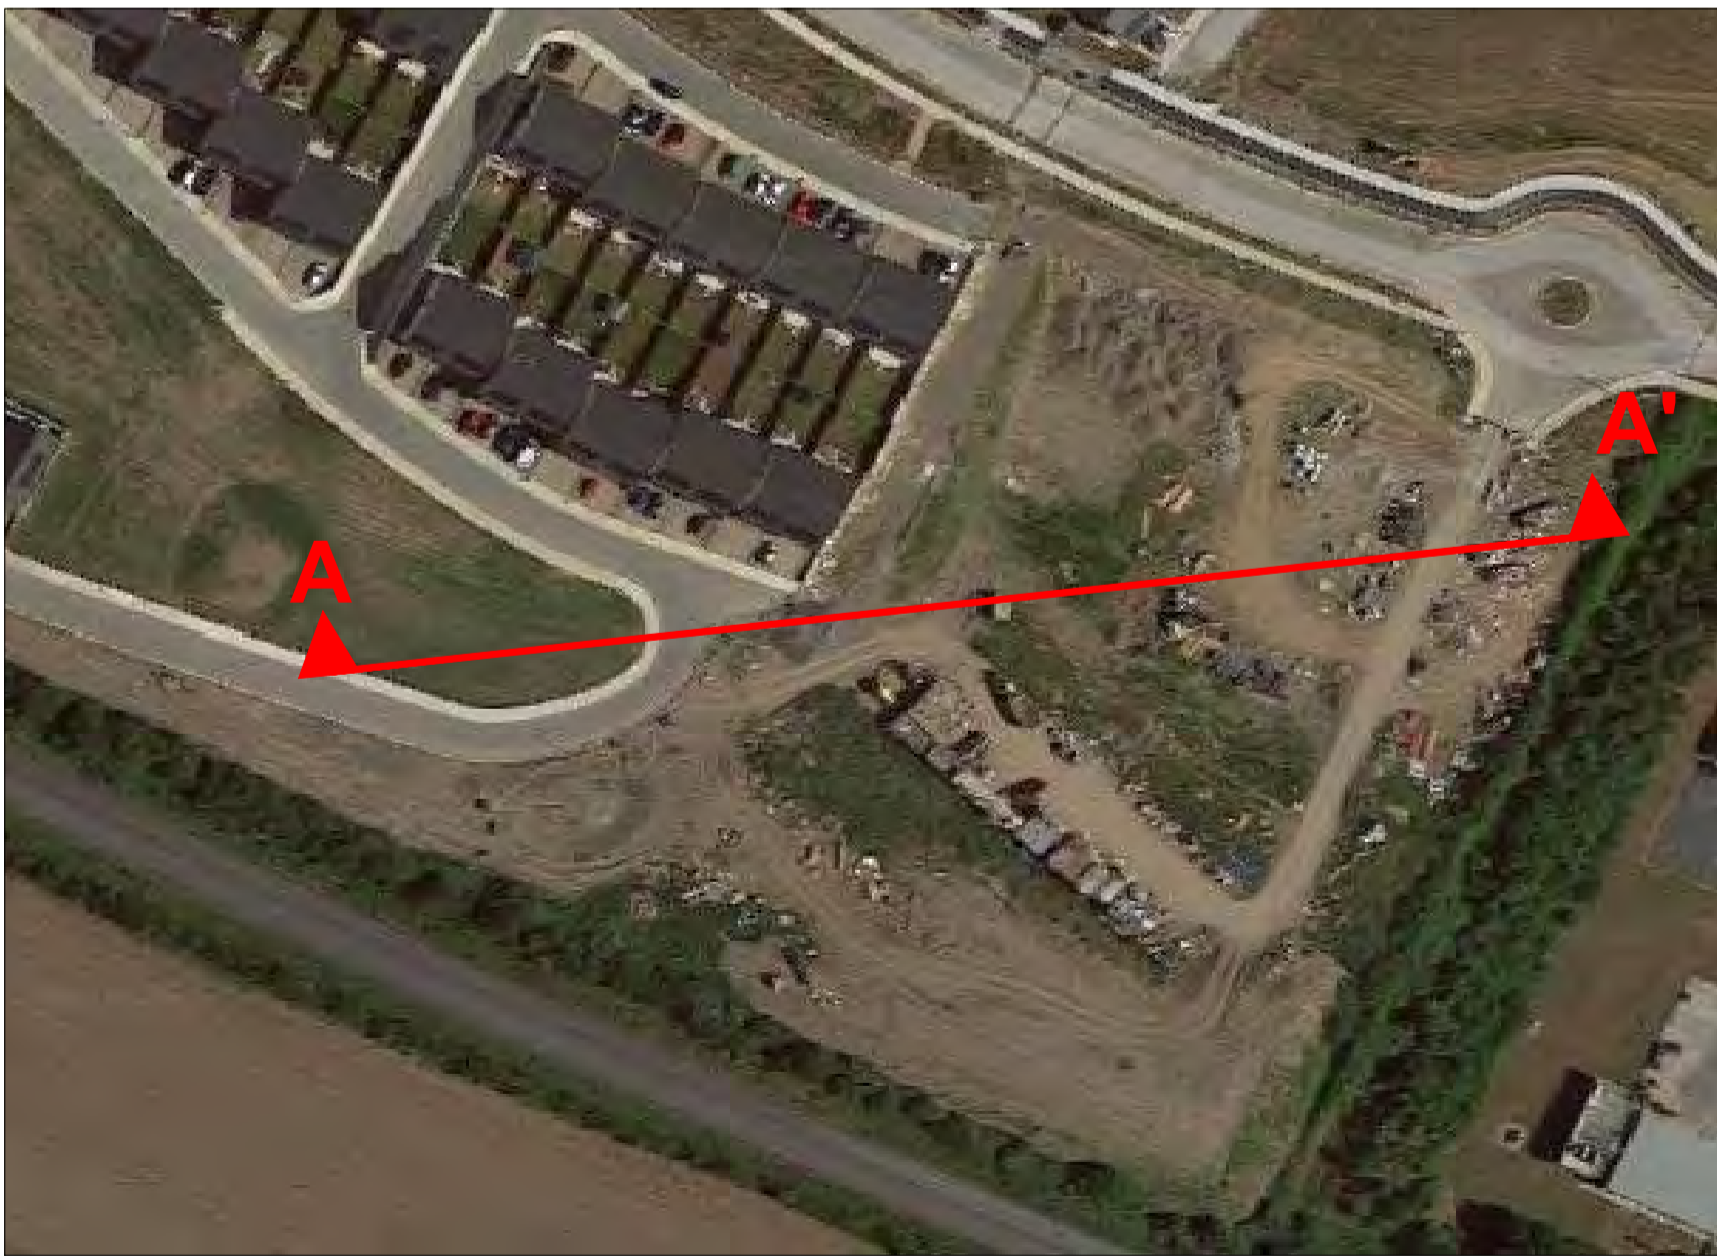
R:\MGE0755 Barnageeragh\0 Drawings\DMGE0755-RPS-00-XX-DR-C-DG0003- Groundwater Borehole Cross Section.dwg

- █ MADE GROUND
- █ FILL MATERIAL
- █ SAND AND GRAVEL DEPOSITS
- █ WEATHERED SKERRIES FORMATION SS
- █ SKERRIES FORMATION SS
- ▾ GROUNDWATER LEVEL MAY 2018
- TOPOGRAPHY
