**WINSAC LTD.,
RESIDENTIAL DEVELOPMENT,
BARNAGEERAGH COVE, SKERRIES
PHASE II SITE INVESTIGATION/DQRA &
LANDFILL GAS SURVEY**

**FINAL REPORT
VOLUME I. REPORT TEXT**

26th February 2019

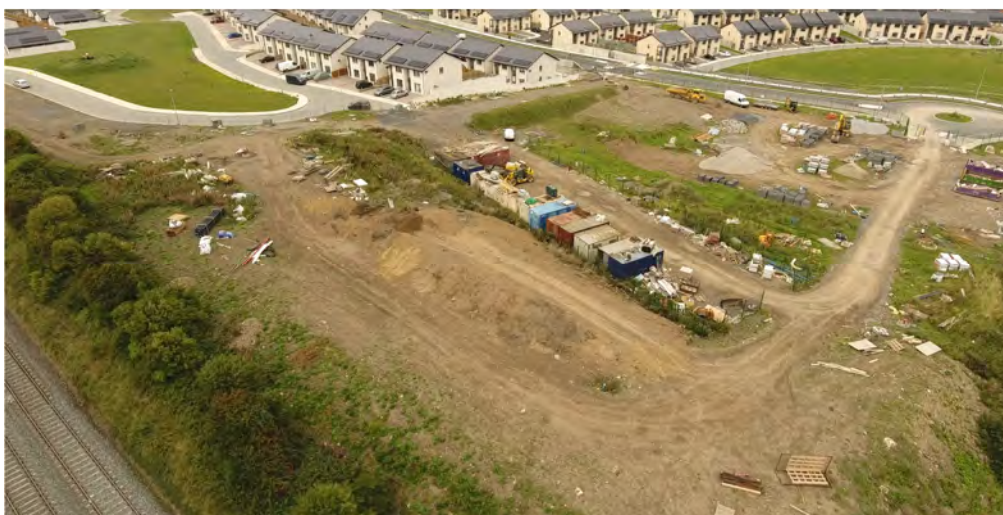
Plate 1. Photograph of historic landfill on 21/08/18 taken from southern boundary facing northwards with Dublin-Belfast railway line to the west, builders compound to its east and existing Hamilton Hill housing development to the northwest

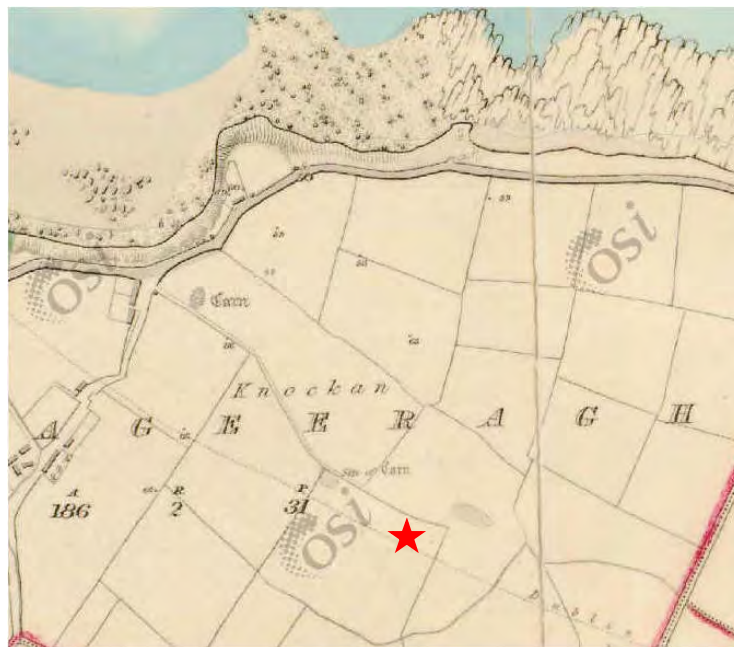
Plate 2. 6-inch OS Mapping (1837-1842) showing position of Cairn and possible evidence of sand and gravel pit to east

A comprehensive review of aerial photography and Ordnance Survey historical mapping has been carried out with both publically (i.e. web-based) digital mapping assessed and mapping archives visited in the Ordnance Survey, Phoenix Park. The principle purpose of this exercise was to determine when sand and gravel quarrying had commenced on site to determine if possible the relative extent of the sand and gravel pit (i.e. and possibly the extent of the landfill's footprint). A review of Ordnance Survey historical 6-inch mapping shows the position of the cairn (i.e. national monument record DU005:0017001) to the northwest of the subject site (see Plate 2 below). At the time of surveying (i.e. 1837-1842), there was some evidence of possible sand and gravel extraction to the northeast of the subject area.

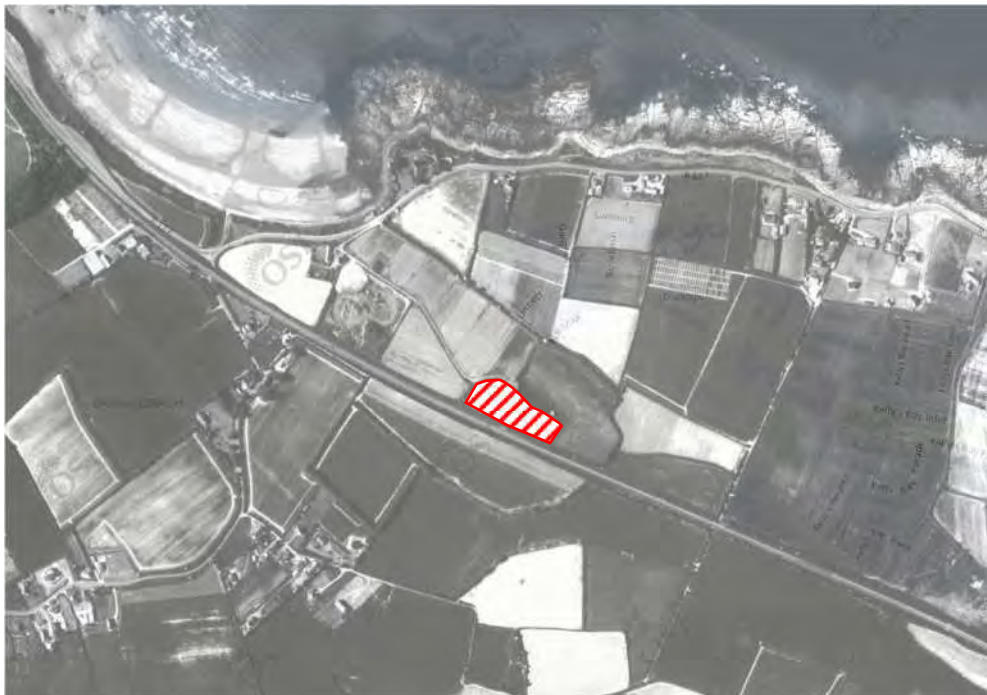
Plate 3. 1995 OS aerial photography with red boundary showing possible extent of former of sand and gravel pit to east. The sand and gravel pit to the northwest of the site is clearly visible.

It should be noted that the earliest aerial photography available for the site is black and white photography from 1995 (see Plate 3 below). This photography pre-dates the construction of the wastewater treatment plant. The plate below illustrates a black and white aerial photograph of the site in 1995. It should be noted that 2nd afore-mentioned sand and gravel pit is visible from this photograph approximately 200m to the west.

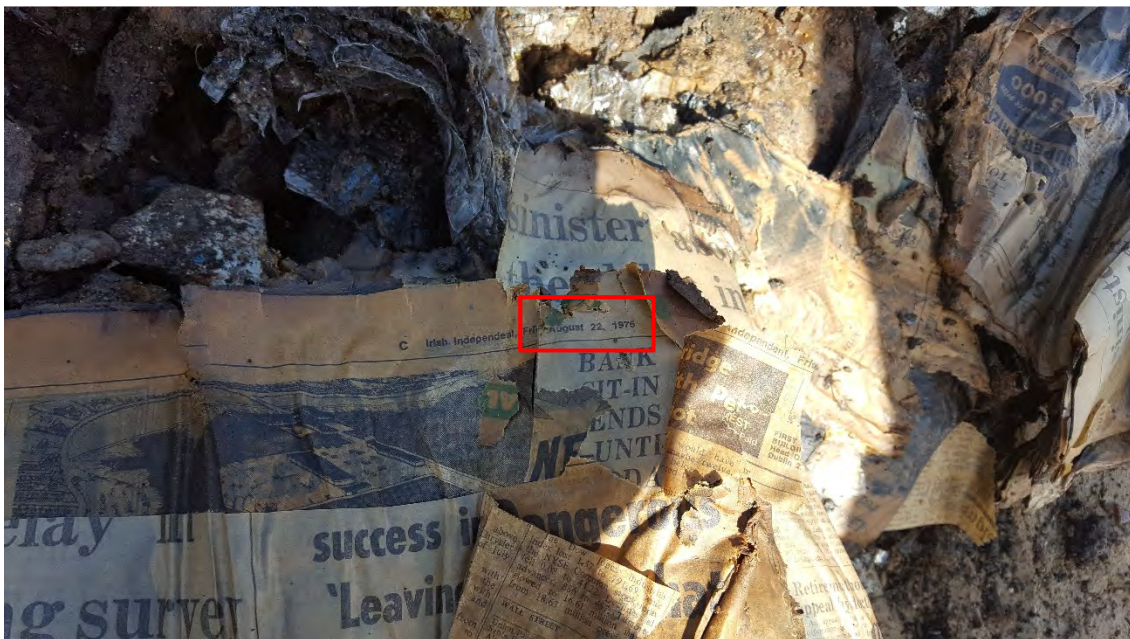
However, following consultation with the former land owner, John Ellis, it is understood that waste was not landfilled on site after 1977. During the trialpitting exercise carried out by Mulroy Environmental on the 2nd June, 2017, it should be noted that a newspaper dating from 1975 was found in trialpit, TP2 (see Plate 5 below).

Plate 5. Newspaper found in trialpit, TP2 excavated as part of the site investigation works.

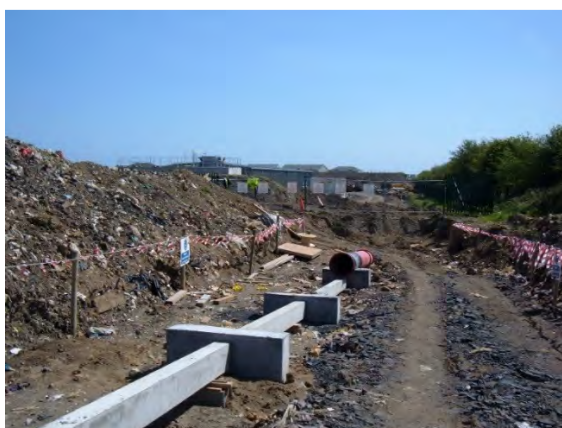
Plate 6. Photograph taken during rising main construction through waste body on 28/4/2006 (facing SE from subject site towards WWTP under construction)

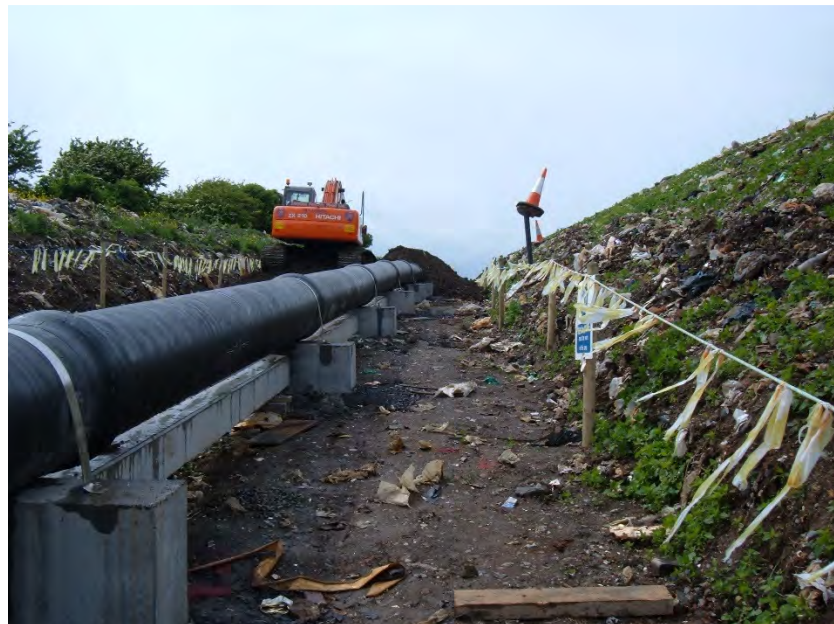
As part of the construction works, a trench was excavated through the waste and piles were installed at regular intervals to support the rising main (see Plate 7 below).

Plate 7. Photograph taken during rising main construction through waste body on 23/5/2006 (facing NW from eastern boundary of site with railway line to the left)

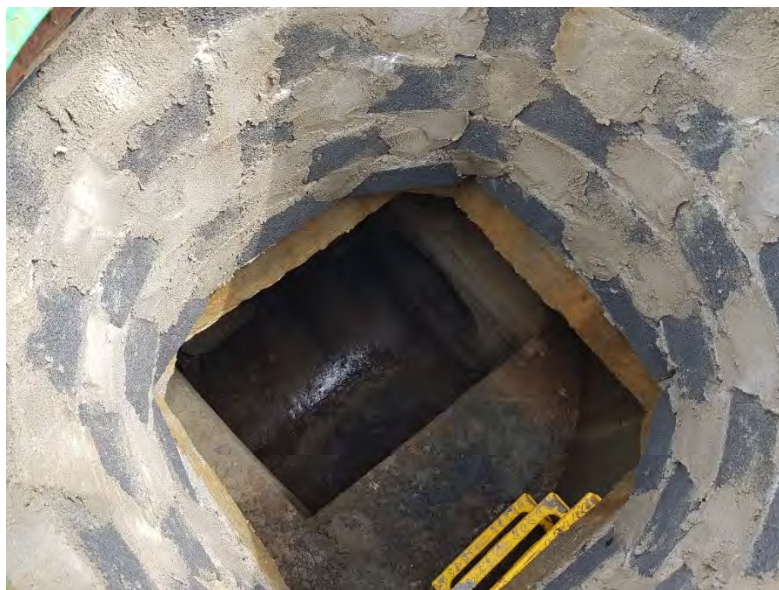
Plate 8. Surface water monitoring point, SW2 which was dry during a sampling round carried out in June 2018

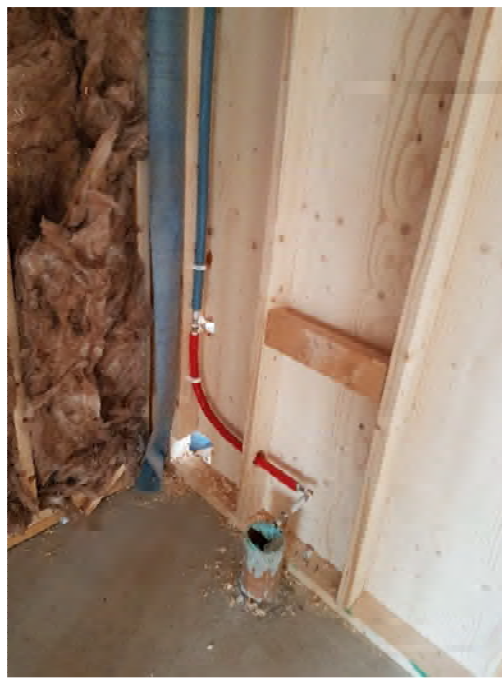
Plate 9. Services within newly built residences which were inspected and checked for the presence of landfill gases

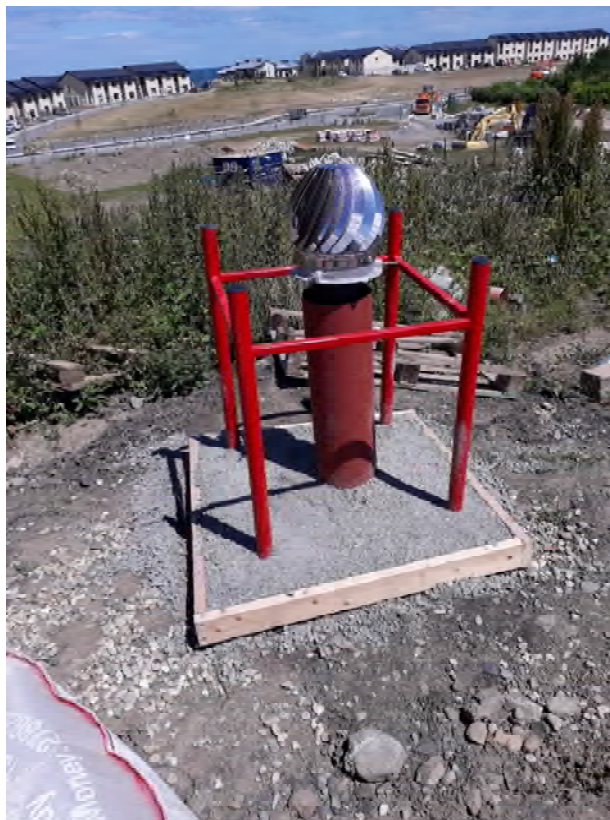
Given that methane was detected at the highest levels in the vicinity of boreholes BH1 and BH4 during the landfill gas monitoring period, it was concluded that a number of passive gas venting wells should be installed in their vicinity to aid in the venting off of methane being generated and/or trapped in these areas. Five passive gas venting wells (GV1 – GV5) were installed onsite over a two-week period (i.e. 25th April 2018 – 3rd May 2018) (see Figure 15). Each well was installed down through the overburden and into the waste body. All 5 wells were terminated above the base of the waste body (i.e. as determined from the trialpitting, borehole drilling and geophysical survey data) (see gas venting well logs in Appendix 8). Each passive gas venting well was installed with a top 1m of plain HDPE pipe (160mm ϕ) with the remainder slotted HDPE pipe (160mm ϕ) located underneath. In addition, each well installation included a 0.5m bentonite seal, top hat cover, concrete plinth and traffic bollard. At the top of each casing, a Rotorvent rotating wind cowl was installed to increase the draw of gases up through the standpipe and into the atmosphere (see following Plate 10).

Plate 10. Gas venting well GV4 facing northwards towards builder's compound

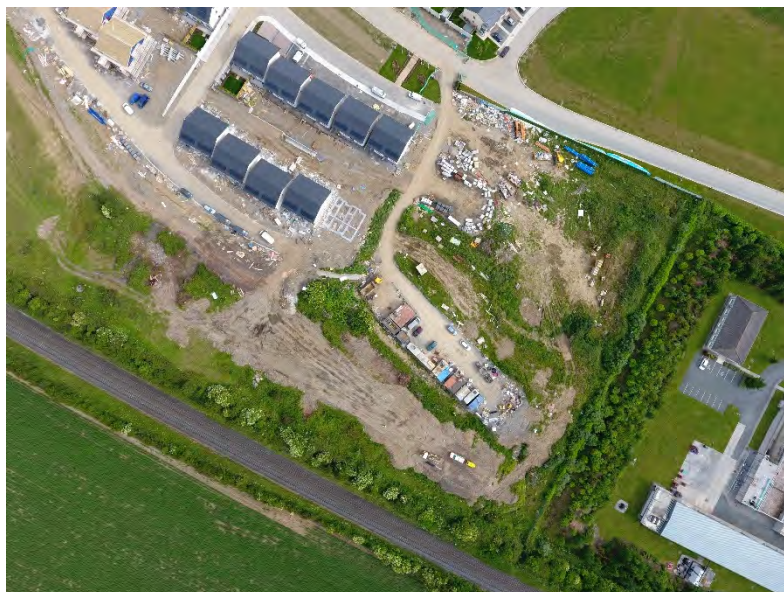
Plate 11. Historic landfill with newly built residences located to the north and northeast (note that the construction of Residences No. 25 and 26 required a piled foundation prior to subsequent completion)

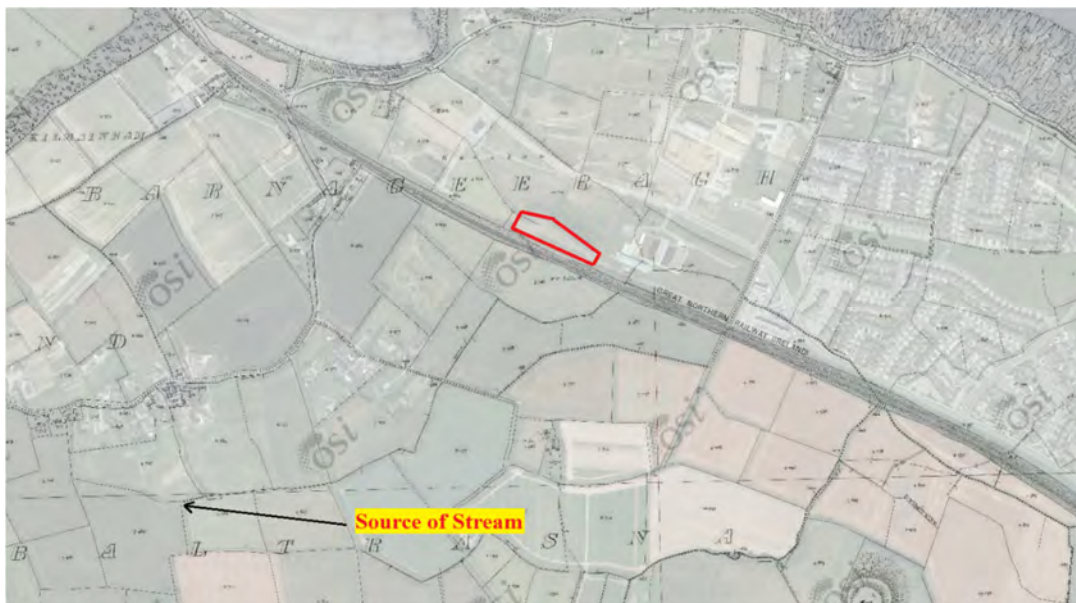
Plate 12. Map showing location of site and source of stream to southwest of site

The site is located within the Mill Stream (Skerries) 010 WFD River Sub Basin (see Figures 9 and 10 and plate 12 following). This river water body is located within the Palmerstown_SC_010 WFD Sub-Catchment which in turn is located within the Nanny - Devlin WFD Catchment and Hydrometric Area. The hydrology of the site and alterations made as a result of the development of the Wastewater Treatment Plant and Barnageeragh Cove Residential Development are explained with the aid of 3 figures, Figures 9, 10 and 11. As can be seen from Figure 9, there are 2 streams which pass through the WWTP site.

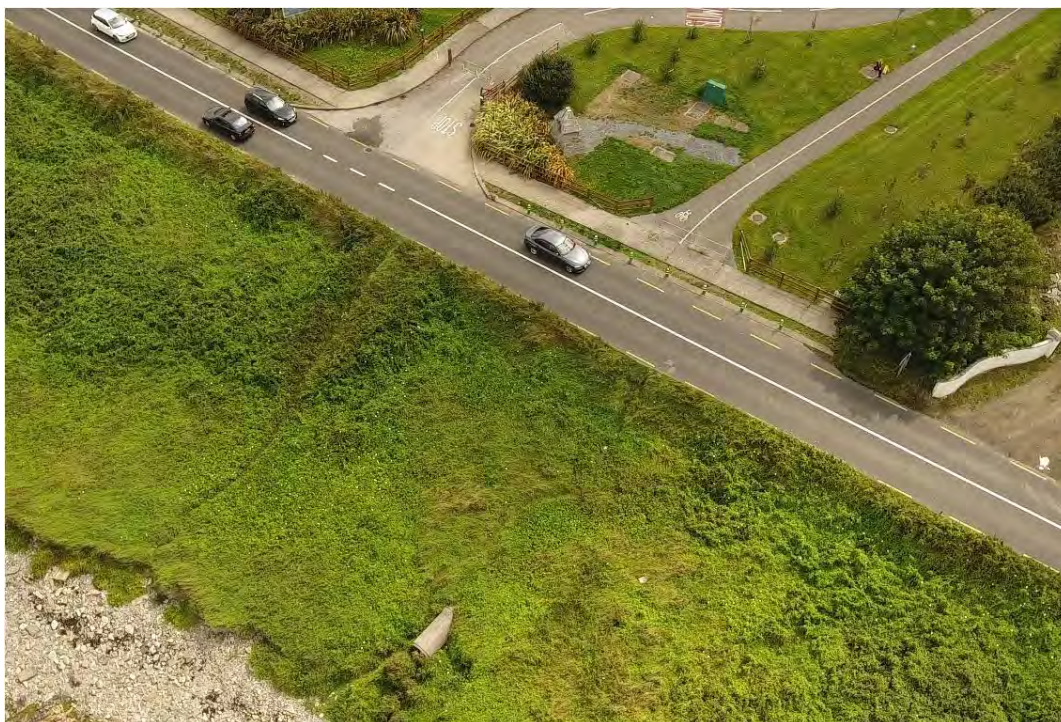
Figure 11 shows in more detail the existing stormwater drainage network which carries the stream towards its marine discharge point to the north of the site. As can be seen from Figures 10 and 11, the stormwater drainage system has intercepted the stream which originally discharged on the beach to the west of the site. This stream has been diverted in a north-easterly direction via the Barnageeragh Cove stormwater drainage system and now discharges to the Irish Sea to the north of the site (see plate 13 below).

Plate 13. Drone aerial photograph of marine stormwater discharge point to north of site (see Figure 11)

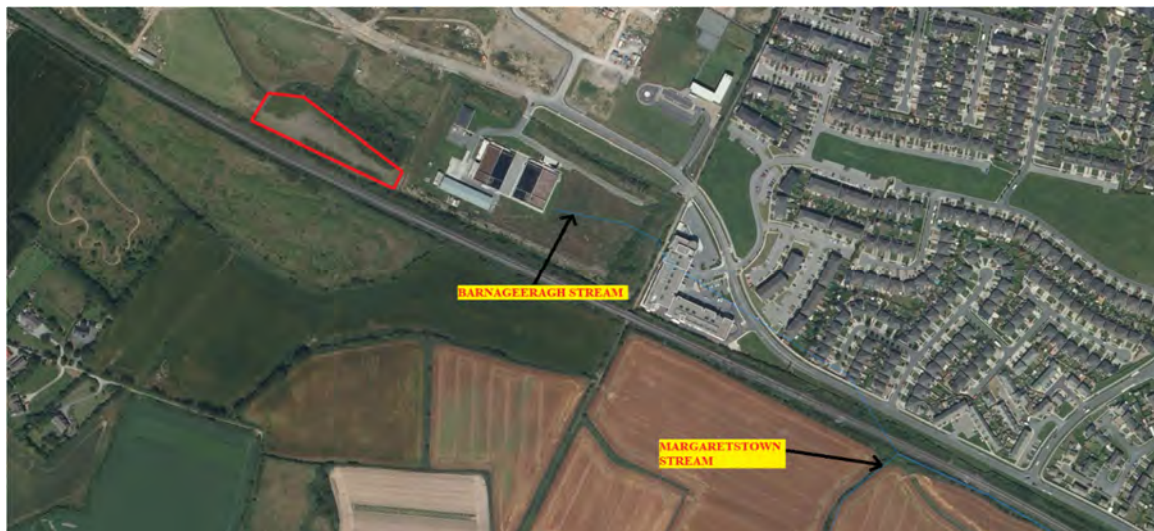
Plate 14. Barnageeragh Stream rising within WWTP site and flowing in easterly direction towards Skerries

The 2nd surface water body, the Barnageeragh Stream rises approximately 170m to the east of the site within the footprint of the Fingal C.C. WWTP site (see Figures 10 and 11 & Plate 14). From there, the Barnageeragh Stream is diverted to the south of Skerries Point Shopping Centre and thereafter, flows in a general south-easterly direction where it joins the Margaretstown River approximately 450m downstream. The Margaretstown River joins the Mill Stream (Skerries), which flows onto South Beach approximately 2.5km from the site. No surface water quality status has been assigned to these waterbodies as they are not currently monitored as part of Ireland's Water Framework Directive (WFD) monitoring programme.

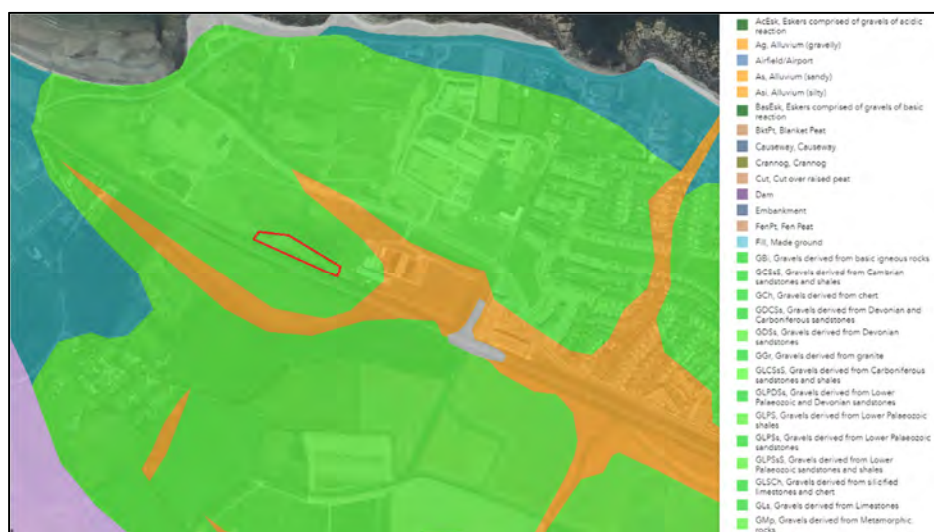
Plate 16. EPA/Teagasc subsoil mapping for the Barnageeragh area

The origin of the subsoil material in this region is associated with the movement and deposition from glaciers during the last Ice Age. The ice sheets ground down the underlying bedrock, breaking the rock and grinding it to small sizes ranging from clays to boulders. The powerful erosive force of these ice sheets are considered to have moulded/sculpted the landscape in the area, with glacial features evident in the area. Glacial deposits in the area consist of tills, which were deposited at the base of moving glaciers, and to a lesser extent fluvio-glacial sand and gravels, which were deposited by glacial meltwaters. The National Soil Mapping Project carried out jointly by the EPA and Teagasc have identified the majority of the site, including the landfilled area as subsoil type *GLPSsS –*

Gravels derived from Lower Palaeozoic sandstones and shales (see Plate 16). The area of land located to the north of the landfill and on the northern boundary of the proposed public park area is classified as having ‘A – Alluvium undifferentiated’ subsoil.

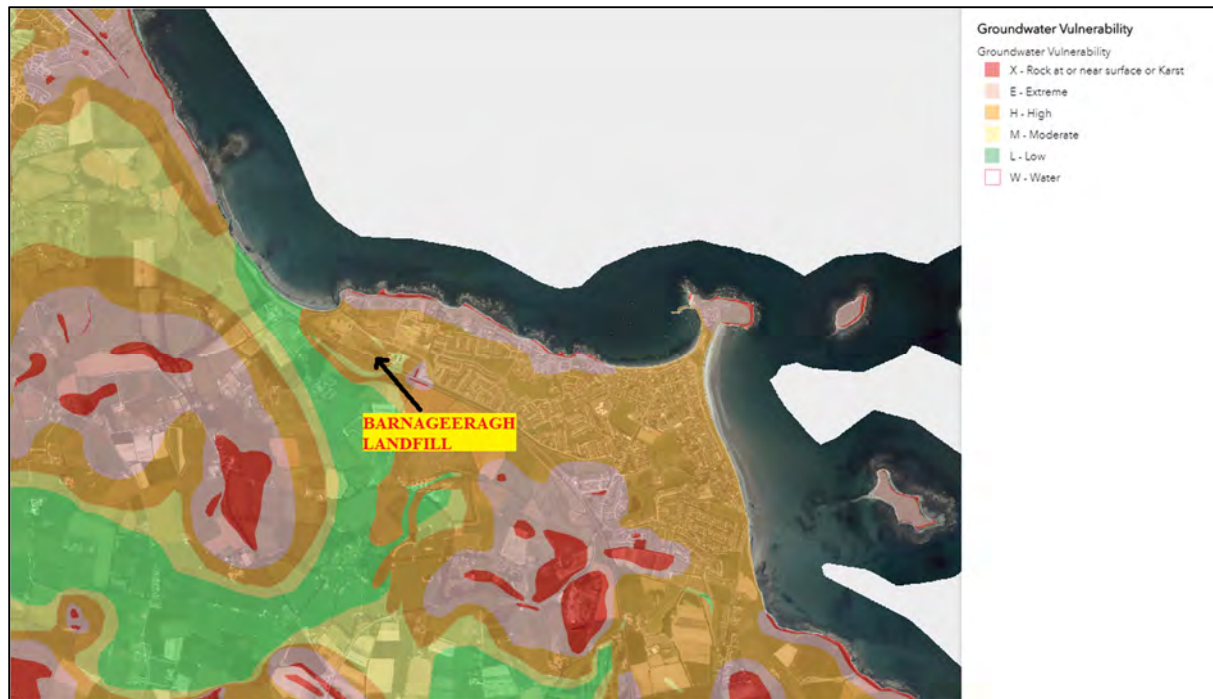
Plate 19. Groundwater vulnerability mapping for Barnageeragh Area

The Irish GSI’s vulnerability mapping guidelines allow for the assignment of vulnerability ratings from “*extreme*” to “*low*”, depending upon the subsoil type and thickness. The aquifer vulnerability for the majority of the site is described as ‘*H – high*’. This area largely coincides with the area of the site whereby the subsoil is *GLPSsS – Gravels derived from Lower Palaeozoic sandstones and shales* (see Plate 19 following). This vulnerability classification has been assigned on the basis that the sand and gravel overburden is estimated to be >3m in thickness (see Table 2). A small portion of land to the north-western corner of the proposed public park area is classified as ‘*M – Moderate*’ groundwater vulnerability (see Plate 19).

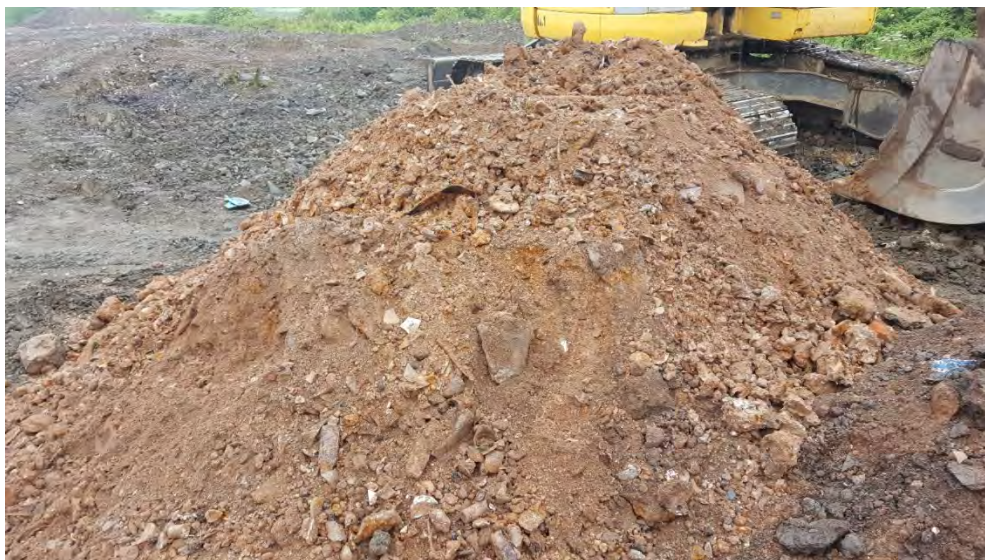
Type 1 waste was largely confined to the western/north-western portion of the landfill. The footprint of this area is approximately 2,041m². This waste typically contained a mixture of red/orange gravelly sandy SILT & CLAY intermingled with glass and ceramics with a small amount of plastics (see Plate 20 below). The soil laboratory results also indicated that the organic carbon content was low for this waste type. Lead and zinc concentrations within this waste type were found to be elevated.

Plate 20. Typical stockpile of Type 1 waste (i.e. note red/orange coloration & sand/gravel SILT & CLAY)

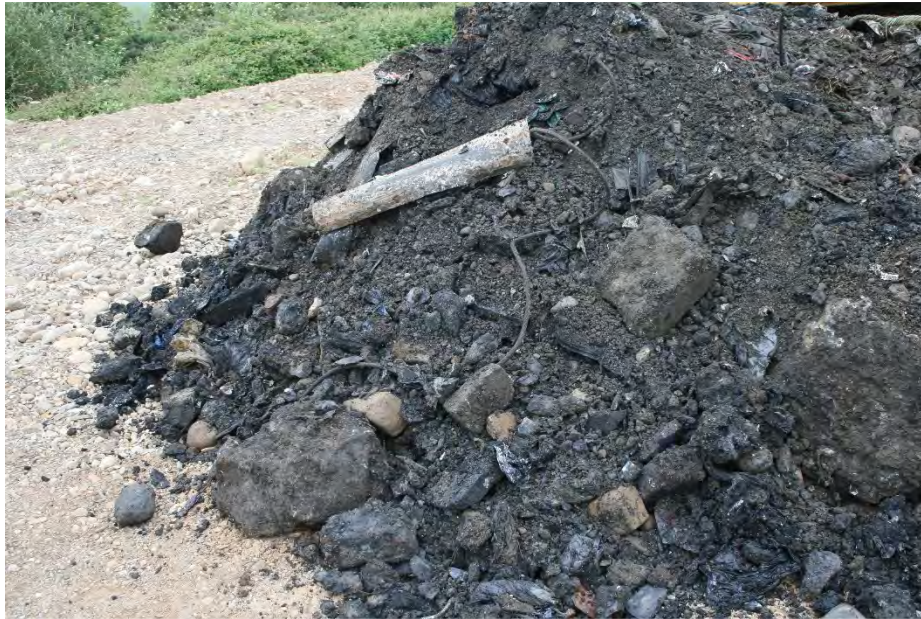
Type 2 waste was largely confined to the central and eastern areas of the landfill. The footprint of this area is approximately 5,659m² and over twice the footprint of Type 1. This waste principally consisted of very dark brown/black gravelly sandy SILT & CLAY mixed with a greater volume of municipal waste (see Plate 21 following). The soil laboratory results also indicate that the organic carbon content was higher for this waste type.

Plate 21. Typical stockpile of Type 2 waste (i.e. note grey/black coloration & high organic matter content, trialpit TP16 stockpile)

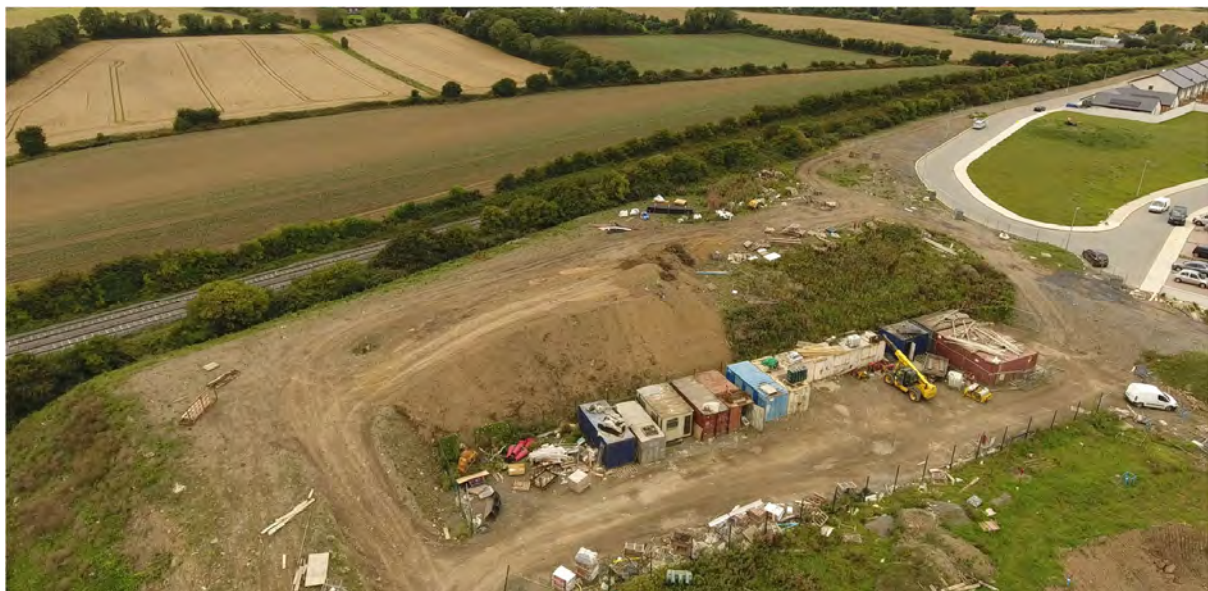
The boundary and depths of the historic landfill has been defined through a combination of trialpitting, borehole installation and geophysical surveying (see Figure 7). A total waste body footprint of 7,659m² was determined. The landfill is approximately 159m in length and 58m in width (i.e. at its widest).

Plate 22. Aerial photograph of landfill body facing west with builder's yard in foreground and Dublin-Belfast Railway line on western boundary

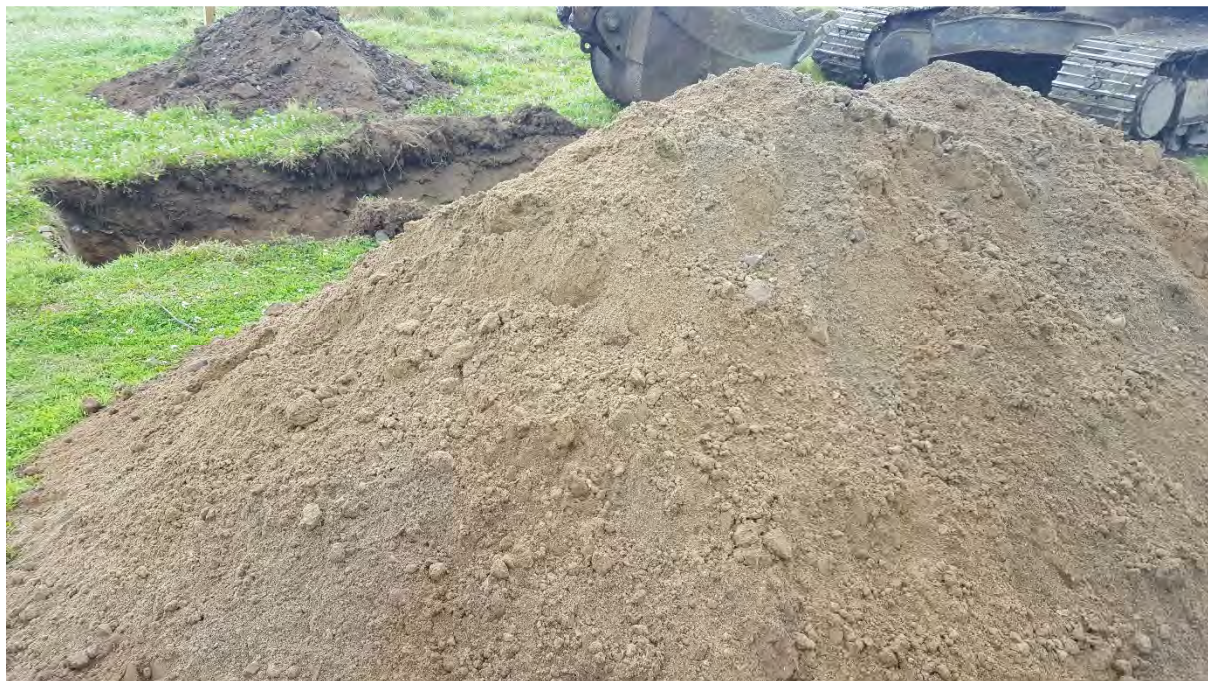
Additionally, Mulroy Environmental excavated two trialpits (i.e. TP30 & TP33) to the west of the cairn/burial mound to investigate the presence of landfilling (see Figure 7). No waste was recorded within the trialpits (see Trialpit Logs in Appendix 6 and Trialpit Photo Log in Appendix 7). As can be seen from Plate 23 below, a SAND subsoil was identified in the area. As can be seen from Figure 7, TP30 and TP33 were excavated in the vicinity of Residences Nos. 52 and 53.

Plate 23. Stockpile of soil from trialpit, TP31 (i.e. note undisturbed indigenous SAND subsoil)

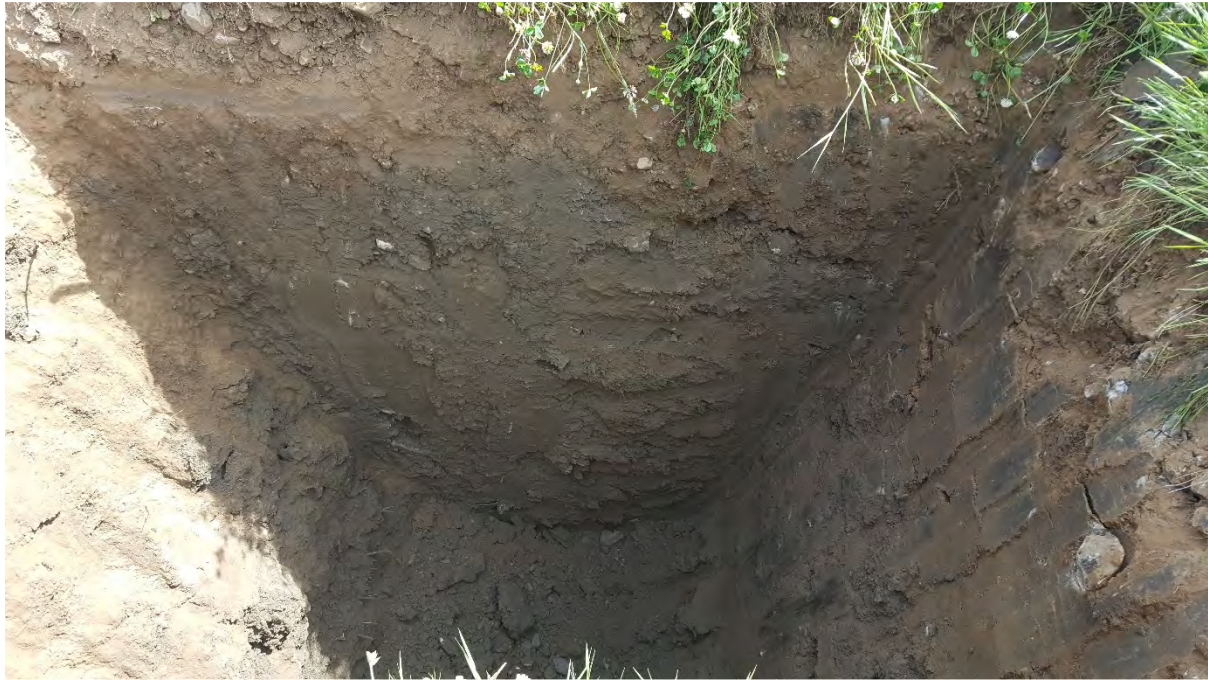
It was determined that the north-eastern boundary of landfill did not extend beyond the builder's compound. Mulroy environmental excavated 4 trialpits (i.e. TP25, TP26, TP27 & TP29) directly to the north of the compound's boundary. The trialpits were observed to contain clean subsoil (i.e. made ground) deposited there as a result of clearance from other areas within the Barnageeragh Cove residential development (see Plate 24 below). Waste was not observed within these trialpits.

Plate 24. Soil profile of trialpit, TP25 excavated to the north of the builders compound (i.e. note absence of waste)

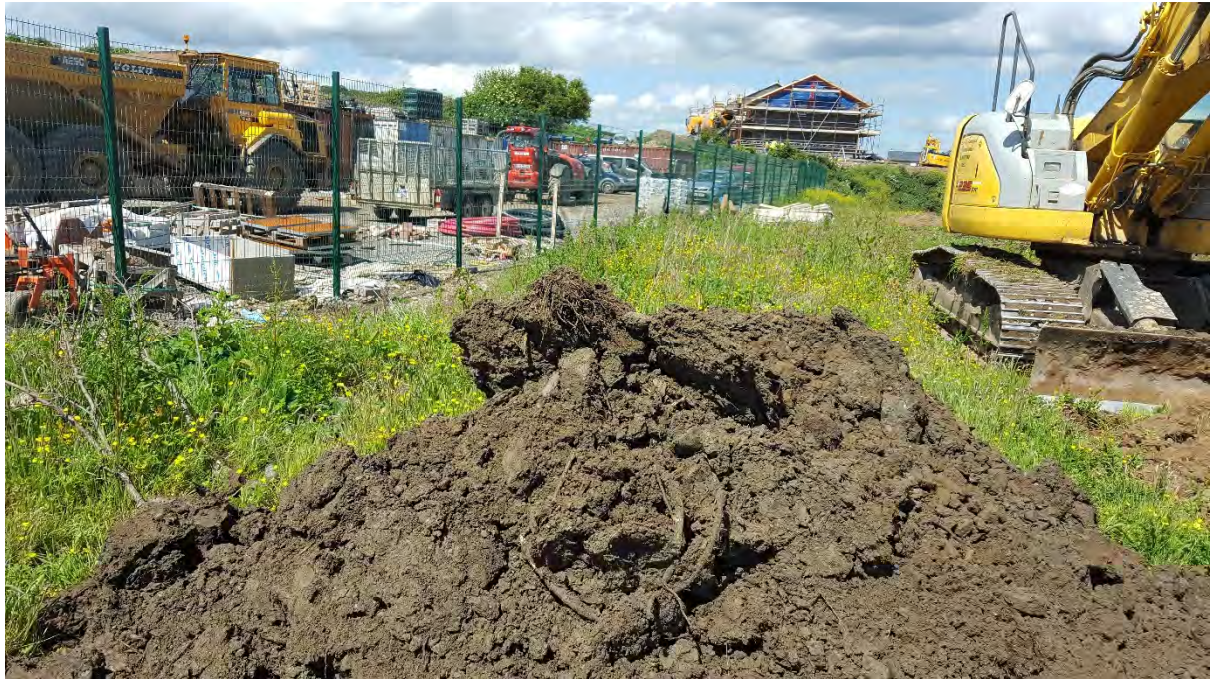
The electrical resistivity tomography (ERT) profile R3 was surveyed across the area where TP25, TP26, TP27 and TP29 were excavated. No municipal waste was detected in the ERT profile. The geophysical survey indicated that the gravelly SILT/CLAY (MADE GROUND) extended to a maximum depth of circa 7m bgl and was underlain with gravelly silty SAND. The resistivity profile readings for the fill material was interpreted as '*C&D waste with lower organic & or metallic content or waste mixed with sandy gravelly SILT/CLAY*'. The C&D waste has been attributed to small/sporadic amounts of wood fragments within the SILT/CLAY matrix (see APEX Geoservices Drawing AGL 18018_14 in Appendix 9). This is consistent with the findings of the trialpit investigation (see Plate 25).

Plate 25. Soil stockpile of trialpit, TP25 excavated to the north of the builders compound
