WINSAC LTD.,  
RESIDENTIAL DEVELOPMENT,  
BARNAGEERAGH COVE, SKERRIES  
PHASE II SITE INVESTIGATION/DQRA &  
LANDFILL GAS SURVEY

**FINAL REPORT**  
**VOLUME III. APPENDICES 1-10**

## EXTRACT OF DUBLIN CITY COUNCIL LANDFILL REGISTER, 1988

## WALKOVER

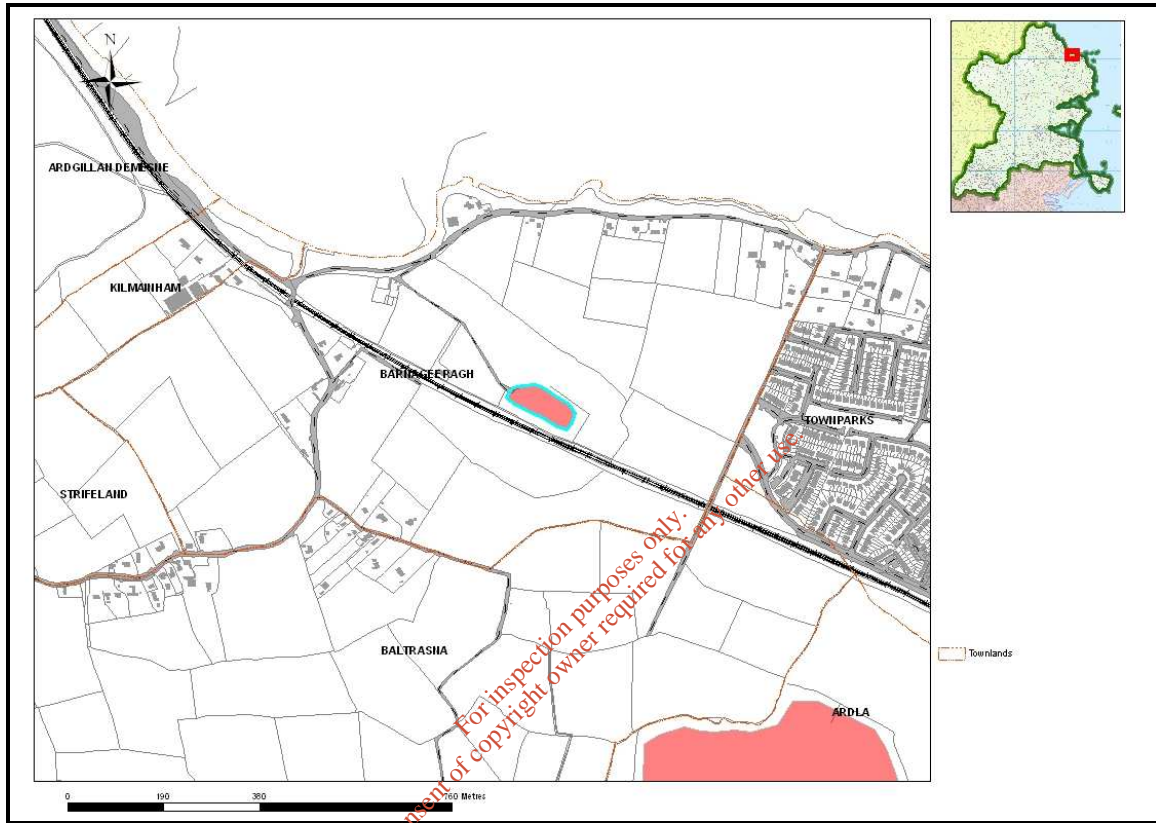
**LOCATION:** On the northern site of the railway, about 2.25km North West of Skerries.

**SITE FOOTPRINT:** based on interviews and aerial photos of the area and queries shape from historic map from 1935

**SIZE OF THE SITE:** 6,382m<sup>2</sup> = 0.63ha (according to the map)

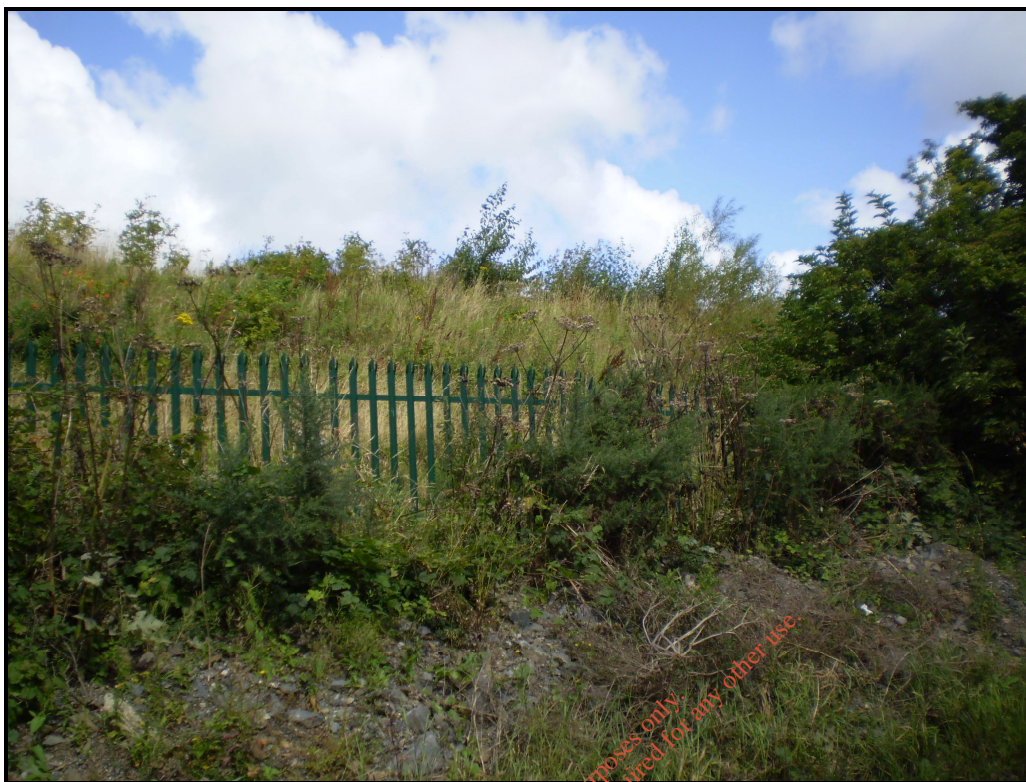
Photo no. 1

At the present the site is close. Partly overgrown by vegetation, on the rest of the site the Skerries Waste Water Treatment Plant is located. Access to the site is protected by the metal fence and monitored as a part of WWTP.

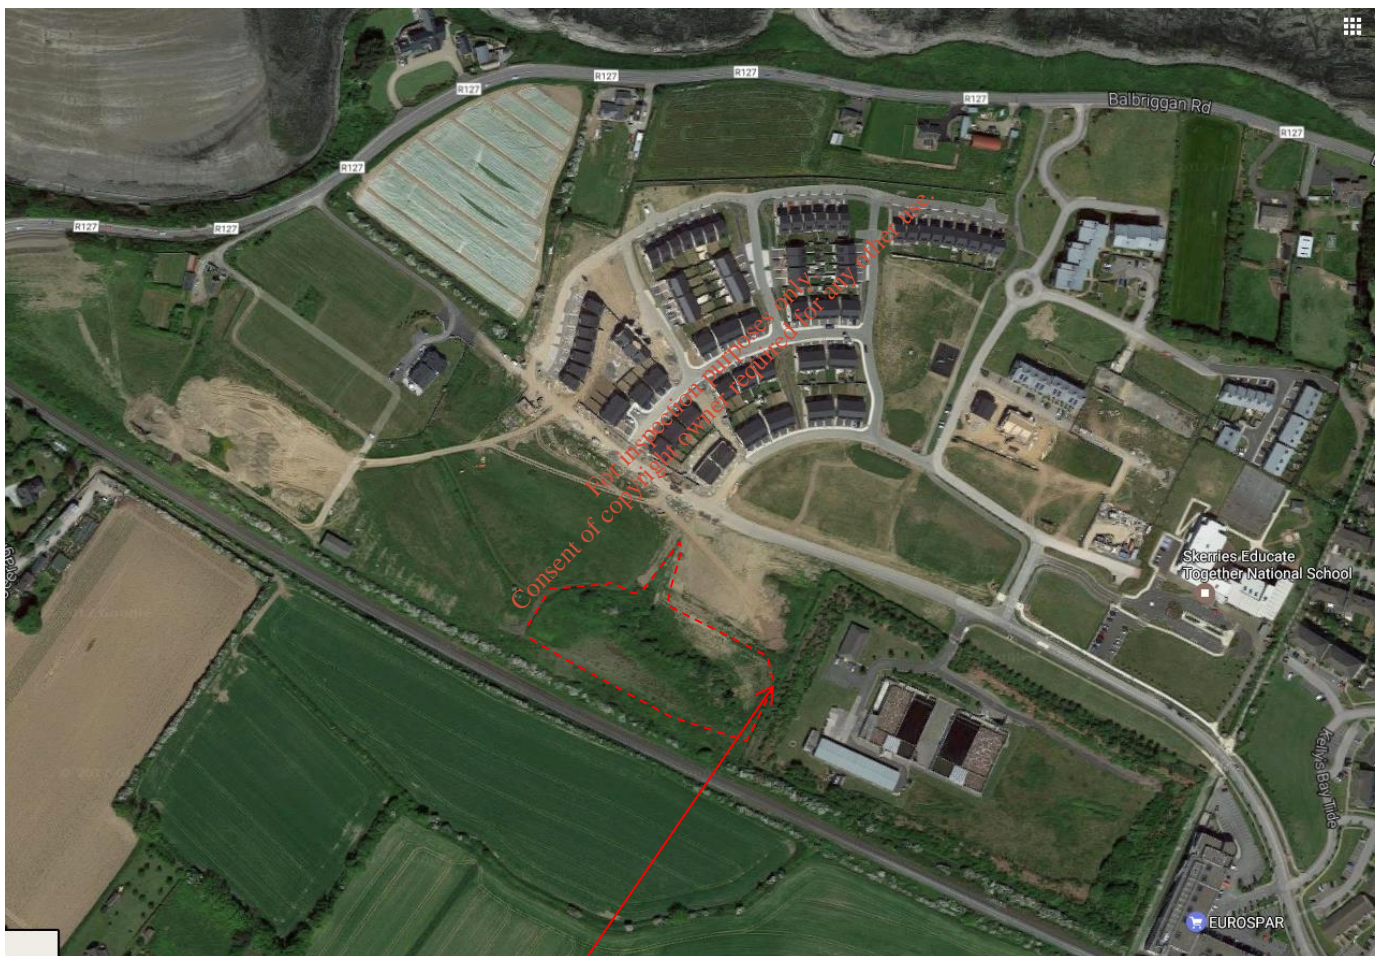
# Google Maps – Feb 2016

Historical Landfill Outline

A review of the historical aerial photos and maps shows the waste body to the south east of the site which is identifiable back to the 1995 aerial photos. The original waste body can probably be well defined using these images. However from our visit on site today it appears that the material has been moved around quite a bit so the current extent cannot assumed to be the same as the historical imagery.

In terms of the investigation and assessment of the material this should progress in a phased manner. In the interest of public safety we recommend that any immediate risks from gas migration to the site are identified. We recommend that a landfill gas survey is completed within each of the houses on the construction site. A landfill gas meter can be used to monitor for standard gases such as methane, carbon dioxide, oxygen and hydrogen sulphide.

In the absence of any existing boreholes we recommend that some shallow boreholes/probes are installed to approximately 2m and installed as gas monitoring boreholes in accordance with BS-ISO 10175 (Investigation of potentially contaminated sites). The borehole installation can be completed using a window sampler which can be readily mobilised to site and small enough to located holes within the site. We recommend that at least six holes are installed across waste body and on the development site boundary adjacent the waste.
