Report No. 2263/C	BORING RECORD	
Contract KNOCK/CLAREMORRIS BY-PASS		Borehole No. 9600 Sheet (L)
Location	Type and Diameter Cable Tool 200mm	
Client MAYO COUNTY COUNCIL	Ground Level	Date 15.7.93

APPENDIX 5

Japanese Knotweed Management & Treatment Plan Including Biosecurity Measures

Proposed Solar Farm at Clare, Claramorris, Co Mayo

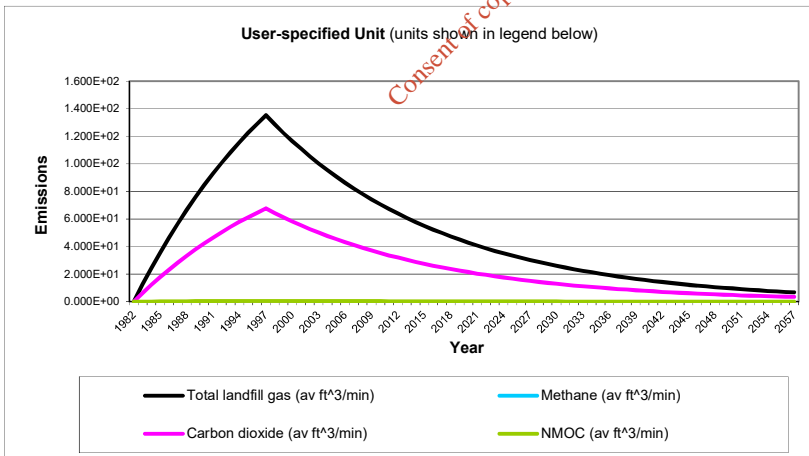
Graphs

LandGEM is based on a first-order decomposition rate equation for quantifying emissions from the decomposition of landfilled waste in municipal solid waste (MSW) landfills. The software provides a relatively simple approach to estimating landfill gas emissions. Model defaults are based on empirical data from U.S. landfills. Field test data can also be used in place of model defaults when available. Further guidance on EPA test methods, Clean Air Act (CAA) regulations, and other guidance regarding landfill gas emissions and control technology requirements can be found at <http://www.epa.gov/ttnatw01/landfill/landflpg.html>.

Year	Total landfill gas			Methane		
	(Mg/year)	(m ³ /year)	(av ft ³ /min)	(Mg/year)	(m ³ /year)	(av ft ³ /min)
1982	0	0	0	0	0	0
1983	2.325E+02	1.862E+05	1.251E+01	6.211E+01	9.309E+04	6.255E+00
1984	4.537E+02	3.633E+05	2.441E+01	1.212E+02	1.816E+05	1.220E+01
1985	6.641E+02	5.318E+05	3.573E+01	1.774E+02	2.659E+05	1.786E+01
1986	8.642E+02	6.920E+05	4.650E+01	2.308E+02	3.460E+05	2.325E+01
1987	1.055E+03	8.444E+05	5.674E+01	2.817E+02	4.222E+05	2.837E+01
1988	1.236E+03	9.894E+05	6.648E+01	3.300E+02	4.947E+05	3.324E+01
1989	1.408E+03	1.127E+06	7.575E+01	3.761E+02	5.637E+05	3.787E+01
1990	1.572E+03	1.259E+06	8.456E+01	4.198E+02	6.293E+05	4.228E+01
1991	1.728E+03	1.383E+06	9.295E+01	4.615E+02	6.917E+05	4.647E+01
1992	1.876E+03	1.502E+06	1.009E+02	5.011E+02	7.510E+05	5.046E+01
1993	2.017E+03	1.615E+06	1.085E+02	5.387E+02	8.075E+05	5.426E+01
1994	2.151E+03	1.722E+06	1.157E+02	5.746E+02	8.612E+05	5.428E+01
1995	2.279E+03	1.825E+06	1.226E+02	6.086E+02	9.123E+05	6.130E+01

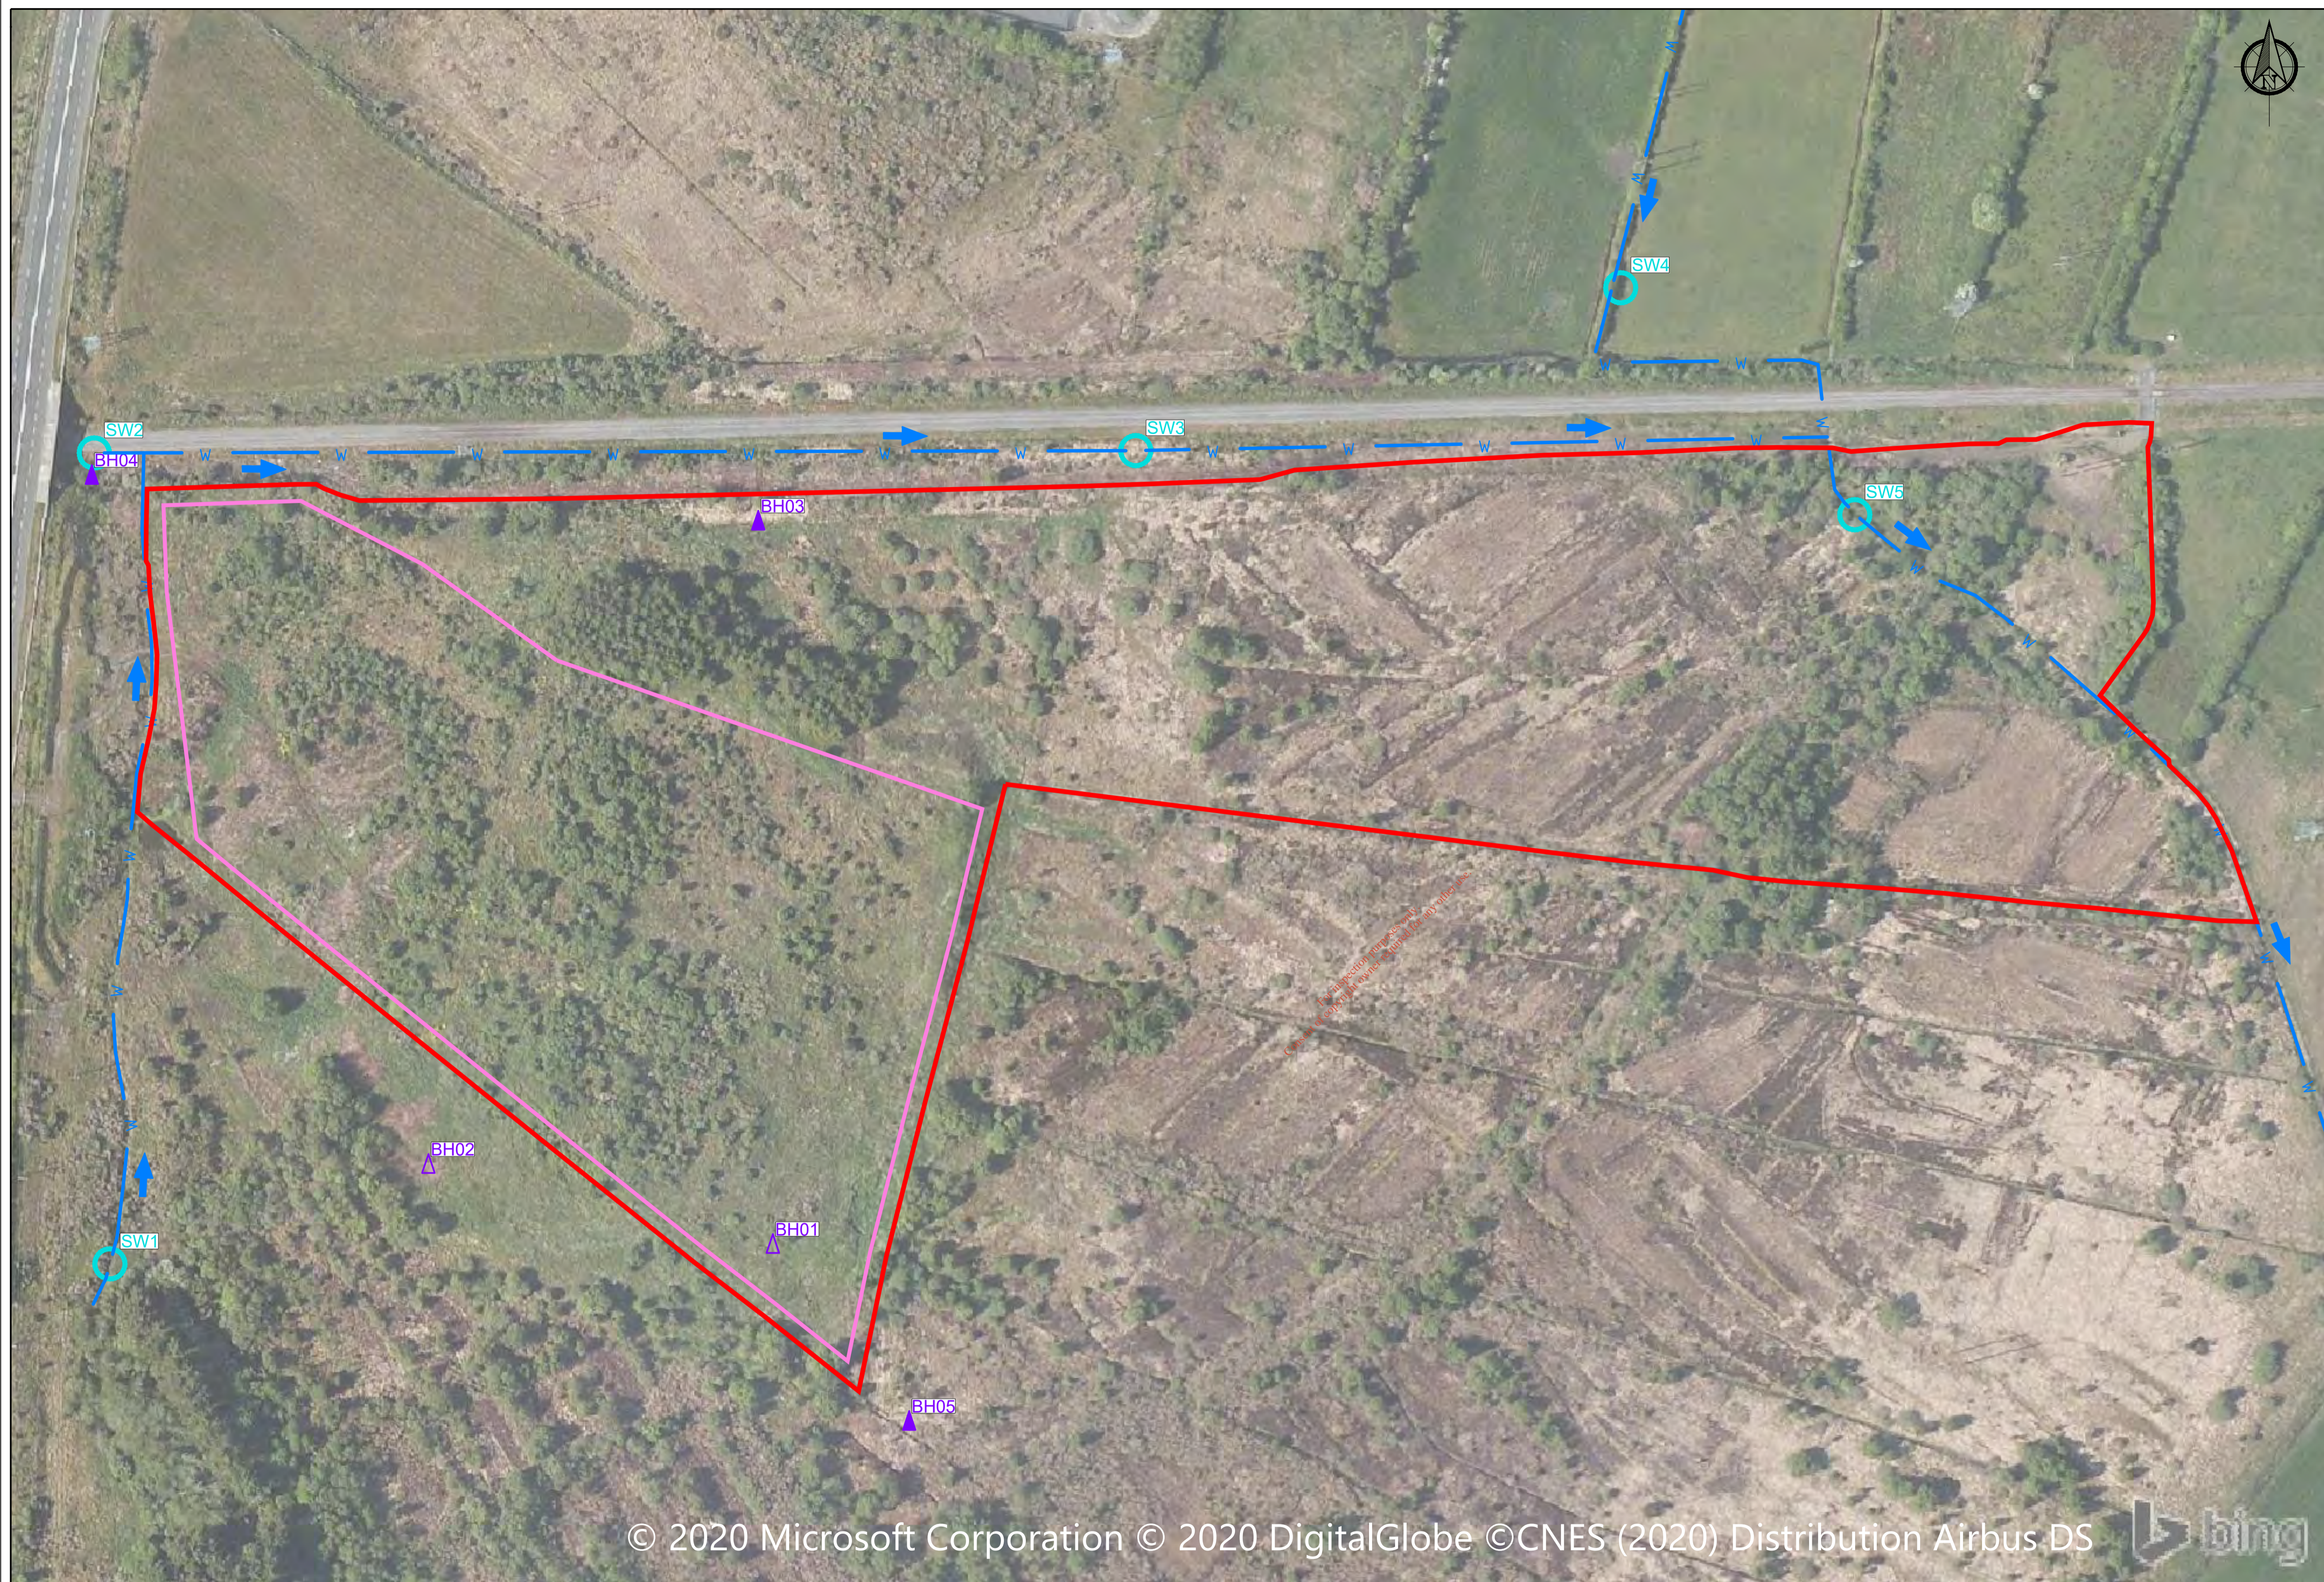
- Legend**
- Site Boundary/Extent of Solar Development
 - Proposed SW Monitoring Locations (T.B.A)
 - Approximate Capping Boundary 31,925m² (to be Confirmed by Additional SI)
 - ▲ Existing Boreholes
 - ▲ Proposed Boreholes (Locations T.B.A)
 - Surface Water
 - Flow Direction

Notes:
 All remediation works subject to EPA approval, detailed design and Certificate of Authorisation.
Historic Landfill Engineered Cap
 Engineered cap shall comprise:
