# HISTORIC LANDFILL AT CLAREMORRIS, CO. MAYO

## STAGE 1 APPROPRIATE ASSESSMENT SCREENING REPORT FOR THE REMEDIATION OF HISTORIC LANDFILL SITE, CLAREMORRIS, COUNTY MAYO

Prepared for: Mayo County Council

**Date:** April 2020

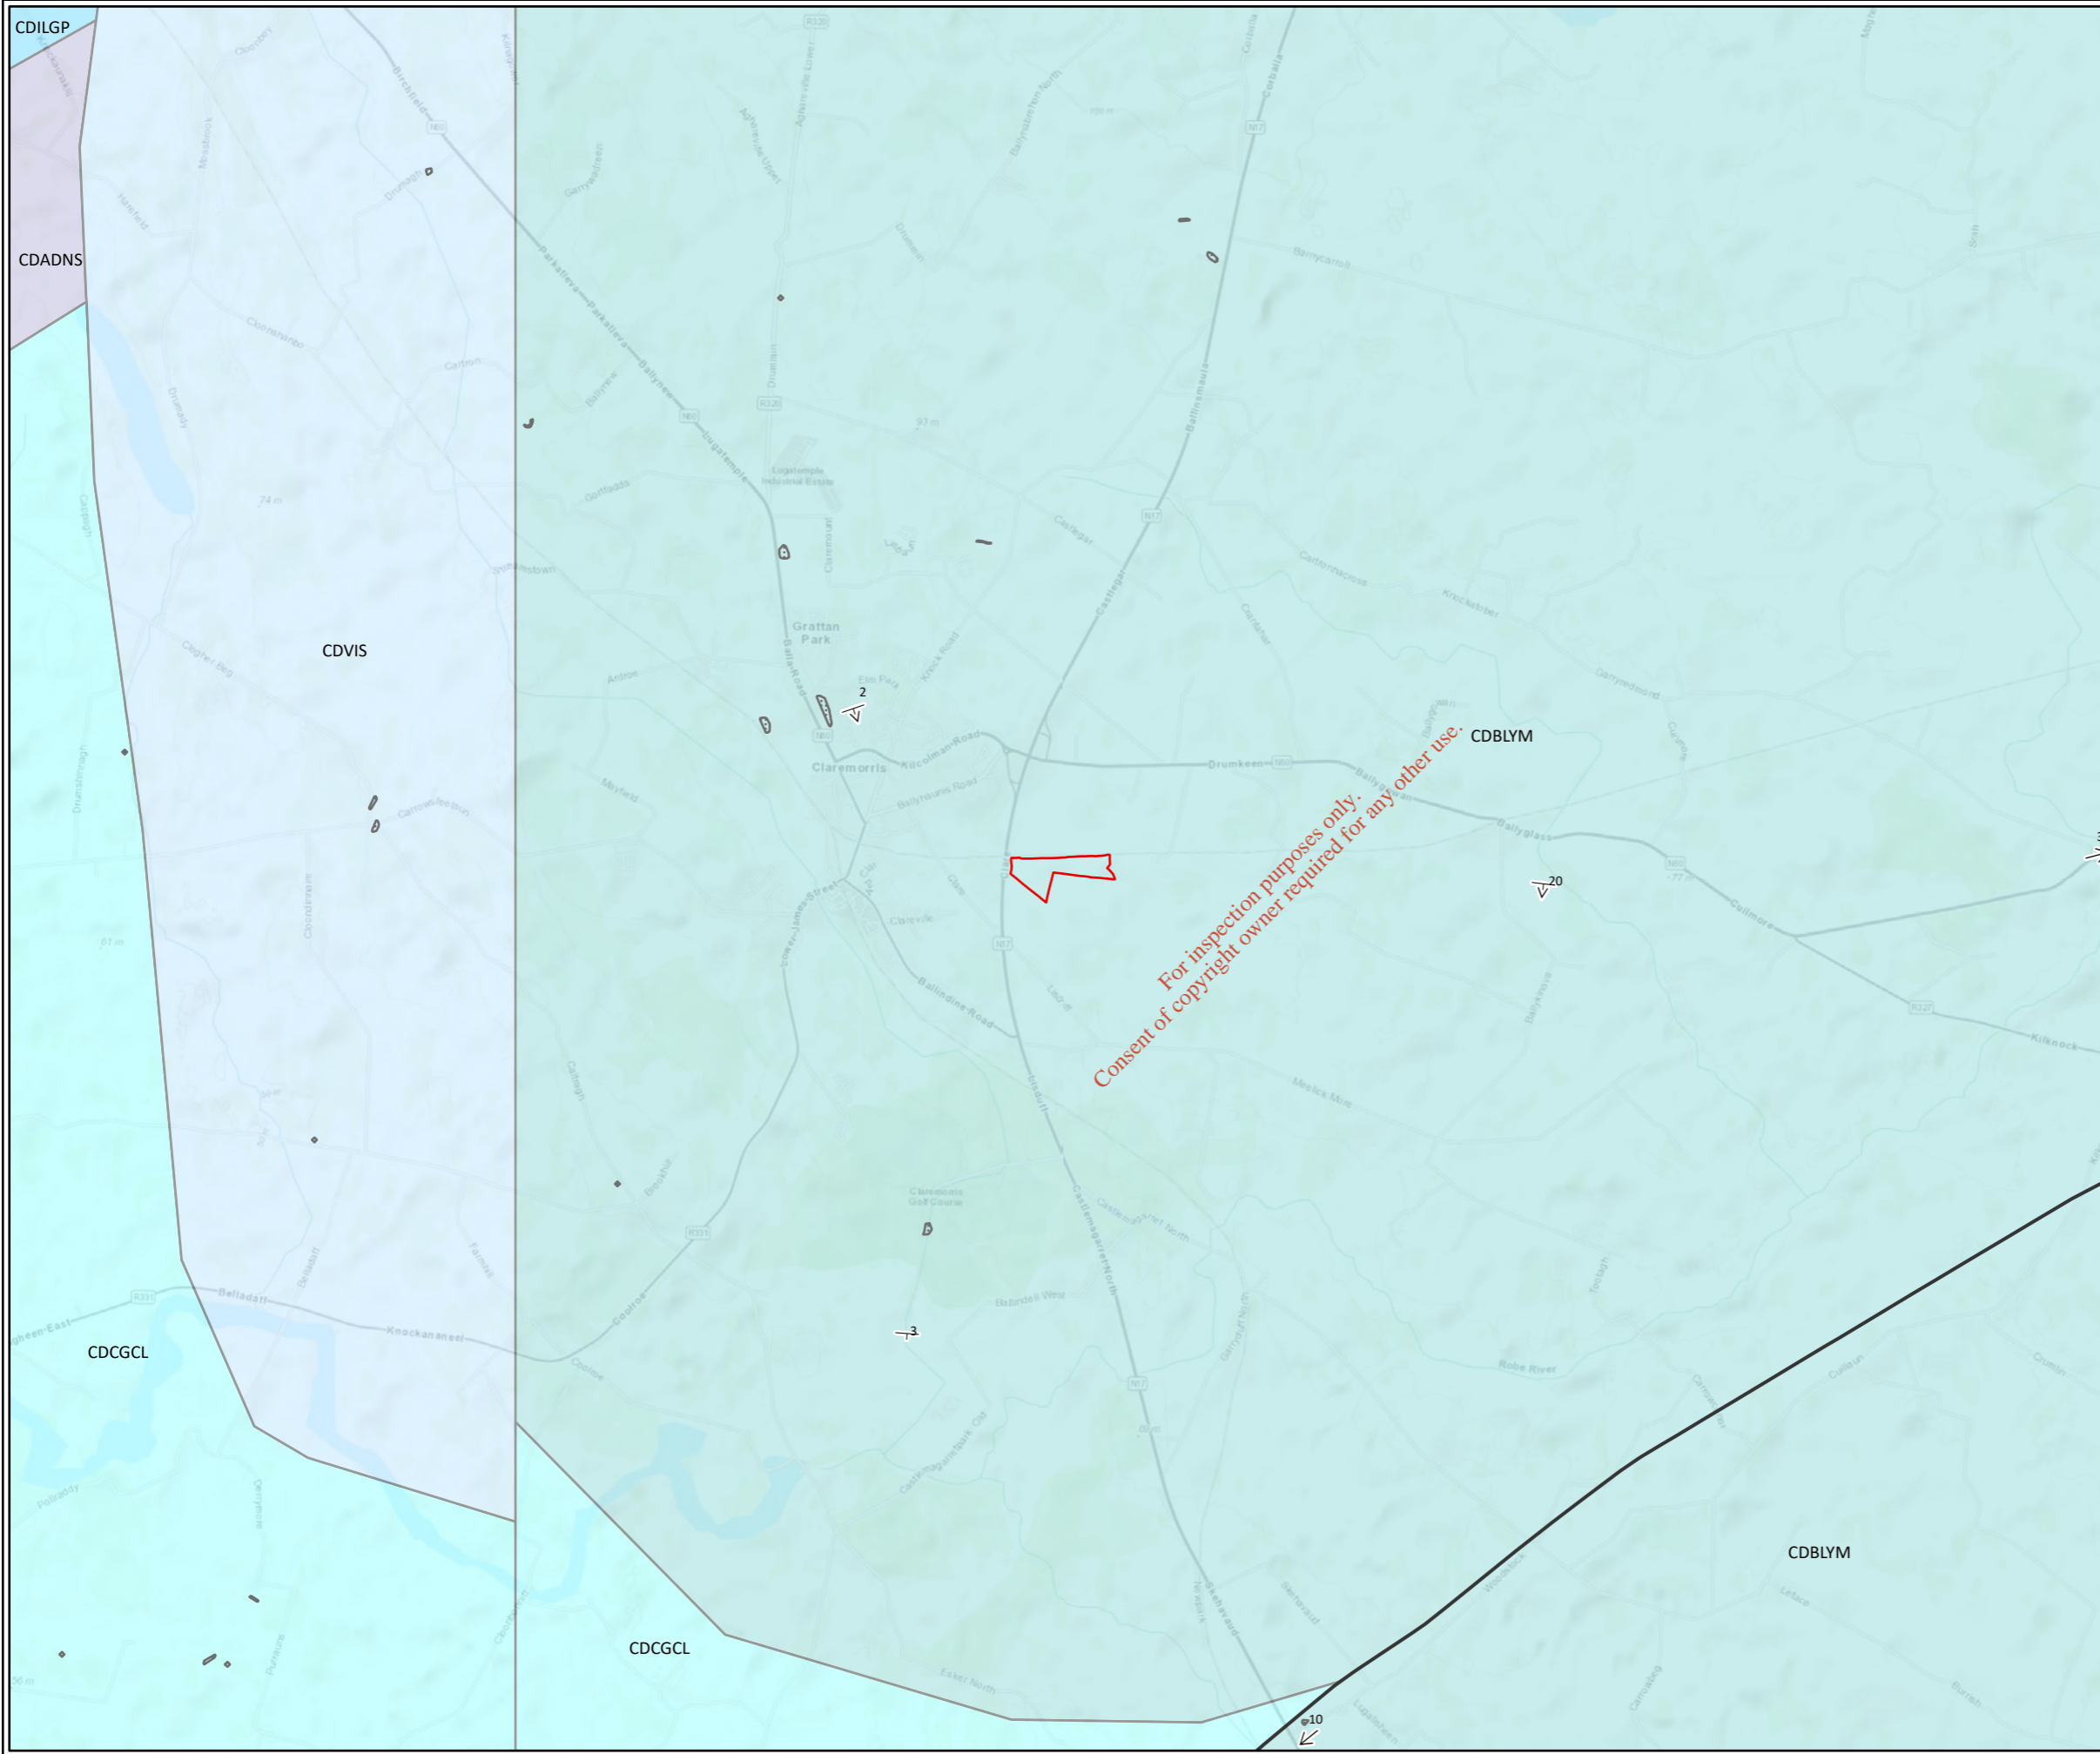
<b>TITLE:</b>	Bedrock Geology	
<b>PROJECT:</b>	Claremorris Tier 3 and Remediation Plan	
<b>FIGURE NO:</b>	2.3	
<b>CLIENT:</b>	Mayo County Council	
<b>SCALE:</b>	1:40,000	<b>REVISION:</b> 0
<b>DATE:</b>	13/01/2020	<b>PAGE SIZE:</b> A3

- Site Boundary
- Dip of bedding or main folia on, old GSI data
- Strike and dip of bedding, right way up
- Strike and dip of bedding, way up unknown
- Fault
- Bedrock Outcrop
- Bedrock Geology**
- Ardnasillagh Formation
- Ballymore Limestone Formation
- Cong Canal Formation
- Illaunagappul Formation
- Visean Limestones (undifferentiated)

The bedrock geology is presented in Figure 2-3.

No bedrock encountered during the installation of boreholes BH01 and BH02, as referenced in the JS Drilling borehole logs (Appendix 2).

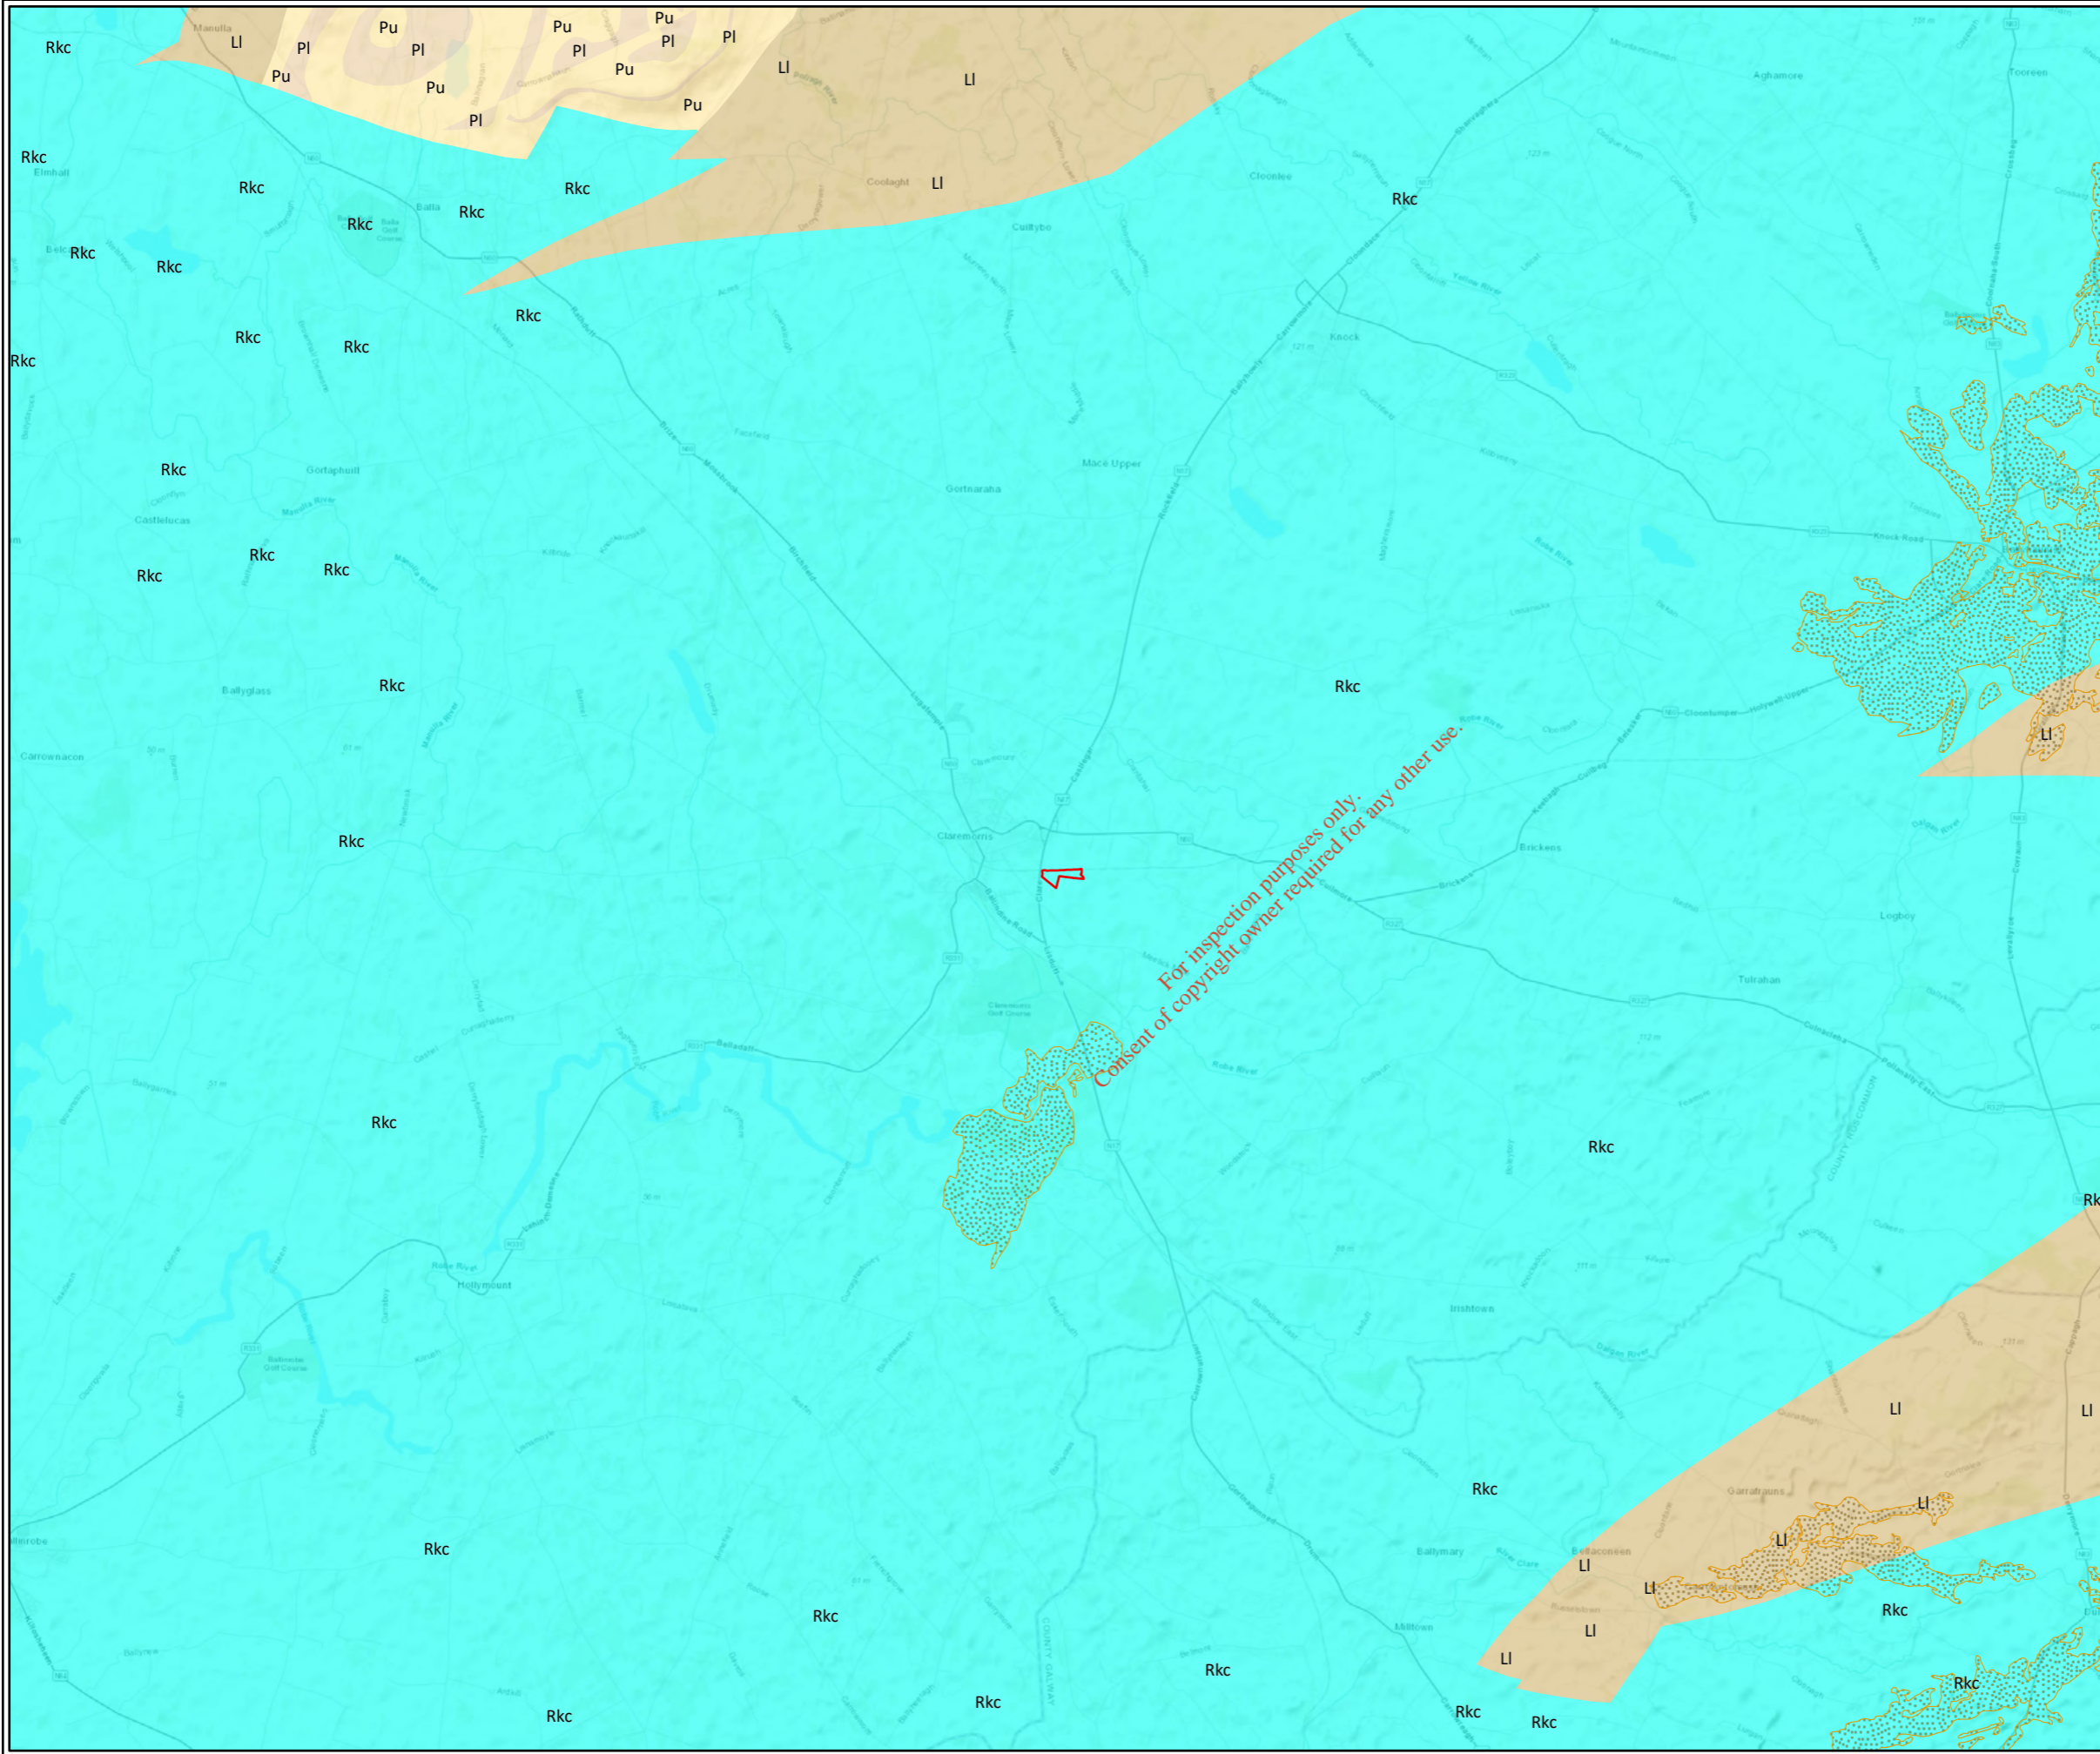
<b>TITLE:</b>	Aquifer Classification	
<b>PROJECT:</b>	Claremorris Tier 3 and Remediation Plan	
<b>FIGURE NO:</b>	2.4	
<b>CLIENT:</b>	Mayo County Council	
<b>SCALE:</b>	1:100,000	<b>REVISION:</b> 0
<b>DATE:</b>	13/01/2020	<b>PAGE SIZE:</b> A3

- Site Boundary
- Sand and Gravel Aquifers**
- Locally important gravel aquifer
- Bedrock Aquifers**
- LI: Locally Important Aquifer - Bedrock Mod Produc ve Locally
- PI: Poor Aquifer Bedrock Generally Unproduc ve Except Locally
- Pu: Poor Aquifer Bedrock Generally Unproduc ve
- Rkc: Regionally Important Aquifer - Karsted (conduit)

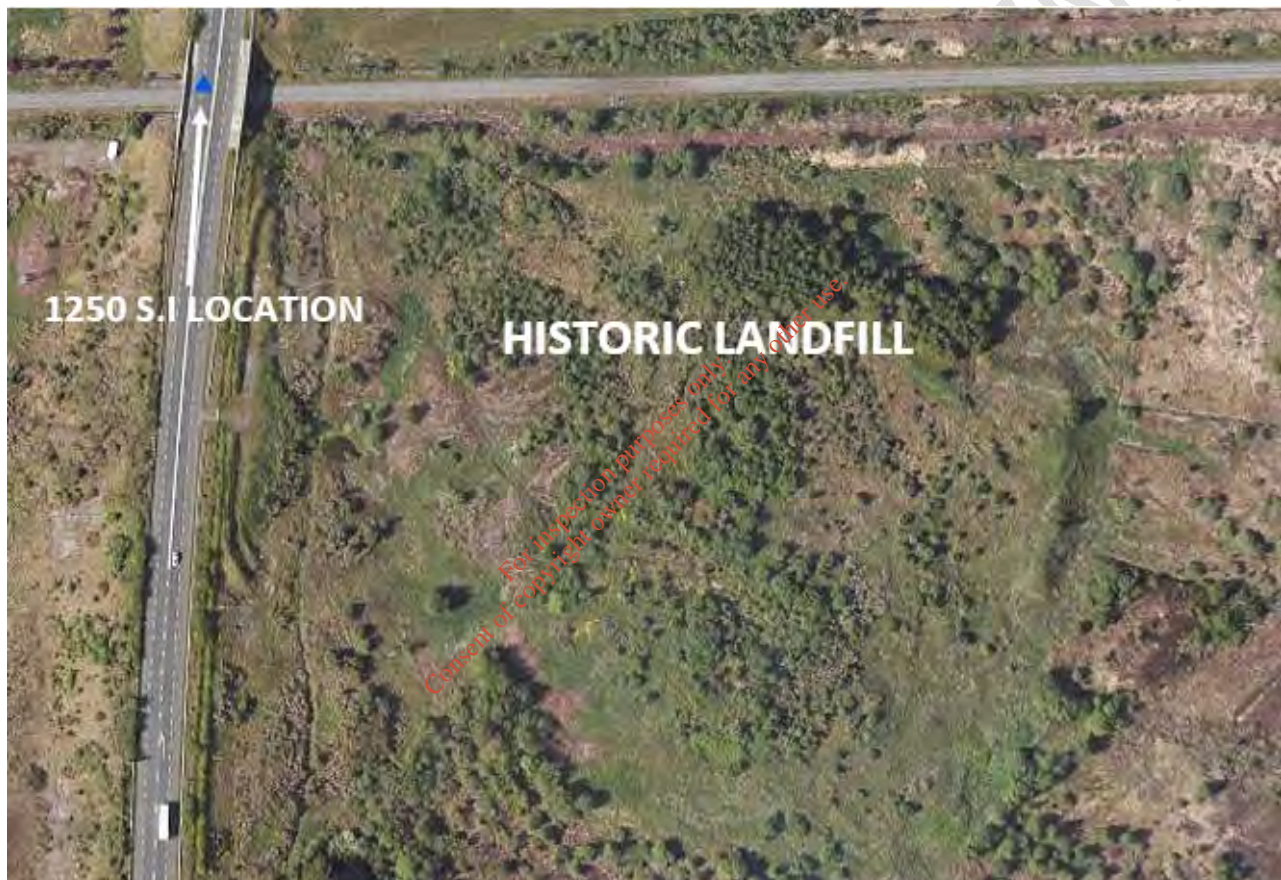
Figure 2-10: GSI Geotechnical Boreholes (Blue Triangle)

The review highlighted two boreholes located close to the site for the then proposed (now existing) railway overbridge. The boreholes are referred to as 1250R and 1250L indicating their chainage location. The approximate location of these boreholes according the GSI is shown in Figure 2-10 below.

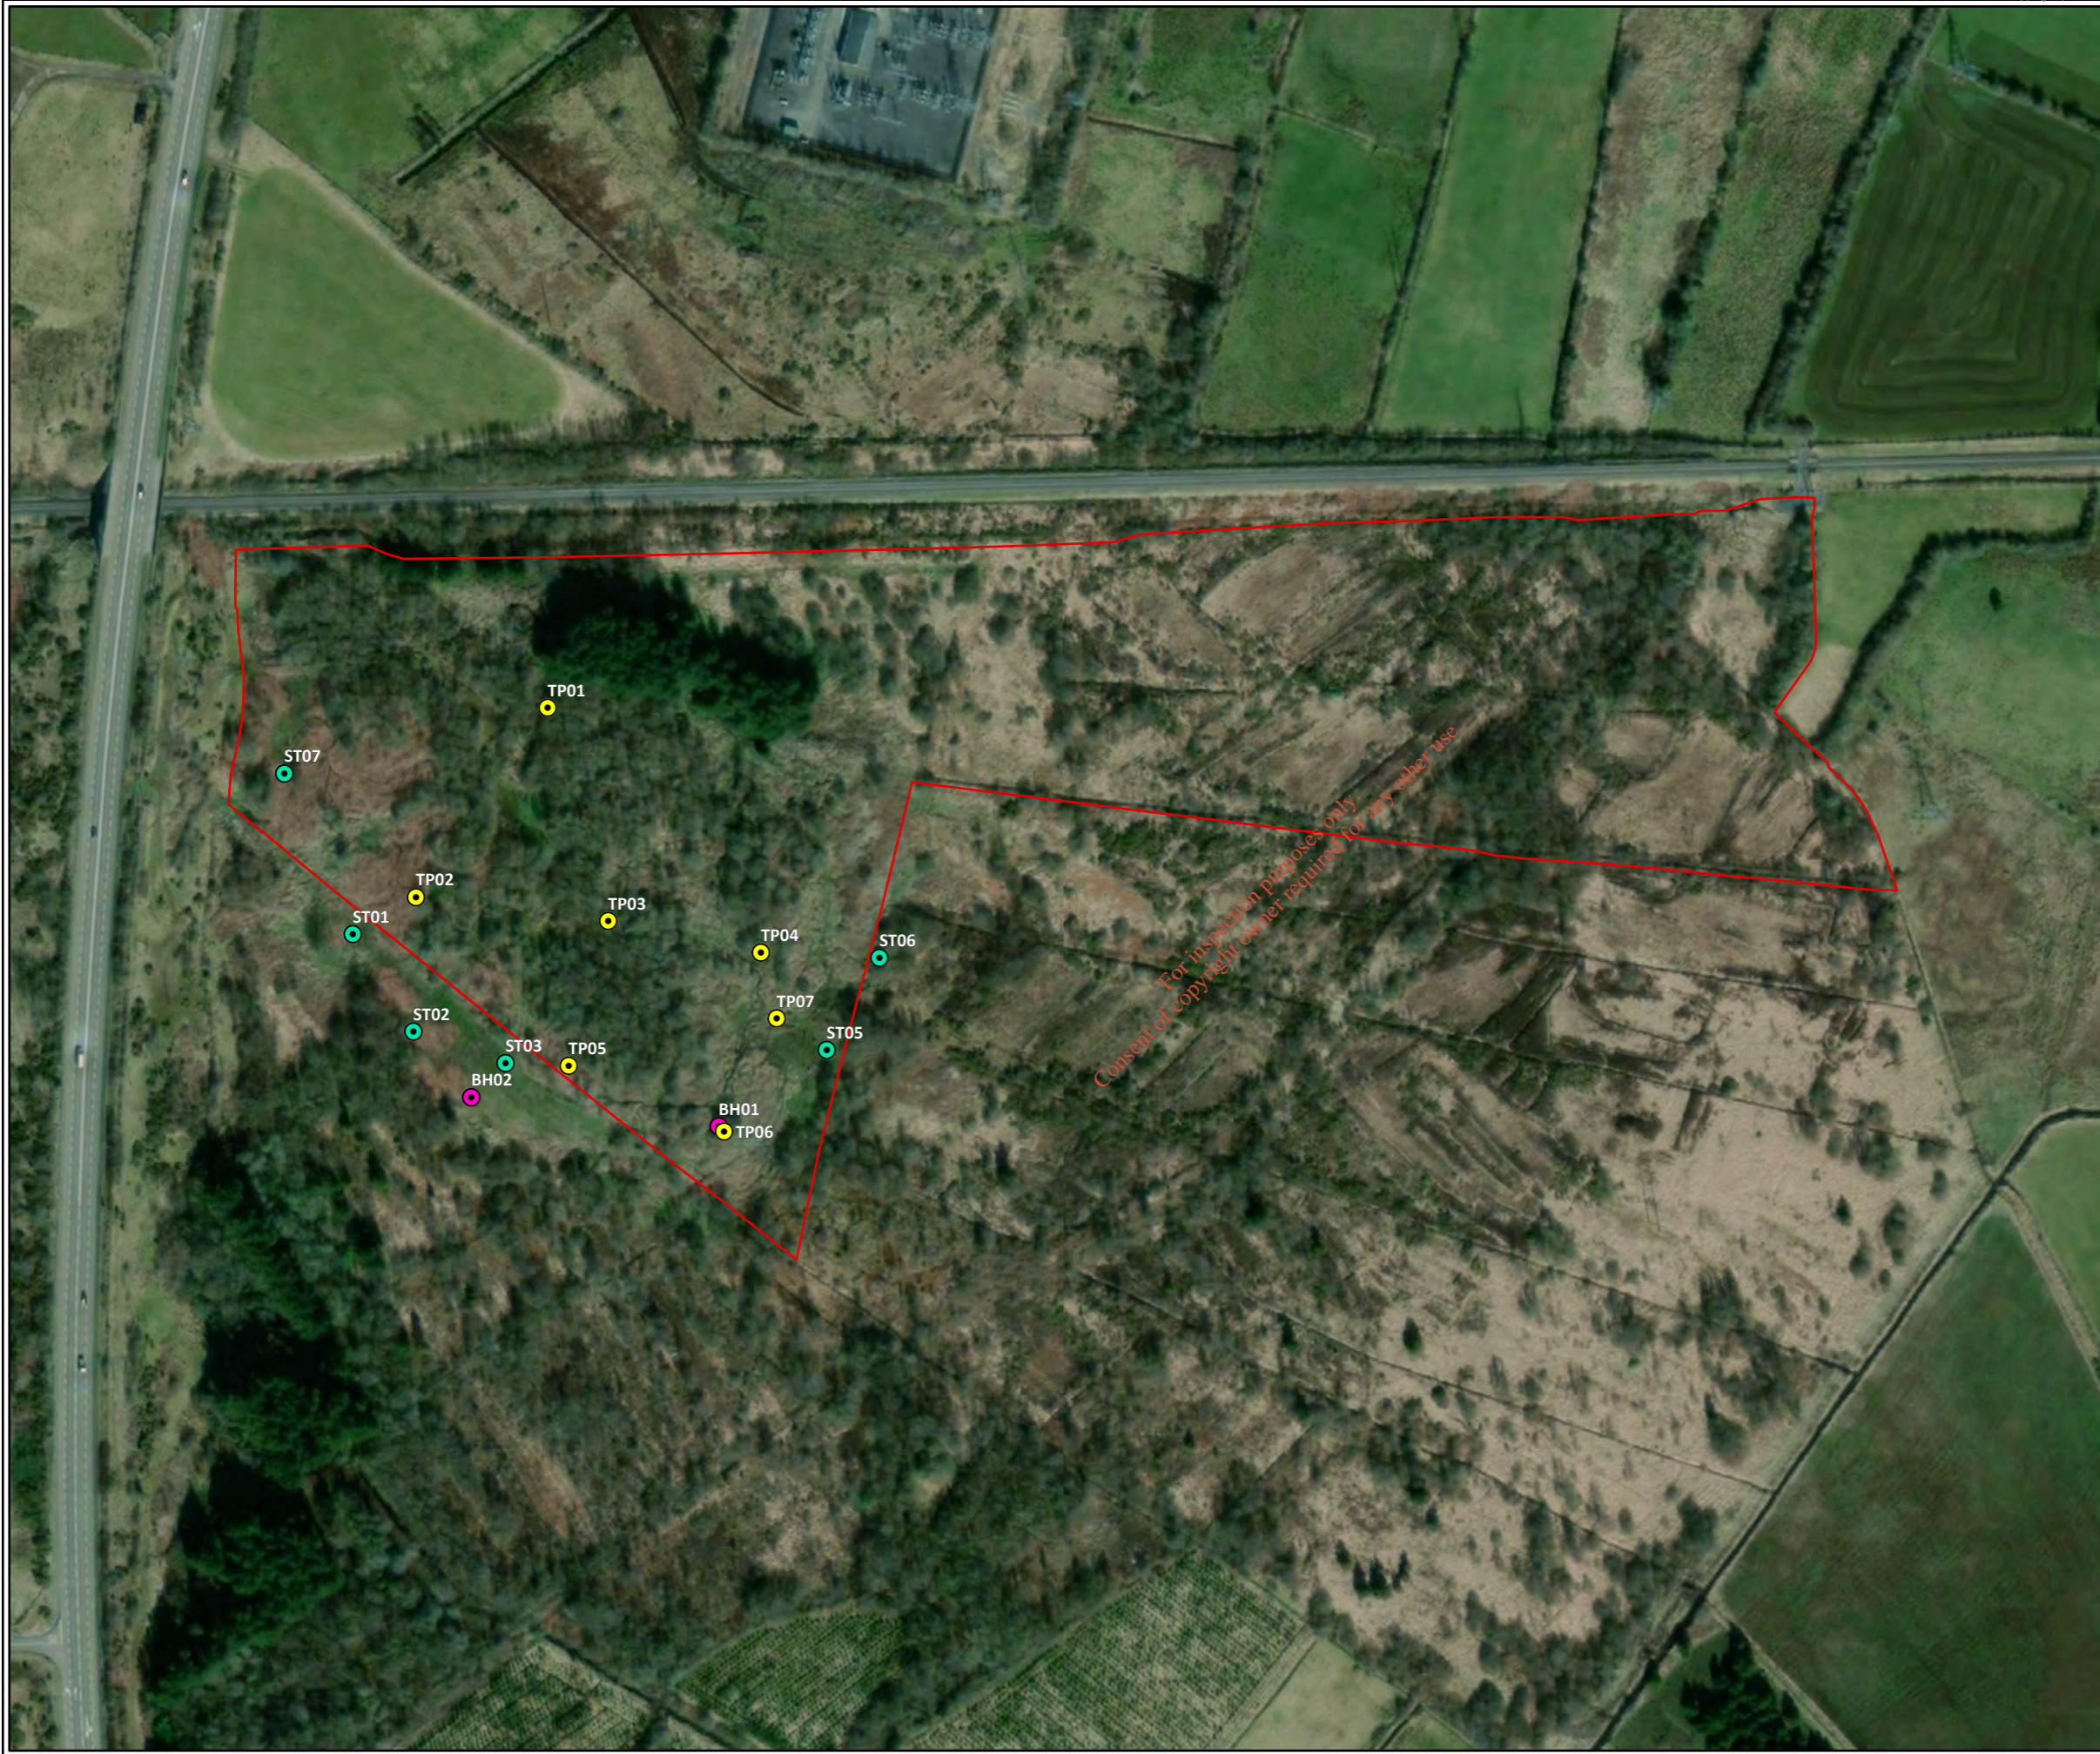
The locations of the intrusive works are presented in Figure 3-1.

- Site Boundary
- BH
- ST
- TP

- Drilling of 2 No. boreholes.
- Excavation of 7 No. trial pits to the full depth of the waste body where possible.
- *In-situ* monitoring of landfill gas.
- Collection of soil/waste samples during drilling/trial pitting.
- Conversion of the 2 No. boreholes to groundwater/leachate monitoring wells.
- Collection of groundwater/leachate from each of the monitoring wells.
