Claremorris Unregulated Landfill Site Investigation

APPENDIX 3

Site Walkover Photos

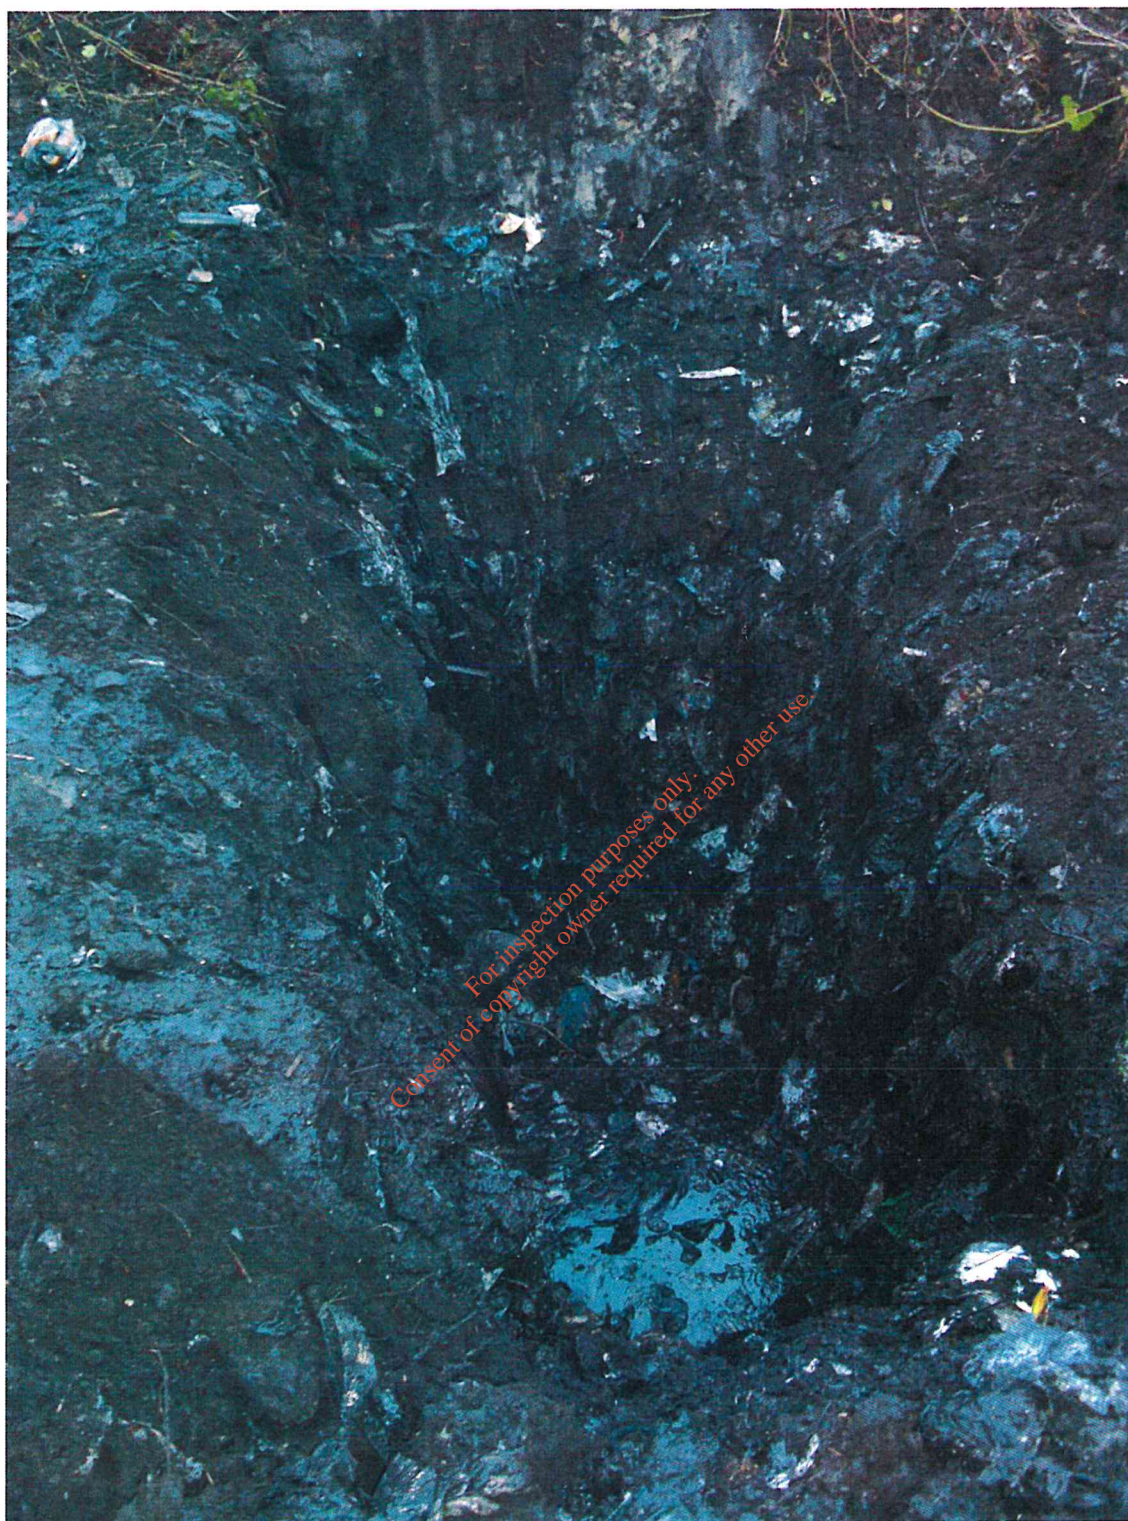
TP02

Soft Ground Boring: Daily Record
Location: Claremorris
Client: Mayo Co Co
Date: 25-11-10
Ground Level: 67 m
(Ordnance datum)
GPS: 35154 74587
Rig Type: Tracked excavator
Site: Claremorris Landfill
Borehole No: TP 03
Sheet: 1 of 1
Engineer: AMR

Table with columns: Depth to base of strata, soft firm stiff, loose med.d. dense, colour, clayey silty sandy, fine med. coarse, soil name, with gravel, cobbles, sand bands, etc. Includes text description of strata at 0.0, 0.7, 6.2, and 6.4m depths.

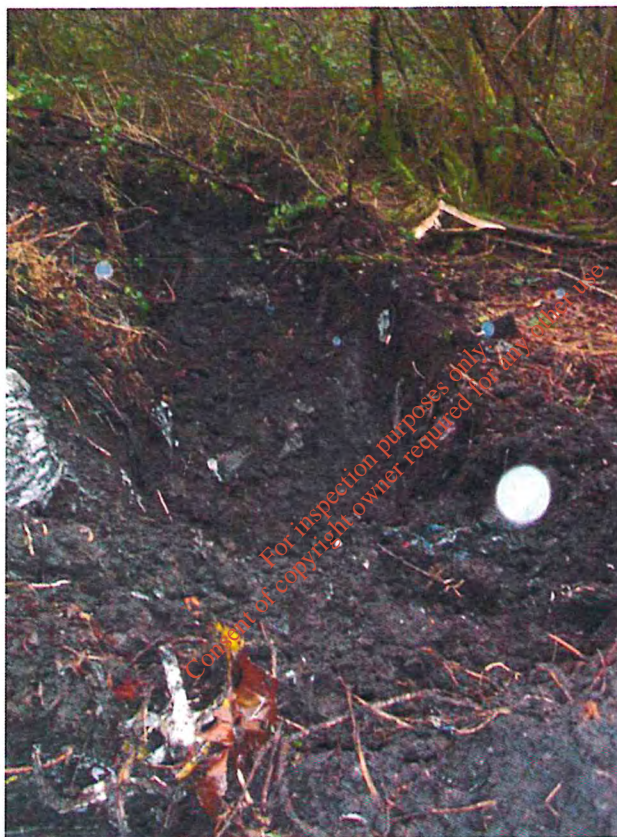
Location: Claremorris	Site: Claremorris Landfill
Client: Mayo Co Co	Slit trench No: ST 02
Date: 26-11-10	Sheet: 1 of 1
Ground Level: 64 m (Ordnance datum)	Engineer: AMR
GPS: 135080 274545	
Rig Type: Tracked excavator

Comments
6m slit trench, edge of waste running into natural peat ground

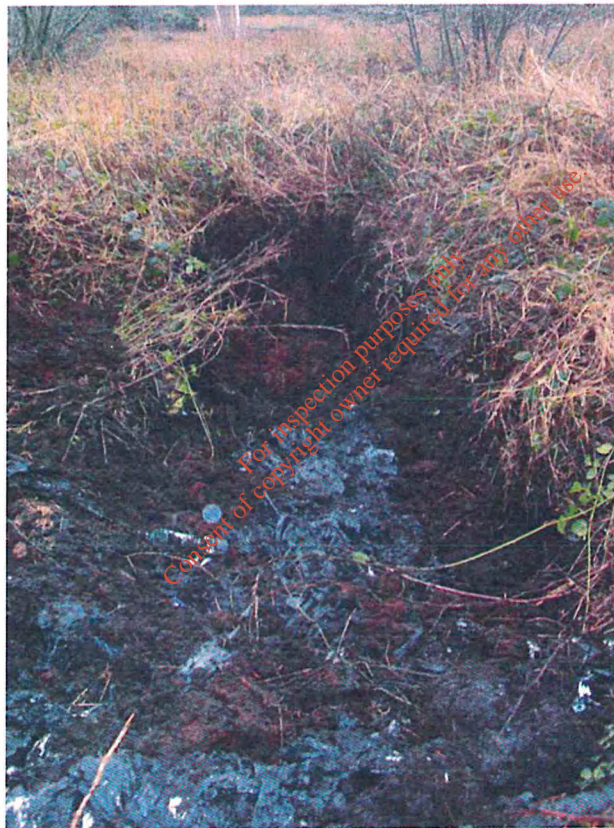
Location: Claremorris	Site: Claremorris Landfill
Client: Mayo Co Co	Slit trench No: ST 06
Date: 26-11-10	Sheet: 1 of 1
Ground Level: 66 m (Ordnance datum)	Engineer: AMR
GPS: 135257 274573	
Rig Type: Tracked excavator

Comments
5m slit trench, edge of waste into natural peat

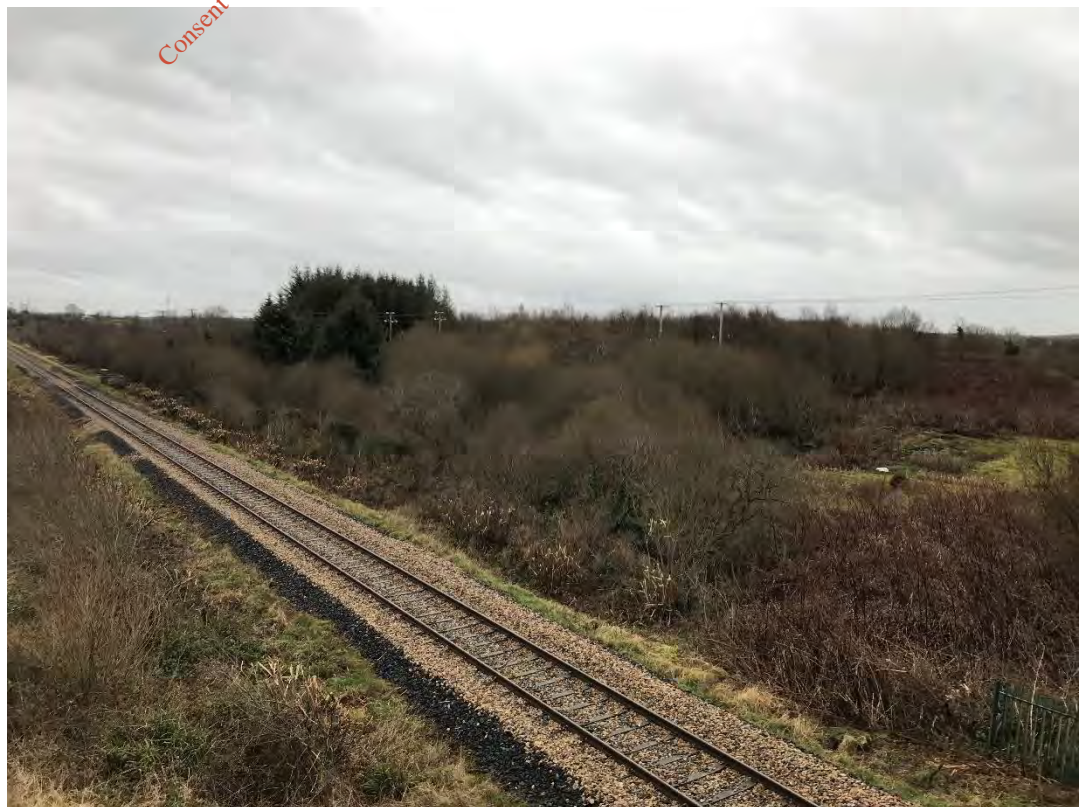
Photo No.
2

Railway located running along the northern boundary of the site

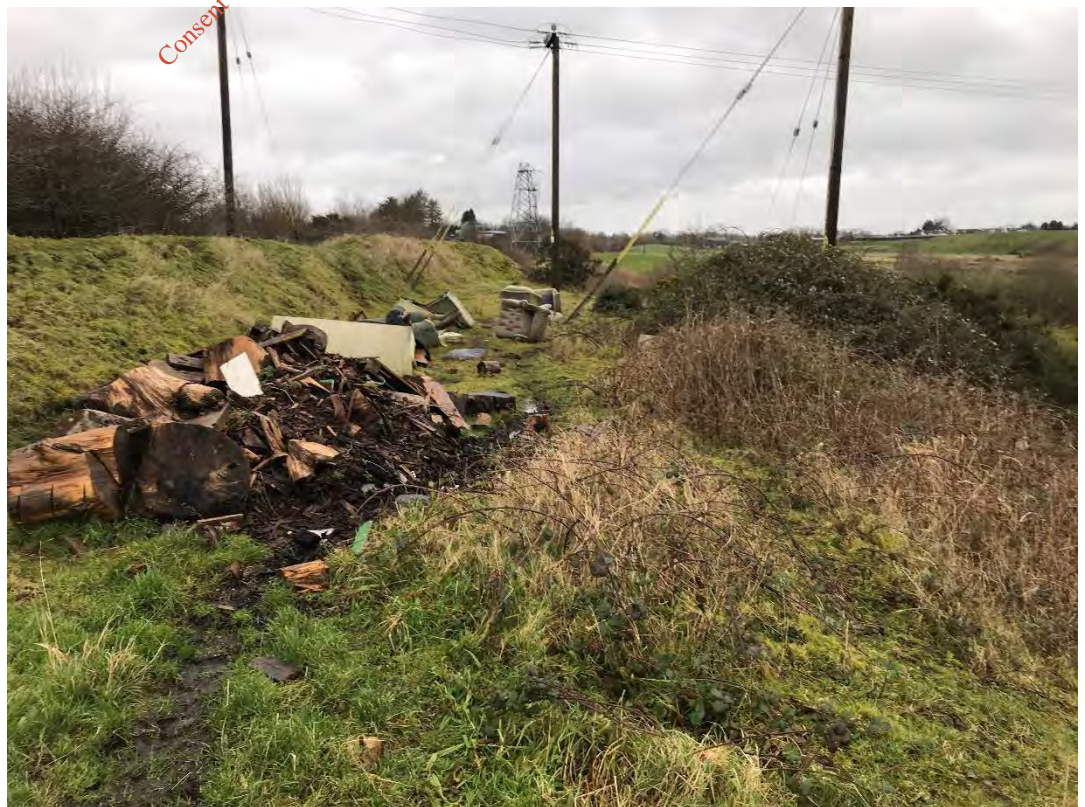
Photo No.
4

Description:
Surface waste

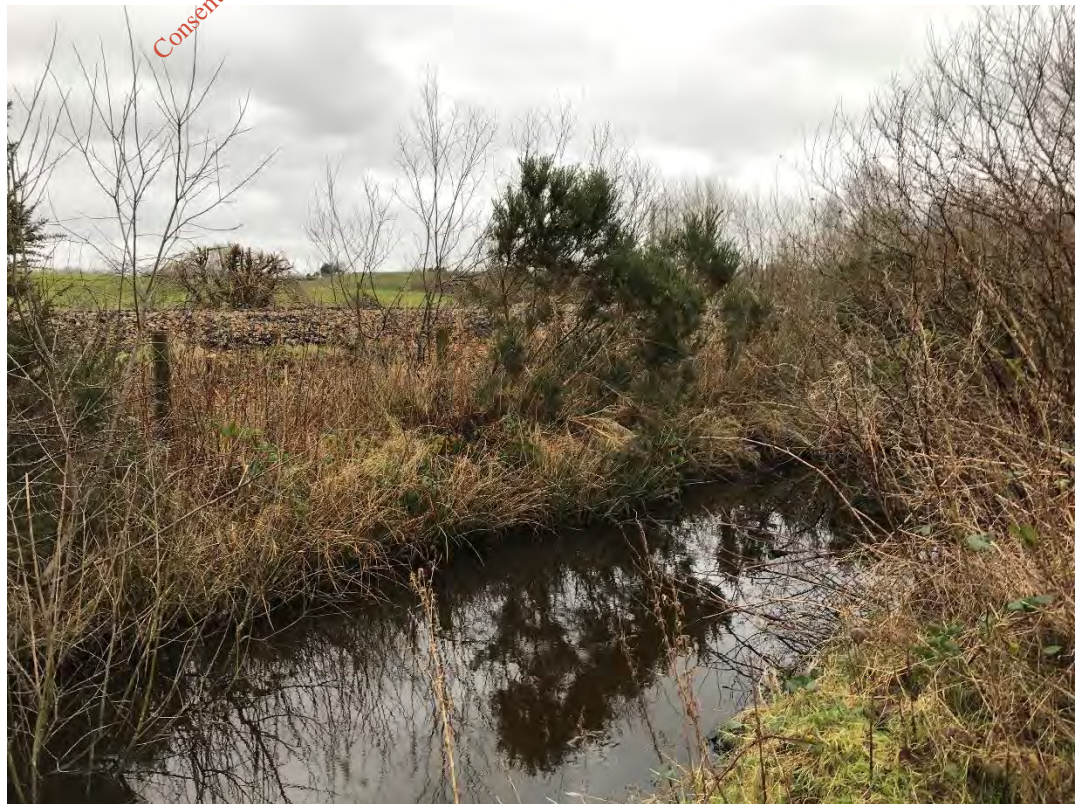
Photo No.
6

Description:
Kilbeg-Malone stream which crosses the site on the North-East corner.

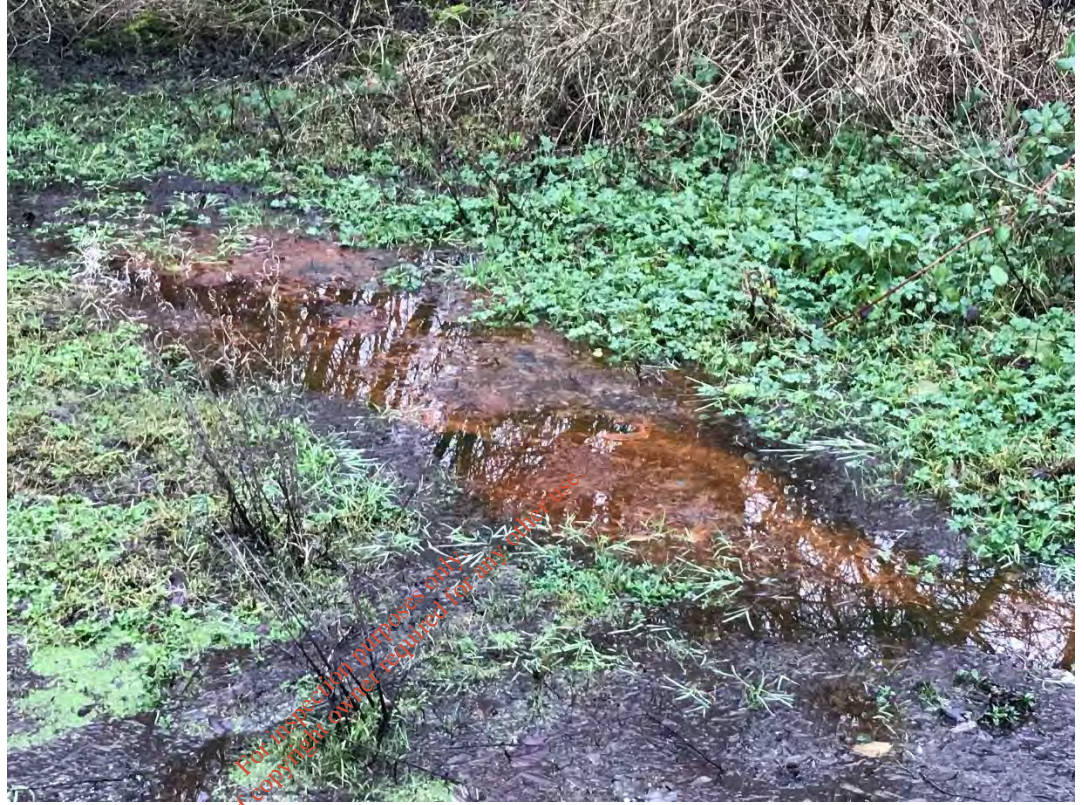
7

Leachate seepage

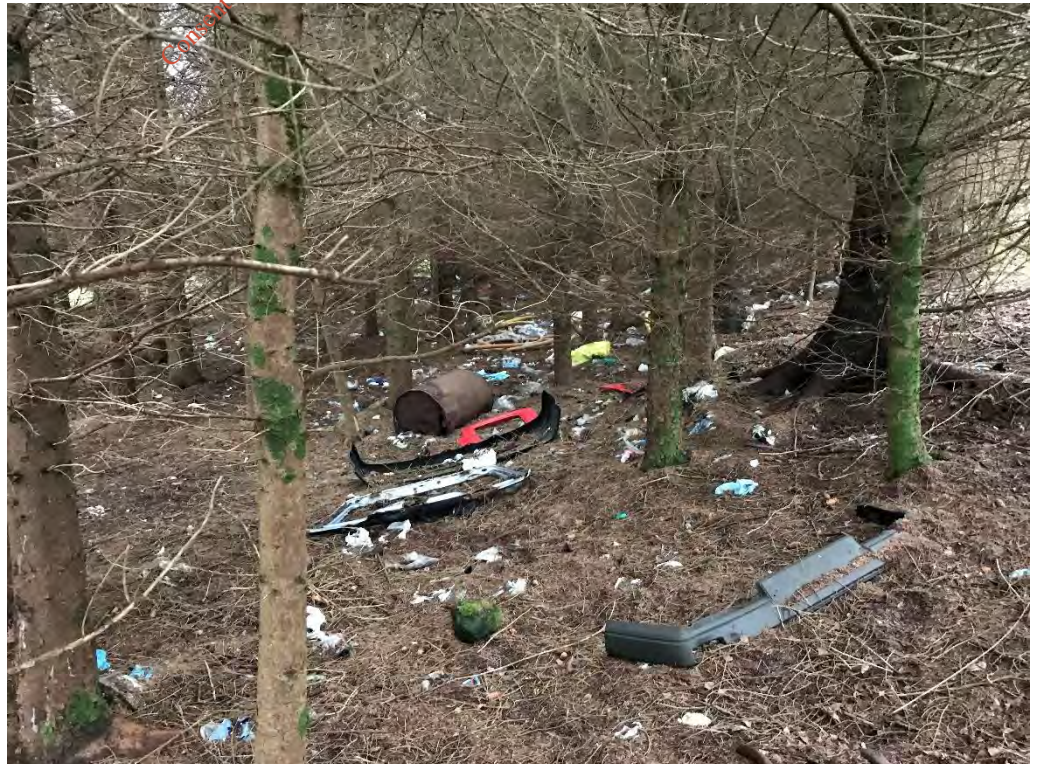
8

Surface waste

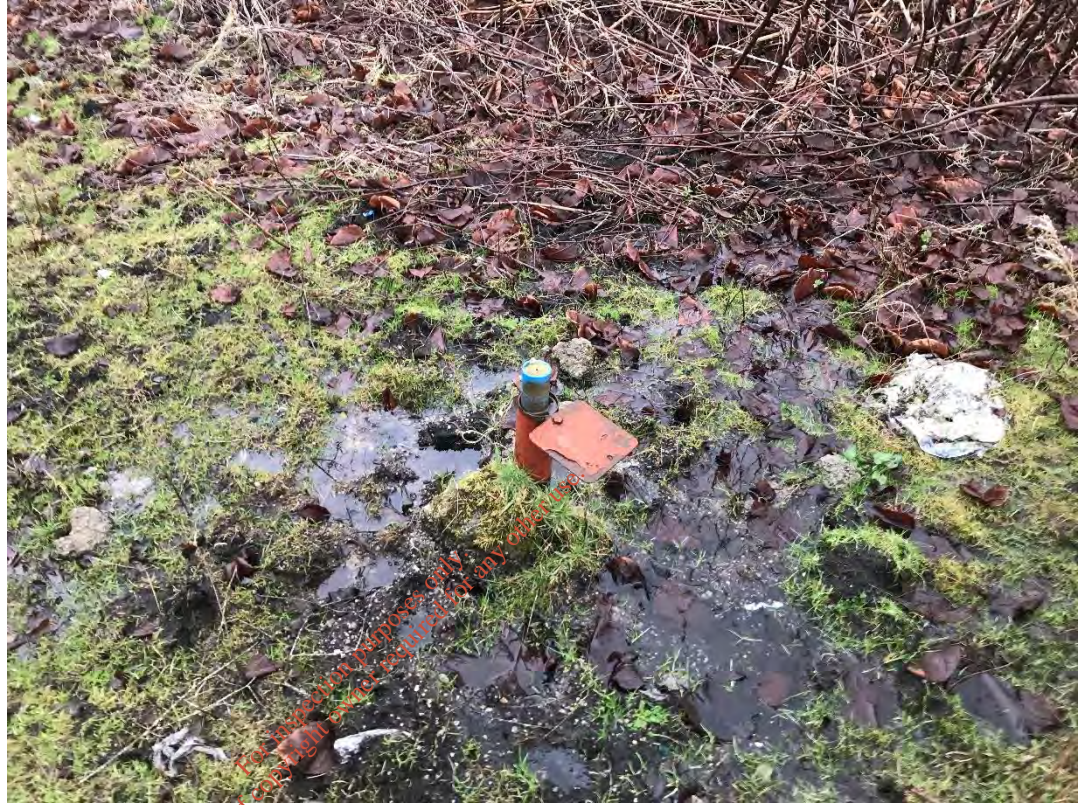
9

BHOX located xxxxx.

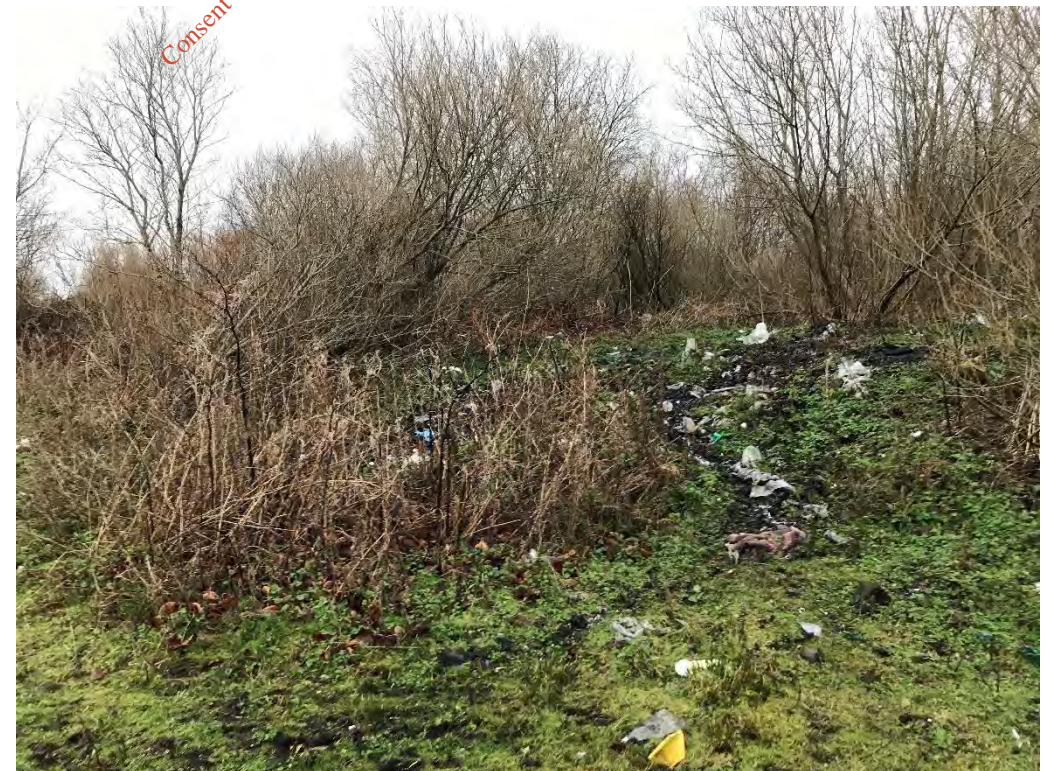
10

Surface waste
