Environmental Risk Assessment

Site at Greenhills

Kildare County Council

Athy, Co. Kildare

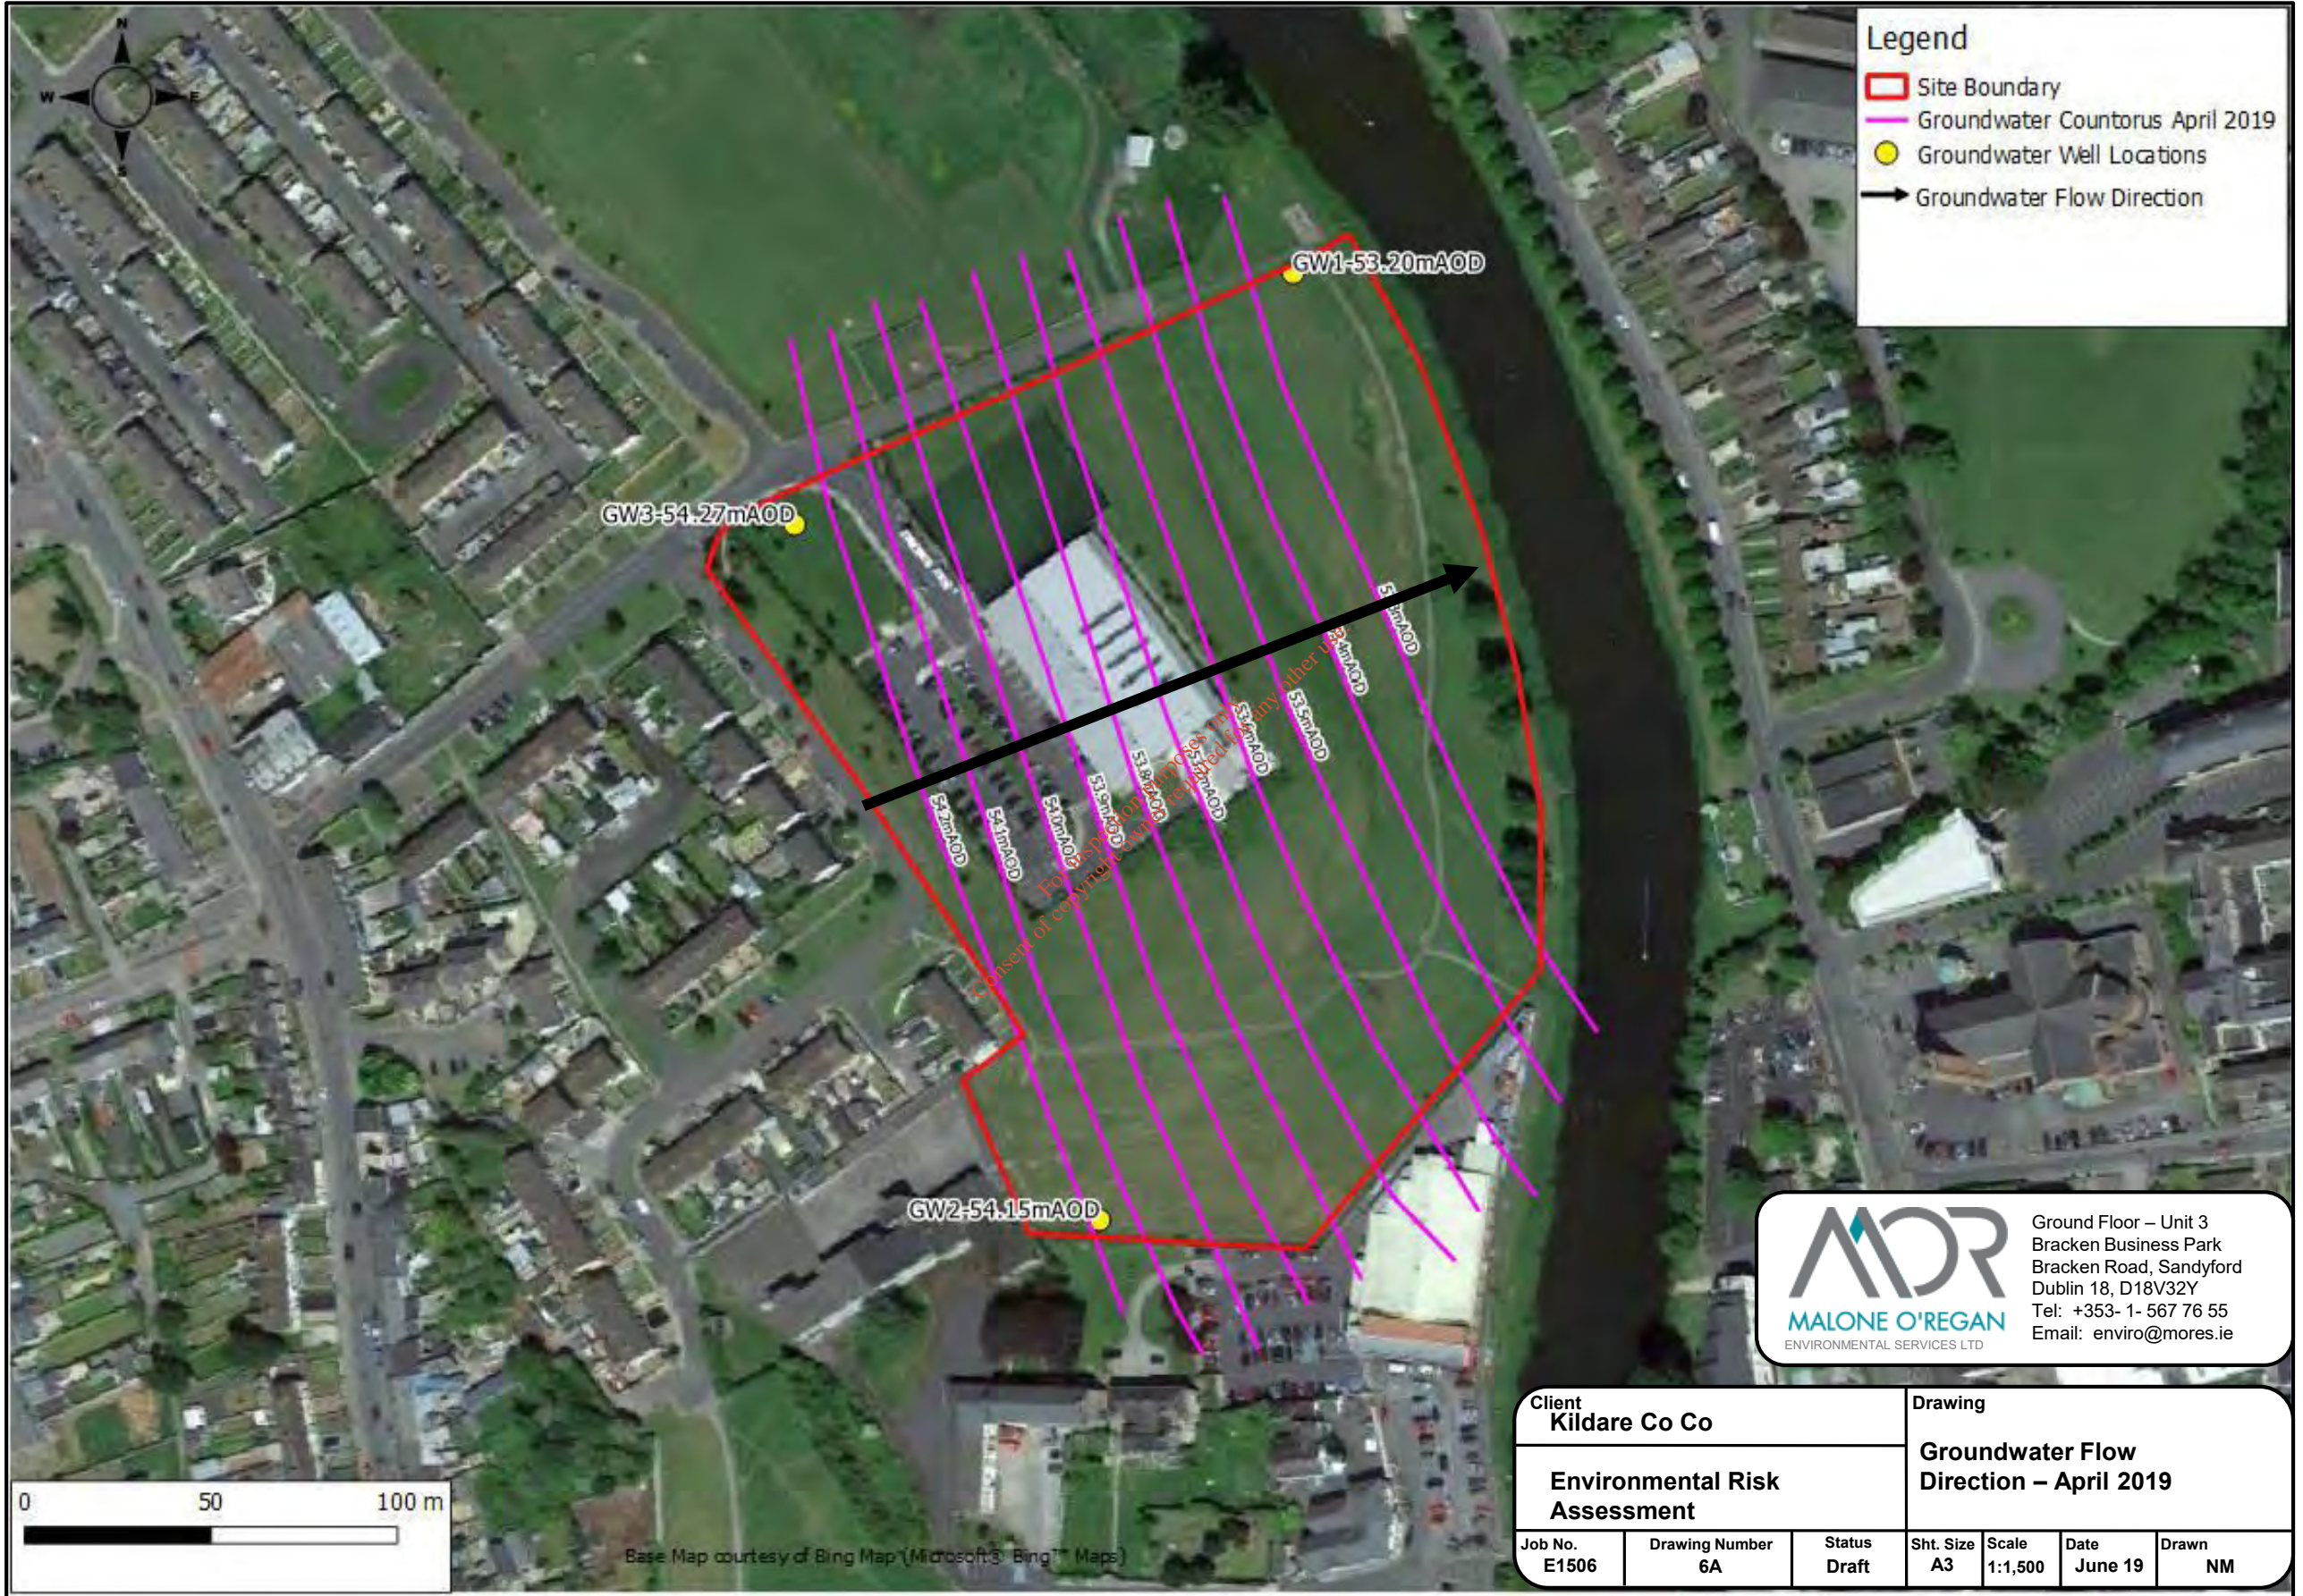
Client Kildare Co Co			Drawing			
Environmental Risk Assessment			Groundwater Flow Direction – April 2019			
Job No. E1506	Drawing Number 6A	Status Draft	Sht. Size A3	Scale 1:1,500	Date June 19	Drawn NM

- Site Boundary
- Groundwater Contour April 2019
- Groundwater Well Locations
- ➔ Groundwater Flow Direction

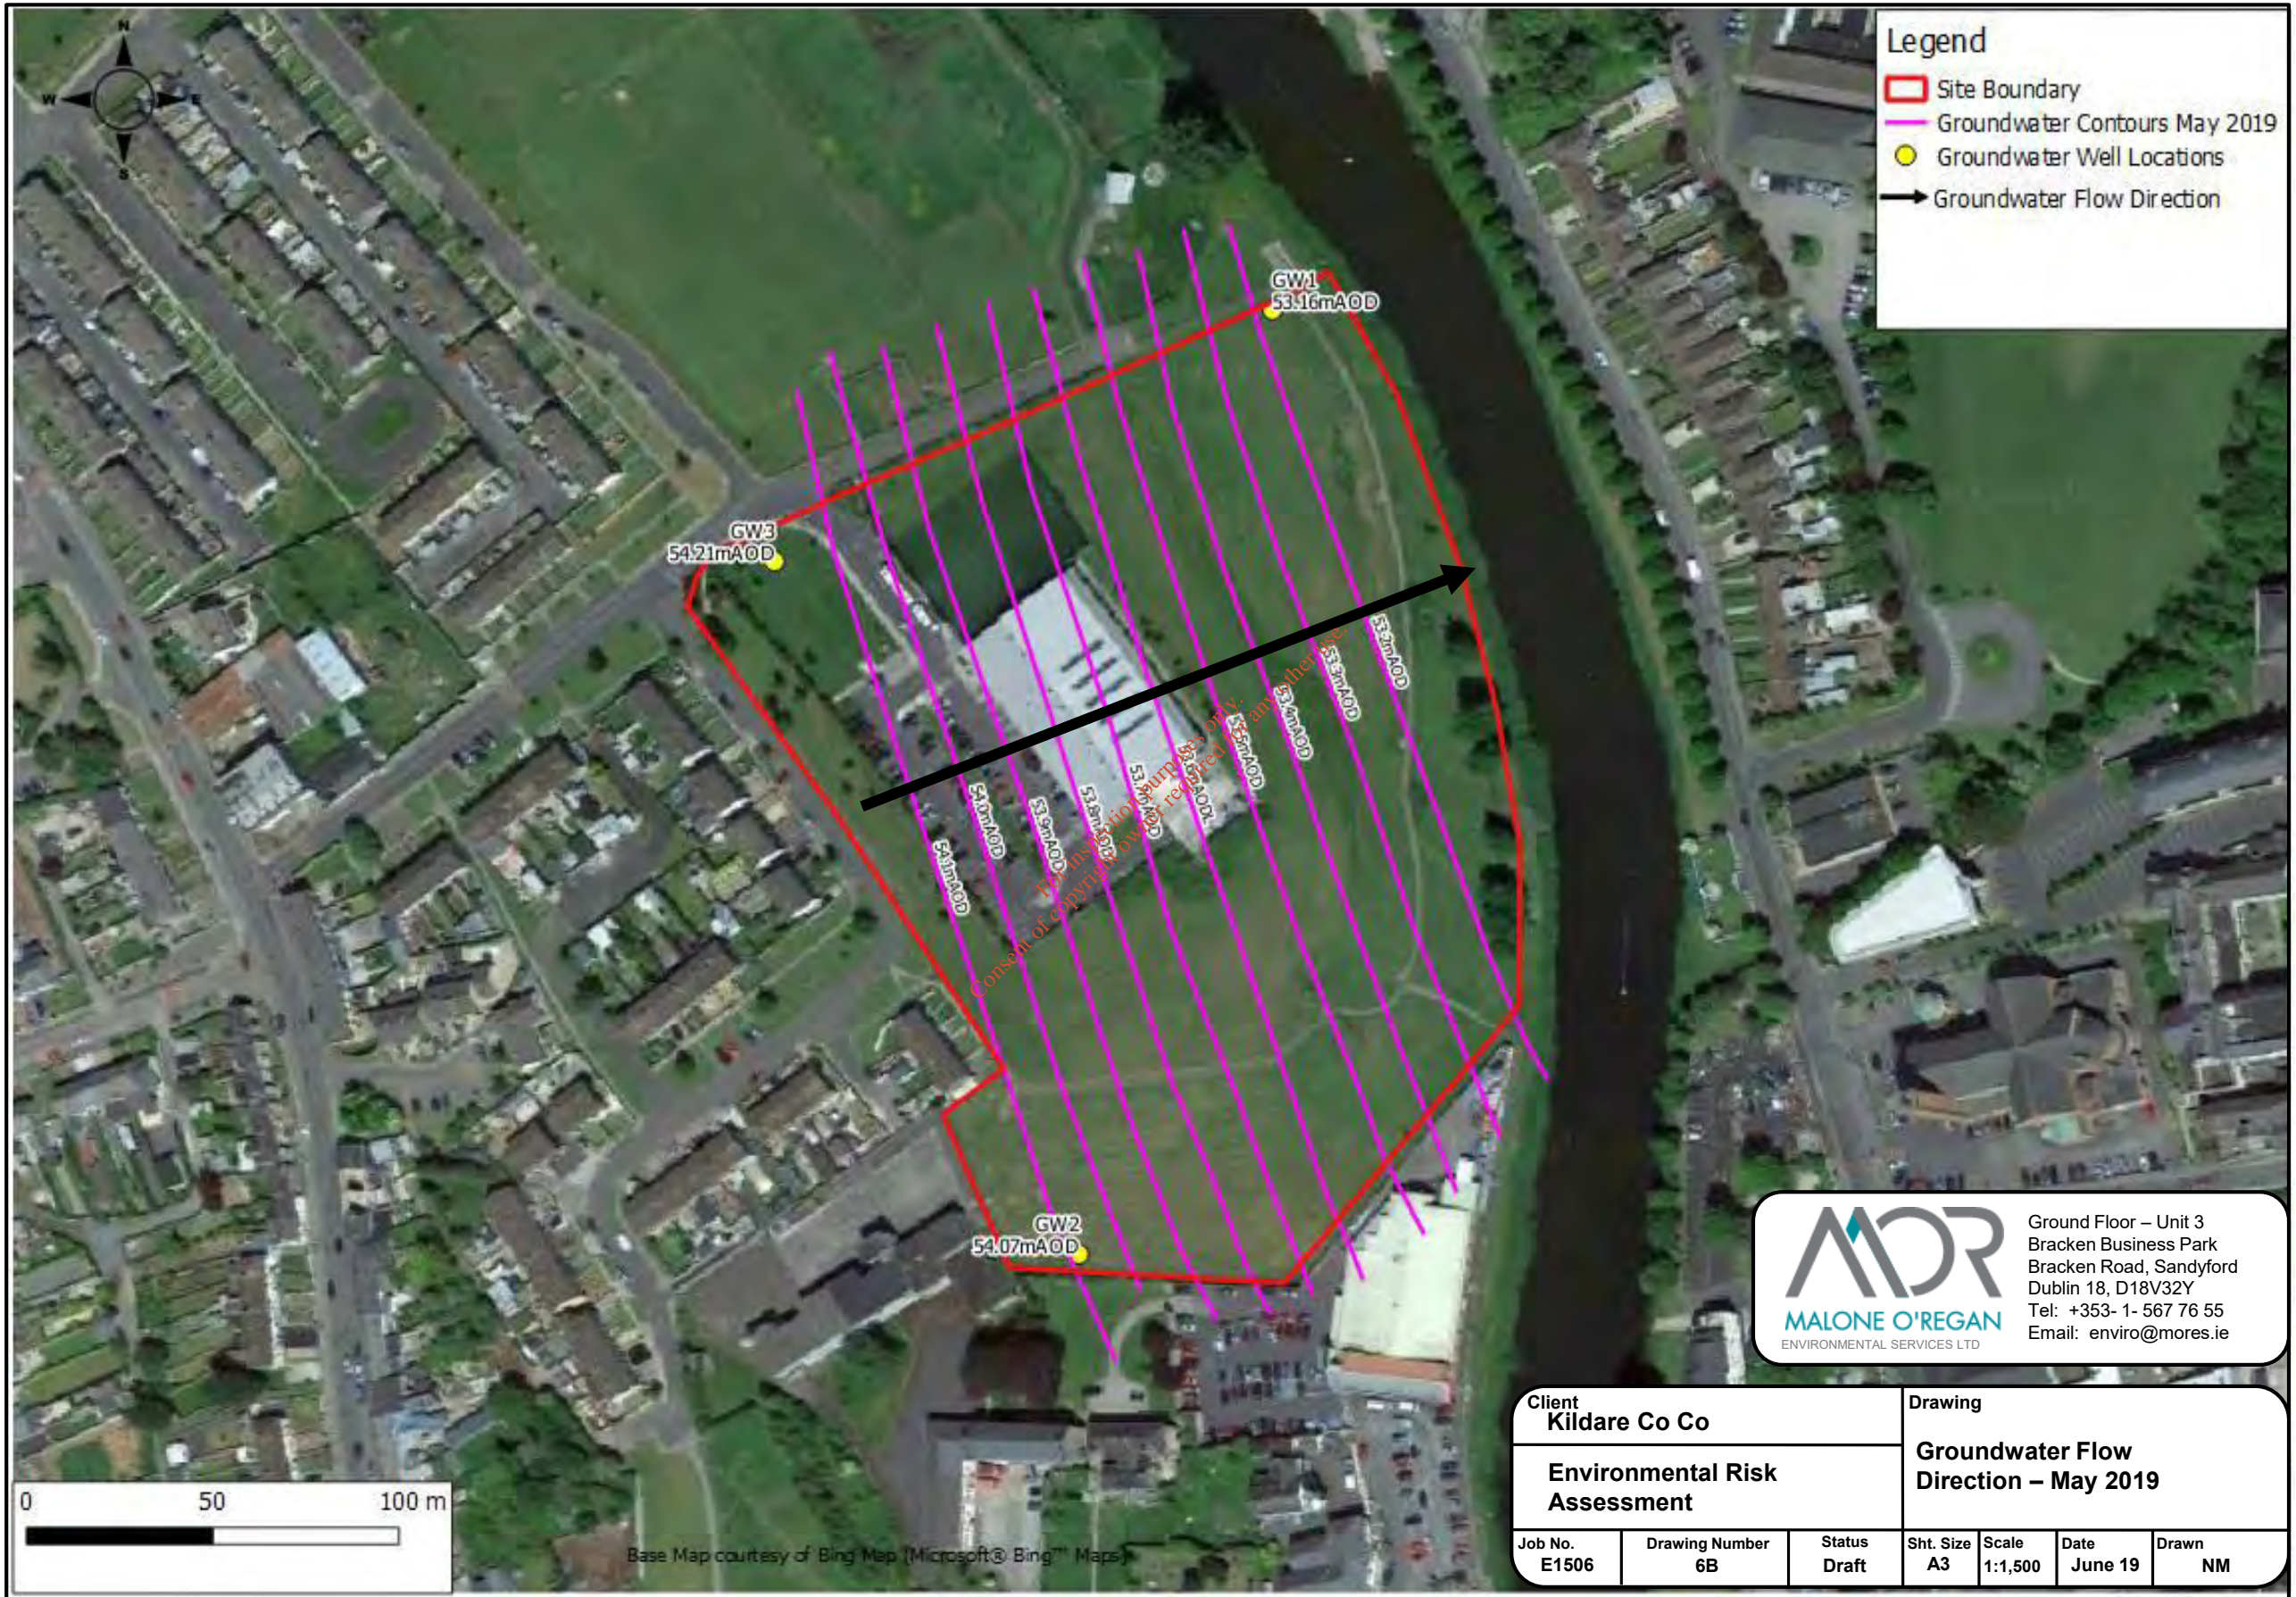
Client Kildare Co Co		Drawing Groundwater Flow Direction – May 2019			
Environmental Risk Assessment					
Job No. E1506	Drawing Number 6B	Status Draft	Sht. Size A3	Scale 1:1,500	Date June 19
					Drawn NM

- Legend**
- ▭ Site Boundary
 - Groundwater Contours May 2019
 - Groundwater Well Locations
 - Groundwater Flow Direction

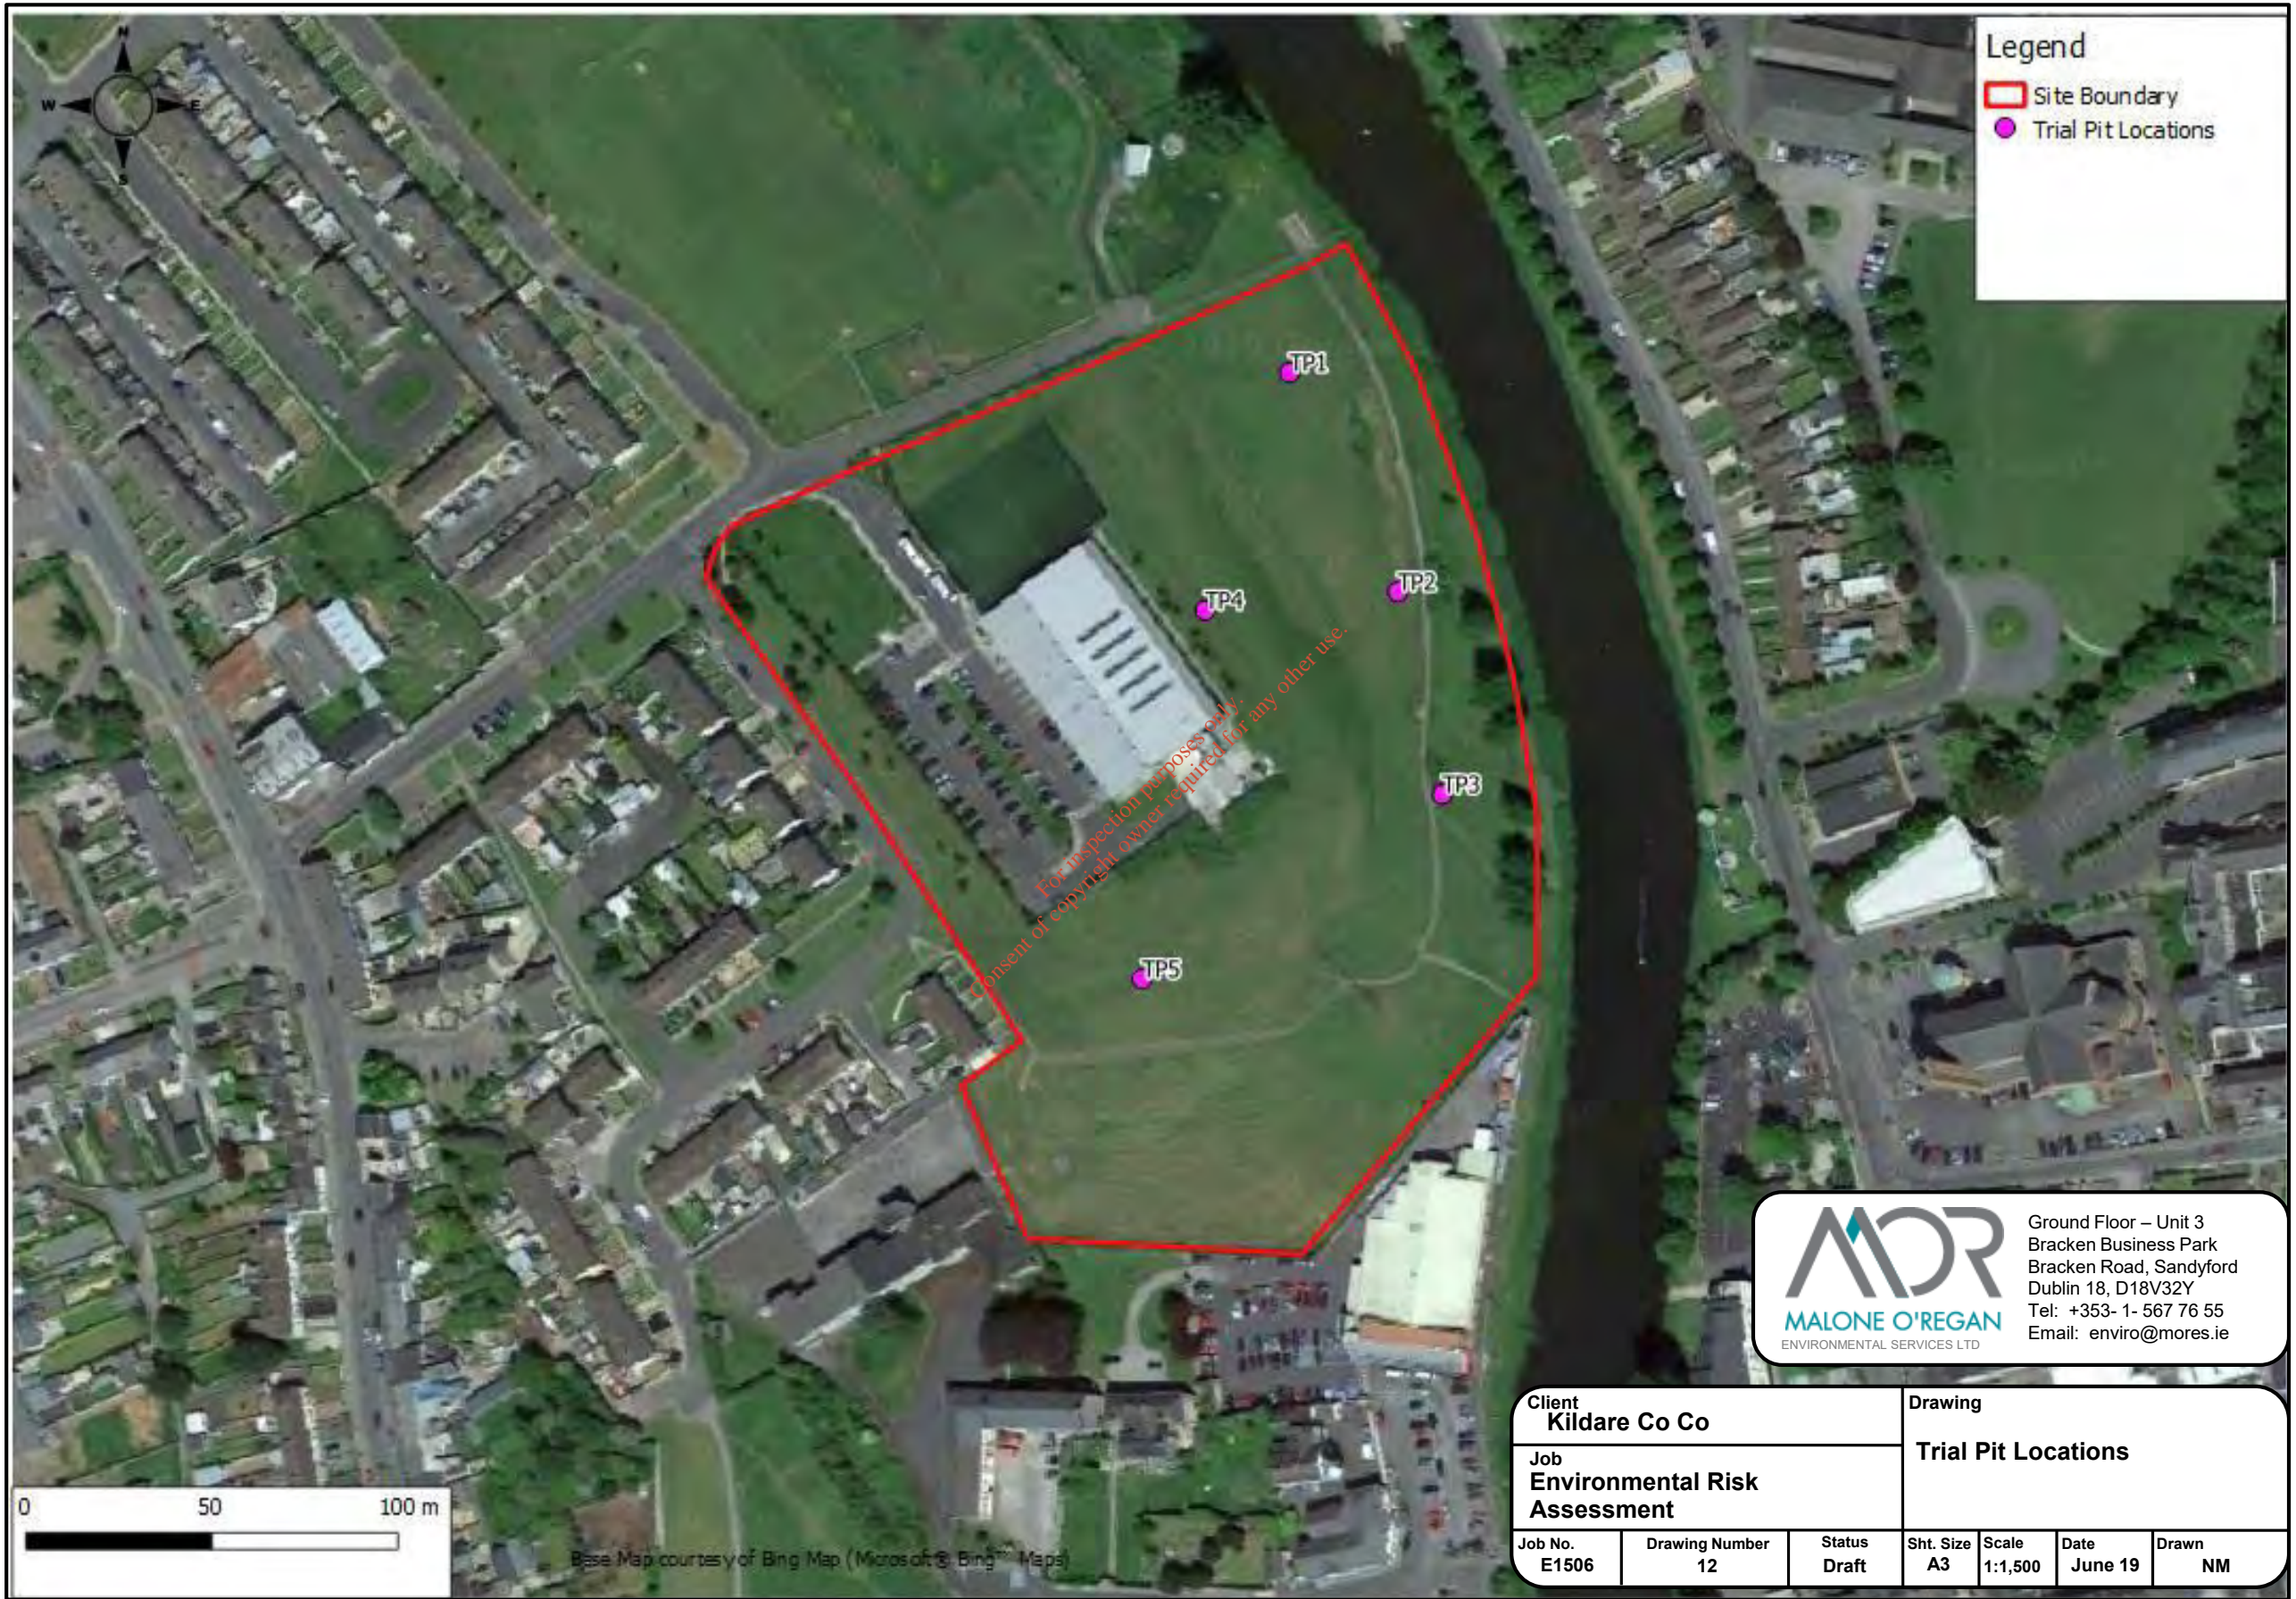
- Site Boundary
- Trial Pit Locations

The excavation of the trial pits to a maximum depth of approximately 4.4mbgl was undertaken using a 13-tonne tracked excavator. Each trial pit was logged in accordance with the BS 5930:2015 standards. Locations for the trial pits were selected based on initial discussions with KCC, findings of the desk-based studies, the site walkover and the results of the geophysical survey. Each trial pit was re-instated to as close to its original condition as possible. Exact locations are shown in Drawing No. 12. Refer to Appendix D for trial pit logs and also for photographic records of all trial pits. Two (2 No) profiles at the Site were recorded;

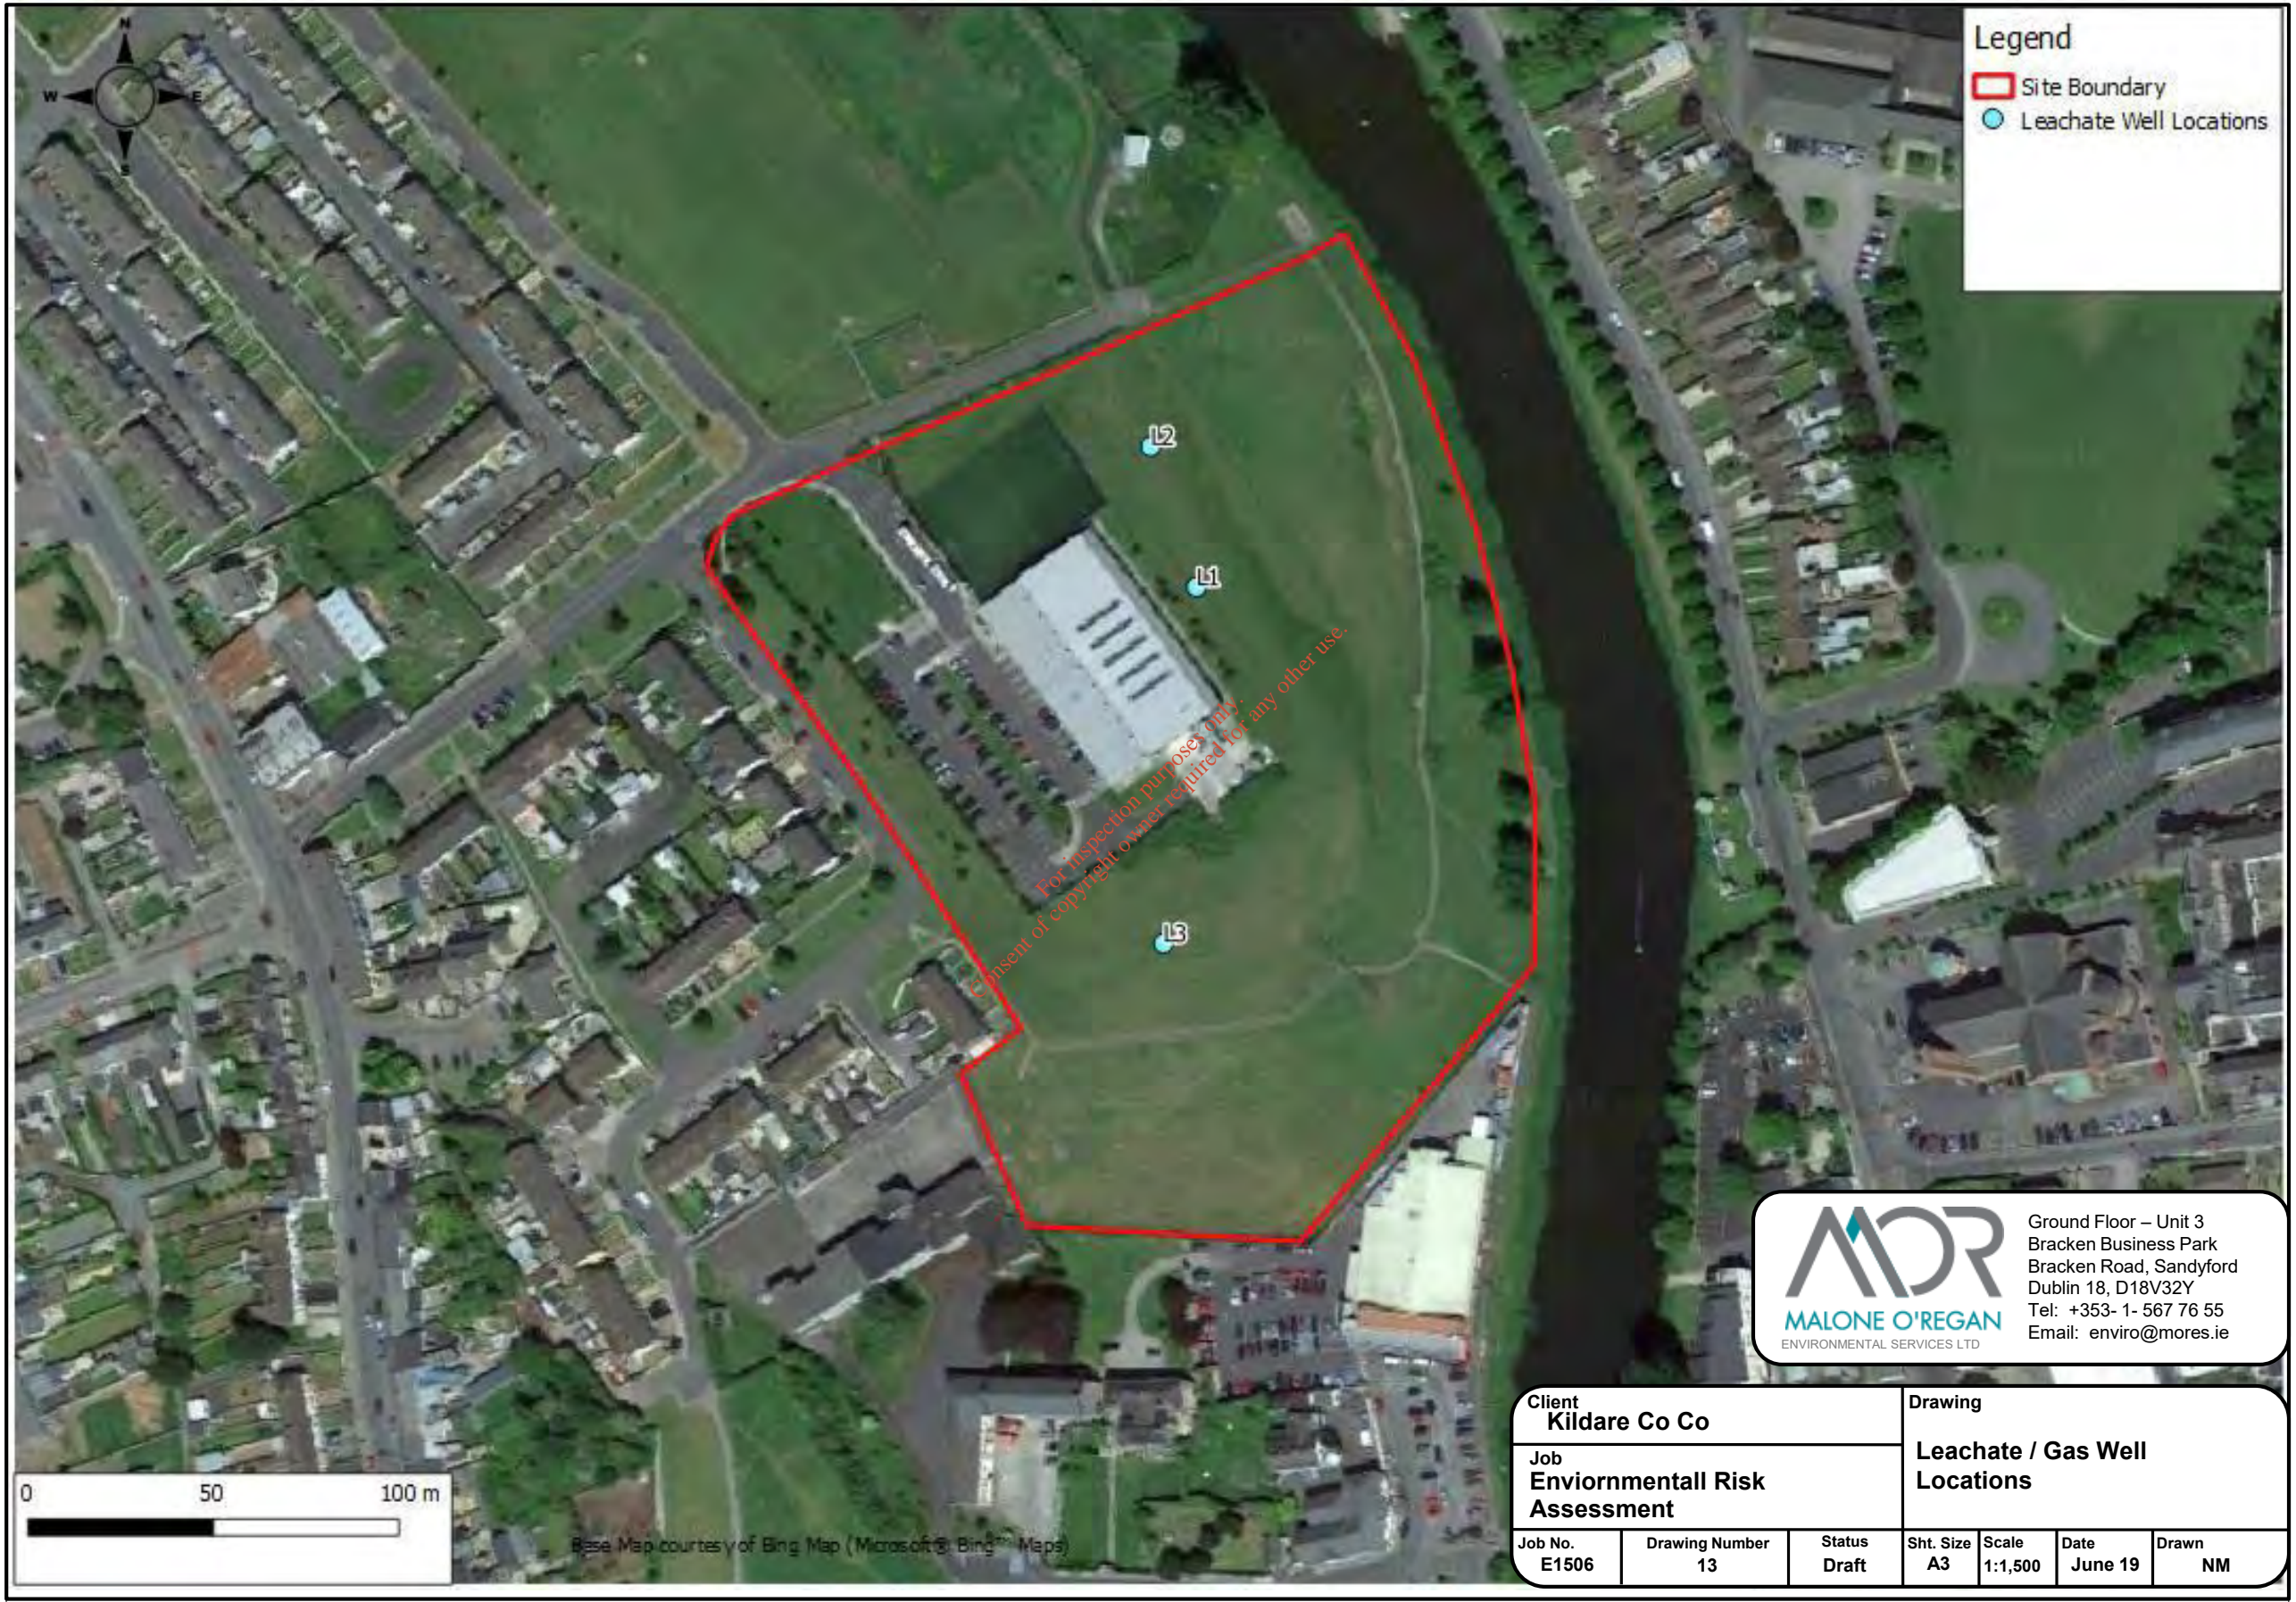
- Site Boundary
- Leachate Well Locations

A shell and auger rig was mobilised to the Site from the 3rd to the 8th of January 2019 to install shallow leachate/gas boreholes (L1 to L3). The three (3 No) combined leachate and gas monitoring wells were installed to 2.5 to 6.7mbgl. During the installation works the MOR consultant noted any field evidence of contamination through the soil/lithological profile to ensure that a conduit was not provided to the underlying aquifer. The borehole logs are shown in Appendix E. Refer to Table 5-3 for details on the installation and Drawing No. 13 for leachate/gas borehole locations.

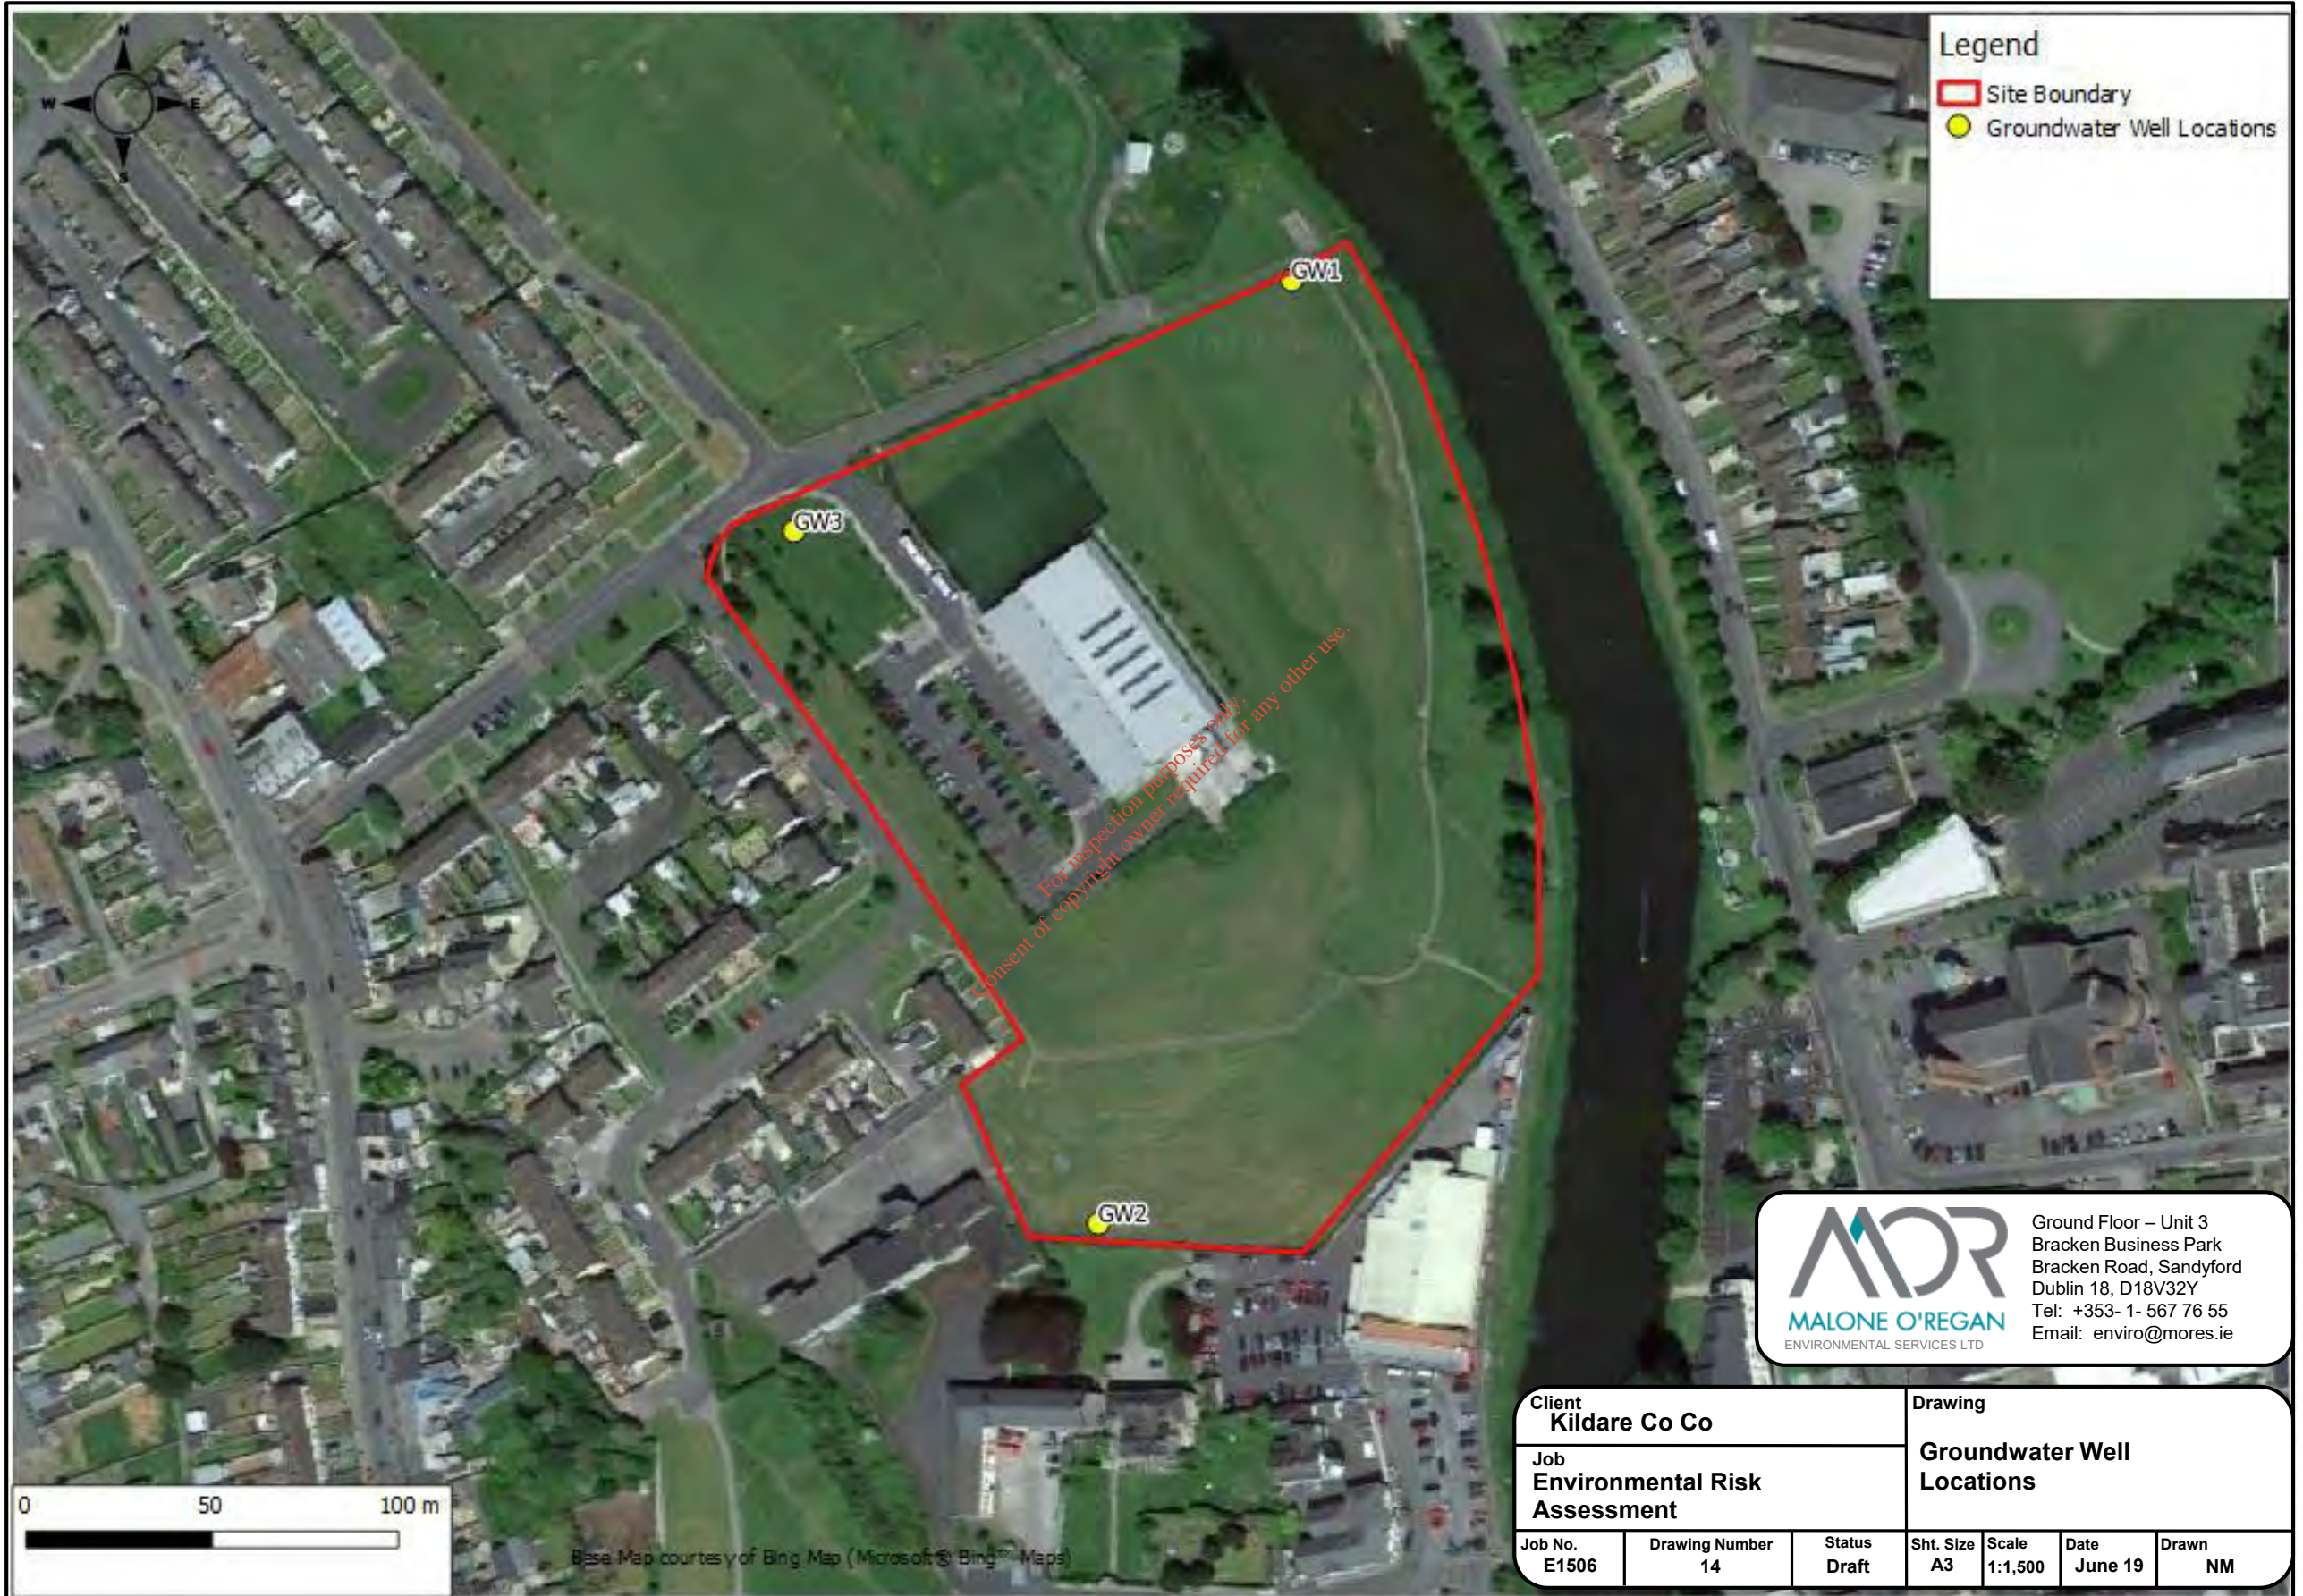
Client Kildare Co Co			Drawing			
Job Environmental Risk Assessment			Groundwater Well Locations			
Job No. E1506	Drawing Number 14	Status Draft	Sht. Size A3	Scale 1:1,500	Date June 19	Drawn NM

- Site Boundary
- Groundwater Well Locations

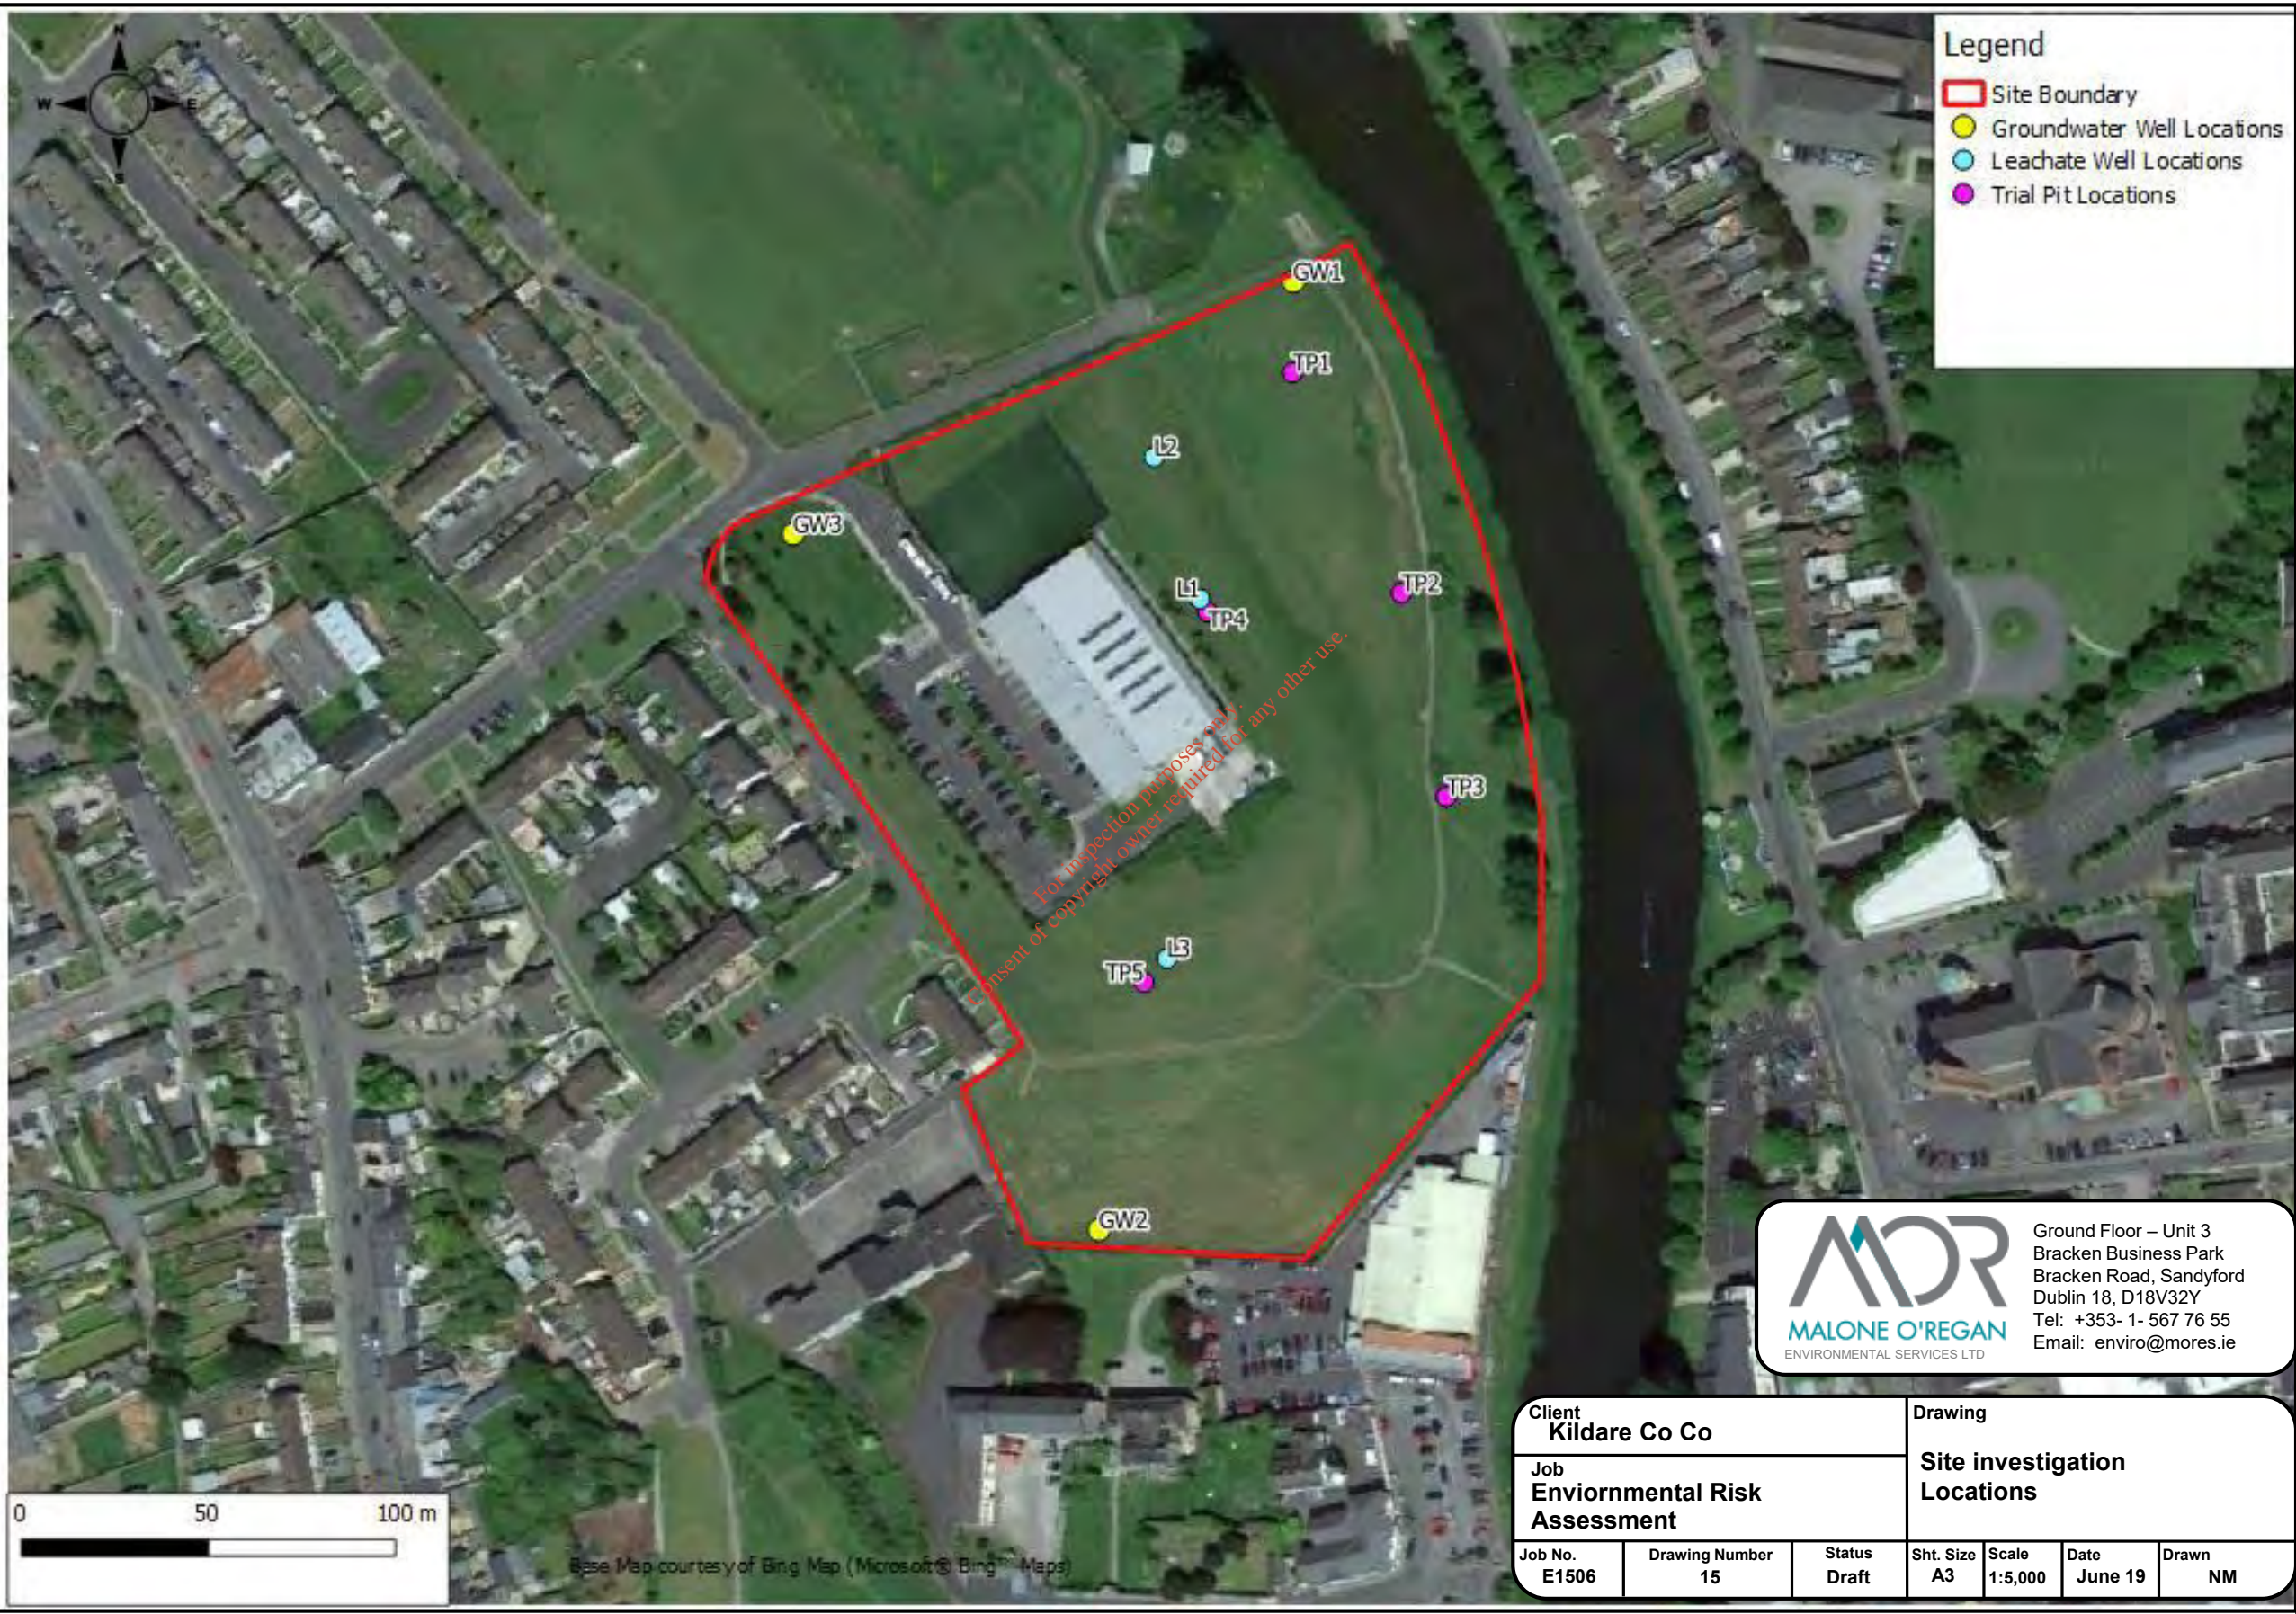
- Legend**
- Site Boundary
 - Groundwater Well Locations
 - Leachate Well Locations
 - Trial Pit Locations
